## Effect of Dredging and Axial Load on a Berthing Structure

**ABSTRACT:** Piles and a diaphragm wall of a supported berthing structure on marine soils are loaded both axially and laterally. Axial loads are typically generated by the self weight of the structure and external live loads; lateral loads are typically generated by wave current and seismic loads. These loads are generally considered in the design of berthing structures. However, the lateral force generated by lateral soil movements due to dredging may not be considered or accounted in the design of berthing structures. Hence, a full-scale field study was conducted on a berthing structure to estimate the actual axial load distribution during axial loading and the lateral displacement during dredging. After construction of the berth, it was decided to conduct a full scale axial load test on a single pile and monitor the lateral movements of the berth during and after dredging. This paper describes the load transfer data obtained from a bored cast – in – situ pile socketed 1.5 m into hard rock and the lateral displacement of the berth recorded during and after dredging to a -9.5 m dredge depth.

Muthukkumar K., Sundaravad

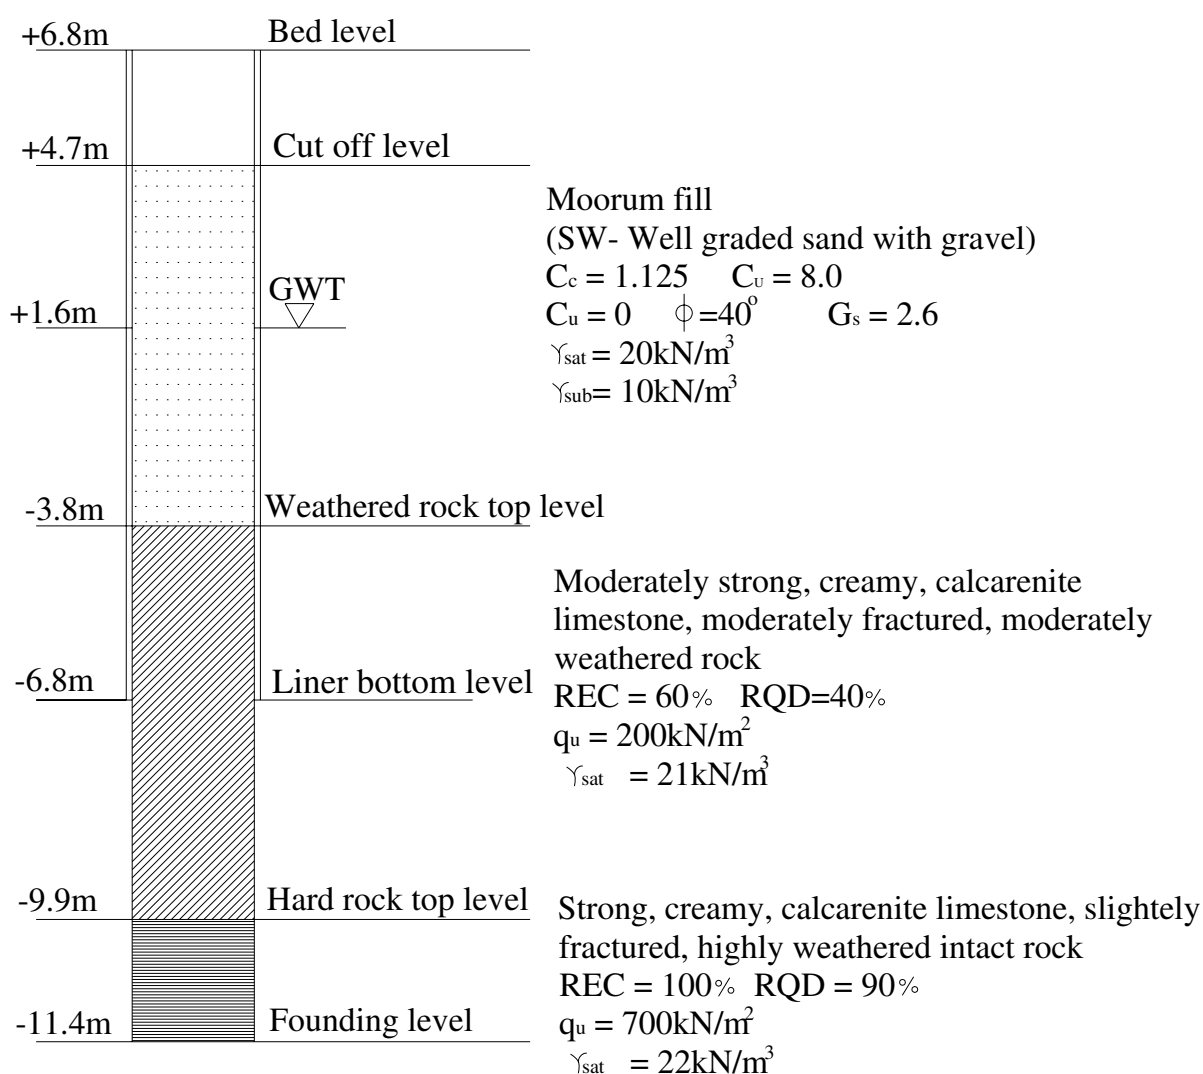
Figure 1. Typical Soil Profile at Pile Load Test Location.

A typical soil profile at the location of pile load test is shown in Fig. 1. The top 10.5 m consist of filled moorum soil, followed by rocky formation. The index and engineering properties of the encountered soils and rock are as follows.

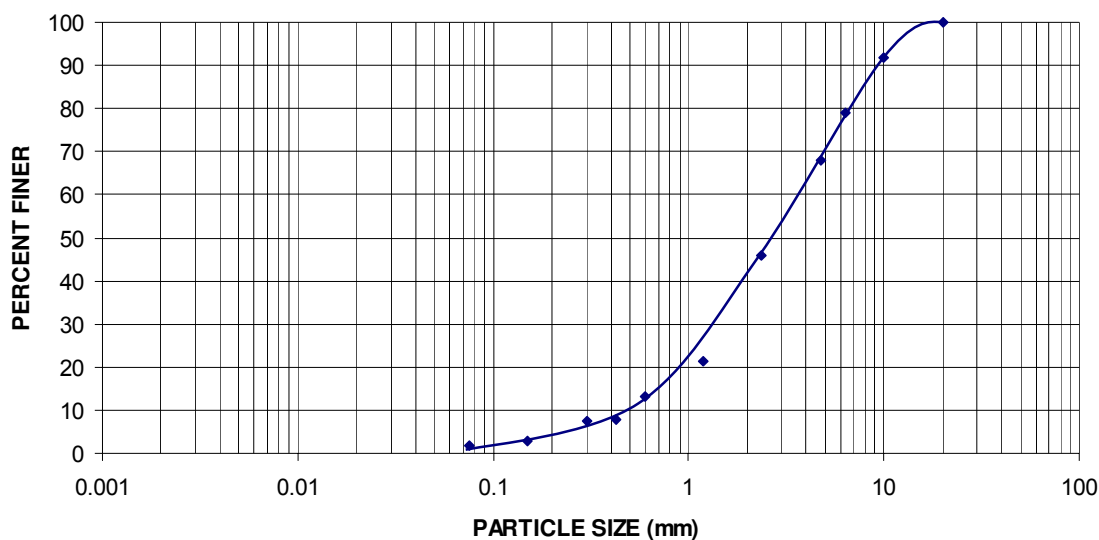
A typical grain size distribution curve of moorum fill is shown in Fig. 2. The effective particle size ( $D_{10}$ ) is 0.5 mm, average particle size ( $D_{50}$ ) is 2.7 mm, Coefficient of Uniformity ( $C_U$ ) is 8.0, Coefficient of Curvature ( $C_C$ ) is 1.125 and Specific Gravity ( $G_s$ ) is 2.6. As per ASTM D-2487, the moorum fill soil is classified as well graded sand with gravel (SW). To obtain the value of angle of internal friction, direct shear tests were conducted on the moorum soil. The average angle of internal friction of the moorum soil was estimated to be  $40^\circ$ . Typical direct shear test results are presented in Fig. 3.

Figure 2. Grain Size Distribution Curve for Moorum Soil.

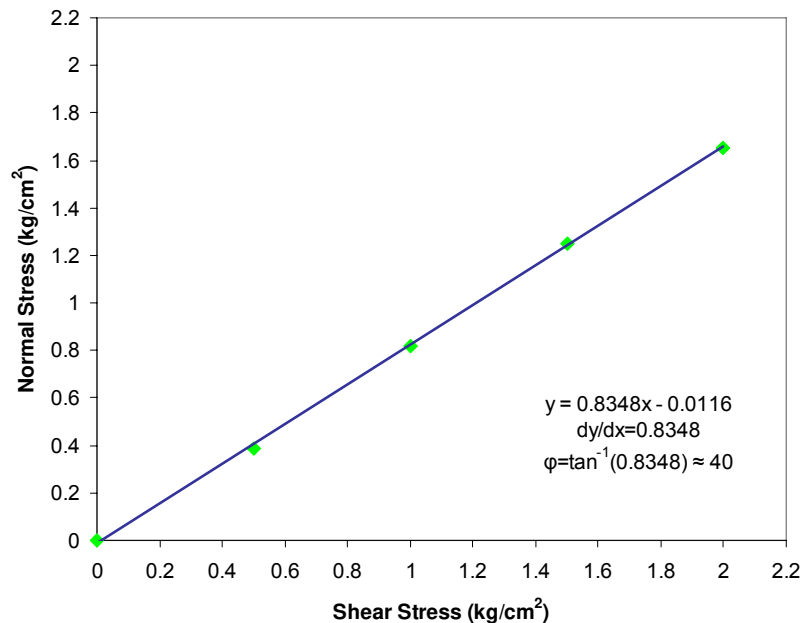
Figure 3. Direct Shear Test Result of Moorurum Soil.

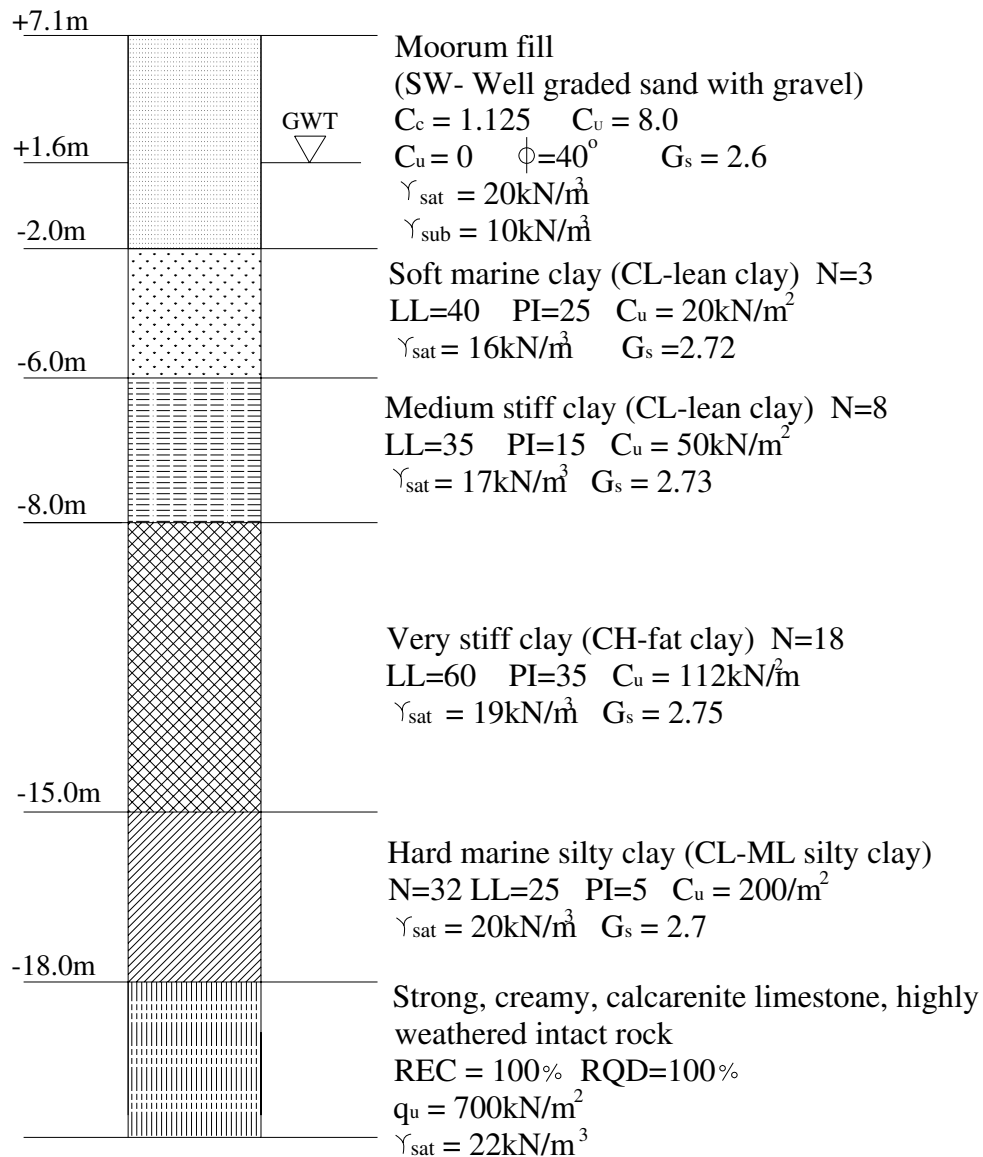
Fig. 4 shows the typical soil profile at the pile and diaphragm wall panel locations where the inclinometer was installed. The top soil is moorum fill of 9.1 m thickness followed by 4 m soft marine clay with an average SPT (N) value of 3, followed by 2 m thick medium stiff clay with an average SPT (N) value of 8, followed by 7 m thick, very stiff clay with an average SPT (N) value of 18. The clay is underlain by 3 m thick hard marine silty clay with an average SPT (N) value of 32 which in turn is underlain by strong, creamy, calcarenite limestone, highly weathered intact rock with REC value of 100% and RQD value of 100%. Based on the RQD values, the encountered rock formations are classified as excellent rock. The index and engineering properties of the moorum soil are identical to the pile load test location moorum soil, presented previously. The encountered fine-grained soils index and engineering properties are presented below.

Figure 4. Typical Soil Profile at Inclinator Test Locations.

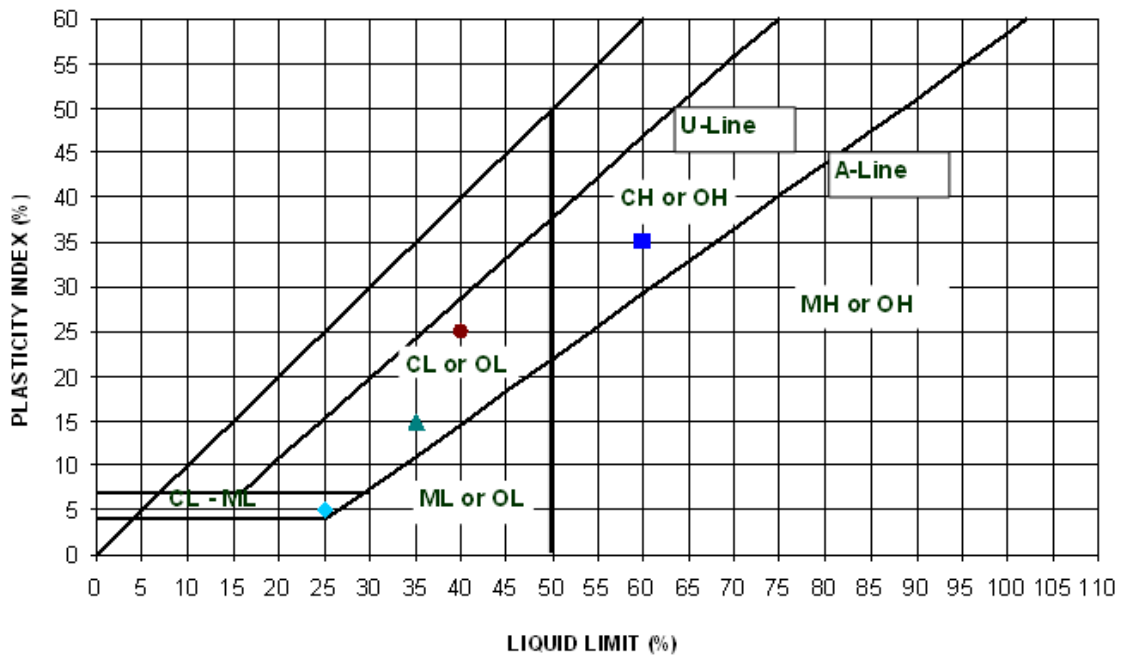
Elevation (m)	Symbol	LL (%)	PI (%)	Passing # 200 Sieve, (%)	USC Classification
-2.0 to -6.0	●	40	25	70	CL (Lean Clay)
-6.0 to -8.0	▲	35	15	60	CL (Lean Clay)
-8.0 to -15.0	■	60	35	80	CH (Fat Clay)
-15.0 to -18.0	◆	25	5	40	CL-ML (Silty Clay)

Figure 5. Classification of fine grained soil (ASTM D2487)

To obtain the index and engineering properties of the fine-grained soils, disturbed and undisturbed soil samples were collected at different depths. Liquid limit and plastic limit tests were conducted on the collected soil samples, to classify the soils based on the Unified Soil Classification System (USCS). The classification of the encountered fine grained soils is presented in Fig. 5. The undrained shear strength of the encountered fine grained soils was evaluated by conducting in-situ field vane shear tests in the soft clay soil and unconfined compression tests in the collected undisturbed soil samples. Two vane shear tests were conducted at elevations -2.0 m and -4.0 m. The average undrained shear strength of the layer (elevations between -2.0 m & -4.0 m) was obtained as 20 kN/m<sup>2</sup>. The vane shear computations are presented in the appendix. The unconfined compression tests were conducted on the undisturbed soil samples collected at elevations of -6.0 m, -8.0 m, -11.0 m, -13.0 m, -15.0 m and -17.0 m. The typical unconfined compressive strength variation plot for elevations of -6.0 m, -11.0 m and -15.0 m are shown in Fig. 6a, 6b and 6c respectively. The average undrained shear strength of lean

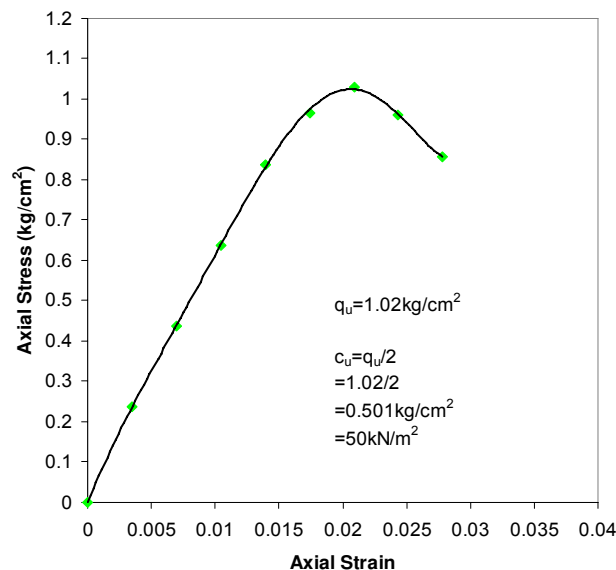
Figure 6a. Unconfined Compression Test Result at -6.0m depth.

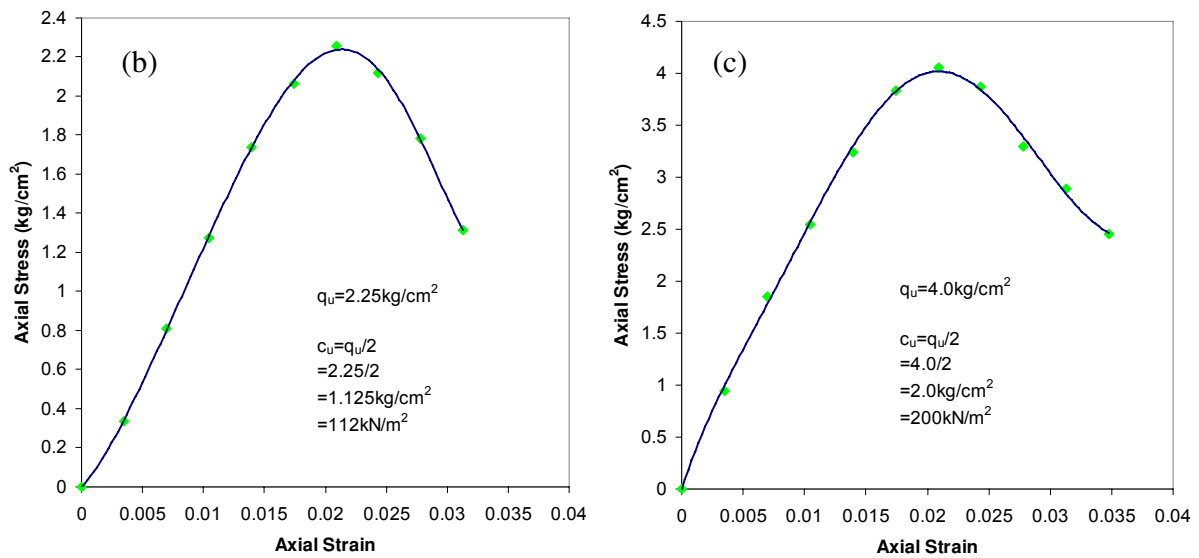
Figure 6b. Unconfined Compression Test Result at -11.0 m depth; 6c. Unconfined Compression Test Result at -15.0 m depth.

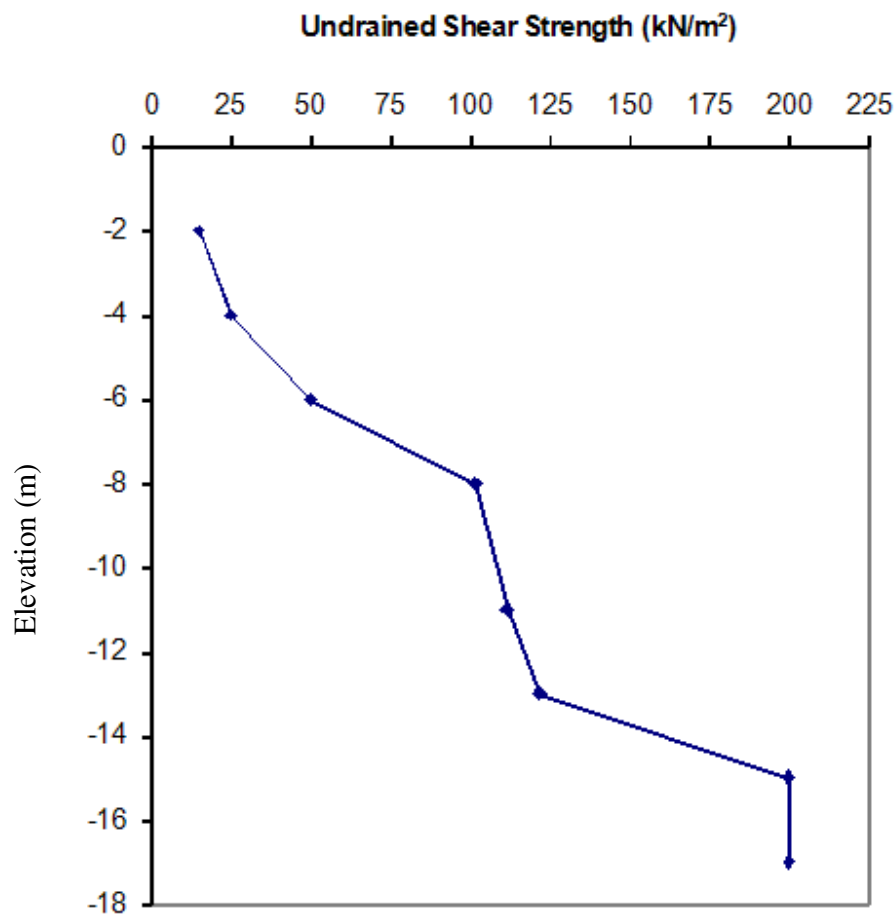
clay at elevations between -6.0 m and -8.0 m was estimated as 50 kN/m<sup>2</sup>. The average undrained shear strength value of fat clay at elevations between -8.0 m and -15.0 m was estimated as 112 kN/m<sup>2</sup>. The average undrained shear strength value of silty clay at elevations between -15.0 m and -18.0 m was estimated as 200 kN/m<sup>2</sup>. The undrained shear strength variation with elevation is shown in Fig. 7. The unconfined compressive strength computations are presented in the appendix.

Figure 7. Variation of Undrained Shear Strength with Depth.

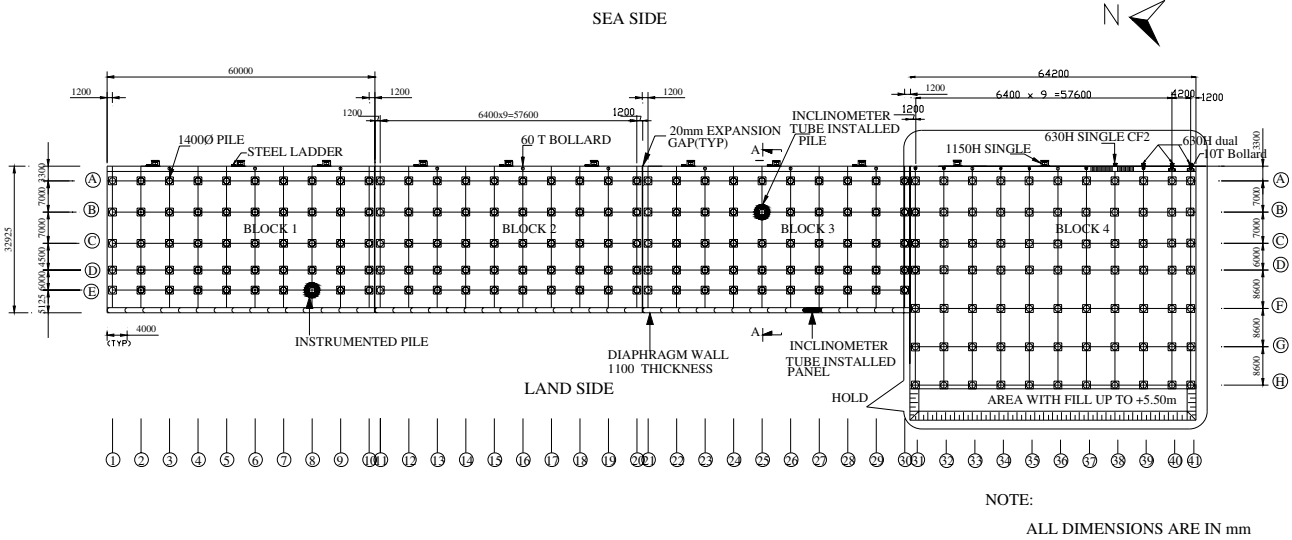
Figure 8. General Layout of Berthing Structure.

The general layout of the berthing structure and a cross section of the berth is shown in Fig. 8 and Fig. 9 respectively. The total length of the berth is 252 m and the width is 33 m. The berth is supported by both piles and the diaphragm wall. The diaphragm wall thickness is 1100 mm and extends to an elevation of -25.7 m. The construction of guide walls for the diaphragm wall is shown in Fig. 10. The diaphragm wall is constructed with the appropriate number of panels and each panel has a length of 5.0 m. Bored cast in-situ concrete piles of 1400 mm diameter are used and the founding elevation is varied between -11.4 m and -22.0 m based on the soil profile. The axial load test pile is terminated at an elevation of -11.4 m and the instrumented with inclinometer pile is terminated at an elevation of -22.0 m. The construction sequence of piles is shown in Fig. 11. The bored cast in-situ concrete piles were constructed using piling gantry. The natural seabed level at the structural location is +0.0 m elevation. To satisfy the berthing facility of the vessel, the ground level is required to be dredged up to an elevation of -9.5 m. The dredging was done in three stages, in each stage 3.0 m thick material is dredged. The inclinometer readings were collected when the water elevation in front of the structure was -3 m (prior to dredging) and -9.5 m (after -9.5 m dredging). Two sets of readings were collected at -9.5 m elevation, one immediately after dredge level reached an elevation of 9.5 m and the other 3 months after the first set of readings to evaluate time effects.

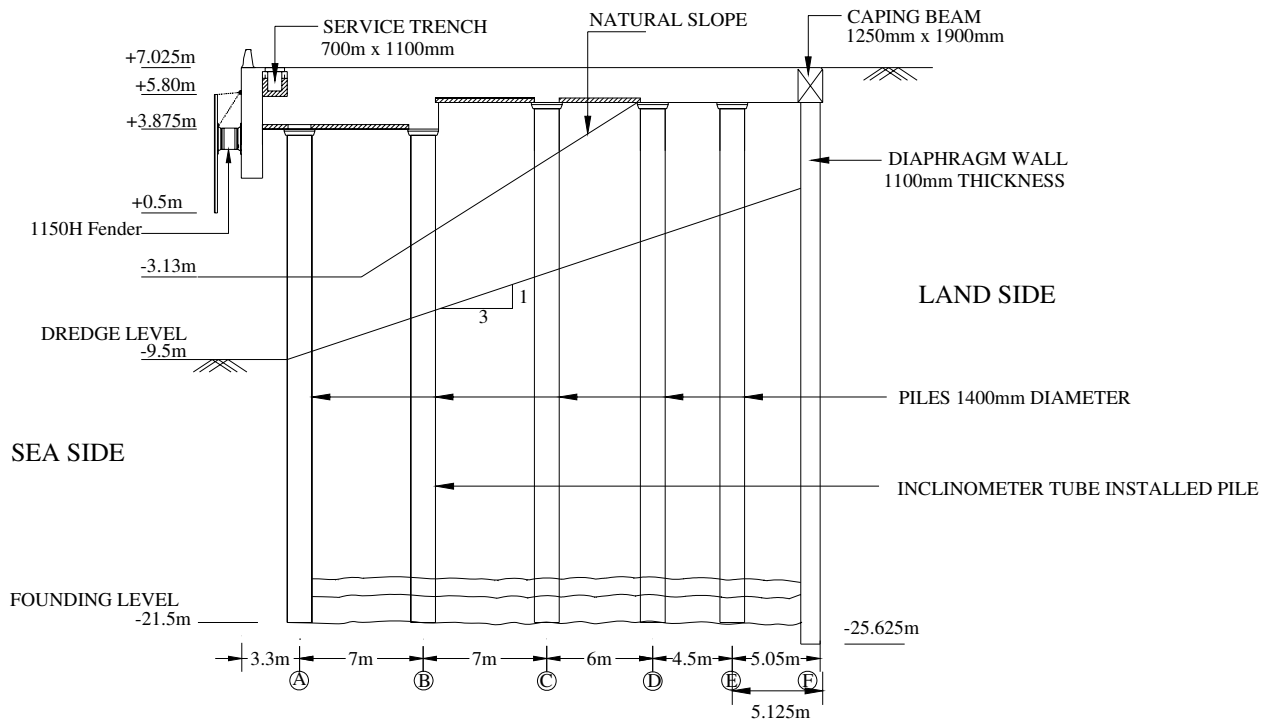
Section A-A  
Figure 9. Typical Cross Section of Berth.

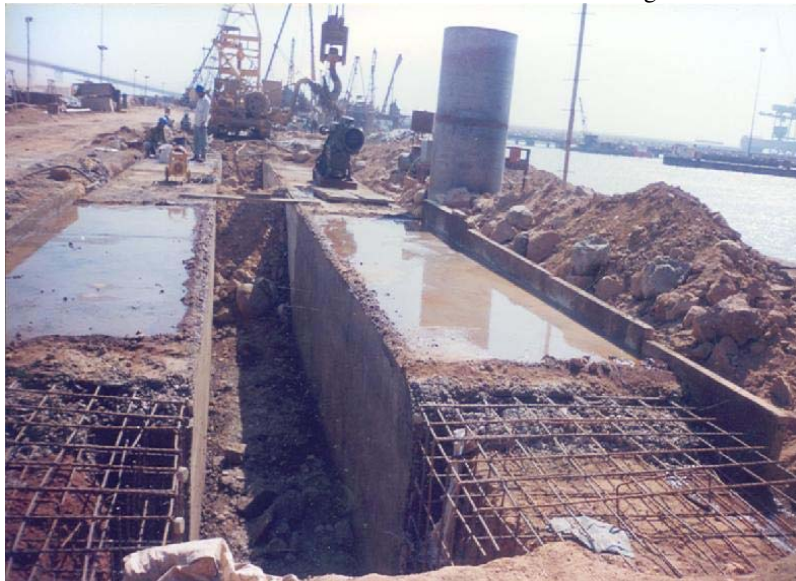
Figure 10. Construction Of Guide Walls For Diaphragm Wall.

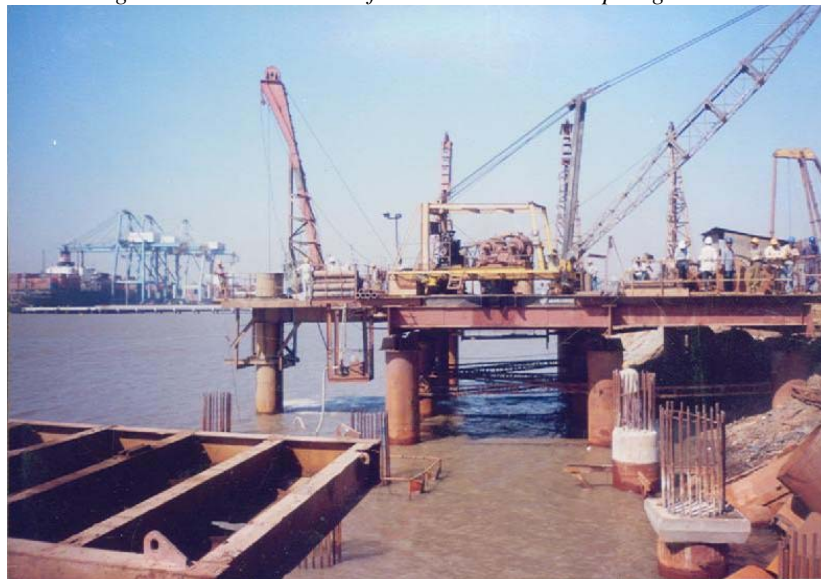
Figure 11. Construction of Piles.

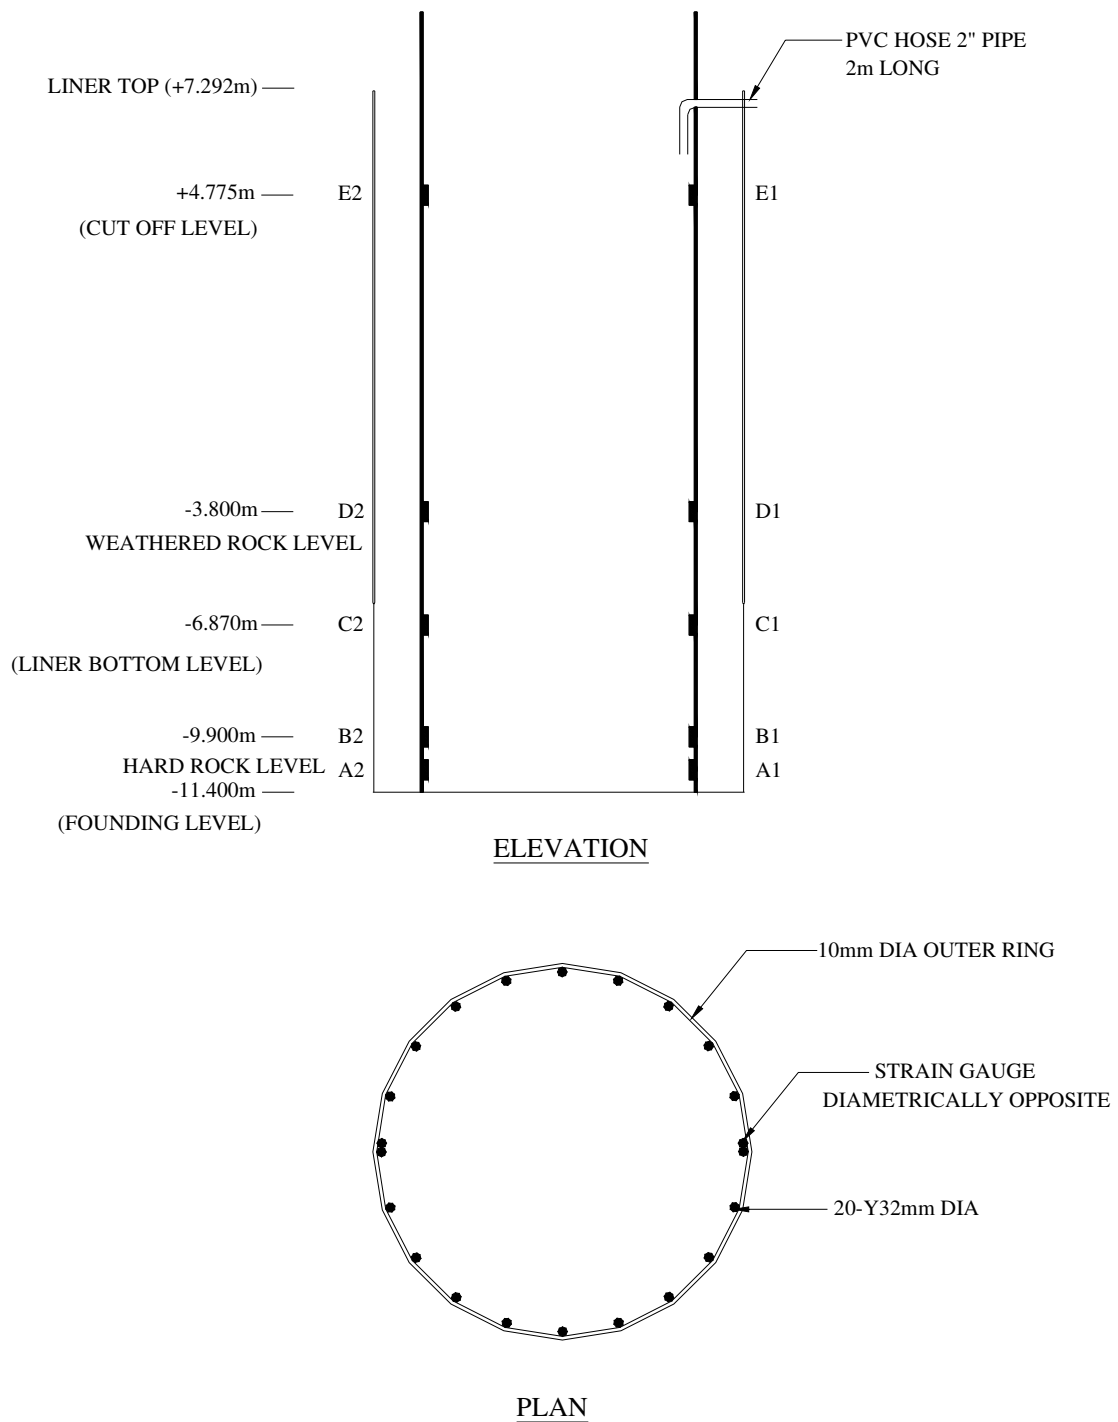
Figure 12. Pile Instrumentation with Strain Gauges.

The test pile is instrumented with electrical resistance type strain gauges. The gauges are attached at five different elevations as shown in Fig. 12. Two diametrically opposite main reinforcement rods are selected to mount the strain gauges. After mounting the gauges, the electric cable from each gauge is safely secured along the reinforcement bar to minimize the possibility of damage by the Tremie pipe during concreting. The cables of the gauges on the same reinforcement rod are bundled together and tied with a plastic wire to the reinforcement rod every 30 cm. The electric cables have a minimum length of 5 m beyond the cut off length to enable connection to the measuring instrument during the load test. All the strain gauges are aligned vertically.

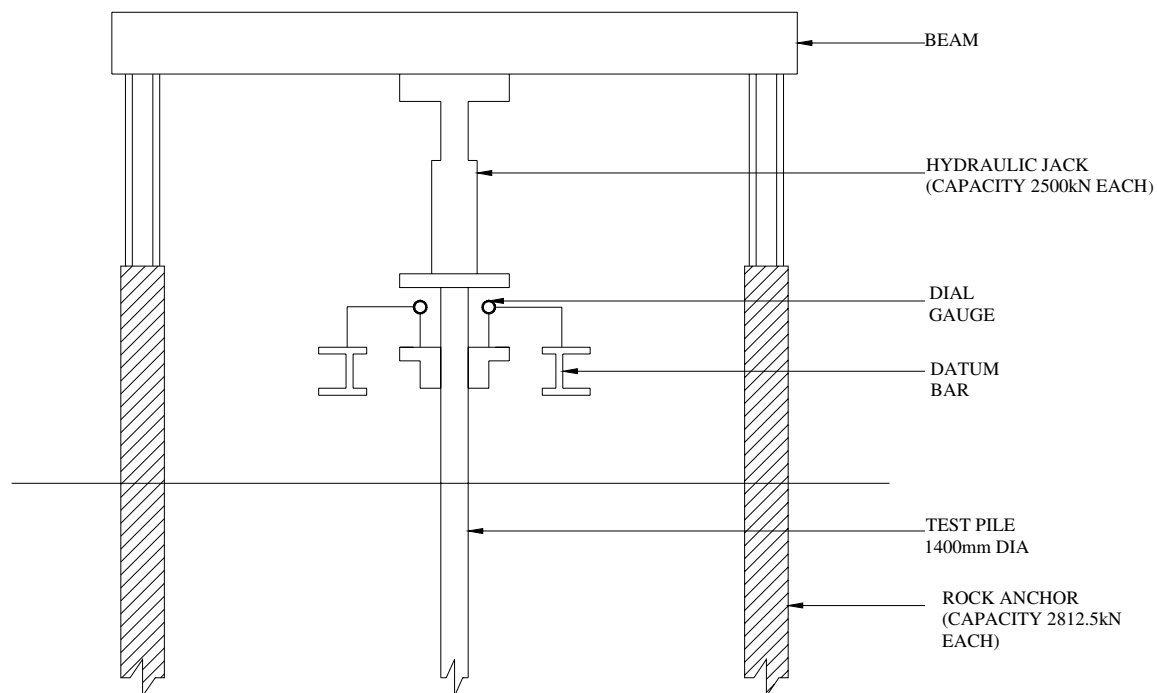
For the axial load test, the load applied on the test pile is obtained by the reaction forces from 4 pre-stressed rock anchors. Each anchor has a capacity of 2812.5 kN. The load on the pile is applied via 4 hydraulic jacks each of 2500 kN capacity. The settlement of the pile is recorded by 4 fixed dial gauges located at the same distance from the center of the pile. These dial gauges are installed on two datum bars with immovable support, at a distance of 3.6 m from the edge of the pile. A schematic view of the pile load test arrangement is shown in Fig. 13.

Figure 13. Schematic View of Pile Load Test Arrangement.

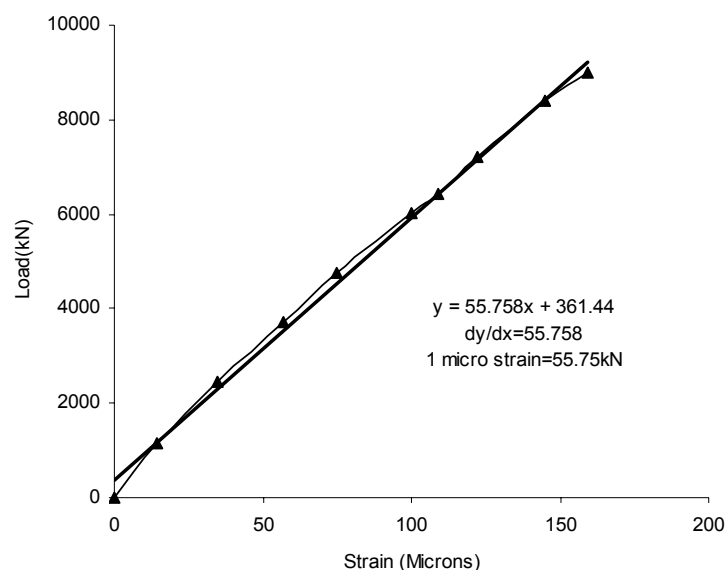
load test, the axial strain of the pile at each level was measured by the read out unit for every increment of loading. Strain gauge readings were taken 10 to 15 minutes after the load increment was applied. To estimate the mobilization of axial load along the pile shaft, the measured strain readings were converted to equivalent axial load by using a calibration constant. To obtain the calibration constant, one strain gauge was embedded in a concrete cylinder of 150 mm diameter and 300 mm long. The strain gauge was oriented such that the axis of strain gauge was parallel to the concrete cylinder axis. The cylinder was cured for 28 days and then tested in compression. The strain readings were observed to be almost linear with applied load. Fig. 14 shows the load as a function of strain. From the graph, the calibration constant of 55.75 kN was obtained, 1 micro strain being equal to 55.75 kN load.

Figure 14. Strain Gauge Calibrations.

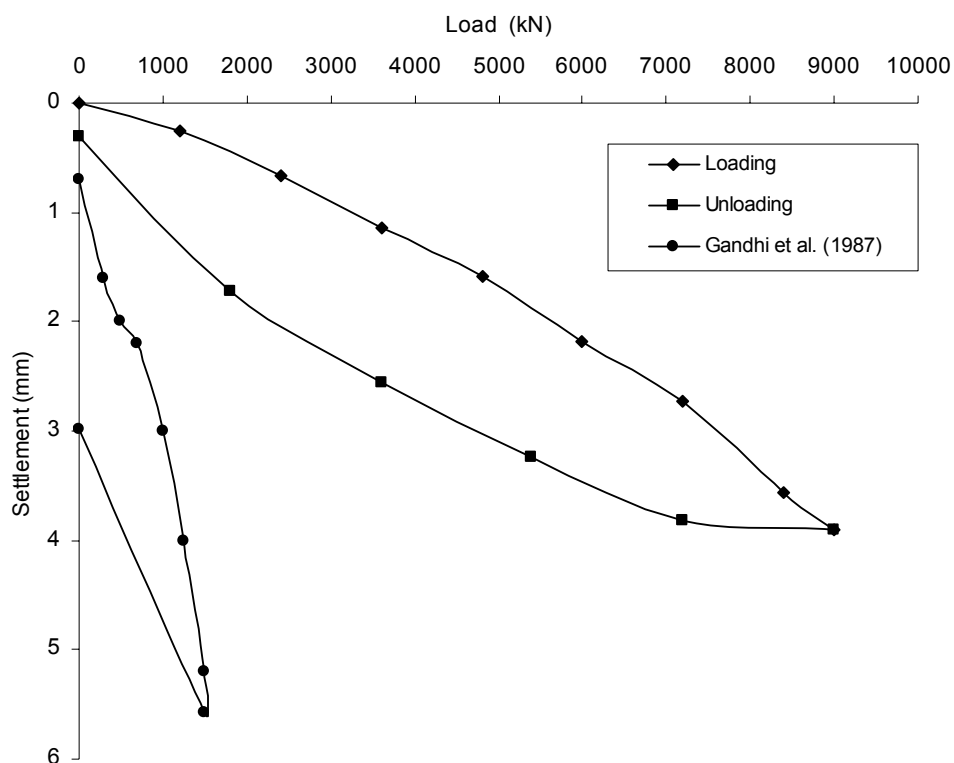
The pile was tested up to 1.5 times the design load, i.e., up to 9000 kN. The load settlement curve is shown in Fig. 15. As per IS 2911 (Part-4) 1985, the maximum settlement at working load (1.5 times design load) may not exceed 12 mm. In the present study, the total settlement was 3.9 mm, rebound was 3.6 mm and net settlement was 0.3 mm, indicating that the pile

behaved well and has not reached its capacity. The pile load test results were compared to the Gandhi et al. (1987) pile load test results, which are also shown in Fig. 15. As presented in that paper, the pile load test was conducted on a 6.5 m long and 0.5 m diameter pile. Out of the 6.5 m, 0.5 m are socketed in hard rock strata. The test was conducted at the NALCO project site, Angul in India. The soil profile at this location includes 3.0 m of red soil with an average SPT (N) value 35, followed by yellowish grey weathered rock with SPT (N) values of about 100. Dark grey hard rock is present at 6.0 m below the ground level. The subsurface stratigraphy of the present study area (JNPT, Mumbai) and Gandhi et al. (1987) study area (NALCO project site, Angul) are not the same and thus, the load-settlement response of the test piles is different.

Figure 15. Load Settlement Curve.

- (1) The total settlement of 3.9 mm was within the settlement limit of 12 mm as per IS 2911 (Part-4) 1985, which indicates that the pile has not reached its capacity.

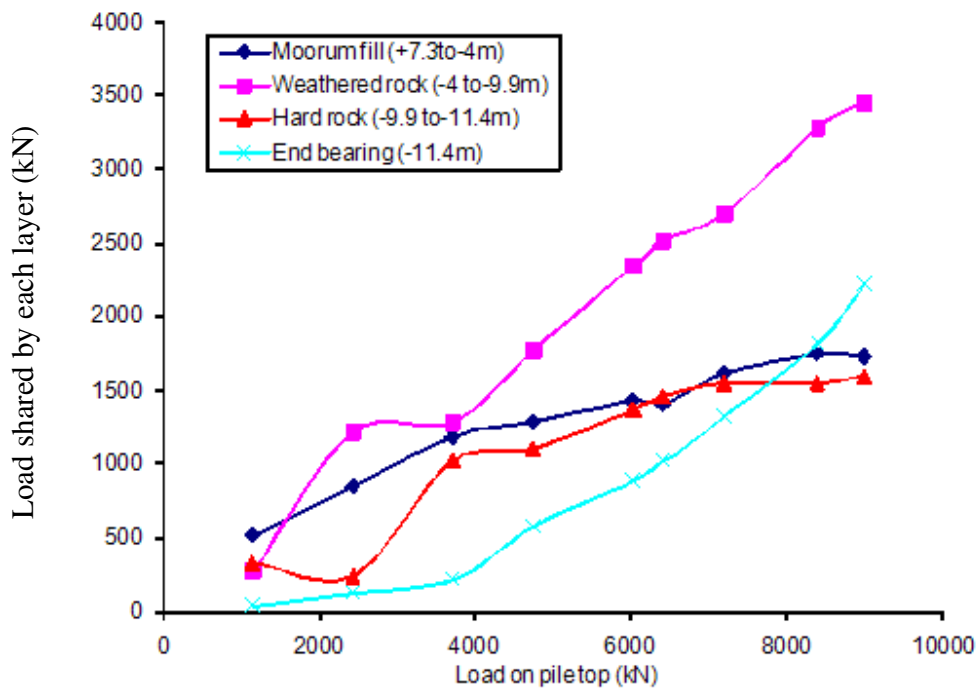
Fig. 17 shows the load shared by each layer for all applied load increments. For all cases except the load increment of 8400 kN and 9000 kN, the frictional resistance was significantly increased in all soil layers compared to the end bearing resistance. For the test load of 9000 kN, the end bearing resistance was higher than the frictional resistances of the moorum fill and the hard rock. However, the mobilization of end bearing was less than the frictional resistance in weathered rock. Nearly 75% of the load is resisted by friction and 25% of the load is resisted by end bearing. The weathered rock contributed about 20% to 45% of the total pile resistance.

Figure 17. Axial Load Shared by Each Layer.

- (2) The weathered rock at the site offered substantial frictional resistance, i.e. about 20% to 45% of the total resistance.
- (3) A maximum of 75% load is mobilized by frictional resistance and the remaining 25% load is mobilized by the end bearing resistance. At higher loads the contribution of the end bearing resistance increases.
- (4) The use of strain gauges was successful in measuring the axial load distribution in concrete piles.

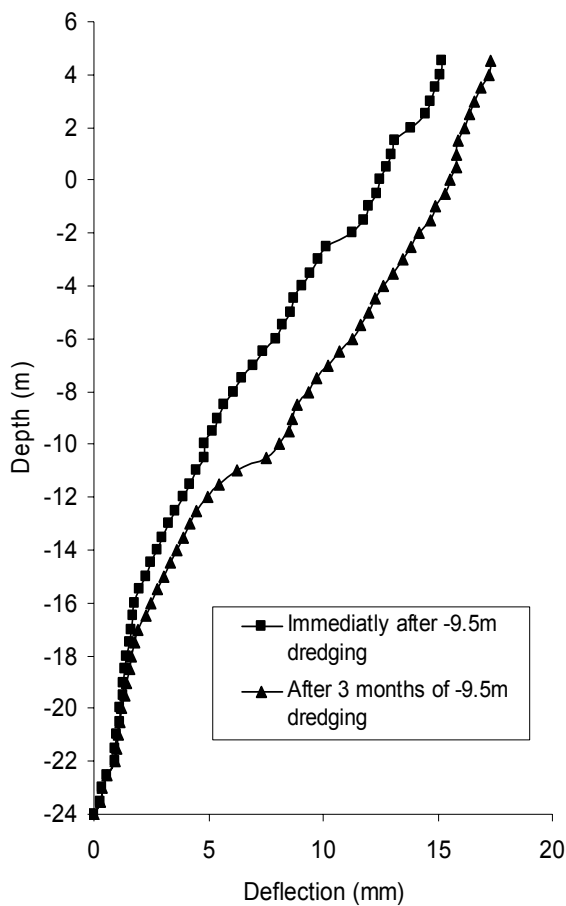
After construction of the full berth, the inclinometer readings were collected in 3 stages. First set of readings were taken after construction of the berth and prior to dredging. This reading represents the initial position of the diaphragm wall and pile. The second readings were collected immediately after dredging to an elevation of -9.5 m. The difference between the second and first reading is the deflected shape of the diaphragm wall panel and pile. The third readings were collected 3 months after dredging to an elevation of -9.5 m. The difference between the third and second reading is shown in Fig. 18 and 19.

It can be observed that for the diaphragm wall immediately after -9.5 m dredging, the maximum deflection is 15.2 mm at the level of +4 m, while at the same level the maximum deflection increased to 17.3 mm after three months. The increase in deflection is probably due to the consolidation and associated pore pressure dissipation effects of the soft clayey soil. The same behavior was observed for the pile also. For both the pile and the diaphragm wall the deflection from -16 m elevation and lower is small compared to the upper layers due to the lower hard layers of marine silty clay and rock.

Figure 18. Deflected Shape of Diaphragm Wall.

- (1) The maximum deflection of 30 mm was measured in the berthing structure after dredging to an elevation of -9.5 m. The permissible lateral movement of the berthing structure was 150 mm and thus the deflections observed were considered small.
- (2) About 87% of the maximum deflection was mobilized at the soft top layers, probably due to the presence of the underlying harder ground materials.

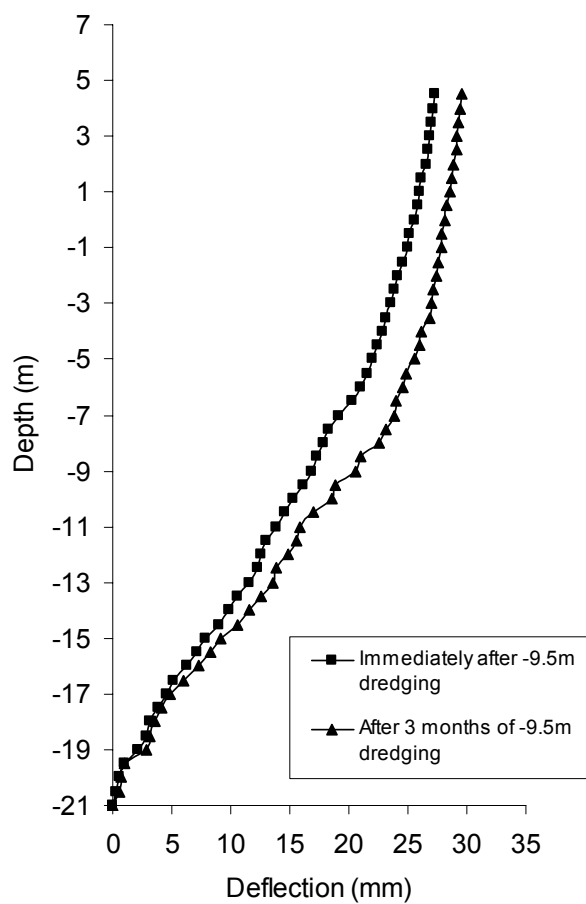
Figure 19. Deflected Shape of Pile.
