## Effect of Dredging and Axial Load on a Berthing Structure

Muthukkumaran K., Sundaravadivelu R., Gandhi S.R. (2007). *Effect of Dredging and Axial Load on a Berthing Structure*. International Journal of Geoengineering Case histories, <http://casehistories.geoengineer.org>, Vol.1, Issue 2, p.73-88.

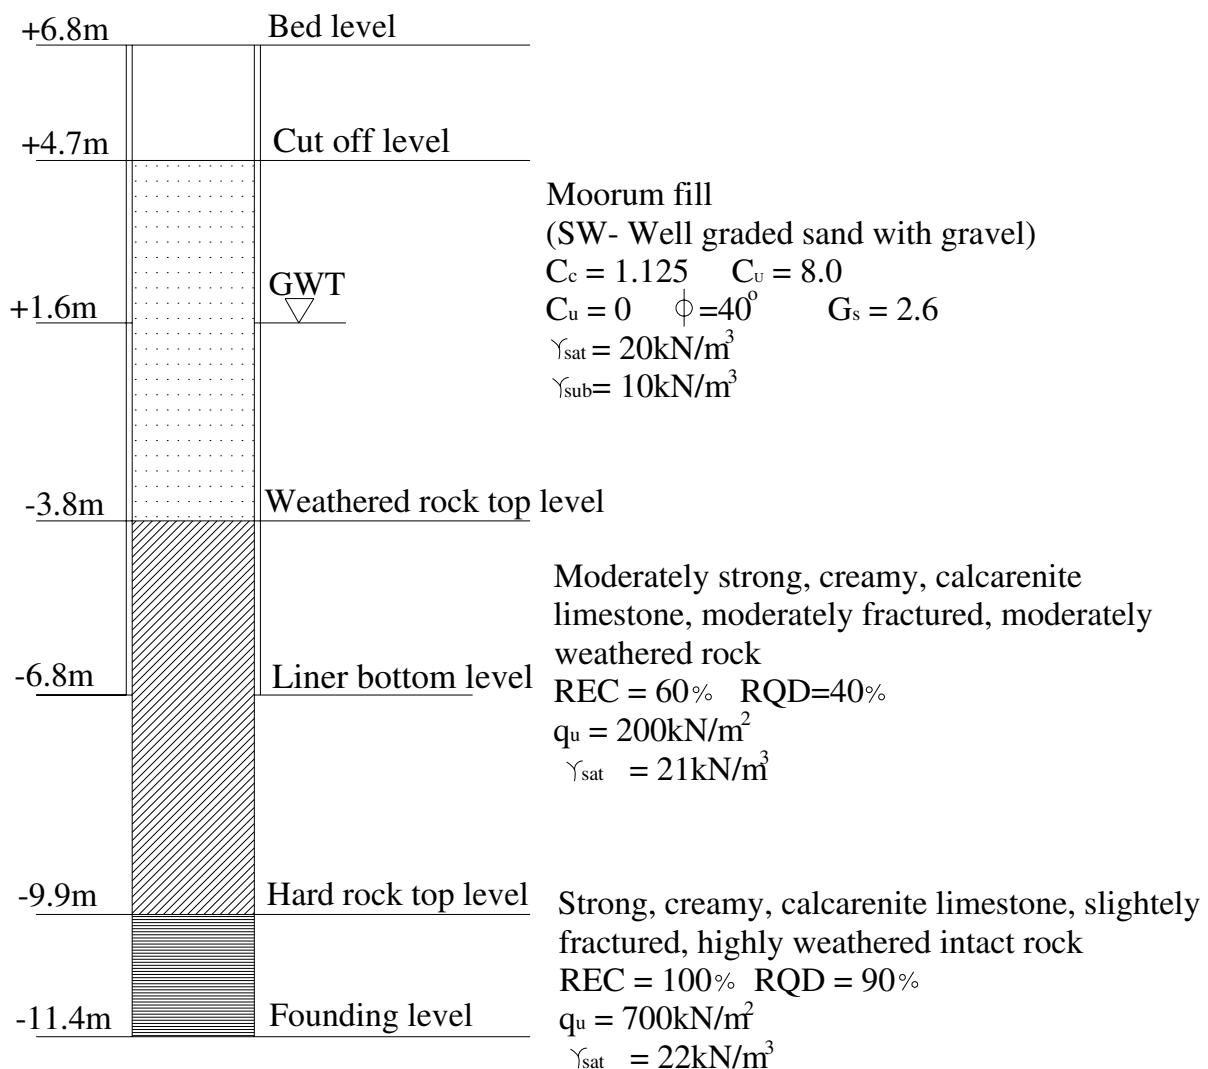
Figure 1. Typical Soil Profile at Pile Load Test Location.

A typical soil profile at the location of pile load test is shown in Fig. 1. The top 10.5 m consist of filled moorum soil, followed by rocky formation. The index and engineering properties of the encountered soils and rock are as follows.

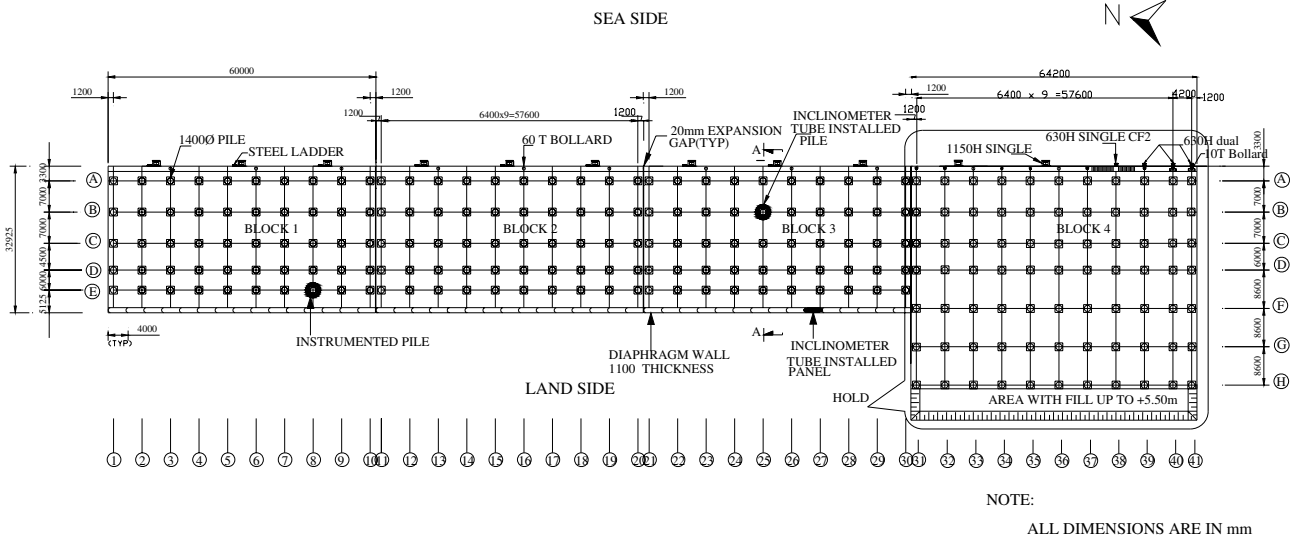
Figure 8. General Layout of Berthing Structure.

The general layout of the berthing structure and a cross section of the berth is shown in Fig. 8 and Fig. 9 respectively. The total length of the berth is 252 m and the width is 33 m. The berth is supported by both piles and the diaphragm wall. The diaphragm wall thickness is 1100 mm and extends to an elevation of -25.7 m. The construction of guide walls for the diaphragm wall is shown in Fig. 10. The diaphragm wall is constructed with the appropriate number of panels and each panel has a length of 5.0 m. Bored cast in-situ concrete piles of 1400 mm diameter are used and the founding elevation is varied between -11.4 m and -22.0 m based on the soil profile. The axial load test pile is terminated at an elevation of -11.4 m and the instrumented with inclinometer pile is terminated at an elevation of -22.0 m. The construction sequence of piles is shown in Fig. 11. The bored cast in-situ concrete piles were constructed using piling gantry. The natural seabed level at the structural location is +0.0 m elevation. To satisfy the berthing facility of the vessel, the ground level is required to be dredged up to an elevation of -9.5 m. The dredging was done in three stages, in each stage 3.0 m thick material is dredged. The inclinometer readings were collected when the water elevation in front of the structure was -3 m (prior to dredging) and -9.5 m (after -9.5 m dredging). Two sets of readings were collected at -9.5 m elevation, one immediately after dredge level reached an elevation of 9.5 m and the other 3 months after the first set of readings to evaluate time effects.

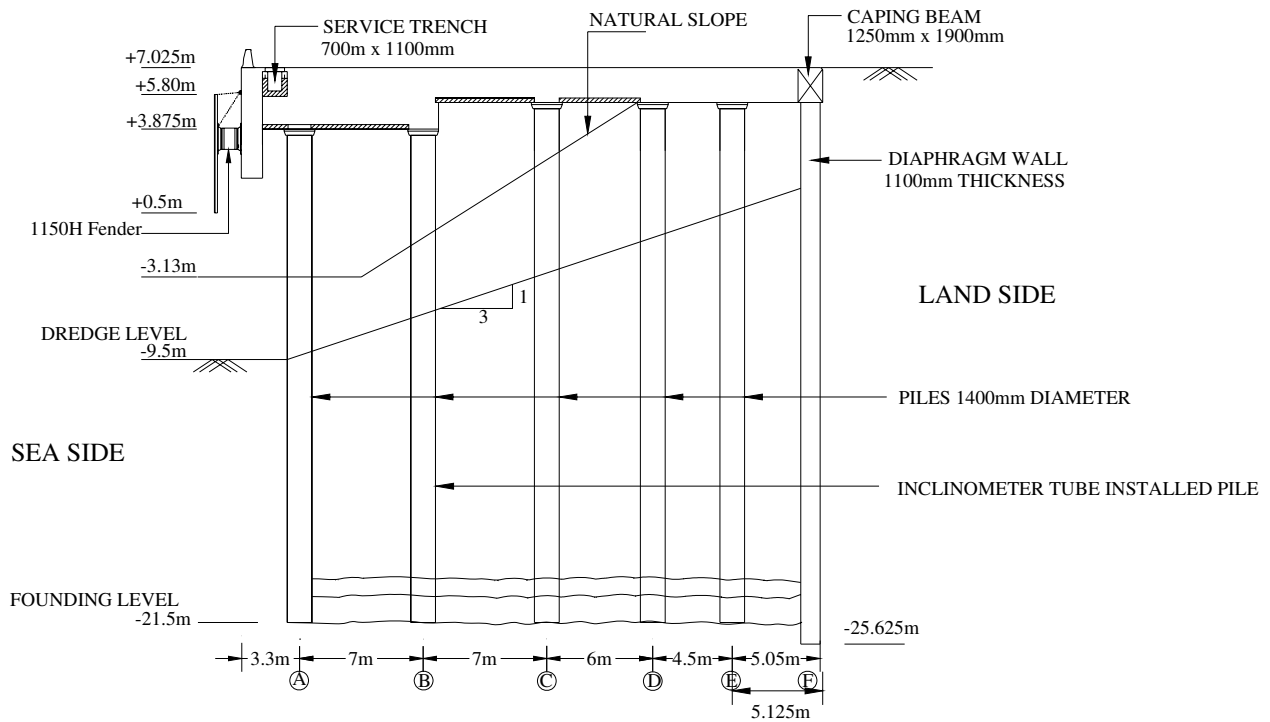
Section A-A  
Figure 9. Typical Cross Section of Berth.

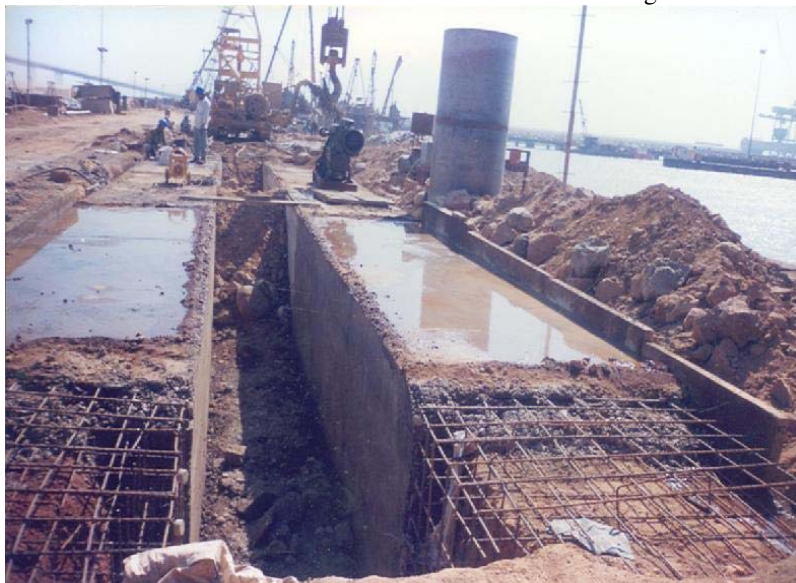
Figure 10. Construction Of Guide Walls For Diaphragm Wall.

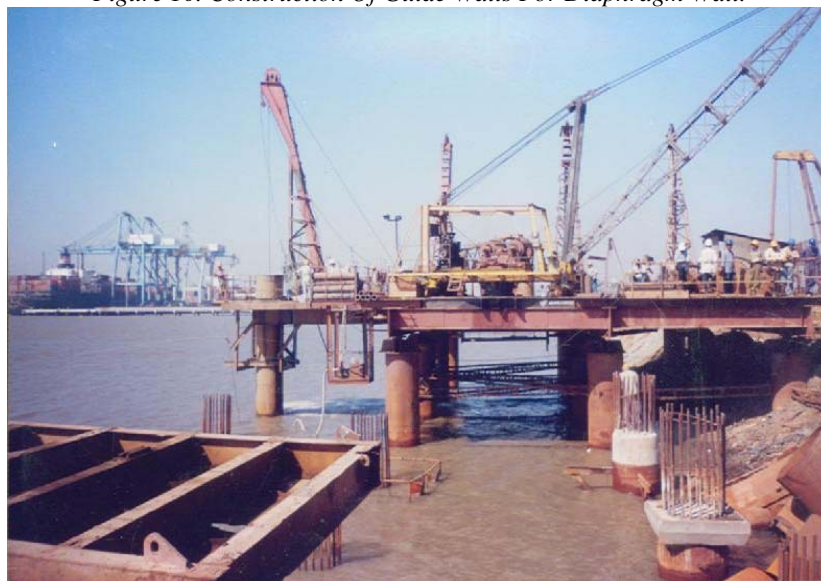
Figure 11. Construction of Piles.

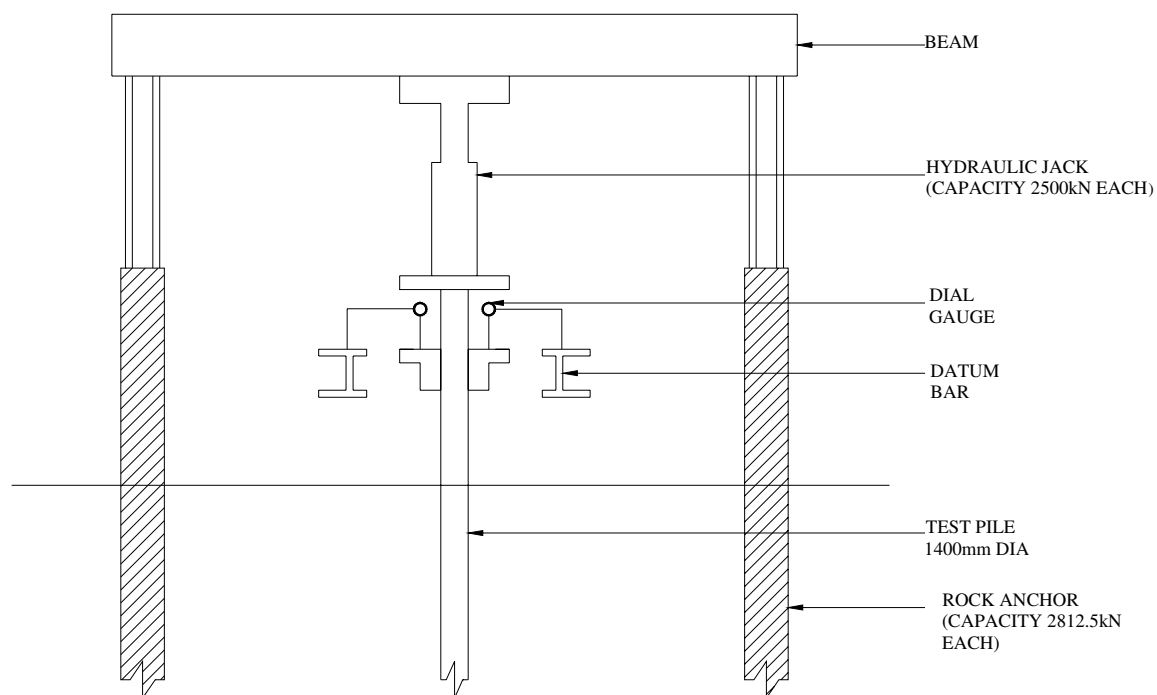
Figure 13. Schematic View of Pile Load Test Arrangement.

For the axial load test, the load applied on the test pile is obtained by the reaction forces from 4 pre-stressed rock anchors. Each anchor has a capacity of 2812.5 kN. The load on the pile is applied via 4 hydraulic jacks each of 2500 kN capacity. The settlement of the pile is recorded by 4 fixed dial gauges located at the same distance from the center of the pile. These dial gauges are installed on two datum bars with immovable support, at a distance of 3.6 m from the edge of the pile. A schematic view of the pile load test arrangement is shown in Fig. 13.

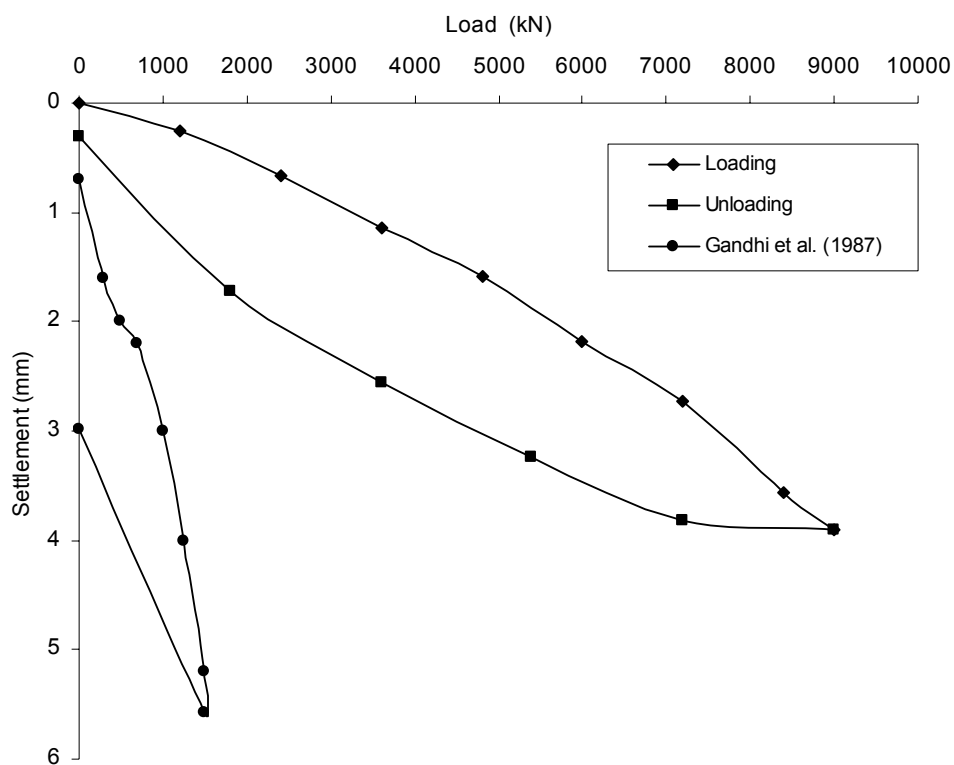
Figure 15. Load Settlement Curve.

The pile was tested up to 1.5 times the design load, i.e., up to 9000 kN. The load settlement curve is shown in Fig. 15. As per IS 2911 (Part-4) 1985, the maximum settlement at working load (1.5 times design load) may not exceed 12 mm. In the present study, the total settlement was 3.9 mm, rebound was 3.6 mm and net settlement was 0.3 mm, indicating that the pile

behaved well and has not reached its capacity. The pile load test results were compared to the Gandhi et al. (1987) pile load test results, which are also shown in Fig. 15. As presented in that paper, the pile load test was conducted on a 6.5 m long and 0.5 m diameter pile. Out of the 6.5 m, 0.5 m are socketed in hard rock strata. The test was conducted at the NALCO project site, Angul in India. The soil profile at this location includes 3.0 m of red soil with an average SPT (N) value 35, followed by yellowish grey weathered rock with SPT (N) values of about 100. Dark grey hard rock is present at 6.0 m below the ground level. The subsurface stratigraphy of the present study area (JNPT, Mumbai) and Gandhi et al. (1987) study area (NALCO project site, Angul) are not the same and thus, the load-settlement response of the test piles is different.

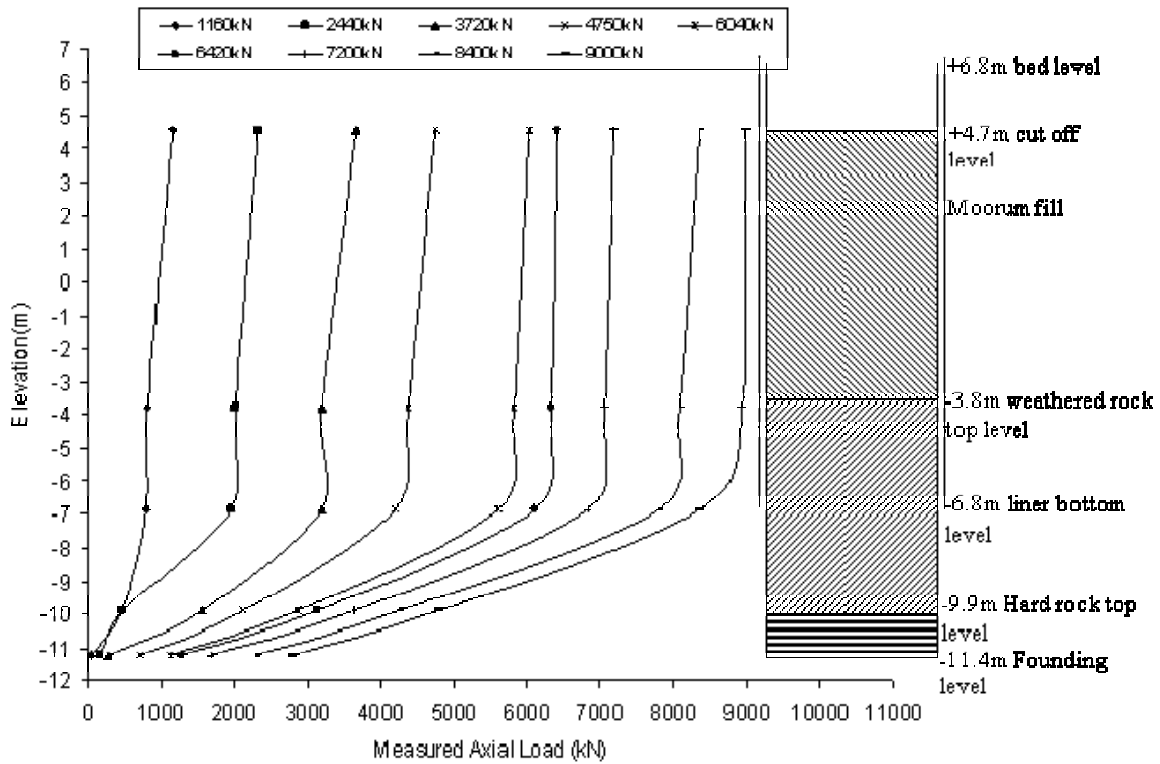
Figure 16. Mobilization of Axial Load.

Fig. 16 shows the load resisted by each soil layer. The maximum load is mobilized from an elevation of -6.87 m to -9.9 m, where the weathered rock is present. The mobilization of frictional resistance is not significant at the top layer of moorum fill. Nearly 4000 kN load is mobilized in the weathered rock, 2000 kN mobilized in hard rock, and 2000 kN mobilized in the moorum fill strata under a total applied load of 9000 kN. Only 1000 kN load is resisted by end bearing by the hard rock.

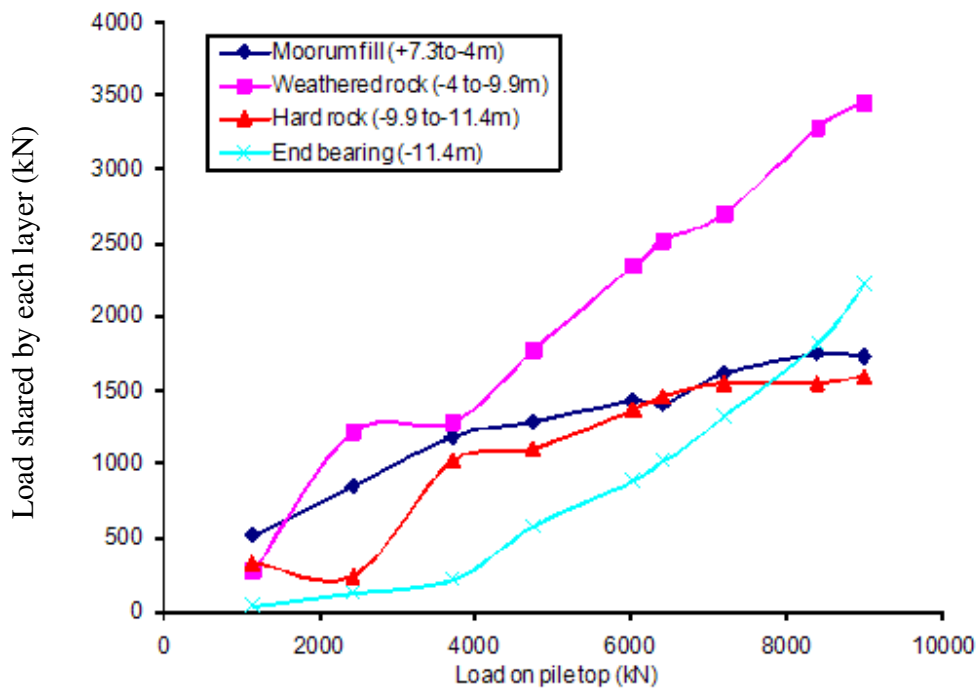
Figure 17. Axial Load Shared by Each Layer.

Fig. 17 shows the load shared by each layer for all applied load increments. For all cases except the load increment of 8400 kN and 9000 kN, the frictional resistance was significantly increased in all soil layers compared to the end bearing resistance. For the test load of 9000 kN, the end bearing resistance was higher than the frictional resistances of the moorum fill and the hard rock. However, the mobilization of end bearing was less than the frictional resistance in weathered rock. Nearly 75% of the load is resisted by friction and 25% of the load is resisted by end bearing. The weathered rock contributed about 20% to 45% of the total pile resistance.

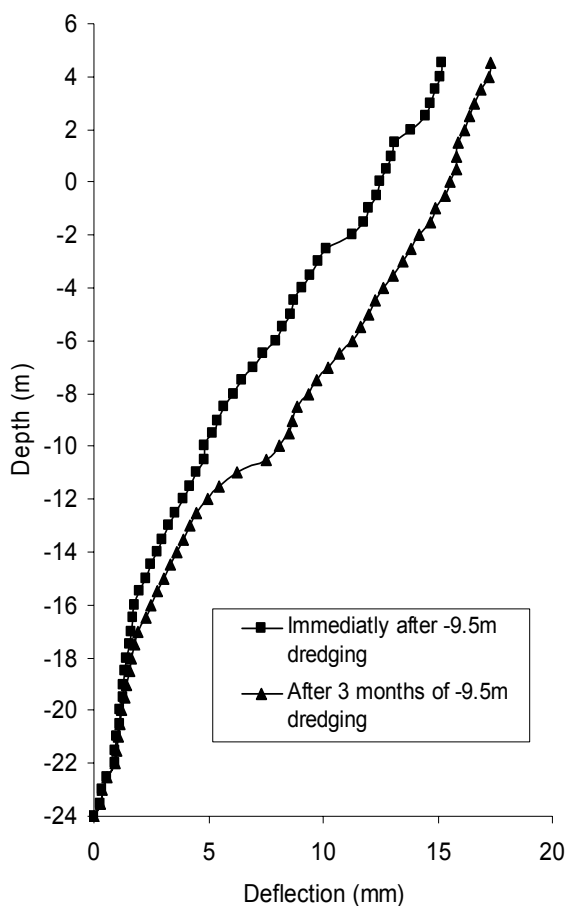
Figure 18. Deflected Shape of Diaphragm Wall.

After construction of the full berth, the inclinometer readings were collected in 3 stages. First set of readings were taken after construction of the berth and prior to dredging. This reading represents the initial position of the diaphragm wall and pile. The second readings were collected immediately after dredging to an elevation of -9.5 m. The difference between the second and first reading is the deflected shape of the diaphragm wall panel and pile. The third readings were collected 3 months after dredging to an elevation of -9.5 m. The difference between the third and second reading is shown in Fig. 18 and 19.

It can be observed that for the diaphragm wall immediately after -9.5 m dredging, the maximum deflection is 15.2 mm at the level of +4 m, while at the same level the maximum deflection increased to 17.3 mm after three months. The increase in deflection is probably due to the consolidation and associated pore pressure dissipation effects of the soft clayey soil. The same behavior was observed for the pile also. For both the pile and the diaphragm wall the deflection from -16 m elevation and lower is small compared to the upper layers due to the lower hard layers of marine silty clay and rock.

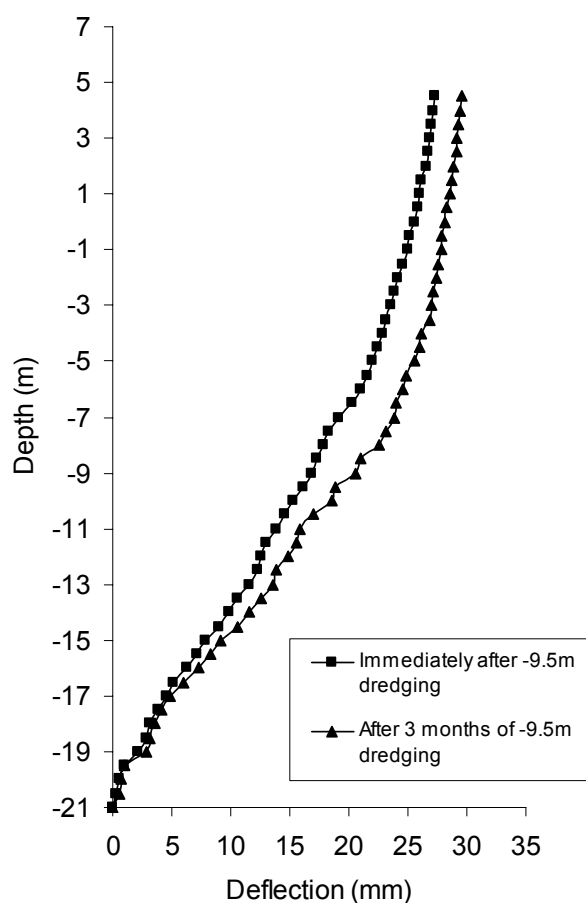
Figure 19. Deflected Shape of Pile.
