Effect of Dredging and Axial Load on a Berthing Structure

ABSTRACT: Piles and a diaphragm wall of a supported berthing structure on marine soils are loaded both axially and laterally. Axial loads are typically generated by the self weight of the structure and external live loads; lateral loads are typically generated by wave current and seismic loads. These loads are generally considered in the design of berthing structures. However, the lateral force generated by lateral soil movements due to dredging may not be considered or accounted in the design of berthing structures. Hence, a full-scale field study was conducted on a berthing structure to estimate the actual axial load distribution during axial loading and the lateral displacement during dredging. After construction of the berth, it was decided to conduct a full scale axial load test on a single pile and monitor the lateral movements of the berth during and after dredging. This paper describes the load transfer data obtained from a bored cast – in – situ pile socketed 1.5 m into hard rock and the lateral displacement of the berth recorded during and after dredging to a -9.5 m dredge depth.

Muthukkumaran K., Sundaravadivelu

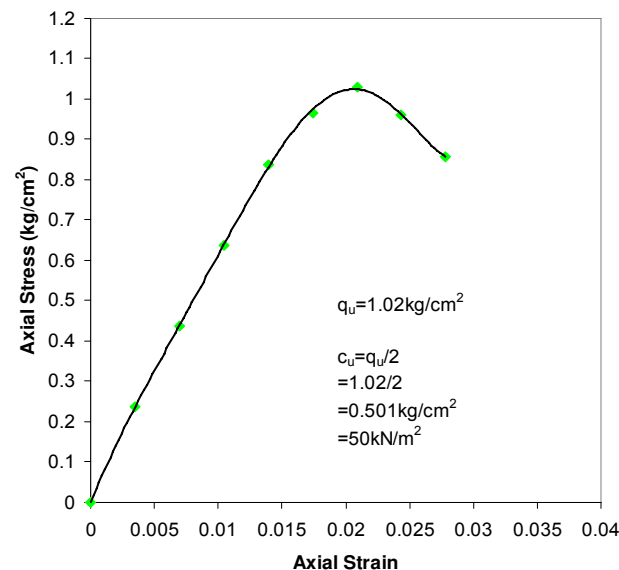
Figure 6a. Unconfined Compression Test Result at -6.0m depth.

To obtain the index and engineering properties of the fine-grained soils, disturbed and undisturbed soil samples were collected at different depths. Liquid limit and plastic limit tests were conducted on the collected soil samples, to classify the soils based on the Unified Soil Classification System (USCS). The classification of the encountered fine grained soils is presented in Fig. 5. The undrained shear strength of the encountered fine grained soils was evaluated by conducting in-situ field vane shear tests in the soft clay soil and unconfined compression tests in the collected undisturbed soil samples. Two vane shear tests were conducted at elevations -2.0 m and -4.0 m. The average undrained shear strength of the layer (elevations between -2.0 m & -4.0 m) was obtained as 20 kN/m². The vane shear computations are presented in the appendix. The unconfined compression tests were conducted on the undisturbed soil samples collected at elevations of -6.0 m, -8.0 m, -11.0 m, -13.0 m, -15.0 m and -17.0 m. The typical unconfined compressive strength variation plot for elevations of -6.0 m, -11.0 m and -15.0 m are shown in Fig. 6a, 6b and 6c respectively. The average undrained shear strength of lean

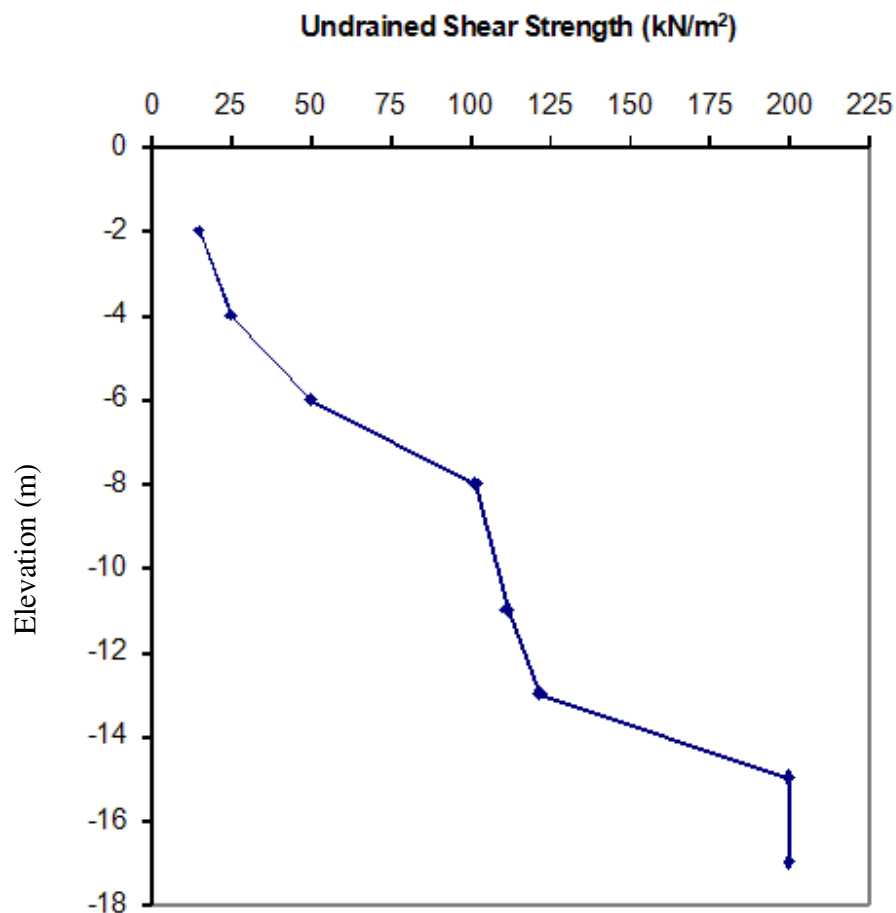
Figure 7. Variation of Undrained Shear Strength with Depth.

clay at elevations between -6.0 m and -8.0 m was estimated as 50 kN/m². The average undrained shear strength value of fat clay at elevations between -8.0 m and -15.0 m was estimated as 112 kN/m². The average undrained shear strength value of silty clay at elevations between -15.0 m and -18.0 m was estimated as 200 kN/m². The undrained shear strength variation with elevation is shown in Fig. 7. The unconfined compressive strength computations are presented in the appendix.

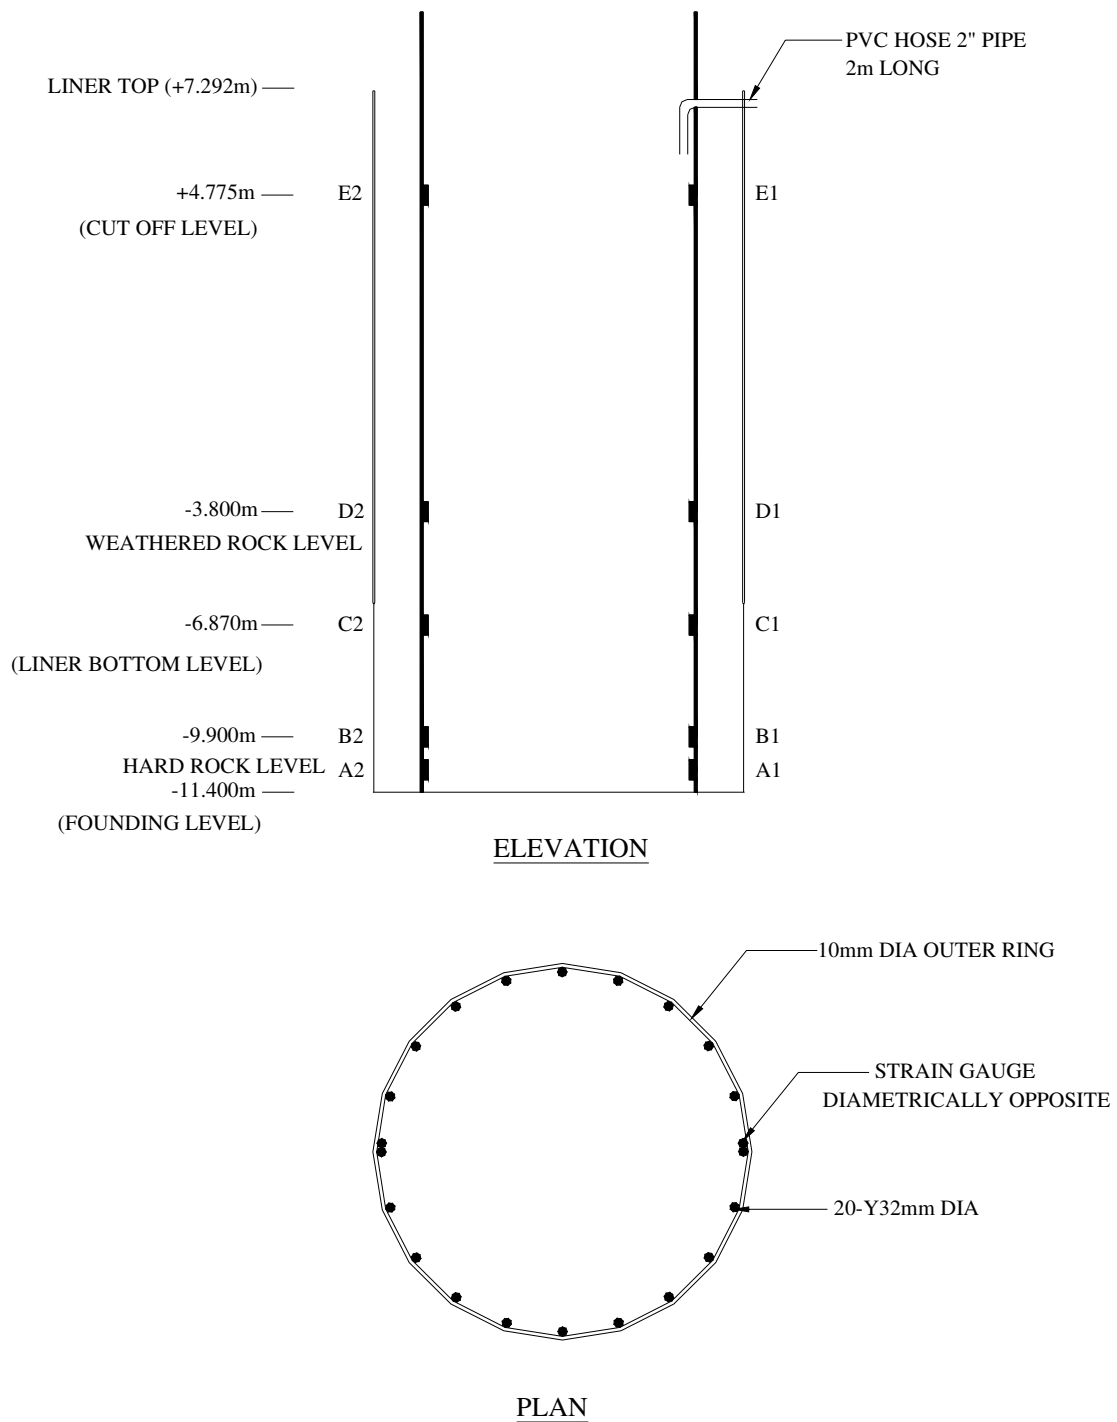
Figure 12. Pile Instrumentation with Strain Gauges.

The test pile is instrumented with electrical resistance type strain gauges. The gauges are attached at five different elevations as shown in Fig. 12. Two diametrically opposite main reinforcement rods are selected to mount the strain gauges. After mounting the gauges, the electric cable from each gauge is safely secured along the reinforcement bar to minimize the possibility of damage by the Tremie pipe during concreting. The cables of the gauges on the same reinforcement rod are bundled together and tied with a plastic wire to the reinforcement rod every 30 cm. The electric cables have a minimum length of 5 m beyond the cut off length to enable connection to the measuring instrument during the load test. All the strain gauges are aligned vertically.

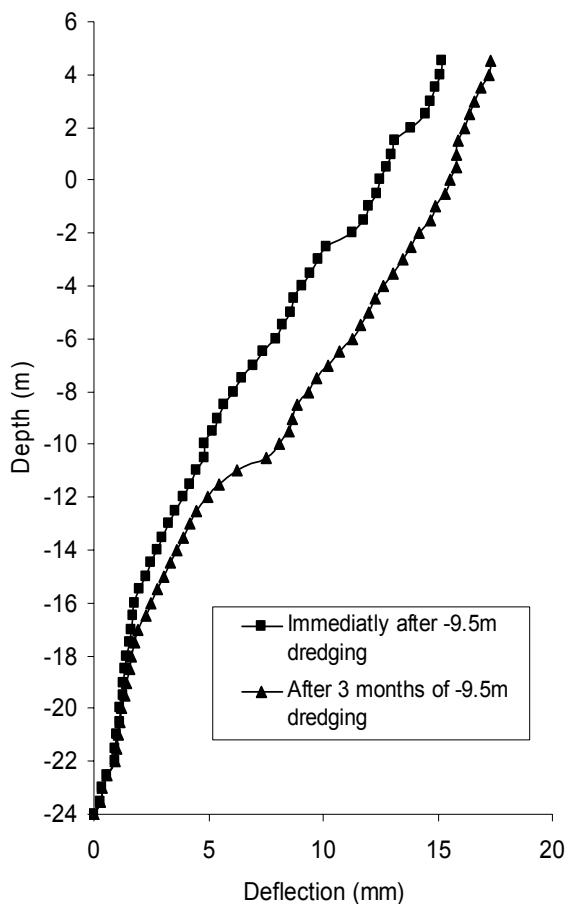
Figure 18. Deflected Shape of Diaphragm Wall.

After construction of the full berth, the inclinometer readings were collected in 3 stages. First set of readings were taken after construction of the berth and prior to dredging. This reading represents the initial position of the diaphragm wall and pile. The second readings were collected immediately after dredging to an elevation of -9.5 m. The difference between the second and first reading is the deflected shape of the diaphragm wall panel and pile. The third readings were collected 3 months after dredging to an elevation of -9.5 m. The difference between the third and second reading is shown in Fig. 18 and 19.

It can be observed that for the diaphragm wall immediately after -9.5 m dredging, the maximum deflection is 15.2 mm at the level of +4 m, while at the same level the maximum deflection increased to 17.3 mm after three months. The increase in deflection is probably due to the consolidation and associated pore pressure dissipation effects of the soft clayey soil. The same behavior was observed for the pile also. For both the pile and the diaphragm wall the deflection from -16 m elevation and lower is small compared to the upper layers due to the lower hard layers of marine silty clay and rock.

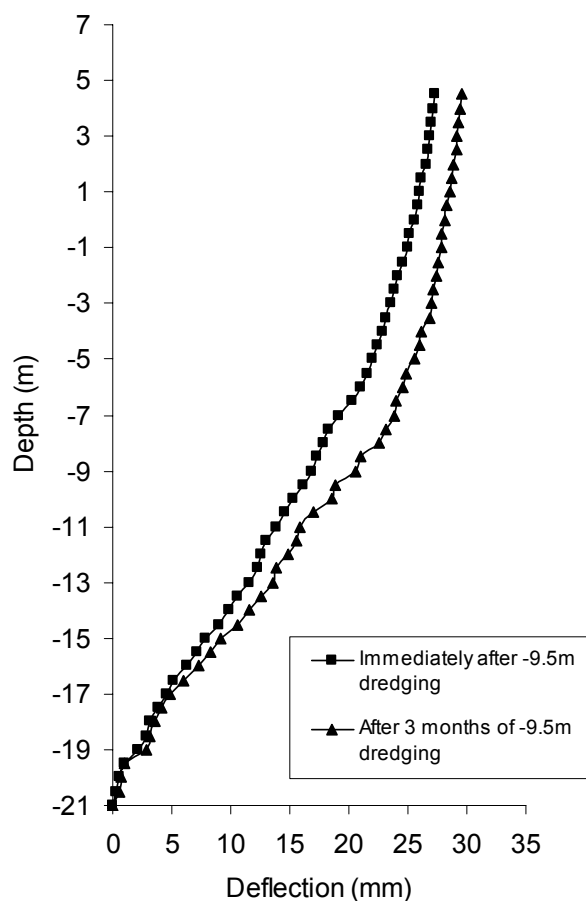
Figure 19. Deflected Shape of Pile.
