Effect of Dredging and Axial Load on a Berthing Structure

Muthukkumaran K., Sundaravadivelu R., Gandhi S.R. (2007). *Effect of Dredging and Axial Load on a Berthing Structure*. International Journal of Geoengineering Case histories, <http://casehistories.geoengineer.org>, Vol.1, Issue 2, p.73-88.

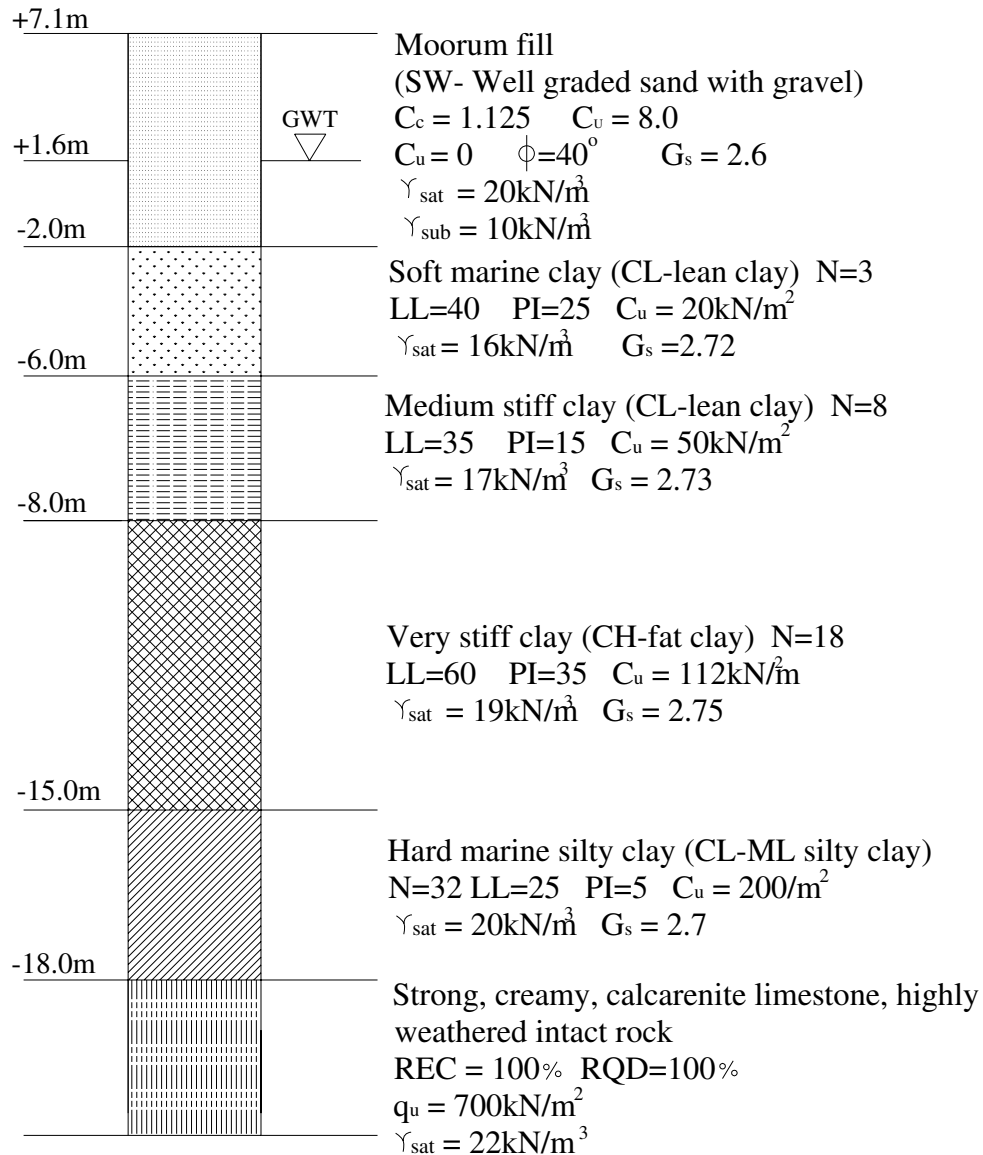
Figure 4. Typical Soil Profile at Inclinator Test Locations.

Fig. 4 shows the typical soil profile at the pile and diaphragm wall panel locations where the inclinometer was installed. The top soil is moorum fill of 9.1 m thickness followed by 4 m soft marine clay with an average SPT (N) value of 3, followed by 2 m thick medium stiff clay with an average SPT (N) value of 8, followed by 7 m thick, very stiff clay with an average SPT (N) value of 18. The clay is underlain by 3 m thick hard marine silty clay with an average SPT (N) value of 32 which in turn is underlain by strong, creamy, calcarenite limestone, highly weathered intact rock with REC value of 100% and RQD value of 100%. Based on the RQD values, the encountered rock formations are classified as excellent rock. The index and engineering properties of the moorum soil are identical to the pile load test location moorum soil, presented previously. The encountered fine-grained soils index and engineering properties are presented below.

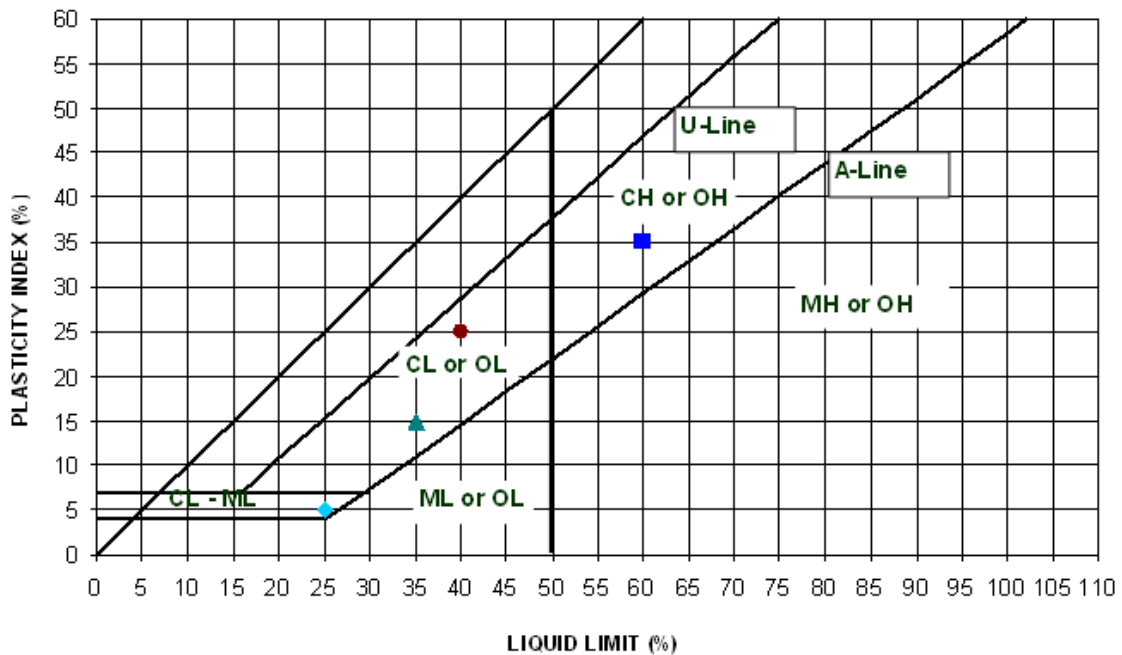
Figure 5. Classification of fine grained soil (ASTM D2487)

To obtain the index and engineering properties of the fine-grained soils, disturbed and undisturbed soil samples were collected at different depths. Liquid limit and plastic limit tests were conducted on the collected soil samples, to classify the soils based on the Unified Soil Classification System (USCS). The classification of the encountered fine grained soils is presented in Fig. 5. The undrained shear strength of the encountered fine grained soils was evaluated by conducting in-situ field vane shear tests in the soft clay soil and unconfined compression tests in the collected undisturbed soil samples. Two vane shear tests were conducted at elevations -2.0 m and -4.0 m. The average undrained shear strength of the layer (elevations between -2.0 m & -4.0 m) was obtained as 20 kN/m². The vane shear computations are presented in the appendix. The unconfined compression tests were conducted on the undisturbed soil samples collected at elevations of -6.0 m, -8.0 m, -11.0 m, -13.0 m, -15.0 m and -17.0 m. The typical unconfined compressive strength variation plot for elevations of -6.0 m, -11.0 m and -15.0 m are shown in Fig. 6a, 6b and 6c respectively. The average undrained shear strength of lean

Elevation (m)	Symbol	LL (%)	PI (%)	Passing # 200 Sieve, (%)	USC Classification
-2.0 to -6.0	●	40	25	70	CL (Lean Clay)
-6.0 to -8.0	▲	35	15	60	CL (Lean Clay)
-8.0 to -15.0	■	60	35	80	CH (Fat Clay)
-15.0 to -18.0	◆	25	5	40	CL-ML (Silty Clay)

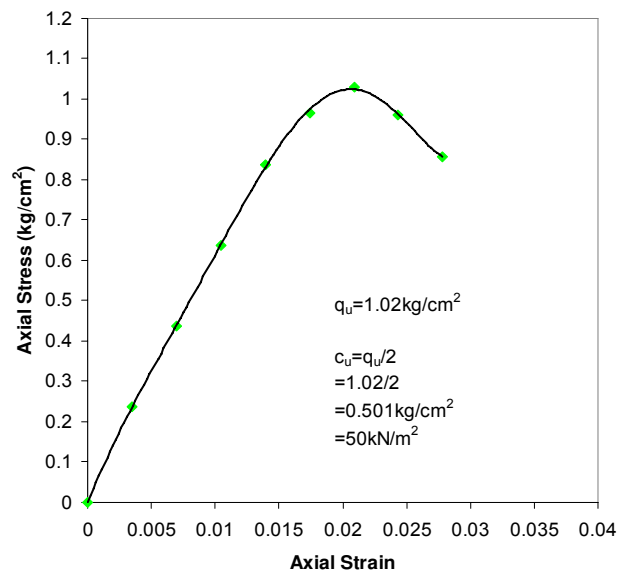
Figure 6a. Unconfined Compression Test Result at -6.0m depth.

Figure 6b. Unconfined Compression Test Result at -11.0 m depth; 6c. Unconfined Compression Test Result at -15.0 m depth.
