Effect of Dredging and Axial Load on a Berthing Structure

Muthukkumaran K., Sundaravadivelu R., Gandhi S.R. (2007). *Effect of Dredging and Axial Load on a Berthing Structure*. International Journal of Geoengineering Case histories, <http://casehistories.geoengineer.org>, Vol.1, Issue 2, p.73-88.

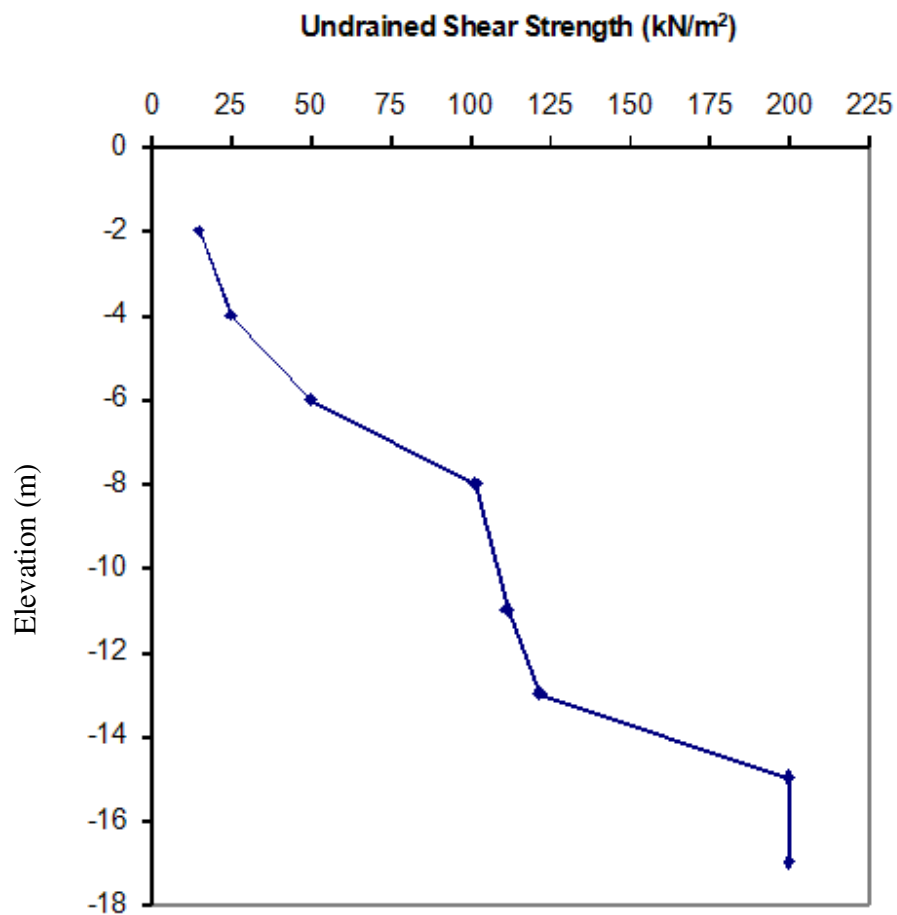
Figure 7. Variation of Undrained Shear Strength with Depth.

clay at elevations between -6.0 m and -8.0 m was estimated as 50 kN/m². The average undrained shear strength value of fat clay at elevations between -8.0 m and -15.0 m was estimated as 112 kN/m². The average undrained shear strength value of silty clay at elevations between -15.0 m and -18.0 m was estimated as 200 kN/m². The undrained shear strength variation with elevation is shown in Fig. 7. The unconfined compressive strength computations are presented in the appendix.
