Effect of Dredging and Axial Load on a Berthing Structure

KEYWORDS: Berthing Structures, Dredging, Lateral Soil Movement, Socketed Pile, Consolidation

A shallow water berth at Jawaharlal Nehru Port Trust (JNPT), Mumbai was recently constructed and comprised of a diaphragm wall and pile rows to support the deck structure. The JNPT is one of the major ports in India. The soil strata consisted essentially of very soft clays extending to large depths. Reclaiming land behind this structure created a number of problems including lateral soil movements. The structure was constructed following placement of fill necessary for reclamation.

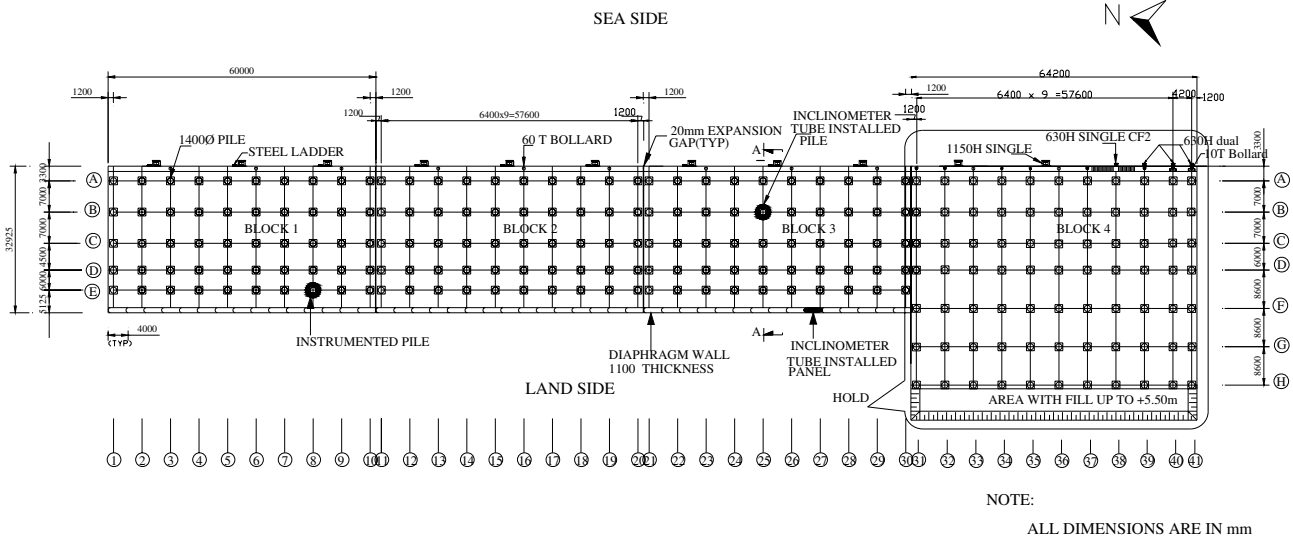
Figure 8. General Layout of Berthing Structure.

The general layout of the berthing structure and a cross section of the berth is shown in Fig. 8 and Fig. 9 respectively. The total length of the berth is 252 m and the width is 33 m. The berth is supported by both piles and the diaphragm wall. The diaphragm wall thickness is 1100 mm and extends to an elevation of -25.7 m. The construction of guide walls for the diaphragm wall is shown in Fig. 10. The diaphragm wall is constructed with the appropriate number of panels and each panel has a length of 5.0 m. Bored cast in-situ concrete piles of 1400 mm diameter are used and the founding elevation is varied between -11.4 m and -22.0 m based on the soil profile. The axial load test pile is terminated at an elevation of -11.4 m and the instrumented with inclinometer pile is terminated at an elevation of -22.0 m. The construction sequence of piles is shown in Fig. 11. The bored cast in-situ concrete piles were constructed using piling gantry. The natural seabed level at the structural location is +0.0 m elevation. To satisfy the berthing facility of the vessel, the ground level is required to be dredged up to an elevation of -9.5 m. The dredging was done in three stages, in each stage 3.0 m thick material is dredged. The inclinometer readings were collected when the water elevation in front of the structure was -3 m (prior to dredging) and -9.5 m (after -9.5 m dredging). Two sets of readings were collected at -9.5 m elevation, one immediately after dredge level reached an elevation of 9.5 m and the other 3 months after the first set of readings to evaluate time effects.

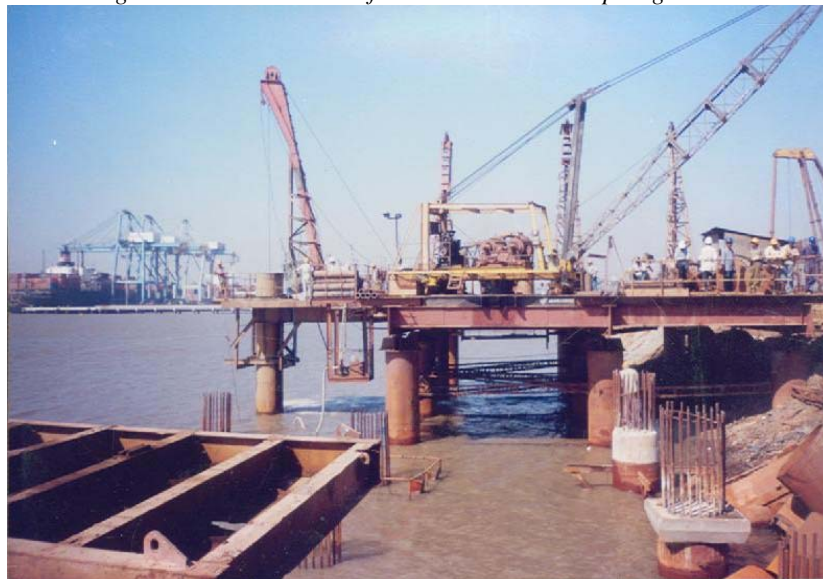
Figure 11. Construction of Piles.

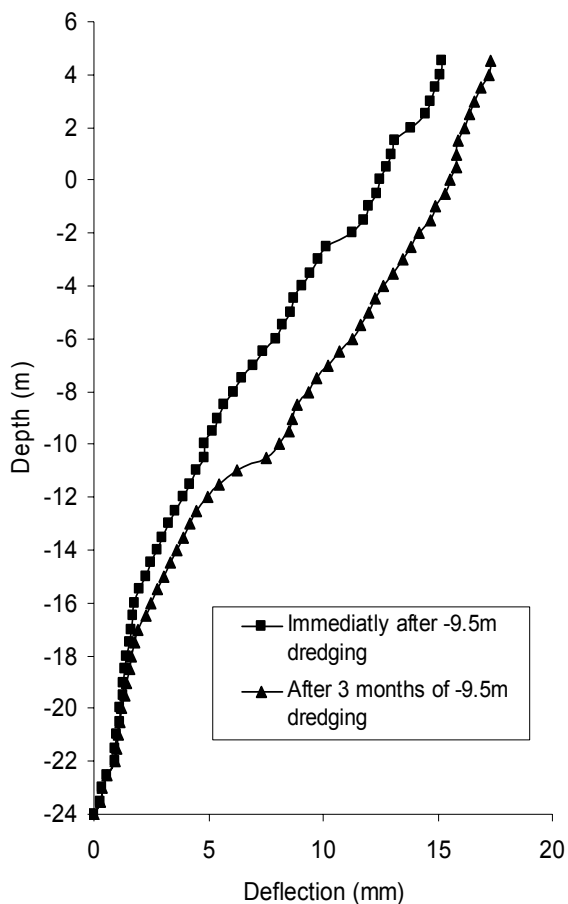
Figure 18. Deflected Shape of Diaphragm Wall.

After construction of the full berth, the inclinometer readings were collected in 3 stages. First set of readings were taken after construction of the berth and prior to dredging. This reading represents the initial position of the diaphragm wall and pile. The second readings were collected immediately after dredging to an elevation of -9.5 m. The difference between the second and first reading is the deflected shape of the diaphragm wall panel and pile. The third readings were collected 3 months after dredging to an elevation of -9.5 m. The difference between the third and second reading is shown in Fig. 18 and 19.

It can be observed that for the diaphragm wall immediately after -9.5 m dredging, the maximum deflection is 15.2 mm at the level of +4 m, while at the same level the maximum deflection increased to 17.3 mm after three months. The increase in deflection is probably due to the consolidation and associated pore pressure dissipation effects of the soft clayey soil. The same behavior was observed for the pile also. For both the pile and the diaphragm wall the deflection from -16 m elevation and lower is small compared to the upper layers due to the lower hard layers of marine silty clay and rock.
