# Leaning Tower of Pisa: Behaviour after Stabilization Operations

**ABSTRACT:** It is well known that the foundations of the Leaning Tower of Pisa were stabilised using the method of underexcavation to reduce the southward inclination of the Tower by about 10 percent in combination with controlling the seasonally fluctuating water table beneath the north side. Having been closed to the public since early in 1990, the Tower was re-opened in December 2001. The paper summarises the response of the Tower during the period of implementation of the stabilisation works. Monitoring of the movements of the Tower has been continuing and the observations obtained since 2001 are presented. It is shown that over the six years between 2003 and 2008 the induced rate of northward rotation of the Tower has been steadily reducing to less than 0.2 arc seconds per year. Similarly the rate of induced settlement of the centre of the foundation has been steadily reducing and is approaching the background rate of settlement of the Piazza. Piezometer measurements close to the north side of the foundation shows that the drainage system has been successful in stabilising the groundwater levels beneath the n

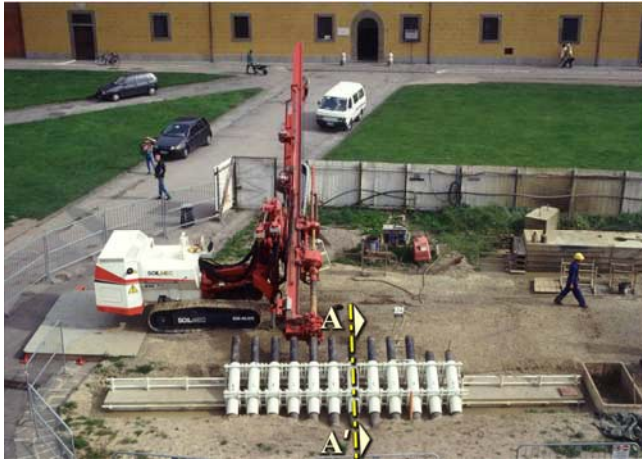
**Preliminary underexcavation  
Extraction hole - Section A-A'**

Figure 9. Holes for preliminary underexcavation.

In August 1998 the Committee agreed to carry out limited soil extraction from beneath the Tower with a view to observing its response. This preliminary underexcavation was to be carried out over a limited width of 6m north of the Tower using twelve bore holes lined with 219mm diameter casings (Fig. 9). On 9th February 1999, in an atmosphere of great tension, the first soil extraction took place. The Tower slowly began to rotate northwards. When the northward rotation had reached about 80 arc seconds by early June 1999 the preliminary soil extraction was stopped. Northward rotation continued at a decreasing rate until October 1999.
