# Leaning Tower of Pisa: Behaviour after Stabilization Operations

**ABSTRACT:** It is well known that the foundations of the Leaning Tower of Pisa were stabilised using the method of underexcavation to reduce the southward inclination of the Tower by about 10 percent in combination with controlling the seasonally fluctuating water table beneath the north side. Having been closed to the public since early in 1990, the Tower was re-opened in December 2001. The paper summarises the response of the Tower during the period of implementation of the stabilisation works. Monitoring of the movements of the Tower has been continuing and the observations obtained since 2001 are presented. It is shown that over the six years between 2003 and 2008 the induced rate of northward rotation of the Tower has been steadily reducing to less than 0.2 arc seconds per year. Similarly the rate of induced settlement of the centre of the foundation has been steadily reducing and is approaching the background rate of settlement of the Piazza. Piezometer measurements close to the north side of the foundation shows that the drainage system has been successful in stabilising the groundwater levels beneath the n

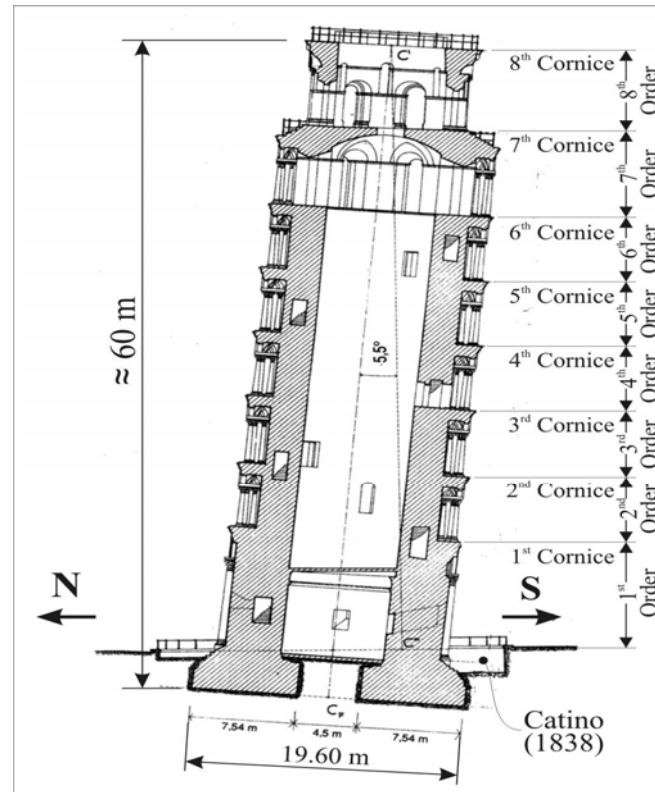
Weight	142 MN
Height of the centre of gravity	22.6 m
Overshooting moment	327 MNm
Average foundation pressure:	≈ 500 kPa

Figure 3. Cross-section in the plane of maximum inclination, situation in year 1993.

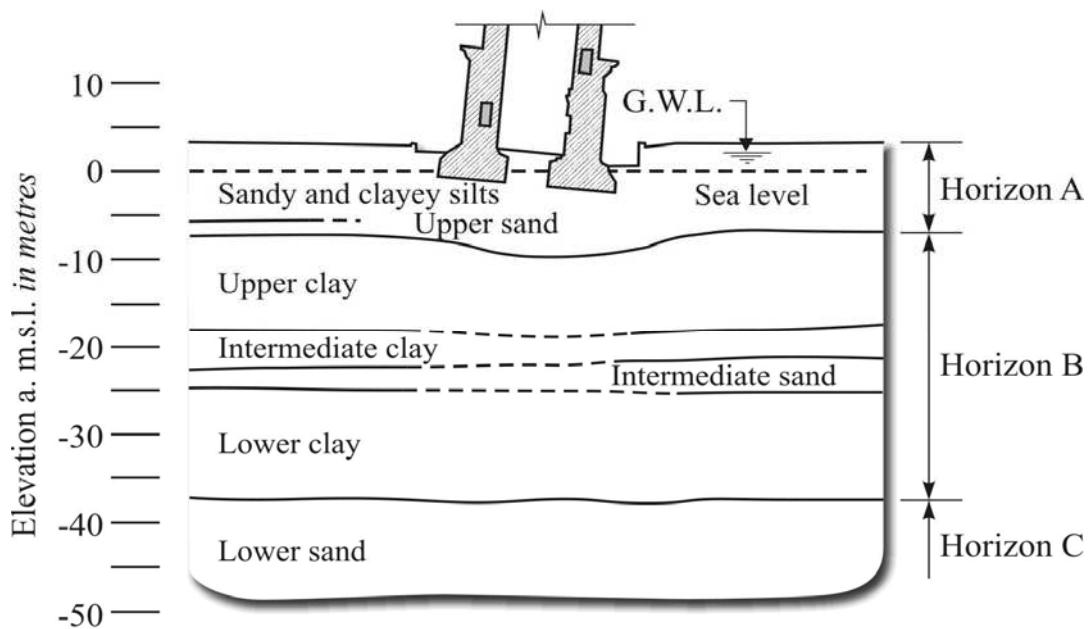
Figure 4. Soil profile.

The ground underlying the Pisa Tower consists of three formations as shown in Fig. 4. Horizon A, about 10m thick, is composed of soft estuarine deposits of sandy and clayey silts laid down under tidal conditions. Horizon B consists of soft sensitive normally consolidated marine clay extending to a depth of about 40m. Because it is very sensitive, this material loses much of its strength if disturbed. Horizon C is dense marine sand extending to a depth of about 60m. An upper perched water table in Horizon A is encountered between 1m and 2m below the level of Piazza dei Miracoli corresponding to elev. +3.0 above m.s.l. The contact between Horizon A and the marine clay of Horizon B is dished beneath the Tower, indicating that it experienced average settlements of between 3.0m and 3.5m.

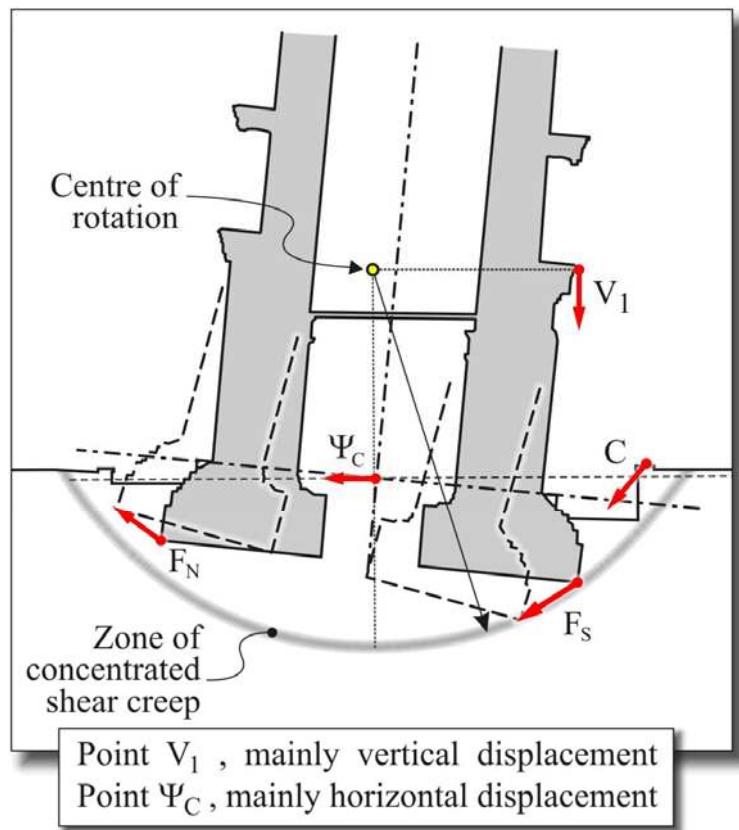
Kinematically admissible mechanism of ground movement, curvilinear concentrated shear creep zone passing through more plastic layer of horizon A

Figure 5. Motion of Tower foundation during steady creep (gradually accelerates) - Burland, Viggiani (1994).

Precise measurements begun in 1911 and show that during the twentieth century the inclination of the Tower has been increasing inexorably each year and the rate of tilt has doubled since the 1930's. In 1990 the increase of tilt was about 6 arc seconds per year which is equivalent to a horizontal movement at the top of about 1.5mm per year (Jamiolkowski, 2001). There has been much debate about the cause of this progressive increase in inclination. It has usually been attributed to creep in the underlying soft marine clay, the assumption being made that the south side was settling more than the north side. A careful study of the geodetic survey measurements going back to 1911 revealed a most surprising form of motion of the foundations which was radically different to previously held ideas. The theodolite measurements showed that the first cornice had not moved horizontally – apart from two occasions in 1934 and the early 1970s when man had intervened. Also, precision level measurements which commenced in 1928 showed that the centre of the foundation plinth had not displaced vertically relative to the surrounding ground. Therefore, the rigid body motion of the Tower could only be as shown in Fig. 5, with an instantaneous centre of rotation at the level of the first cornice vertically above the centre of the foundation. The direction of motion of points FN and FS are shown by vectors and it is clear that the foundation has been moving northwards with FN rising and FS sinking (Burland and Viggiani, 1994).

The discovery that the motion of the Tower was as shown in Fig. 5 turned out to be crucial in four respects:

3. The pattern of ground movements depicted in Fig. 5 led to the important conclusion that the seat of the continuing long-term rotation of the Tower lies in Horizon A and not within the underlying marine clay as had been widely assumed in the past. It can therefore be concluded that the latter stratum must have undergone a considerable period of ageing since the end of construction. The ageing resulted in an increased resistance to yield – a conclusion that proved to be of great importance in the successful computer modeling of the application of the temporary counterweight (Burland and Potts, 1994).

As mentioned previously, the deduced motion of the Tower foundation shown in Fig. 5 led to the conclusion that the seasonal fluctuating water table in Horizon A during intense periods of rain was the main factor responsible for this continuing movement, see Fig. 6. It is also of significance that, apart from these intense periods of rain, the average ground water levels close to the South side of the Tower in Horizon A are 200mm to 300mm higher than those to the North, as shown in Fig. 6. This difference generates a small, but not negligible stabilising moment for the Monument which is so close to falling over. In the autumn and winter, when rainfall events are more intense, the water table rises sharply, reduces the difference in piezometric level and thereby produces southward rotations of the Tower which are not fully recoverable. To minimise this effect it was necessary to eliminate the fluctuations of the water table and, with this objective, a drainage system was installed consisting of three wells sunk on the north side with radial sub-horizontal drains running into them from beneath the north side of the catino, (Fig. 13). The water levels in the wells are controlled by the level of the outlet pipes. The drainage system was implemented in April and May 2002 and lead to a decrease in the pore water pressure as well as a significant reduction in its seasonal fluctuations, as shown in Fig. 14. The installation of this drainage system induced a further northward rotation of the Tower as can be seen in Fig. 15.

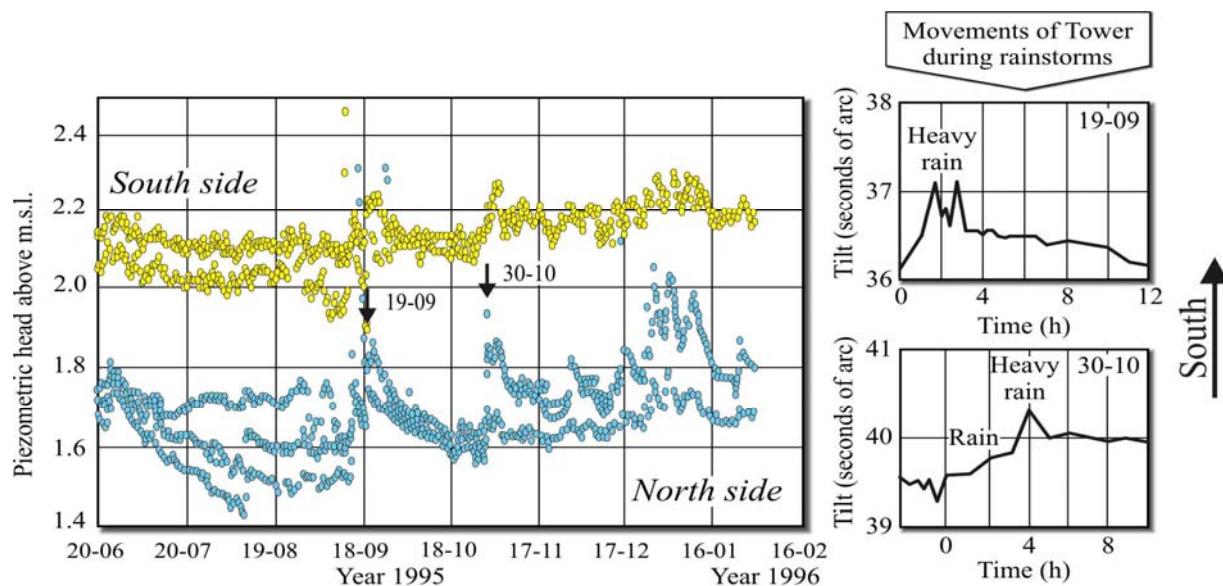
Figure 6. Ground water level fluctuation in horizon A.

4. In the light of the measured motion of the Tower foundation, and consistent with the seat of the movement lying within Horizon A, it was concluded that, in addition to creep, the most likely cause of the progressive seasonal rotation was a fluctuating ground-water level due to seasonal heavy rainstorms that occur between September and December every year. Accordingly a number of stand-pipes were installed in Horizon A around the Tower. Measurements made over a number of years have confirmed this hypothesis. Commencement of rotation each year coincides with very sharp rises in the ground water level in the Horizon A following each heavy rainstorm (Burland et al, 2003). Fig.6 shows the ground water level fluctuations for a selected period of time in the piezometers located to the North and to the South in the vicinity of the Tower. The insert figures to the right show the changes in inclination of the Tower in arc seconds as a result of two heavy rainstorms that occurred in September and October of 1995. Each of these events caused a larger rise in piezometric head on the North side than the South side of the Tower. This resulted in a southward rotation of about one arc second in each case which was only partly reversible.

- **Optimistic Scenario.** The phenomenon of the leaning instability has been stopped, continuing rotation ceases, except for some minor movements caused by the seasonal oscillations of the ground water and of the effects of the solar radiation on the masonry. This scenario implies that the dominant mechanism driving the leaning instability was fluctuations of the ground water level in Horizon A, see Fig. 6.

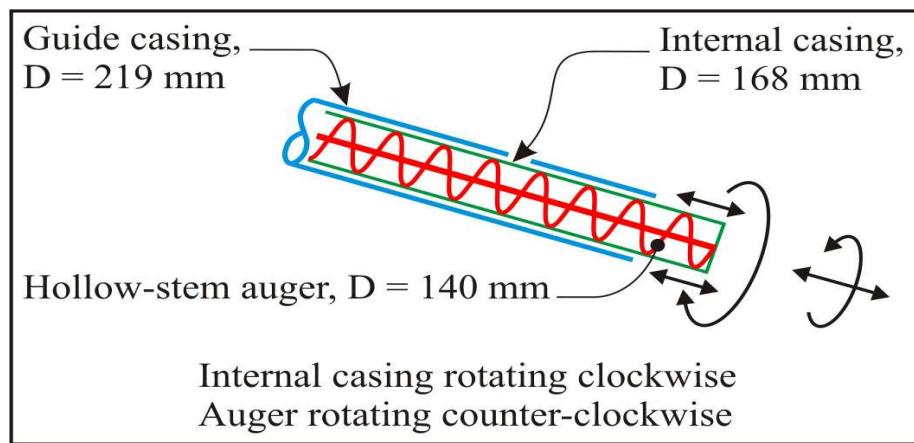
The main purpose of the large-scale trials was to develop the drilling technology for soil extraction. A drill was developed which consisted of a hollow-stemmed continuous flight auger housed inside a contra-rotating 168mm diameter casing (Fig. 8). The arrangement permits the drill to be advanced with minimum disturbance to the surrounding ground. When a chosen location is reached the drill is stopped and withdrawn by about a meter leaving a cylindrical cavity. The trials showed that the cavities formed in the silty soil of Horizon A closed gently and that repeated extractions could be made from the same location. The trial foundation was successfully rotated by about 0.25° and directional control was maintained even though the ground conditions were somewhat non-uniform. Very importantly, an effective system of communication, decision making and implementation was developed. This system consisted of a daily report from the site to the responsible engineer of the response of the foundation to the previous day's soil extractions. The responsible engineer then issued a signed document in which the previous day's response was summarized and analysed, the objectives of the coming day's soil extraction were set out and instructions given for the locations and volumes of the next soil extractions.

Figure 8. Tool for ground extraction.

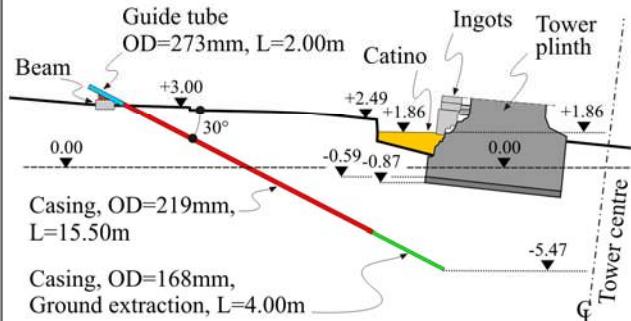
Preliminary underexcavation  
Extraction hole - Section A-A'

Figure 9. Holes for preliminary underexcavation.

In August 1998 the Committee agreed to carry out limited soil extraction from beneath the Tower with a view to observing its response. This preliminary underexcavation was to be carried out over a limited width of 6m north of the Tower using twelve bore holes lined with 219mm diameter casings (Fig. 9). On 9th February 1999, in an atmosphere of great tension, the first soil extraction took place. The Tower slowly began to rotate northwards. When the northward rotation had reached about 80 arc seconds by early June 1999 the preliminary soil extraction was stopped. Northward rotation continued at a decreasing rate until October 1999.

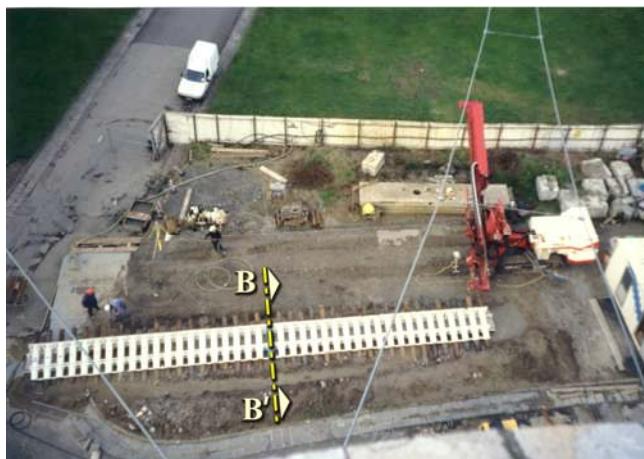
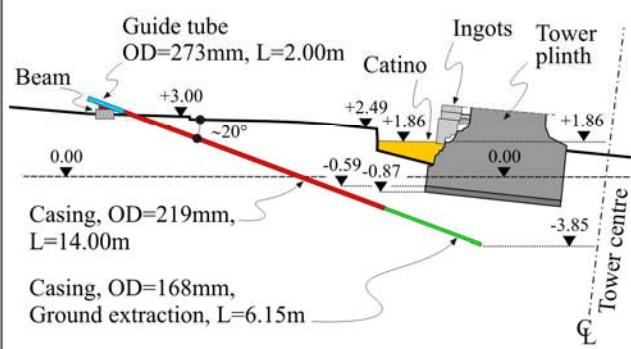
Massive underexcavation  
Extraction hole - Section B-B'

Figure 10. Holes for massive underexcavation.

The success of the preliminary underexcavation persuaded the Committee that it was safe to undertake soil extraction over the full width of the foundation. Accordingly, between December 1999 and January 2000, 41 extraction holes were installed north of the Tower at 0.5m spacing with a dedicated auger and casing in each hole (Fig.10). Full underexcavation commenced on 21st February 2000 and the Tower was steered northwards in a remarkably straight path. Towards the end of May 2000 progressive removal of the lead ingots was commenced. Although this resulted in an increase of overturning moment the soil extraction continued to be effective.

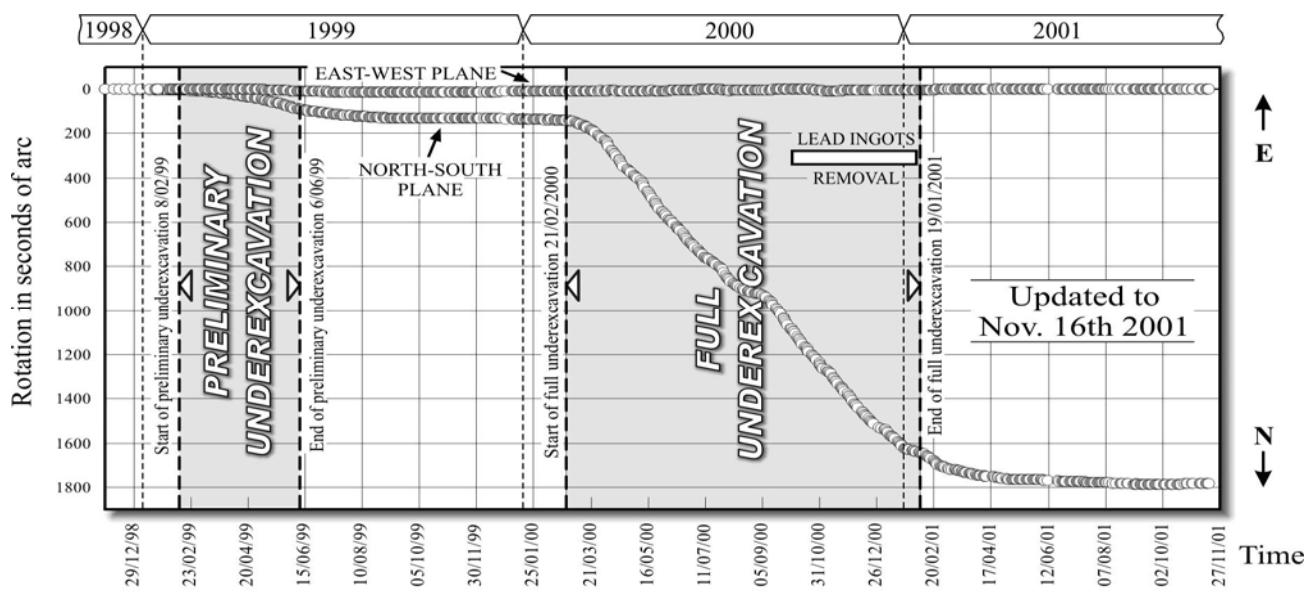
Figure 11. Rotation of Tower plinth during underexcavation.

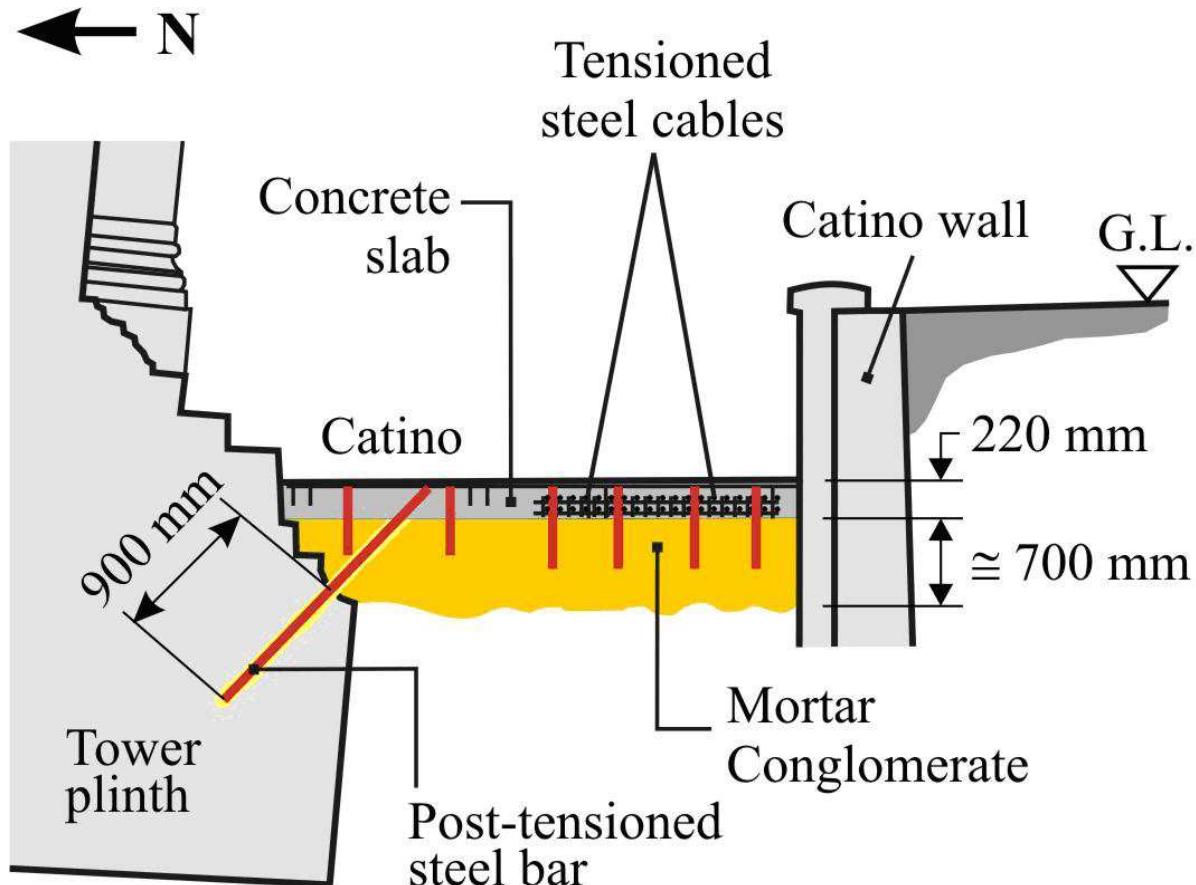
Figure 12. Structural connection of concrete ring to the Tower foundation.

In addition to reducing the inclination of the Tower by half a degree, two other permanent foundation stabilisation measures have been carried out. During the work of the Committee, a 0.8m thick cement-conglomerate ring was detected in the bottom of the catino around the base of the Tower. This ancient concrete ring is of high quality and it has now been connected to the masonry foundation of the Tower by means of stainless steel reinforcement and has been strengthened by circumferential post-tensioning (Fig. 12). As a result, the effective area of the foundations has been substantially increased thereby increasing the factor of safety against leaning instability.

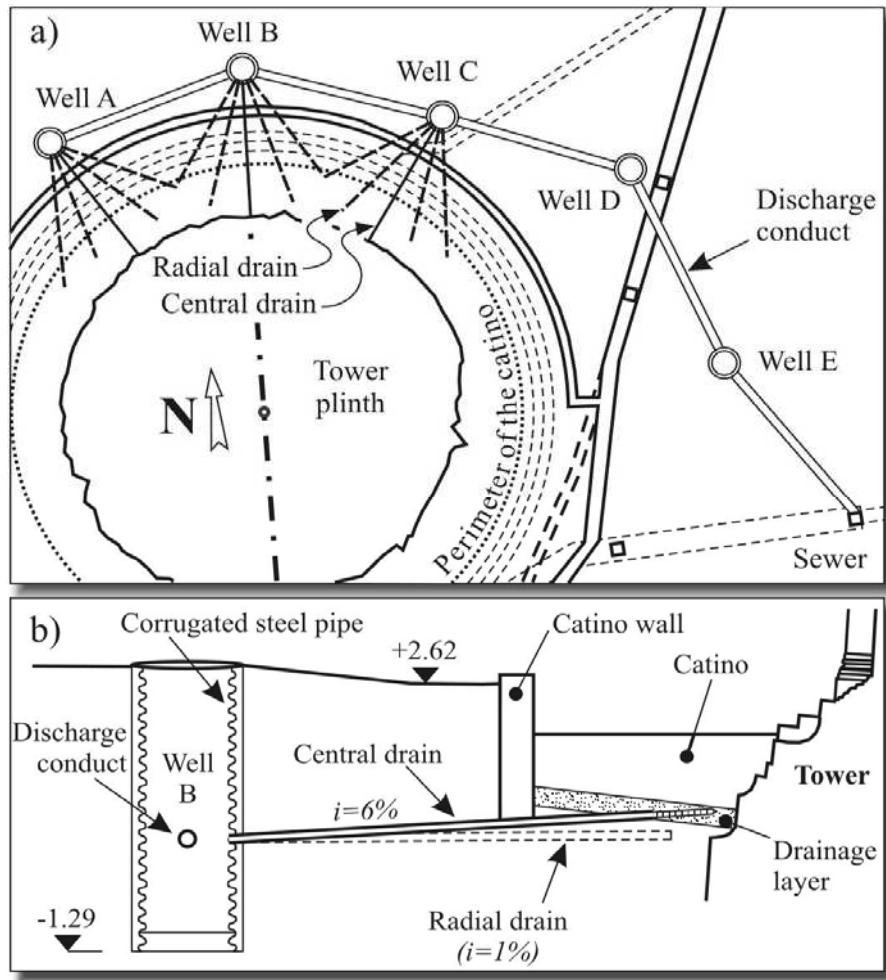
Figure 13. Control of GWL on North Side a) Plan view, b) Cross-section.

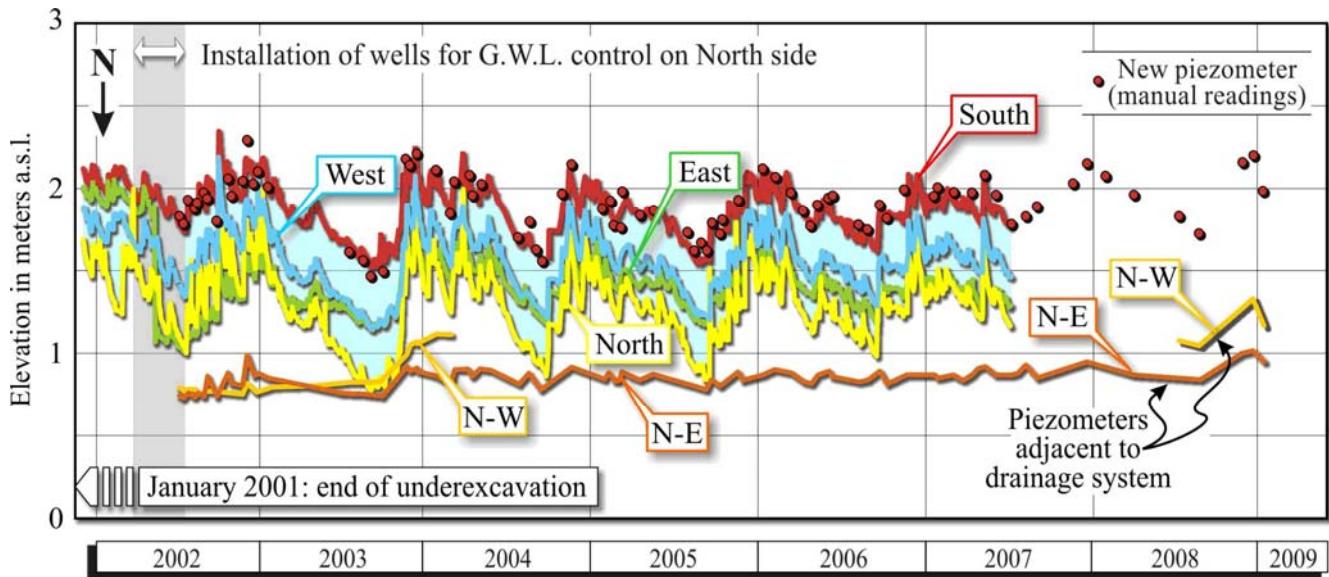
Figure 14. Perched ground water table in horizon "A".

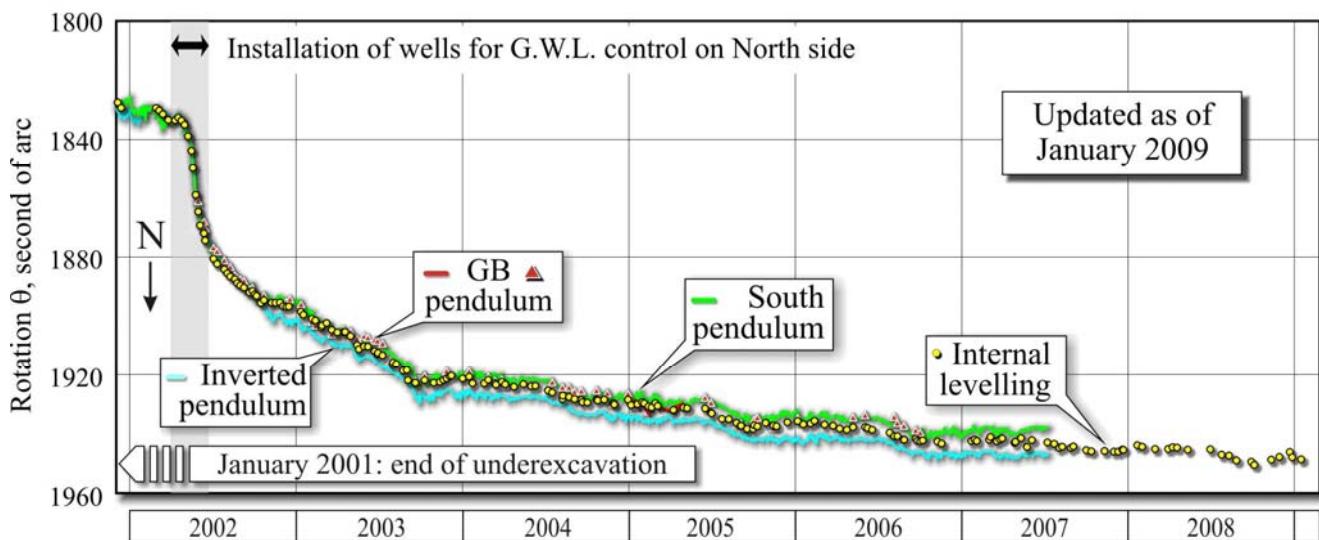
Figure 15. Rotation of Tower plinth after end of underexcavation.

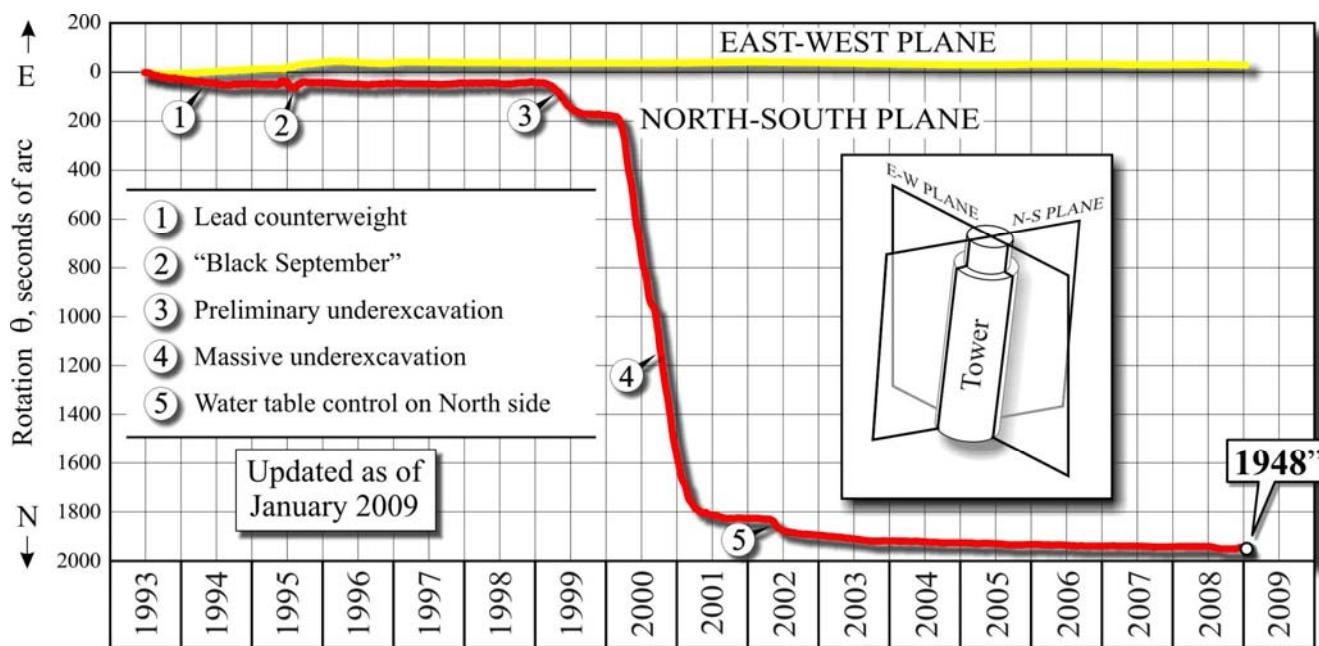
Figure 16. Rotation of Tower foundation as result of stabilization works.

Temporary stabilisation of the foundation was achieved during the second half of 1993 by the application of 600t of lead weights on the north side of the foundations via a post-tensioned removable concrete ring cast around the base of the Tower at plinth level, see Fig. 7. This caused a reduction in inclination of about one minute of arc and, more importantly, reduced the overturning moment by about ten percent. In September 1995 the load was increased to 900t in order to control the accelerating southward movements of the Tower during an unsuccessful attempt to replace the unsightly lead weights with temporary ground anchors. This difficult period during the Committee's activity has been called "Black September" and is referred to in Fig.16.

The previous section of the paper gives a short description of the interventions carried out on the Tower subsoil, aimed at reducing the leaning instability phenomenon, hence preventing for ever, or at least for a long period of time, further increase of inclination. The behaviour of the Tower foundation after the conclusion of the stabilization works in terms of rotations and settlements is summarised in Figs. 16 and 17 respectively.

As a result of the full underexcavation and of the implementation of the ground water control in Horizon A, the Tower foundation in mid 2002 had reduced its tilt by 1880 arc seconds - about 10% of the maximum value reached in 1993. In the succeeding six years the Tower has continued rotating northwards at a reducing rate, so that by September 2008 the

accumulated reduction of the foundation tilt reached 1948 arc seconds, see Fig.16. In the two years from September 2006 to September 2008 the residual rate of rotation northwards has reduced to less than 0.2 arc second per year.

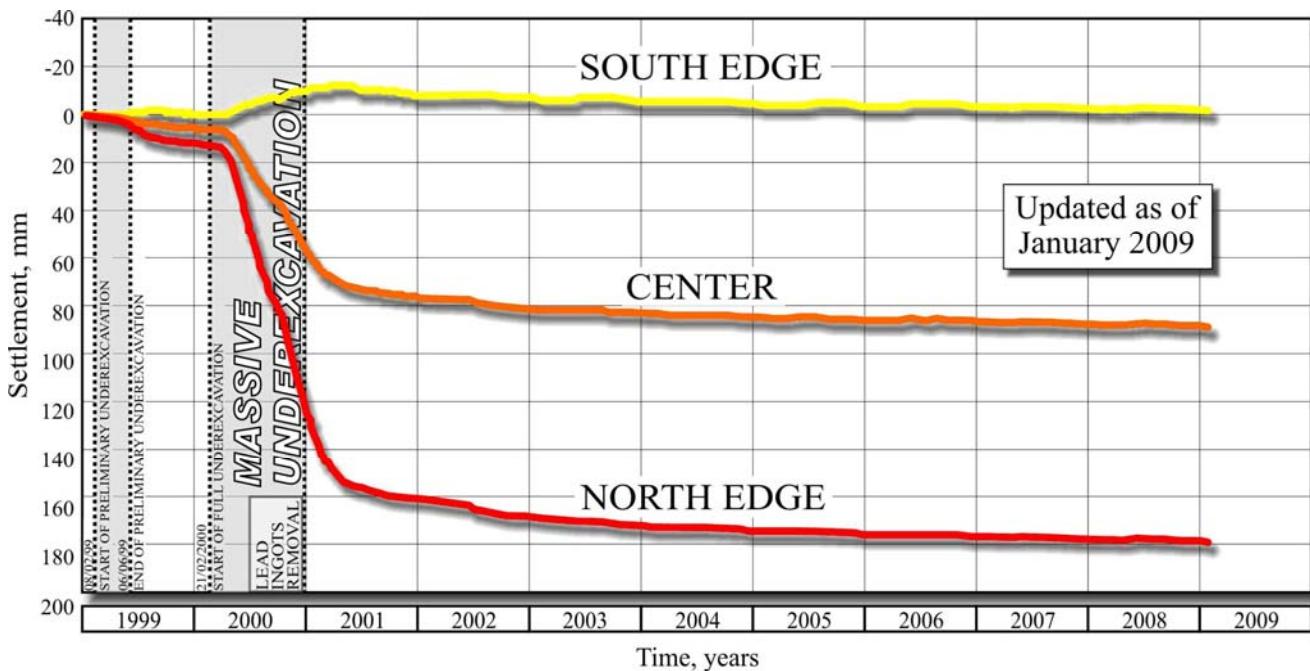
Figure 17. Settlement of Tower foundation as result of stabilization works.

The settlements of the south edge, centre and north edge of the foundation generated by the stabilisation operations, mainly by full underexcavation, are shown in Fig.17. In September 2008 the centre of the foundation had settled around 90mm and is continuing to settle at a rate that, over the last two years, is less than 1.0 mm/year. This is approaching the background rate of settlement of the Piazza due to the general subsidence of the Pisa plain. As regards the South edge of the foundation, it rose by about 15 mm during the underexcavation and has since settled around 12mm. This behaviour indicates that during underexcavation, the axis of rotation was located under the imprint of the plinth and that the pressures due to the Tower weight at the south edge had reduced.

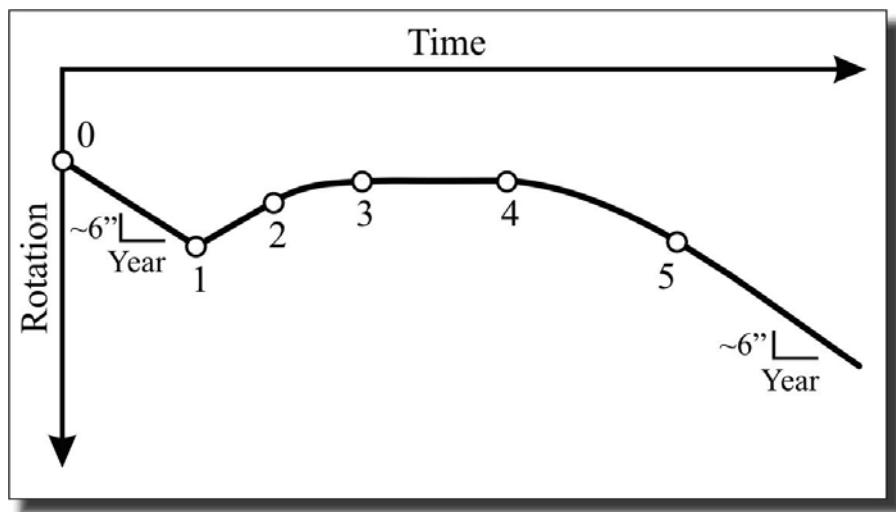
<u>0</u> <u>1</u>	“Steady” motion towards South of Tower before intervention
<u>1</u> <u>2</u>	Reduction of inclination during intervention
<u>2</u> <u>3</u>	“Delayed” effect of intervention
<u>3</u> <u>4</u>	Tower motionless
<u>4</u> <u>5</u>	Southward rotation resumed
<u>5</u>	Rotation rate as before intervention

Figure 18. Expected future behaviour of the Leaning Tower of Pisa.

- **Pessimistic Scenario.** As illustrated in Fig. 18, after the completion of time effects of the underexcavation (period 2-3), the Tower will remain motionless for a period estimated as a few decades (period 3-4), followed by a possible resumption of the southward rotation. Initially this southward rate of rotation will be very much less than the 6 arc second per year that existed before the stabilisation works. However the rotation rate will gradually increase (period 4-5) and may approach again, after a very long time, a value close to 6 arc seconds. In what period of time this will occur is difficult to estimate. However, considering that the stabilisation works brought the Tower inclination back to the situation that existed at the beginning of the XIX century, the authors believe that the period of time for the Tower to return to its 1993 inclination will be at least 200 years.
