# Reconstruction of Konstantinovsky Palace in a Suburb of Saint Petersburg

**ABSTRACT:** *This article describes a complex approach to the condition survey and design executed as part of the remedial works on Konstantinovsky palace in the suburb of Strelna (Saint Petersburg)--one of the most beautiful historic monuments of 18th century Russia. The palace was almost completely destroyed in the 1940s. In 2000 the decision was made to reconstruct the palace, and the project for palace reconstruction was developed. The project was completed in 2003. The following important stages of the project are discussed in this paper: palace condition survey and site investigations, analyses of the palace retaining structures, design project of palace reconstruction, and phases of the remedial works.*

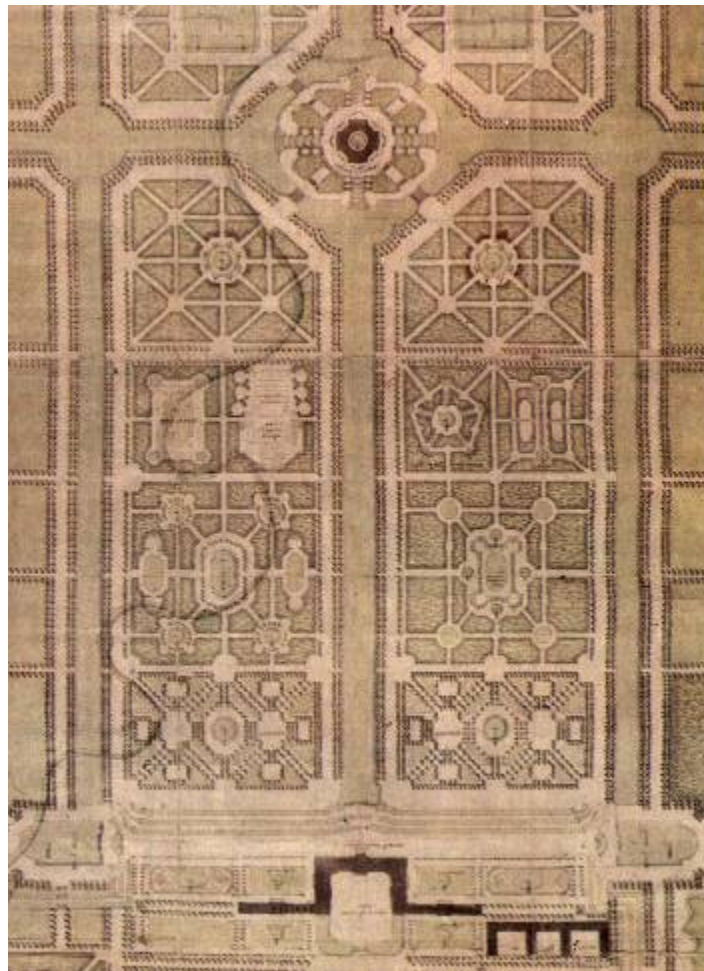
Figure 2. Plan of Konstantinovsky Palace in Strelna. Drawing by Jean-Batiste Leblon. Beginning of the 18th century.

the grottoes served as a spacious terraced square facing the palace. The structure of the terrace at the same time functioned as a retainer for the palace, conditioning stability of the entire palatial complex.

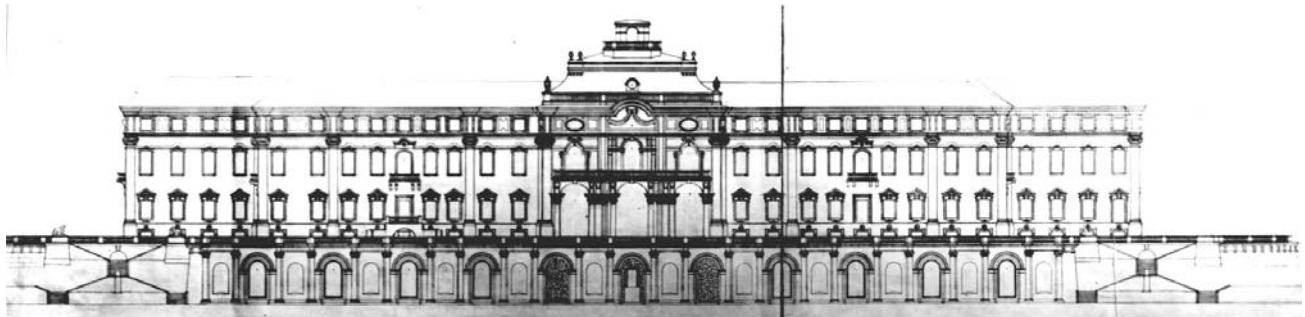
*Figure 5. A drawing of the palace made in the first half of the 20th century.*
