## Seismological and geotechnical aspects of the $M_w=6.3$ L'Aquila earthquake in central Italy on 6 April 2009

**Giuseppe Lanzo**, Professor, University of Rome, Italy; email: [giuseppe.lanzo@uniroma1.it](mailto:giuseppe.lanzo@uniroma1.it)

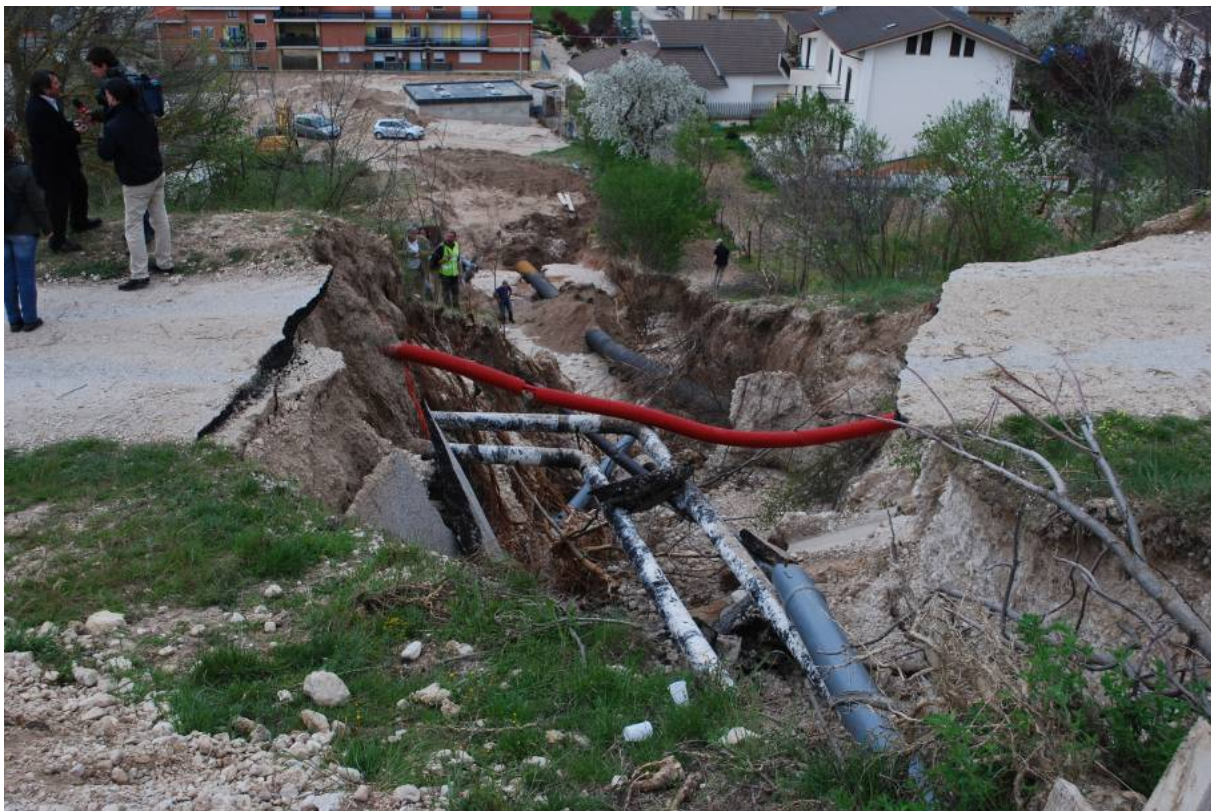
*Figure 27. Paganica village: broken major water pipe (repaired) due to co-seismic rupture (Lat. 42,36537N Long. 13,46803E) (Photo by Mylonakis G).*

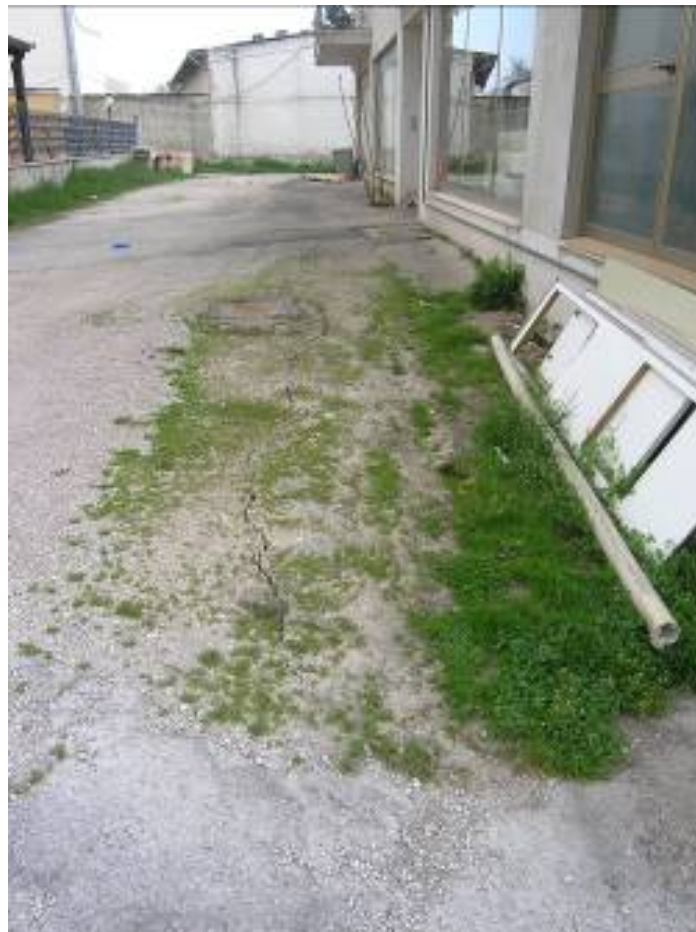
*Figure 31. Ground fissures at the side of the building (42.359817°N, 13.468649°E).*

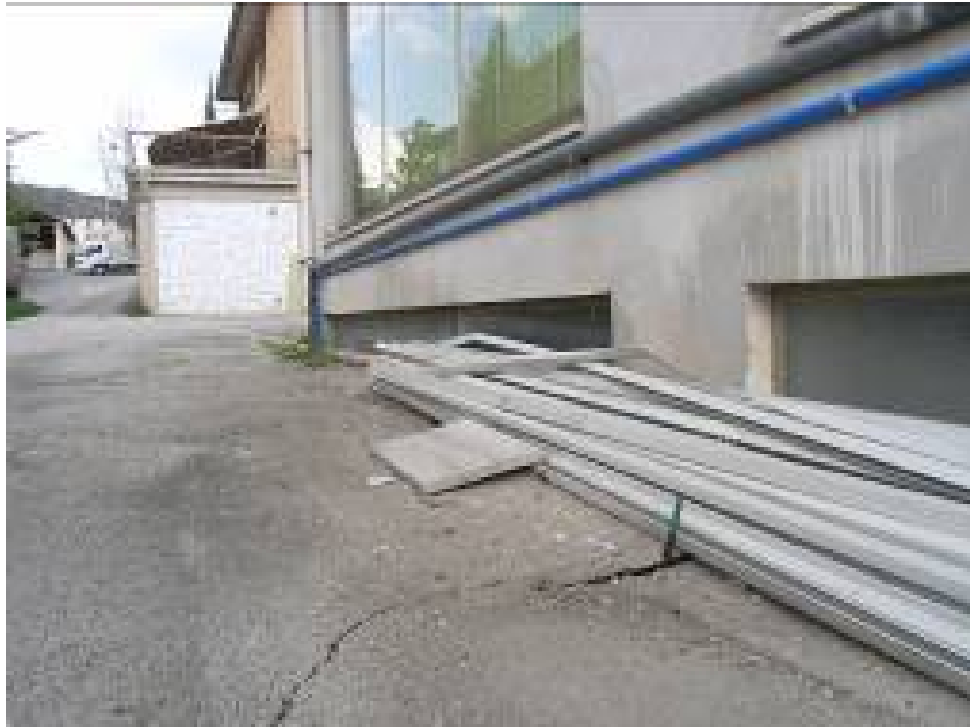
*Figure 32. Ground fissures and settlement at the side of the building (42.359817°N, 13.468649°E).*

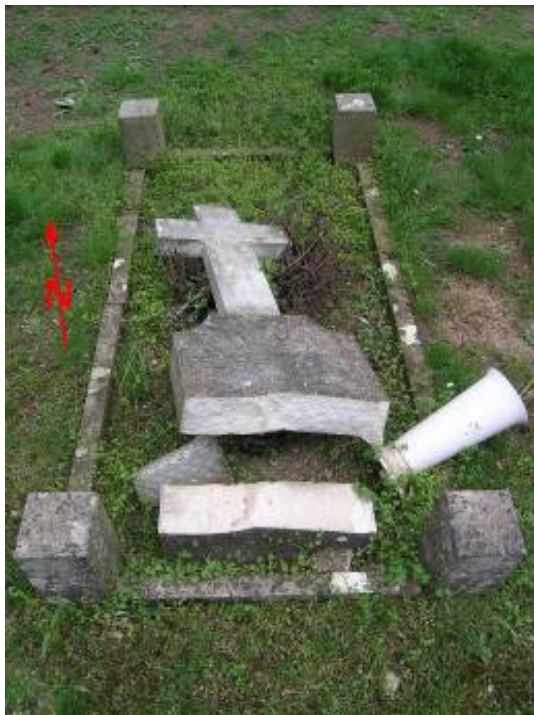
Figure 49. Grave markers breakage.

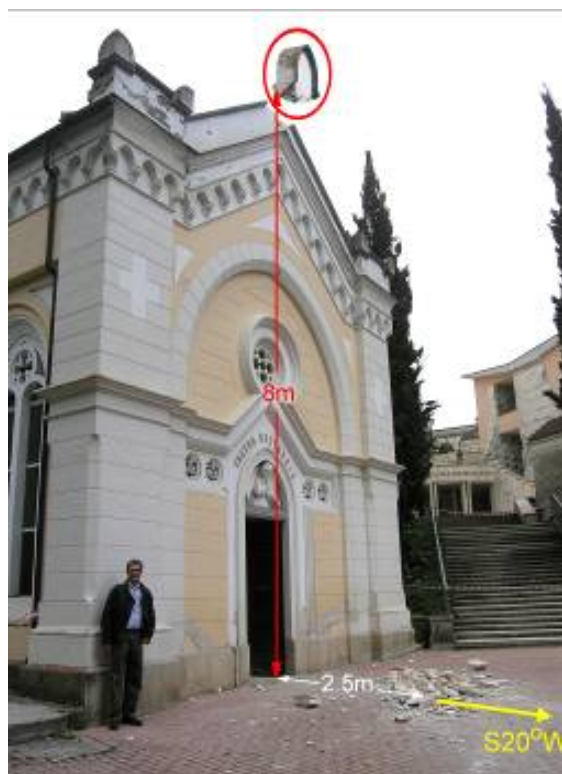
Figure 53. Fall of facade object at mortuary building.

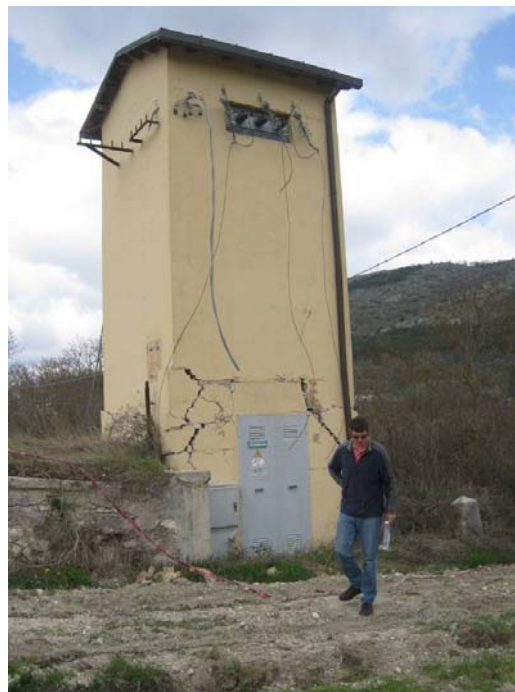
Figure 57. Heavily damaged seismometer station box (not in use at the time of the earthquake, no recording) on the northeast valley beneath the town of Castelnovo. ( $42.2982^{\circ}$ ,  $13.6295^{\circ}$ ).

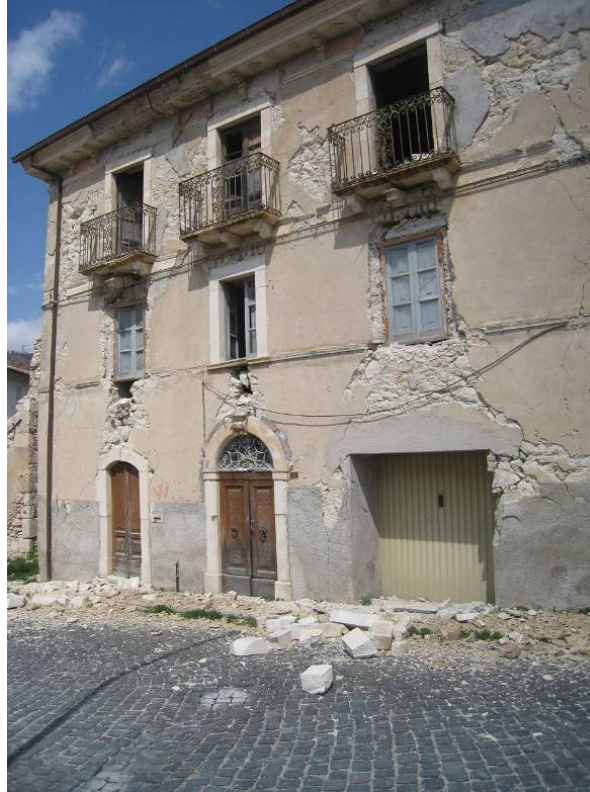
Figure 58. A typical heavily damaged structure in the lower elevation of Castelnuovo. Many structures in the lower elevation neighborhood had less observable damage. (42.2956°, 13.6274°).

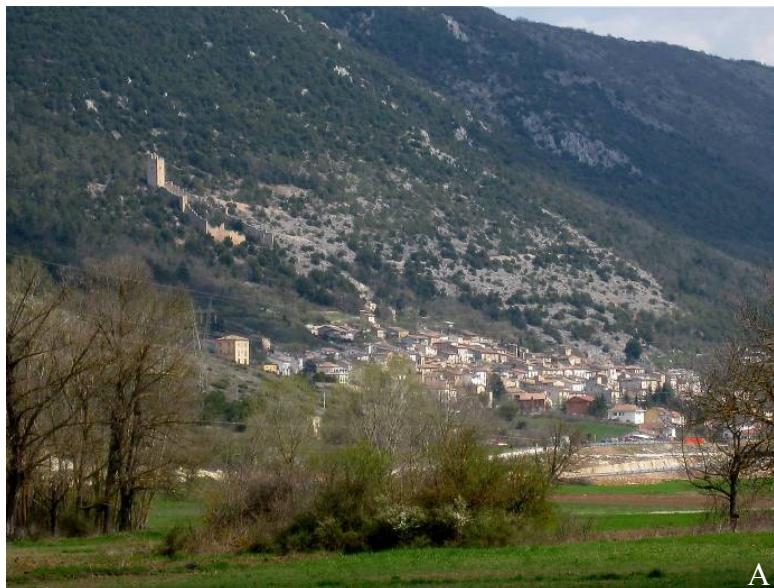
*Figure 61. (A) The village of San Pio delle Camere built on Mesozoic limestone. This picture was taken from the lower flanks of Castelnuovo (from location 42.2898°, 13.6297° looking southeast).*

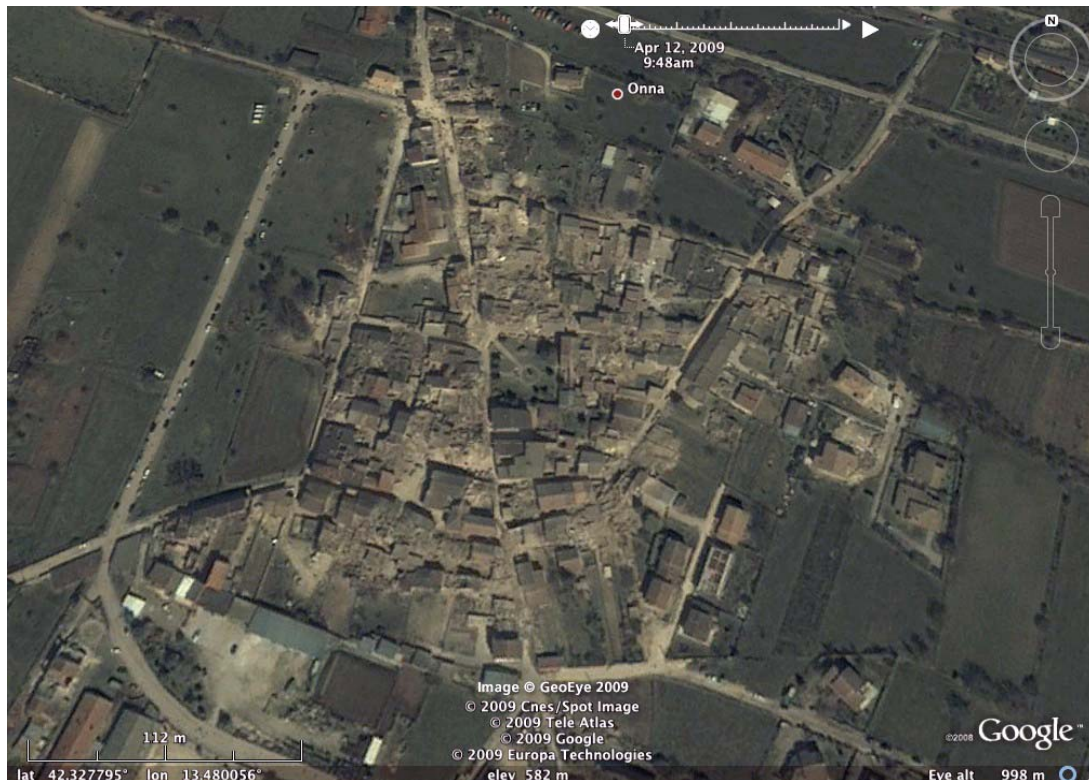
Figure 64. The village of Onna suffered D4–D5 damage in most of the unreinforced masonry structures. Reinforced concrete structures at the margins of the village performed well with only minor damage (D0-D2).

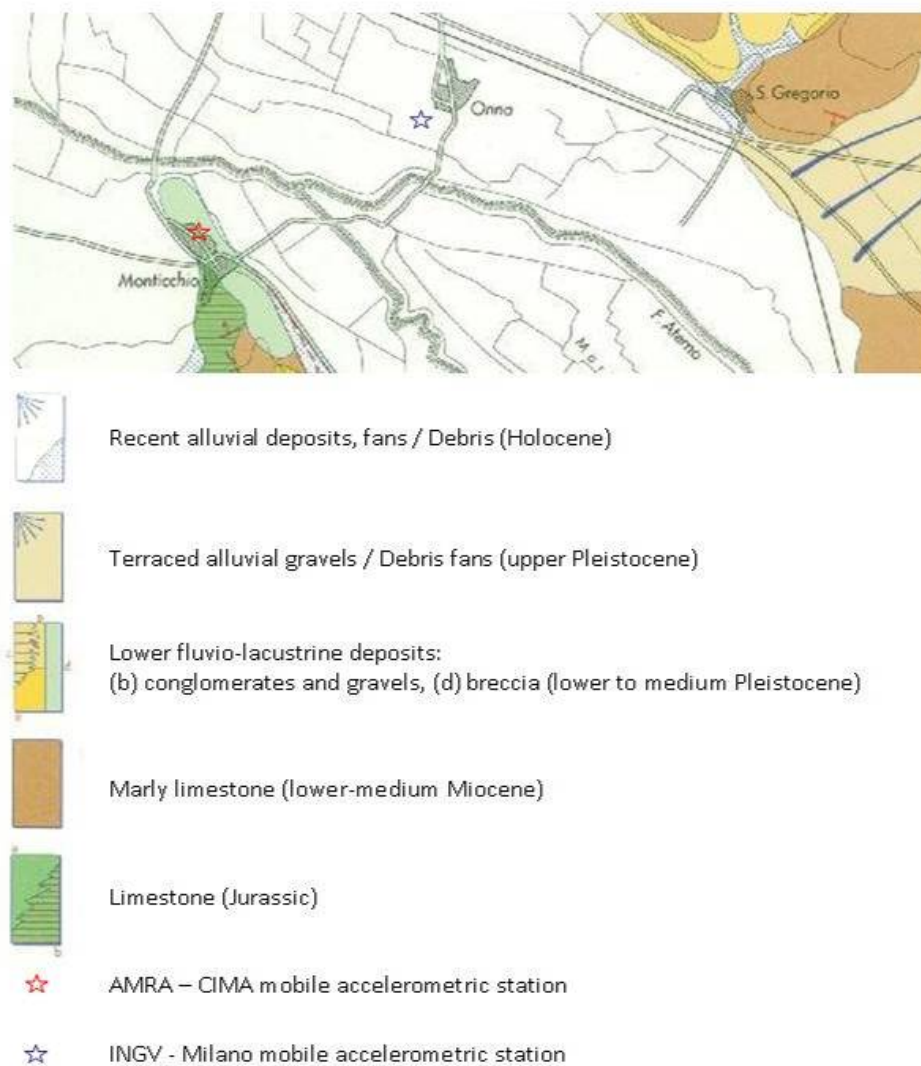
Figure 66. Geological map of Monticchio, Onna and San Gregorio (modified after Bosi and Bertini, 1970).

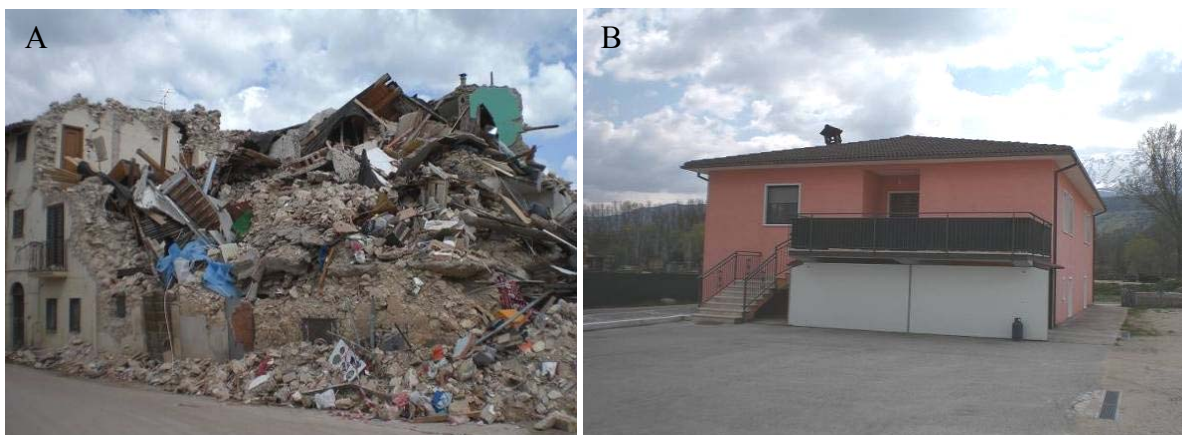
Figure 67. Onna. (A) D5 damage level on masonry building structures, (B) D0 damage on a RC building (except for the tilting of the chimney).

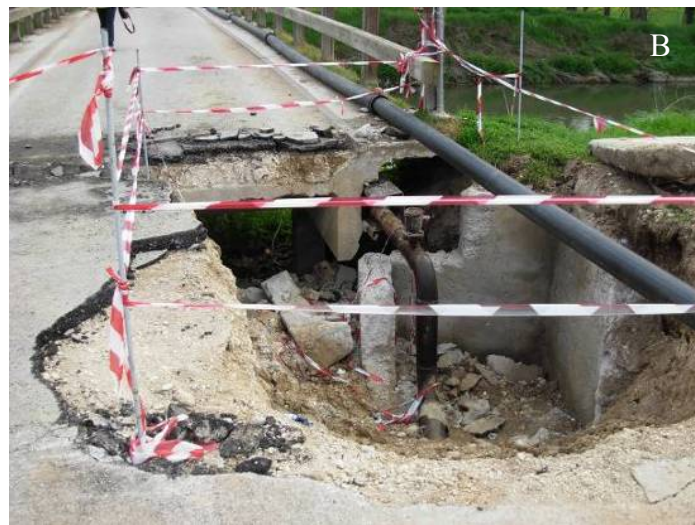
*Figure 68. Onna. (B) Intense damage (D4) of RC bridges on the Aterno river.*

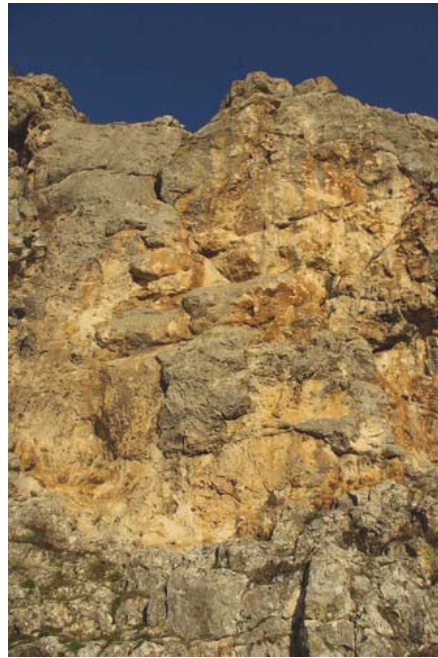
*Figure 69. Monticchio: outcrop of the Jurassic limestone formation.*

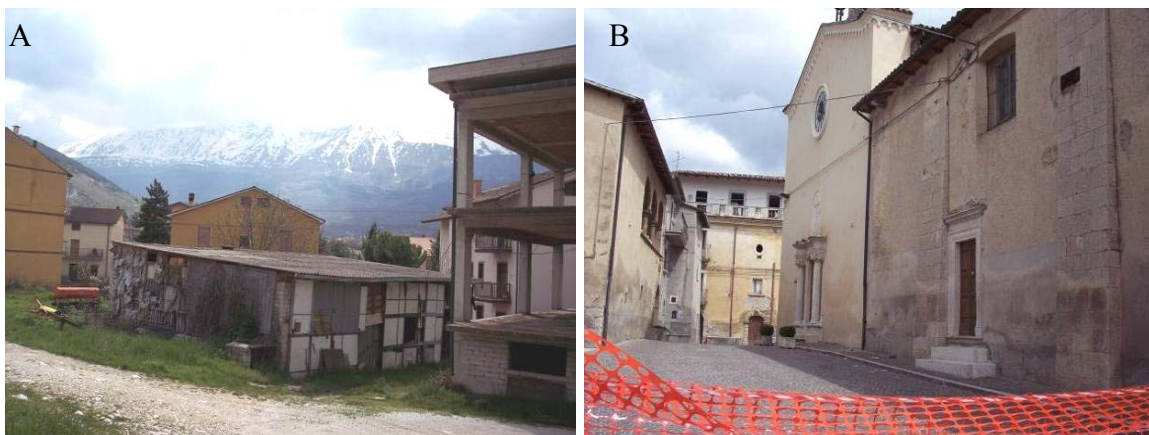
*Figure 70. Monticchio. (A) D0 damage level on different building structures, (B) D0 damage on monumental masonry buildings.*

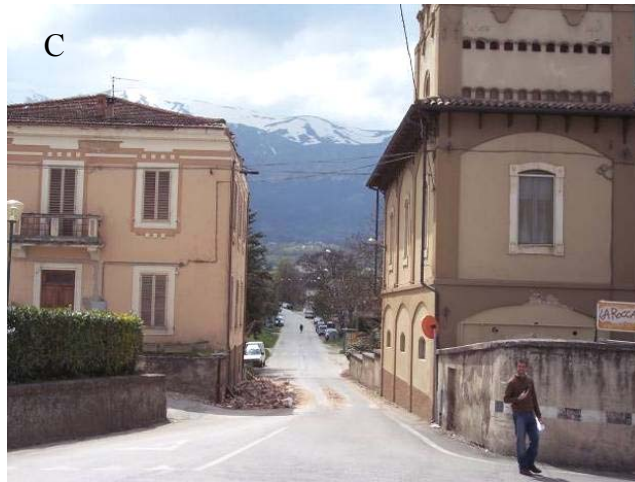
Figure 70. Monticchio. (C) D1 damage (fall of the cornice) on a masonry building.

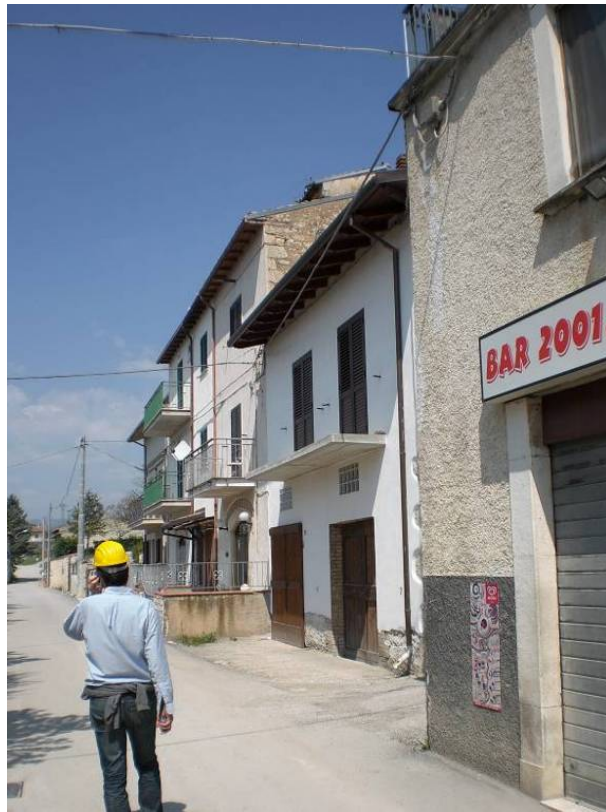
*Figure 73. San Gregorio western part: masonry buildings with minor damages.*

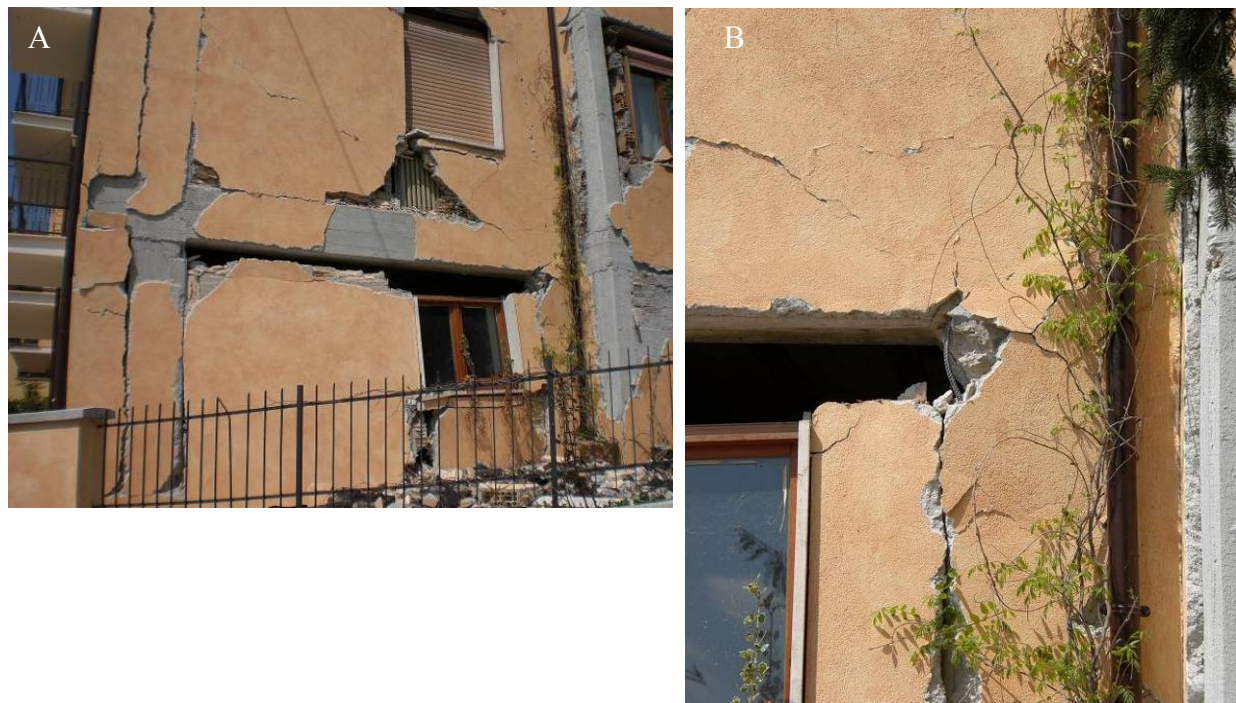
Figure 75. San Gregorio eastern part. (A) RC building with structural damage, (B) Detail of the damage to the beam-column connection.

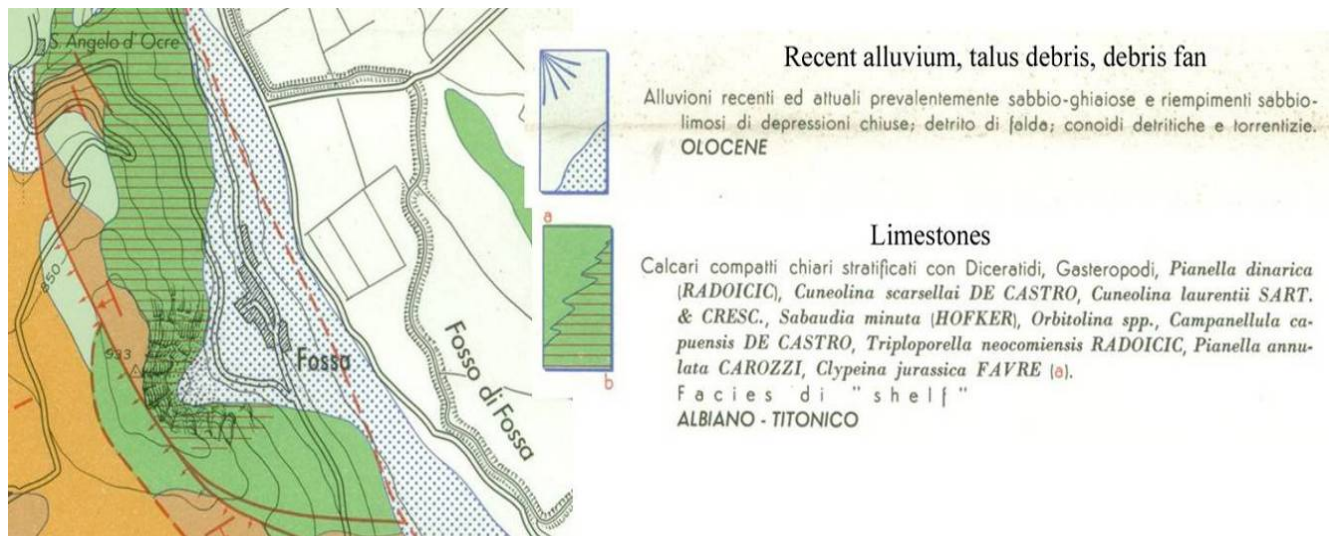
Figure 76. Geological map of Fossa (after Bosi and Bertini, 1970).

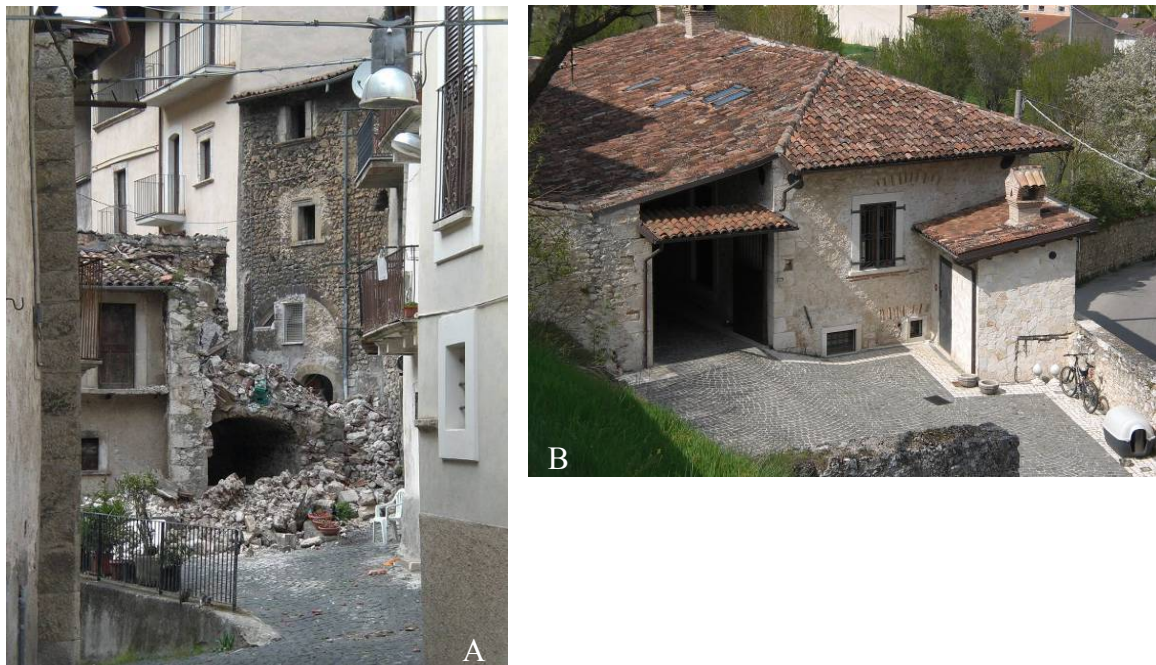
Figure 77. Fossa. (A) Collapse of masonry constructions in the historic center, (B) Strengthened masonry construction with no damage.

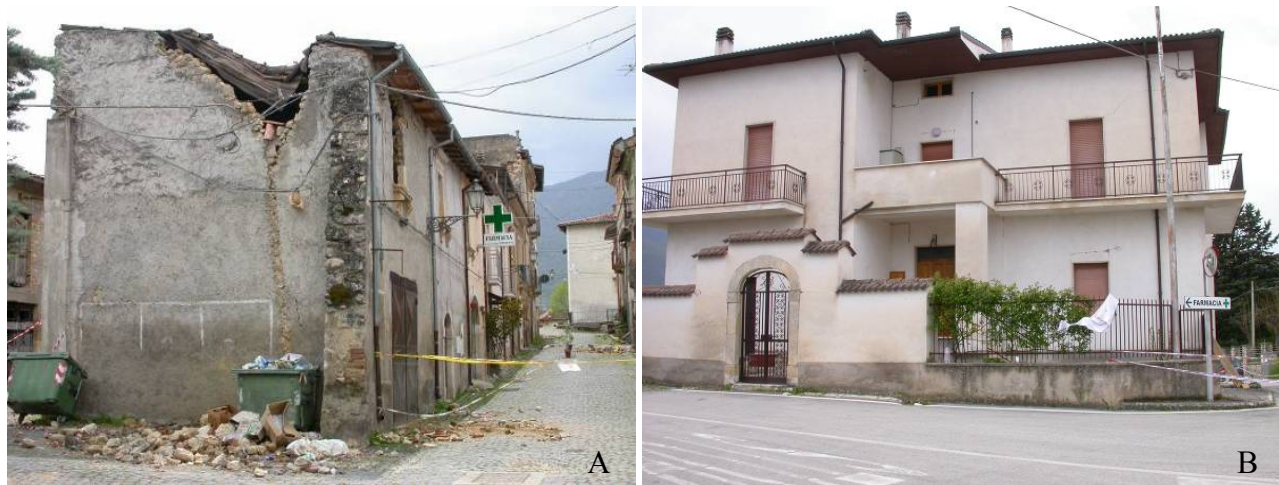
Figure 79. S. Eusanio Forconese village. (A) Partial collapse of masonry building (D4), (B) Slight damage to a RC building nearby (D1).

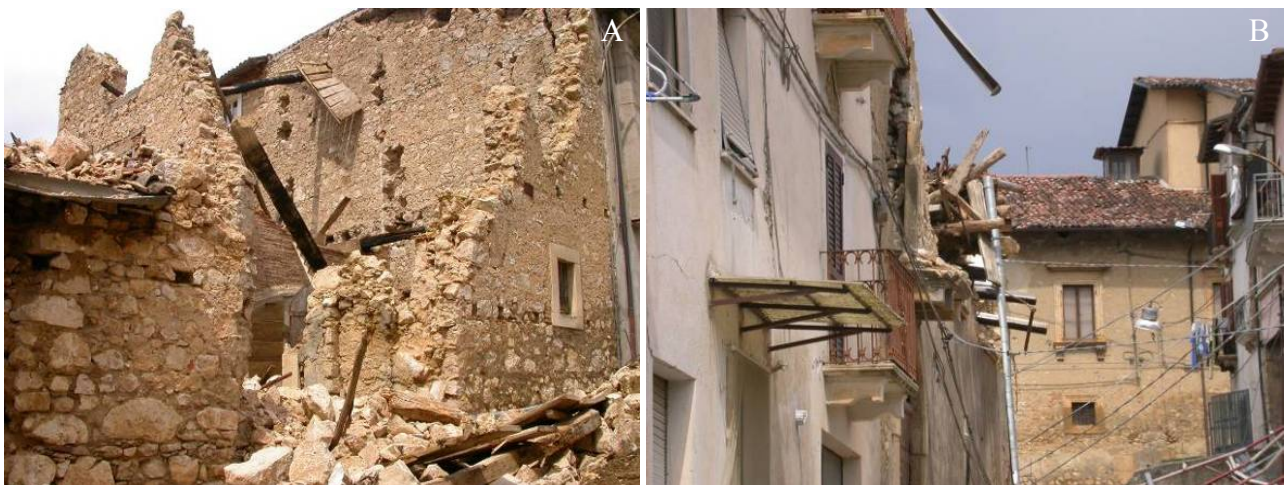
Figure 80. S. Eusanio Forconese. (A) Collapse of old masonry building (D5), (B) Partial collapse of masonry building (D4).

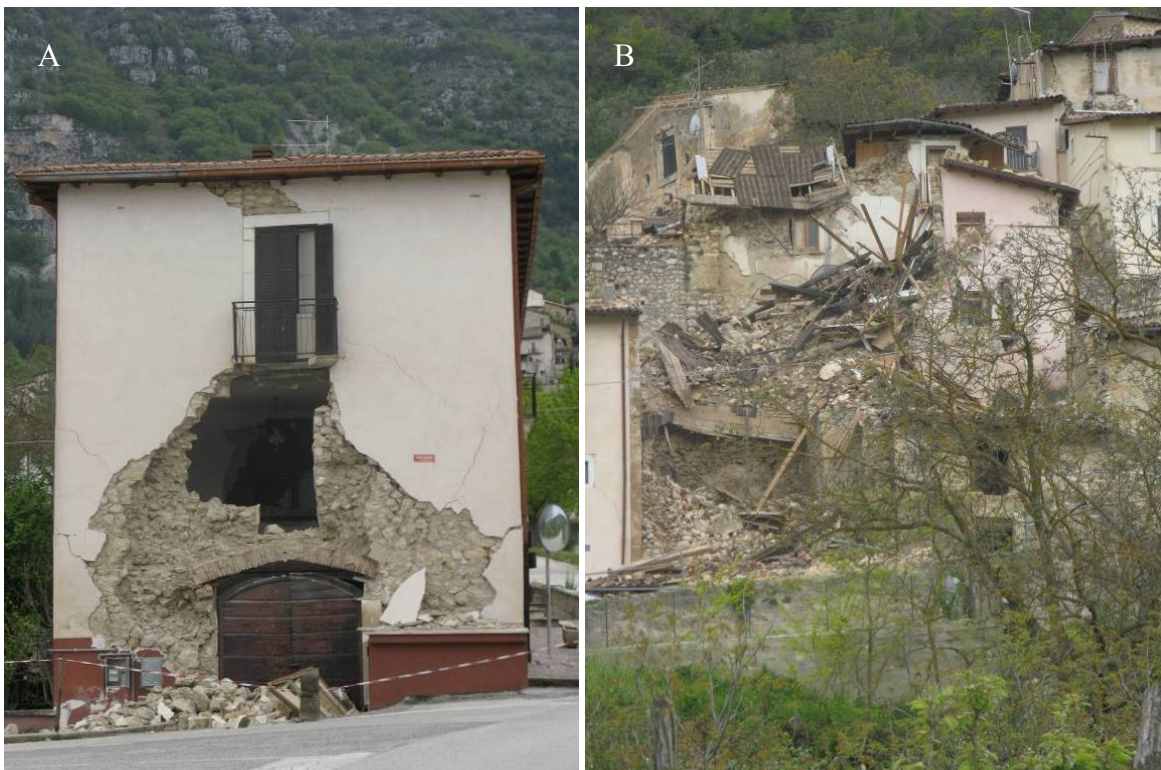
*Figure 82. Casentino. (A) Partial collapse of the masonry building at the entrance of the village, (B) Collapse of old poor quality masonry buildings in the historic center.*

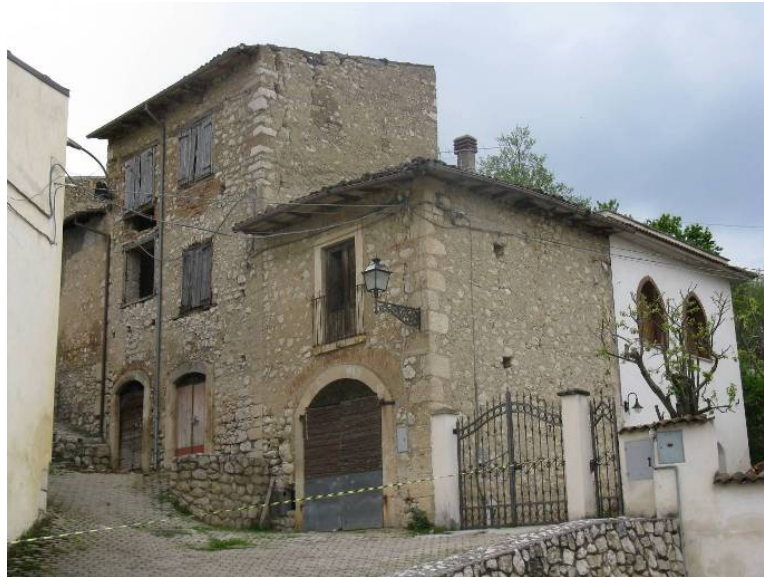
Figure 83. Casentino masonry buildings with some wall cracks.

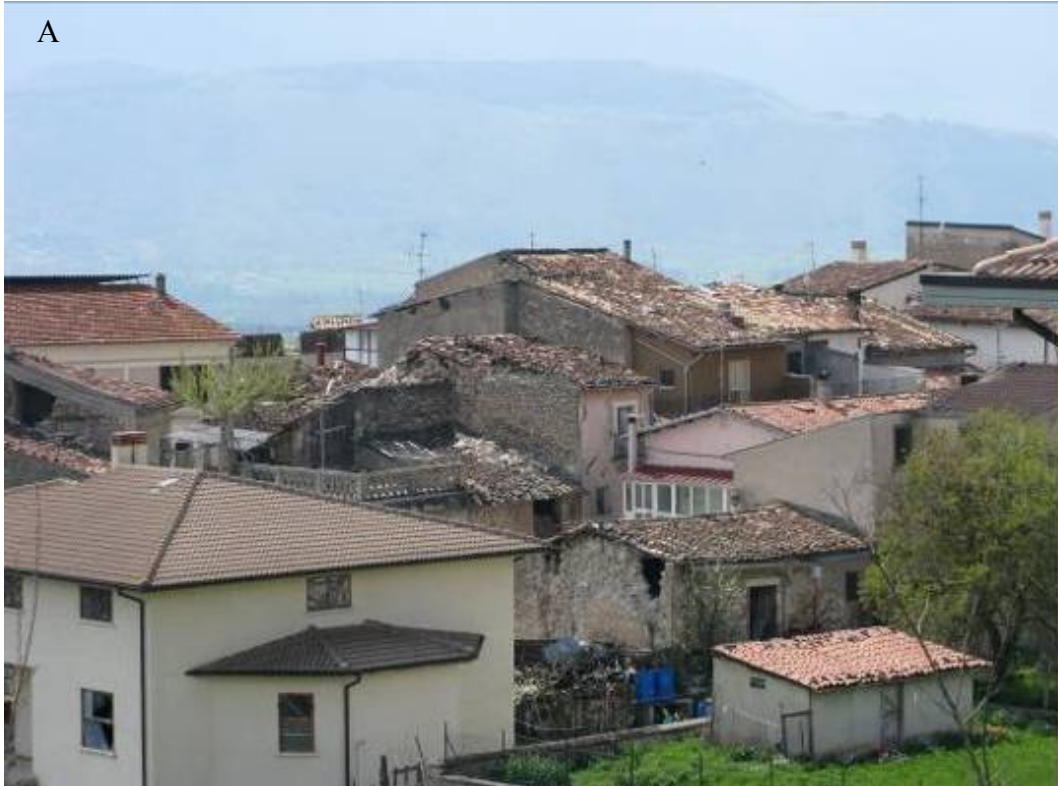
Figure 86. Poggio Picenze. (A) Variable damage (D3-D4) on masonry buildings of different style.

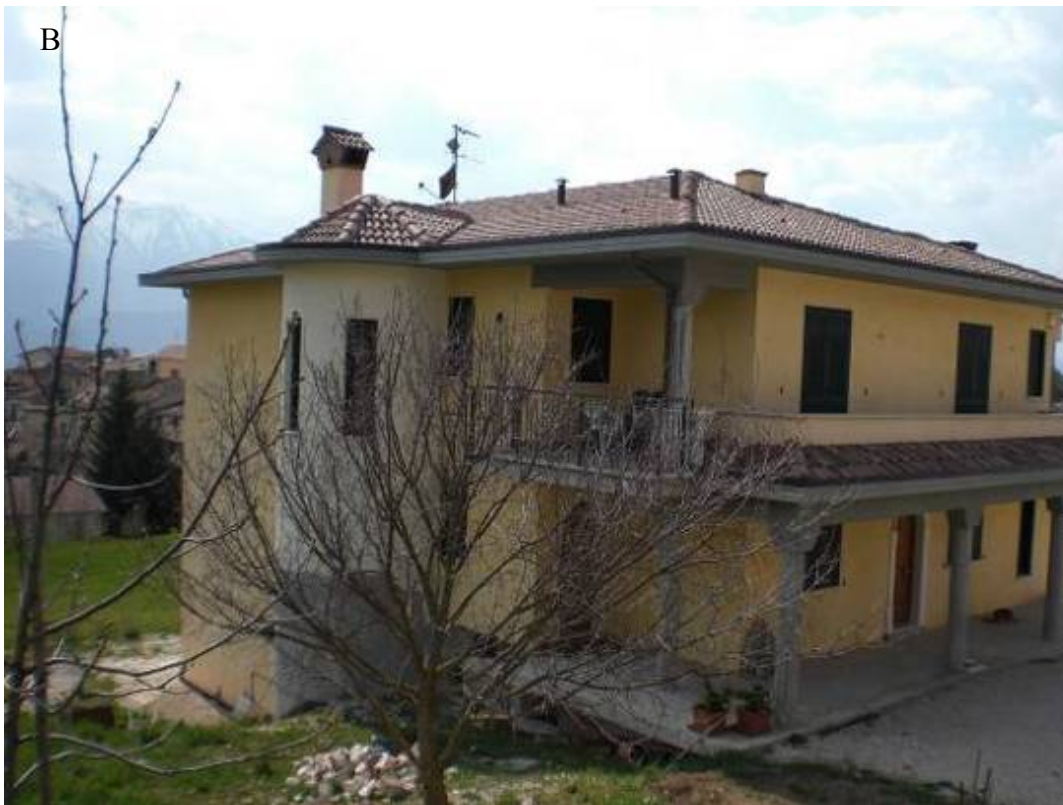
Figure 86. Poggio Picenze. (B) Undamaged RC house (D0) close to the (C) monumental church (D3).

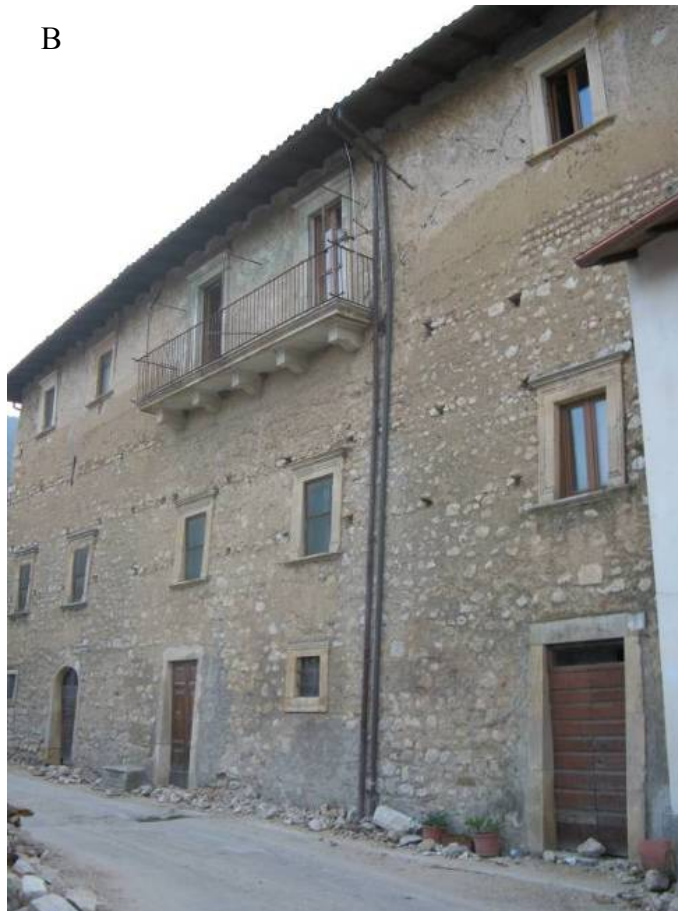
Figure 88. Villa S. Angel. (B) Reinforced masonry in the historic center with minor cracks in the highest story (D2).

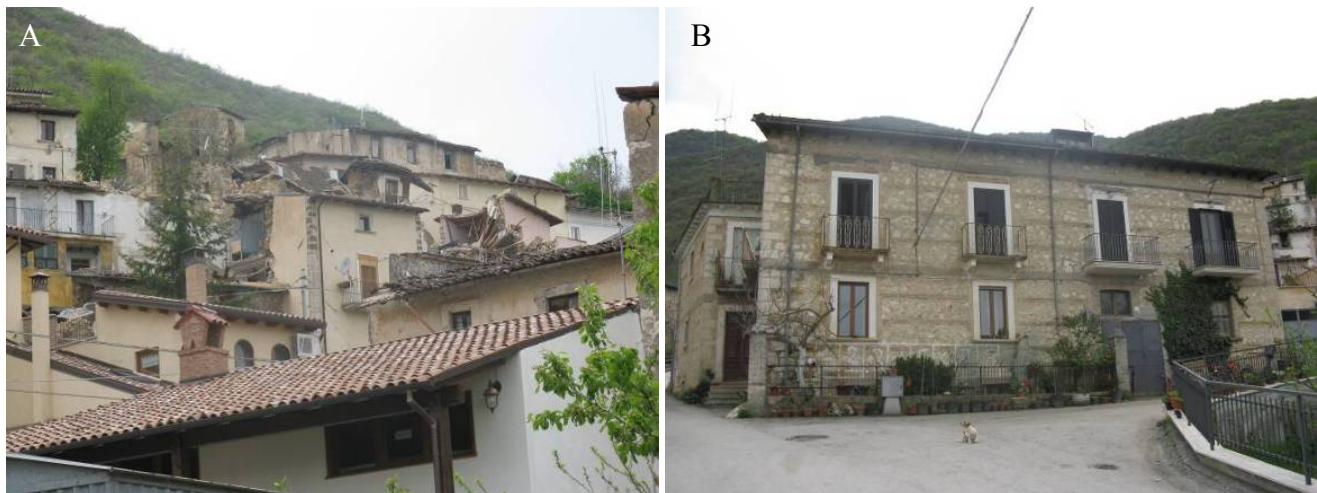
Figure 90. Tussillo. (A) View of the historic center with some collapsed masonry buildings on the background, (B) Masonry building at the entrance of the village showing no damage.

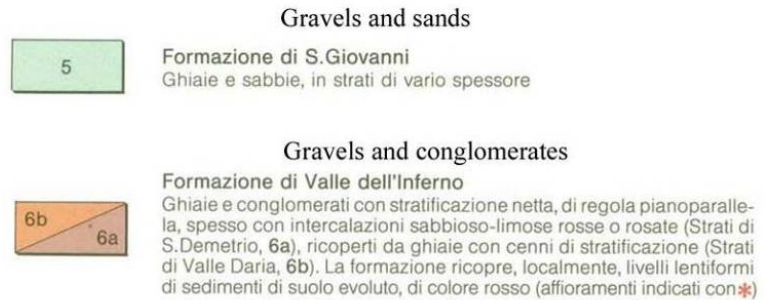
Figure 91. Geological map of S. Demetrio ne' Vestini (Bertini et al., 1989).

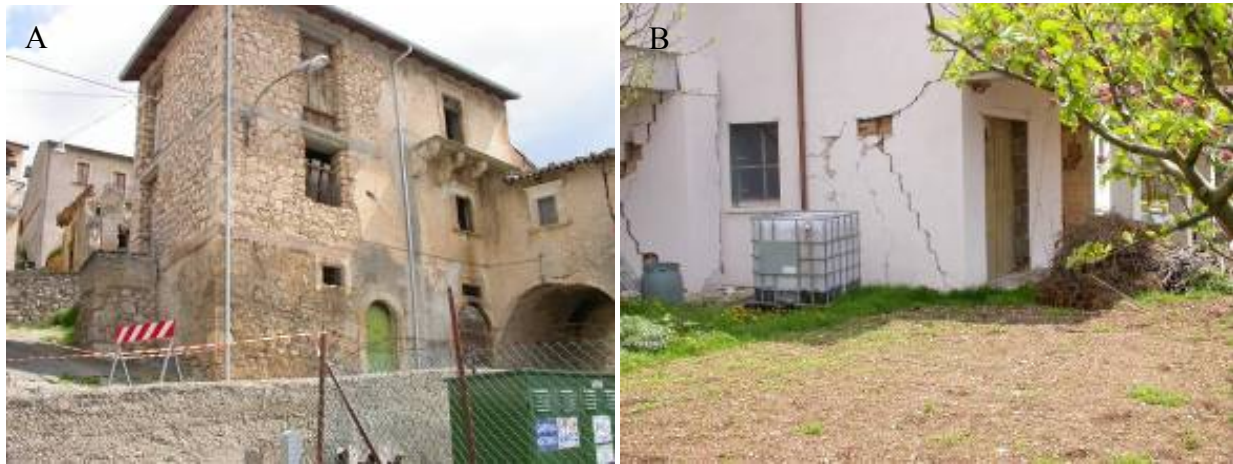
Figure 96. Barisciano. (A) Collapse (D5) of an old masonry building in background, (B) Damages (D1/D2) to RC buildings.

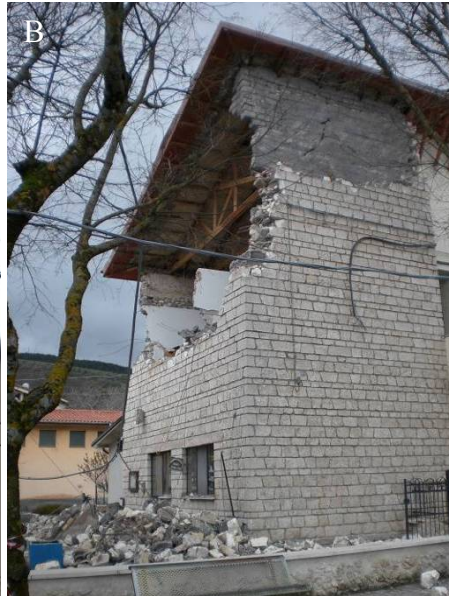
Figure 98. Goriano Sicoli. (A) Diagonal cracks in a masonry building (D3, (B) Partially collapsed masonry school (D4).

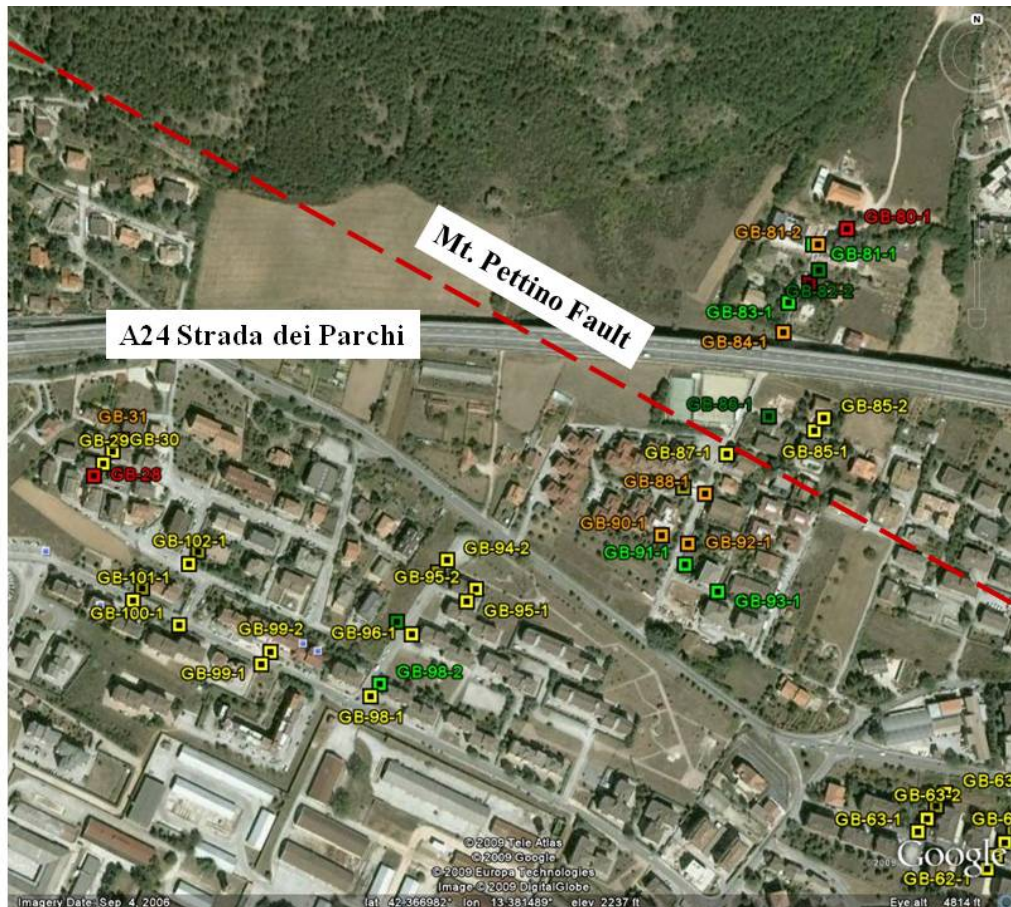
Figure 103. Zone (a) of the building damage survey along the Mt. Pettino Fault.

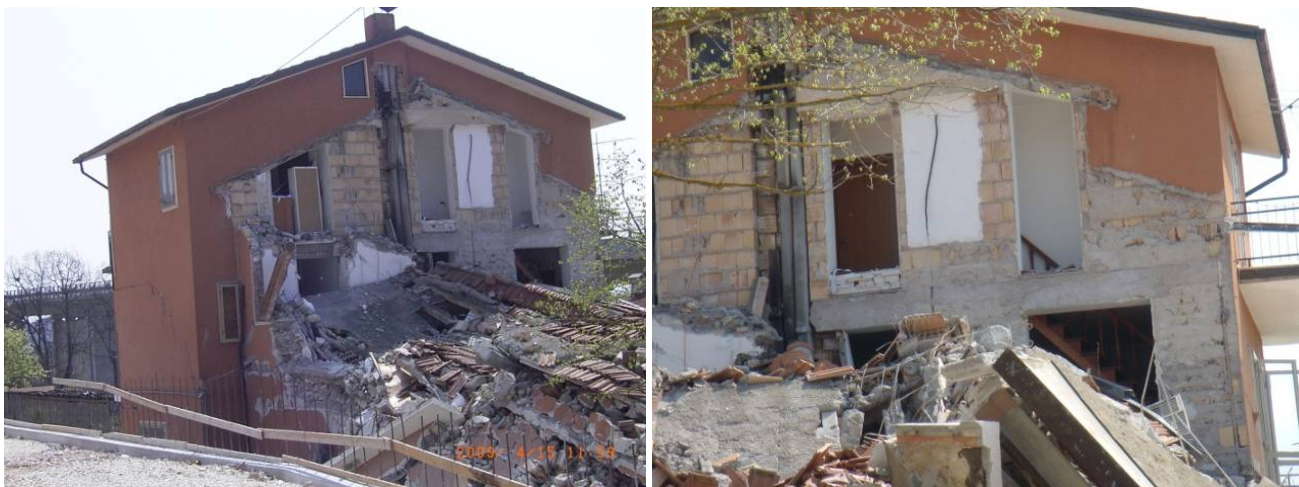
Figure 104. Masonry structure at waypoint GB-82-1.

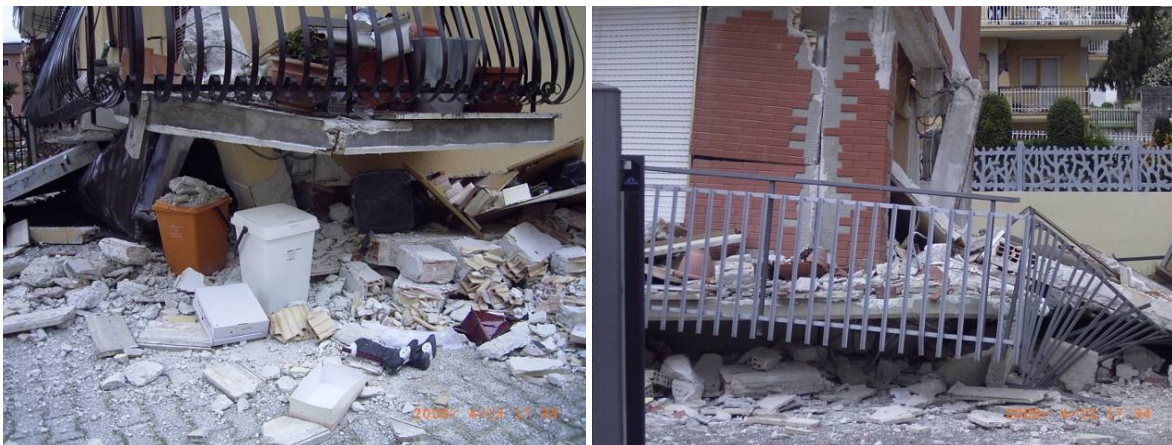
Figure 106. Example of D5 damage in the building at waypoints GB-27-1 and GB-28-1.

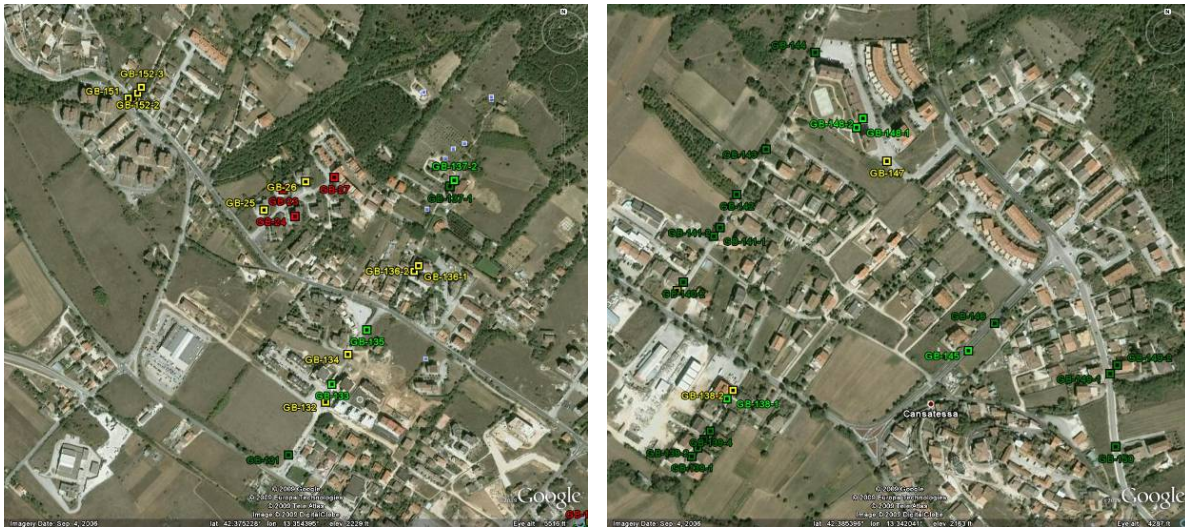
Figure 107. Results of the building damage survey along the Mt. Pettino Fault: Zones b, c, d, and e.

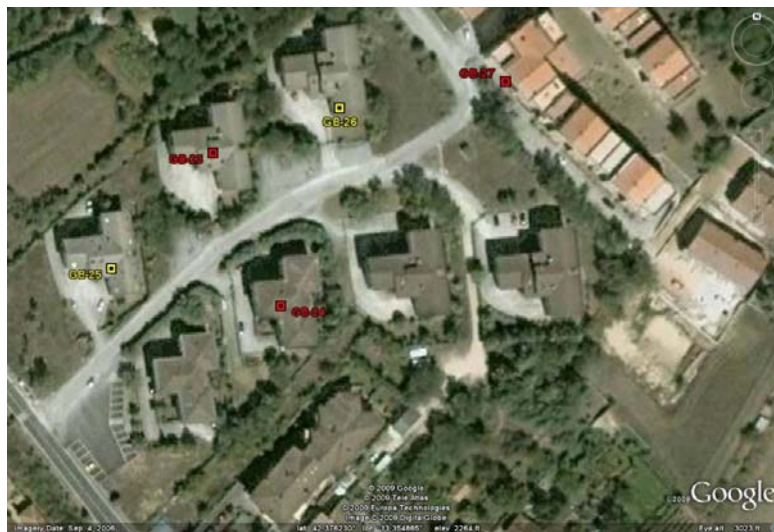
Figure 108. Cluster of damage in zone (d).

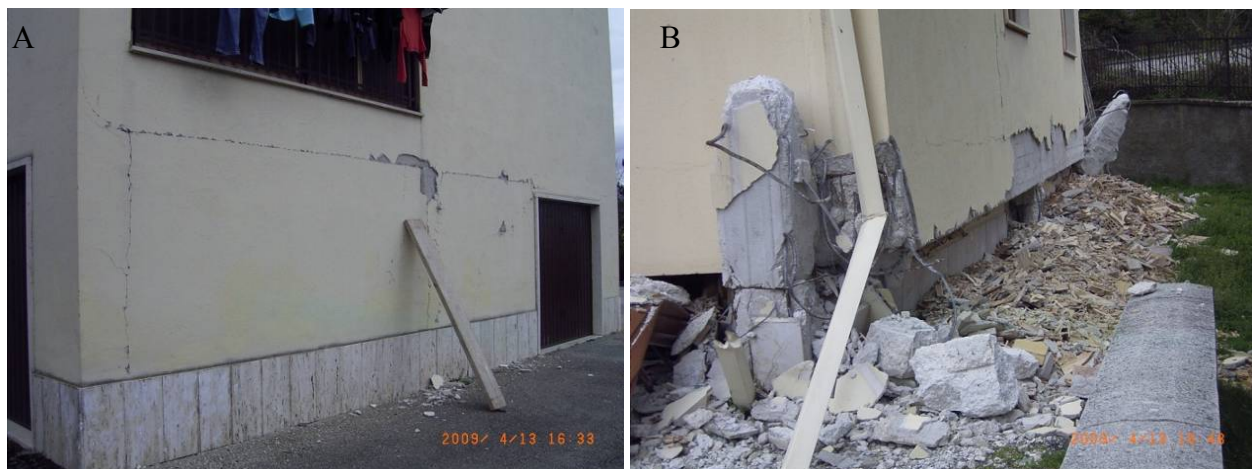
Figure 109. Damage on the structures in the cluster in zone (d). (A) Waypoint GB-22-1 (D1), (B) Waypoint GB-23-1 (D5).

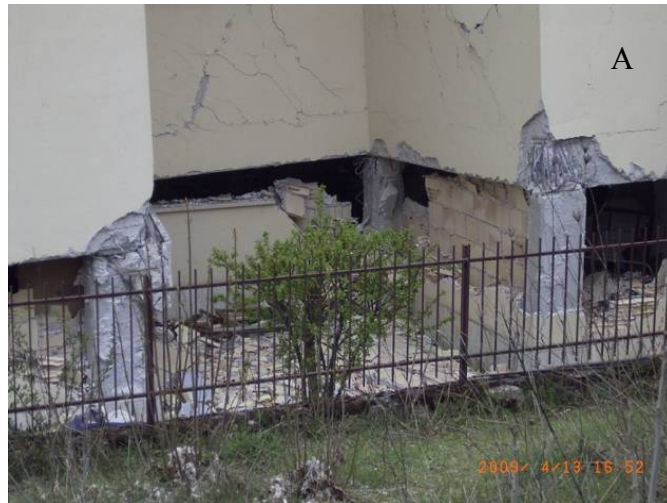
Figure 110. Damage on the structures in the cluster in zone (d). (A) Waypoint GB-24-1 (D5).

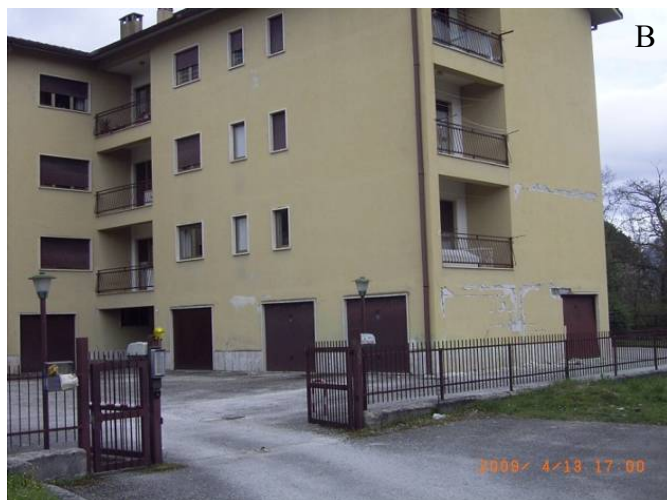
Figure 110. Damage on the structures in the cluster in zone (d). (B) Waypoint GB-25-1 (D2).
