## Seismological and geotechnical aspects of the $M_w=6.3$ L'Aquila earthquake in central Italy on 6 April 2009

**Giuseppe Lanzo**, Professor, University of Rome, Italy; email: [giuseppe.lanzo@uniroma1.it](mailto:giuseppe.lanzo@uniroma1.it)

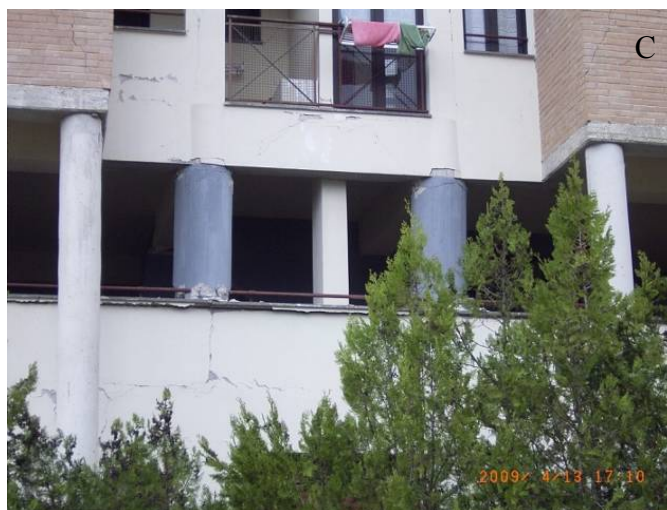
Figure 110. Damage on the structures in the cluster in zone (d). (C) Waypoint GB-26-1 (D2).

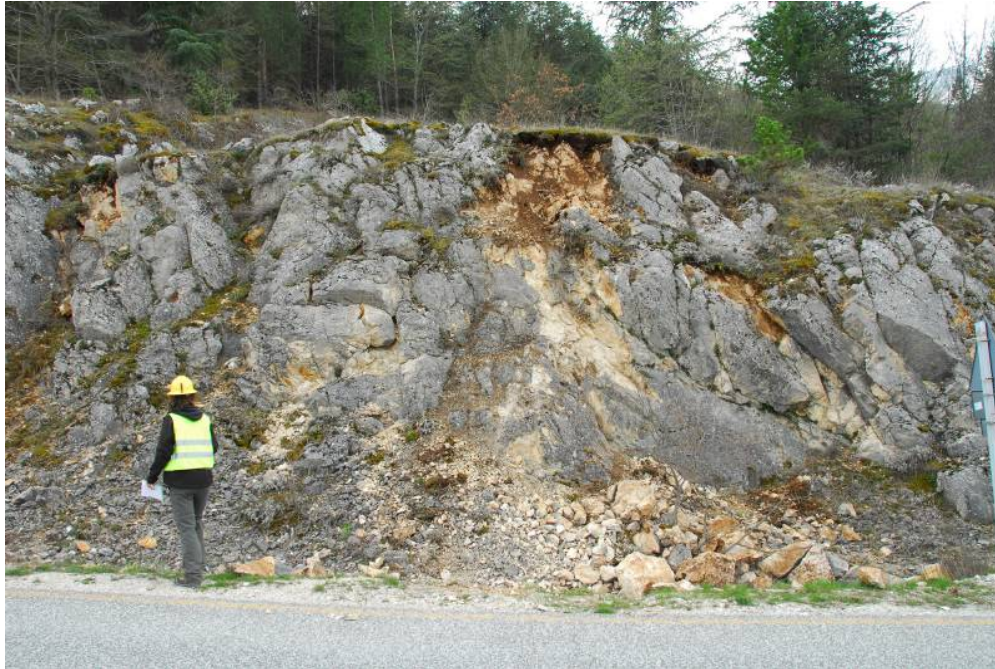
*Figure 117. Shallow ravelling-type failure of weathered limestone blocks (42.278N, 13.467E).*

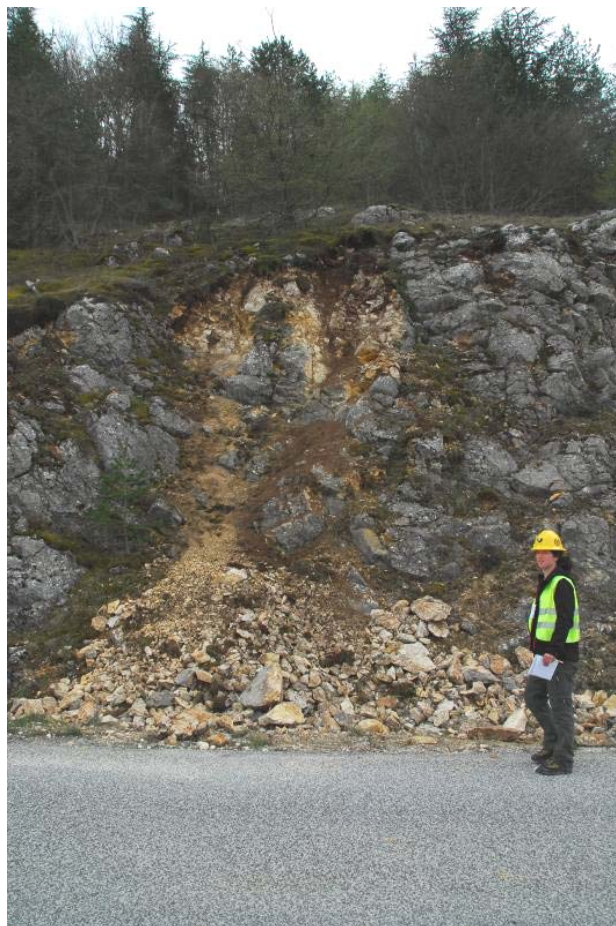
*Figure 118. Shallow ravelling-type failure of weathered limestone blocks (42.278N, 13.468E).*

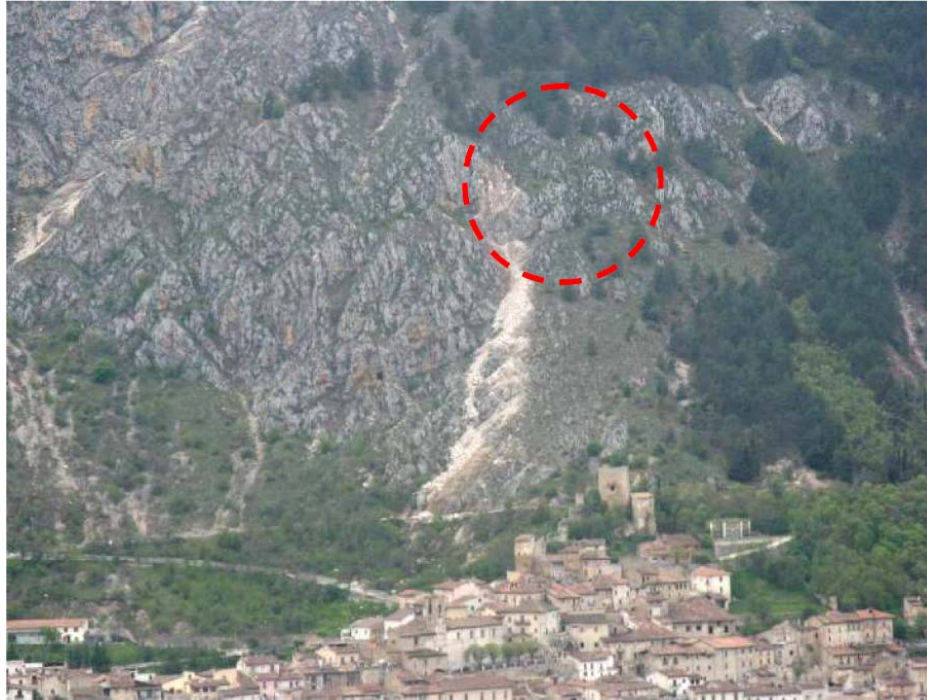
*Figure 119. View of Fossa from Mt. Di Cerro. The detachment area of the rock failure that generated the rock avalanche is circled (42.29274N,13.48575E).*

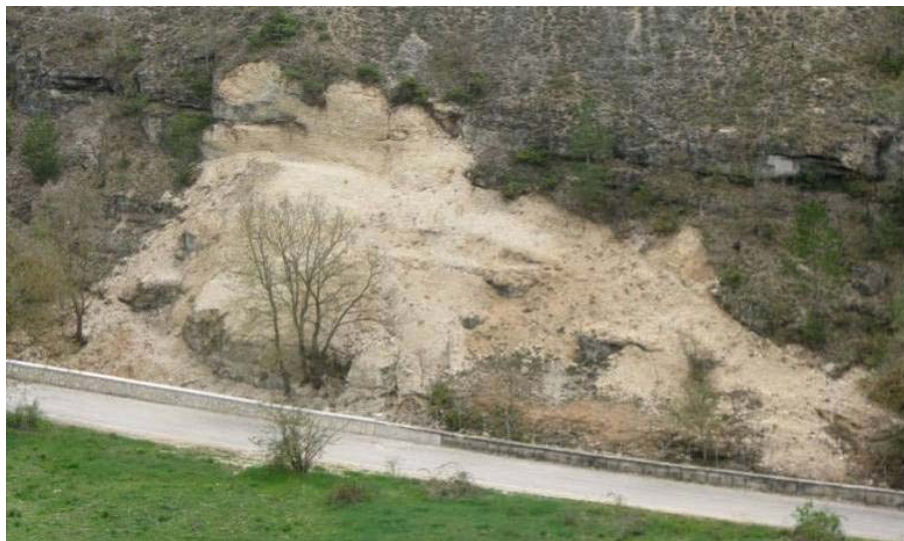
*Figure 122. Ravelling along the road from S. Demetrio to Lake Sinizzo (42.28845N,13.56442E).*

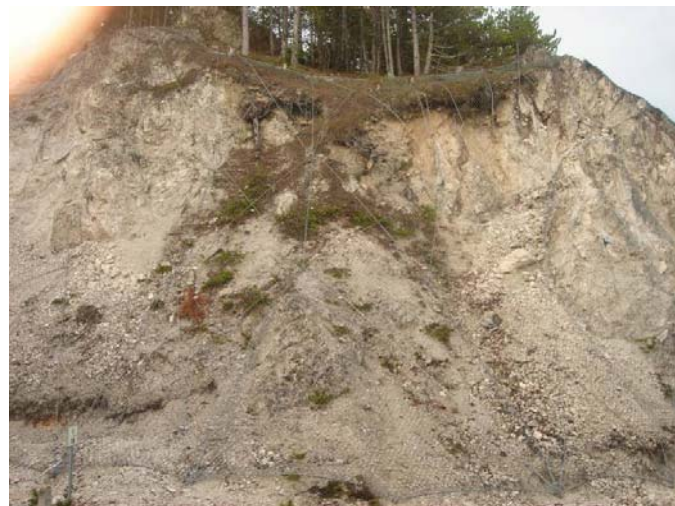
*Figure 131. Ravelling in pervasively fractured/cataclastic limestones on a road cut retained by steel-net protections on SS80 at km 18.2: (DC-18-1) (42.4281N, 13.3460E).*

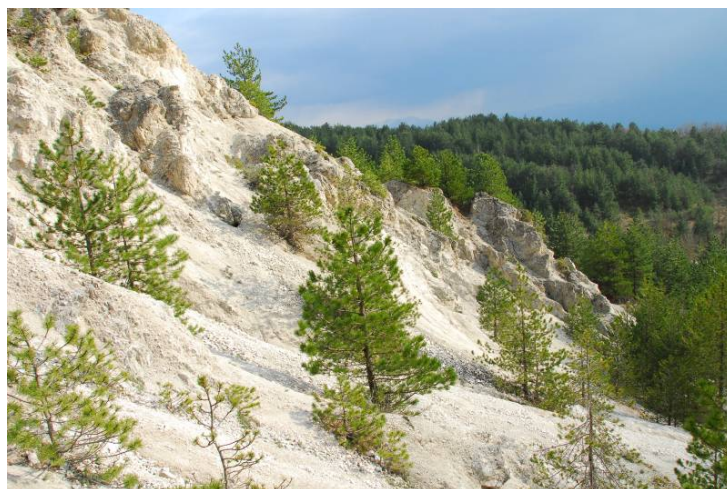
*Figure 132. Characteristic erosional scars developed in cataclasite (42.434N, 13.334E).*

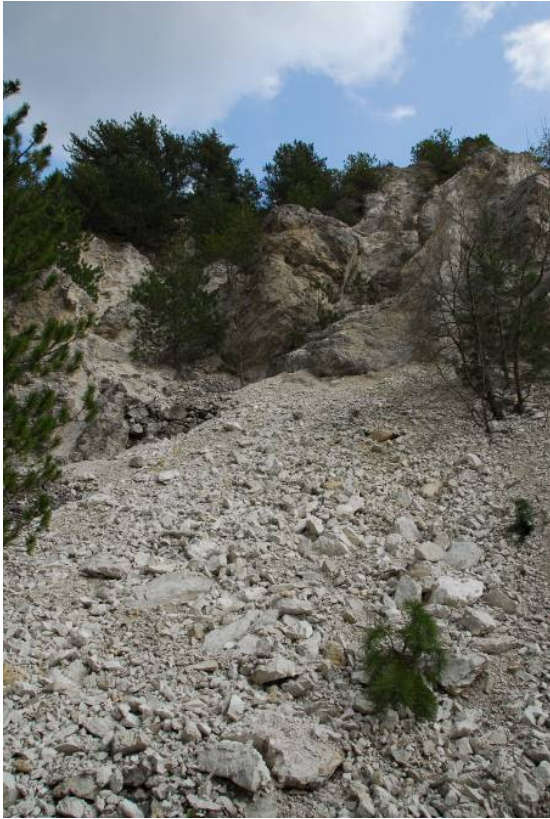
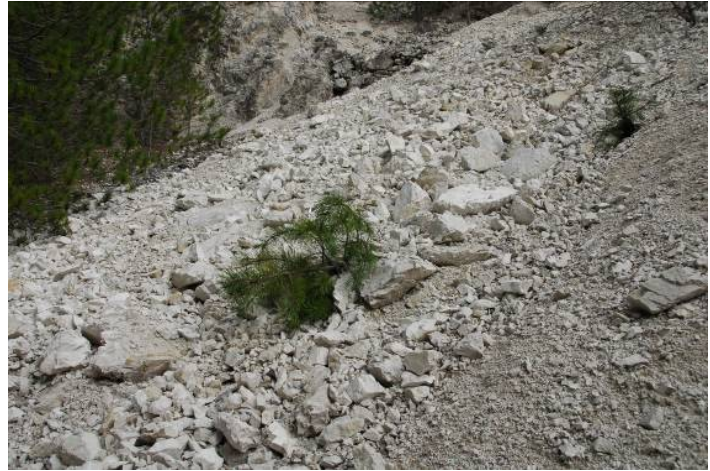
*Figure 133. Characteristic ravelling-type failure in natural outcrops of cataclasite; partially buried pine trees evidence recent movement (42.434N, 13.334E).*

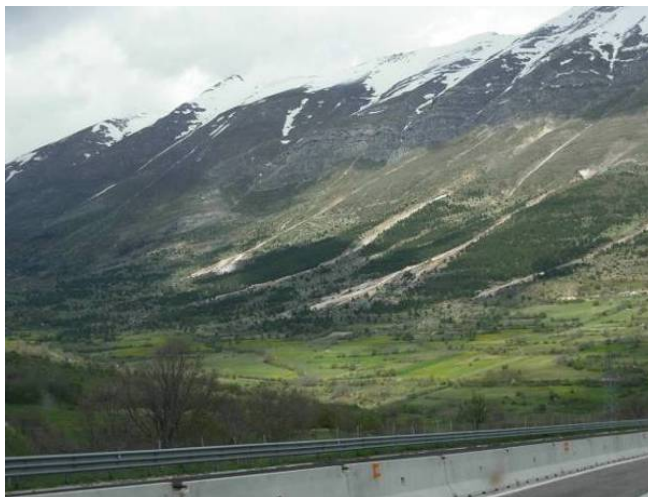
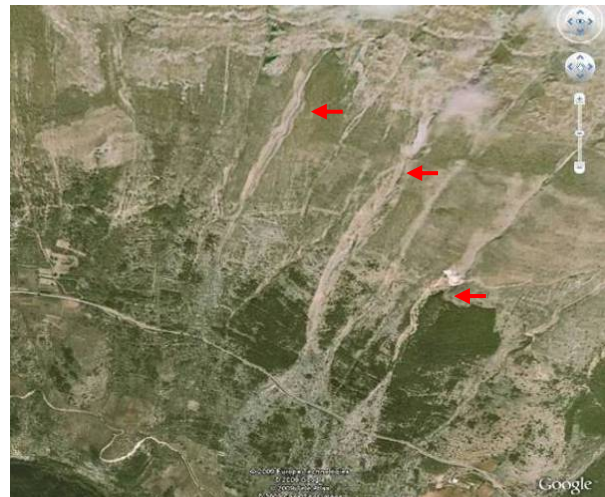
*Figure 136. Left view of the Mt. San Franco flank on 4-30-2009. Right: image from Google Earth taken before the earthquake showing the debris flows (42.4368N, 13.5796E).*

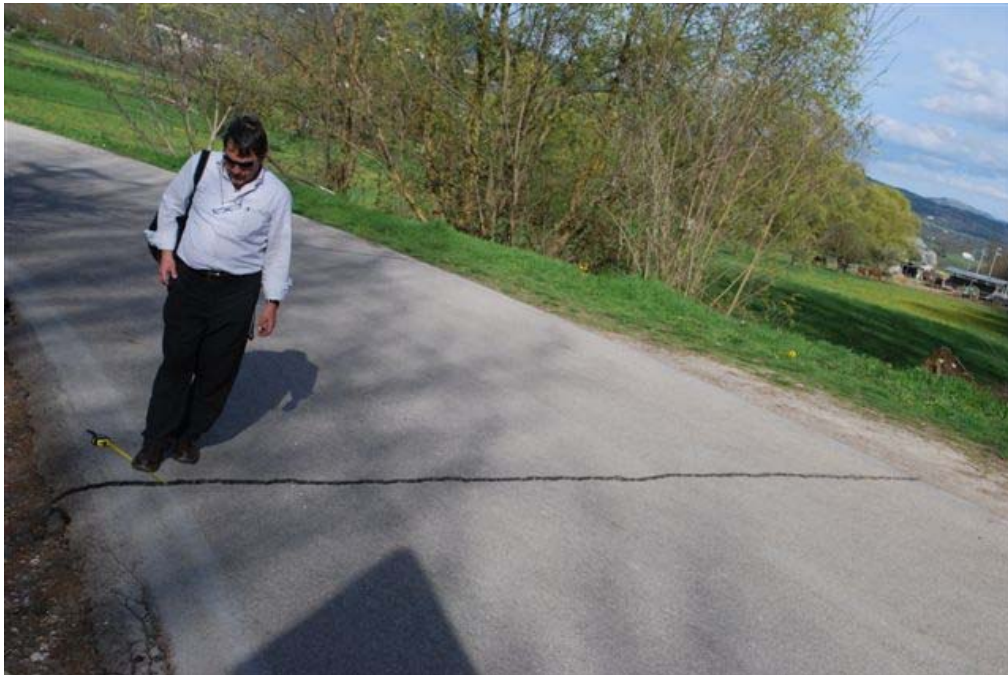
*Figure 141. Characteristic crack developed in bridge approach road directly south of Onna, at distances of 15 m to 160 m from the Aterno River (42.324N, 13.478E).*

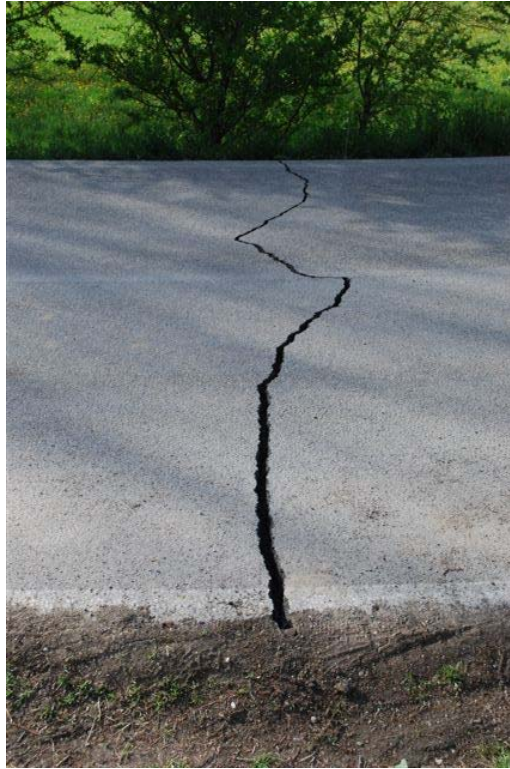
*Figure 142. Typical tensile condition of road cracks, not extending into neighboring sub-base or approach fill embankment (42.324N, 13.478E).*

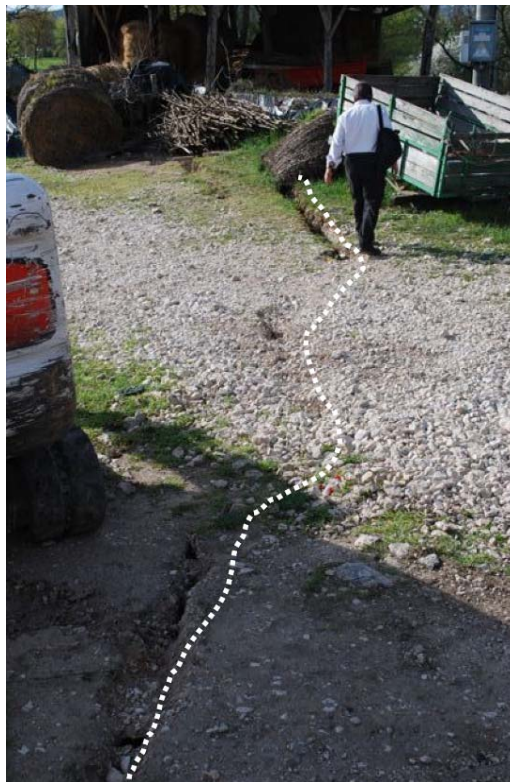
*Figure 143. Ground cracks up to 1.0 m deep, 20 m long, and with maximum of 15 cm vertical displacement (down-dropped toward river) developed directly adjacent to bridge abutment (42.324N, 13.478E).*

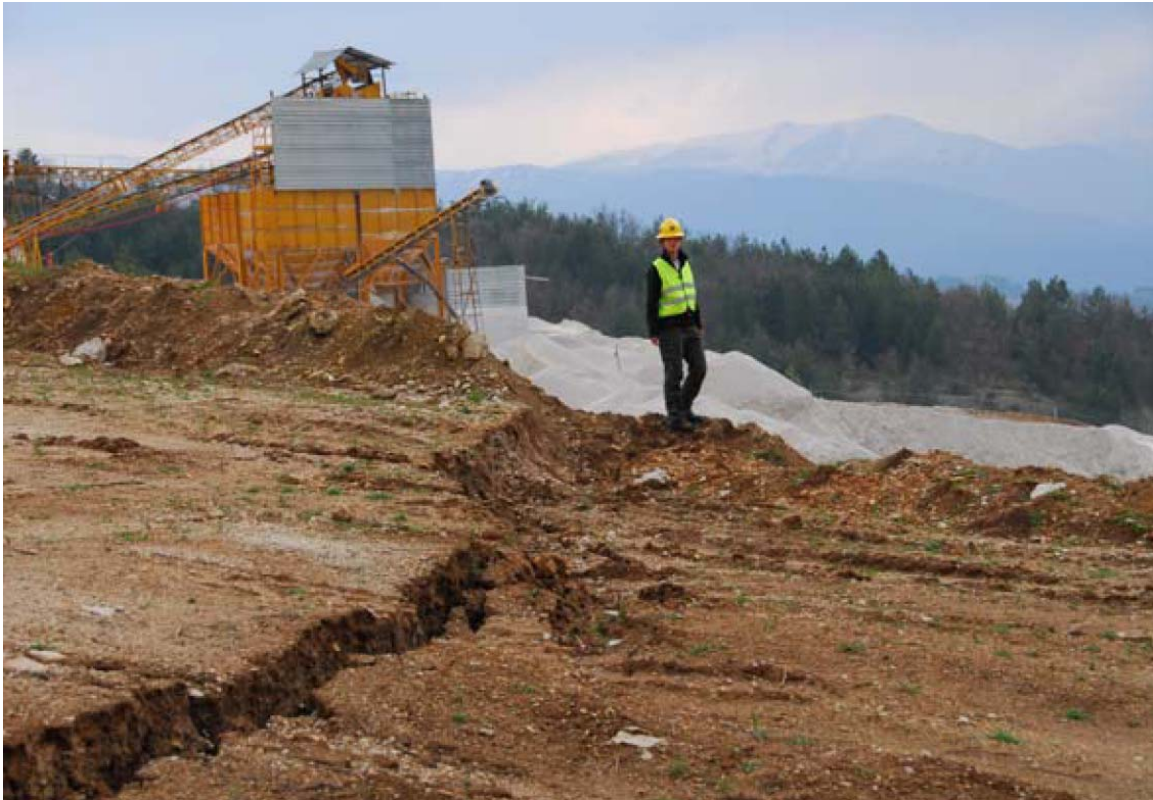
*Figure 149. Shear failure developed in fill material, with vertical displacement increasing to approximately 40 cm at free slope face (42.435N, 13.330E).*

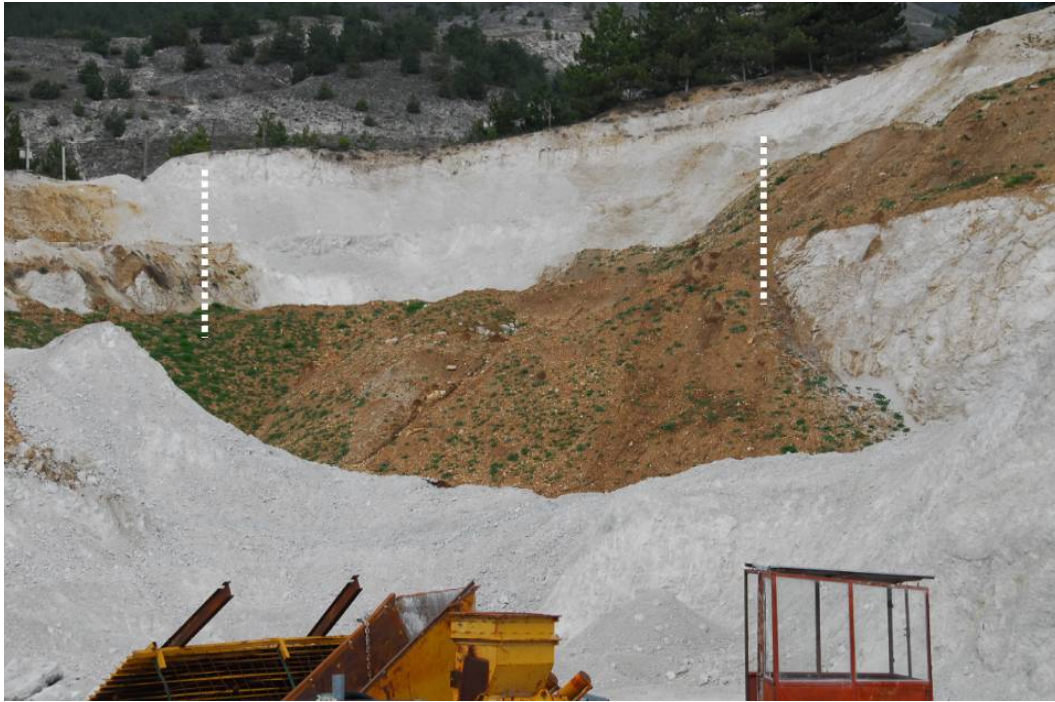
*Figure 151. Graben structure (between vertical lines) and bedrock boundary conditions (42.435N, 13.330E).*

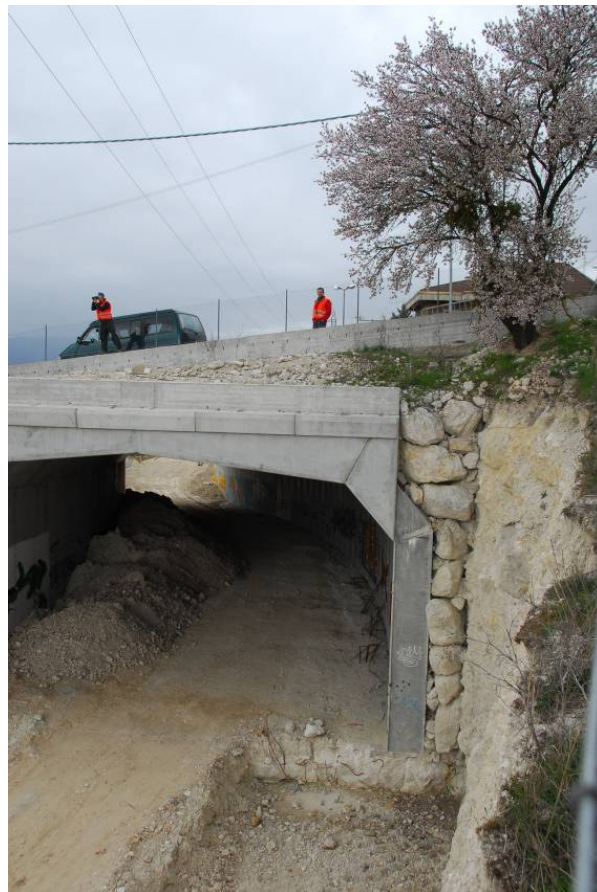
*Figure 152. Boulder fill placed along side wall of cut-and-cover structure (42.358N 13.415E).*

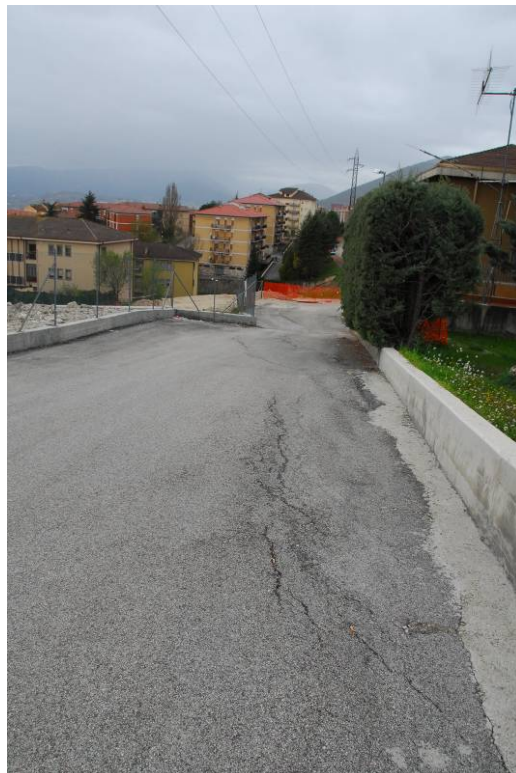
*Figure 154. Cracks in the overlying asphaltic surfaces and a narrow settlement trend along the sidewall of the cut-and-cover structure (42.358N 13.415E).*

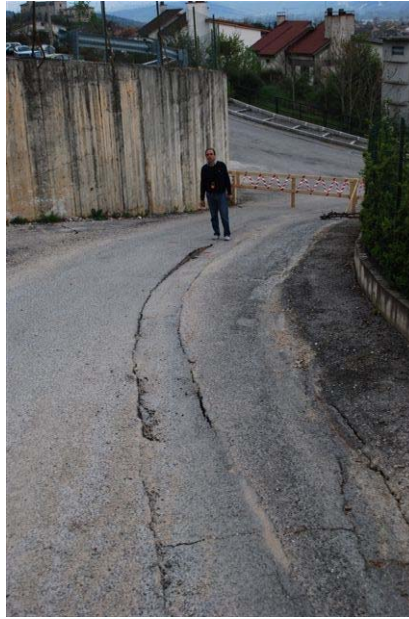
*Figure 155. Seismic compression of trench backfill in the town of Paganica (42.365N, 13.465E).*

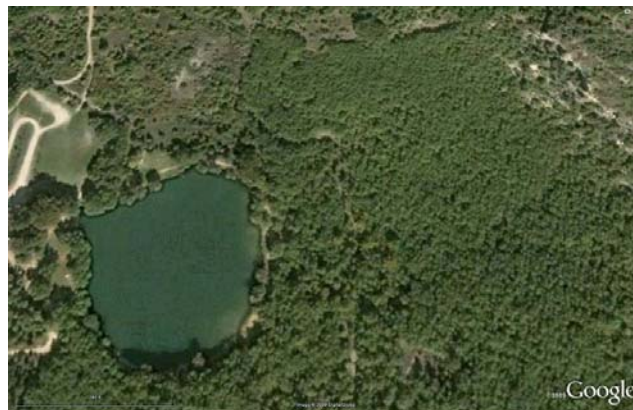
*Figure 156. Overview of Lake Sinizzo with location of impounding embankment indicated by vertical white line (42.291N 13.576E).*

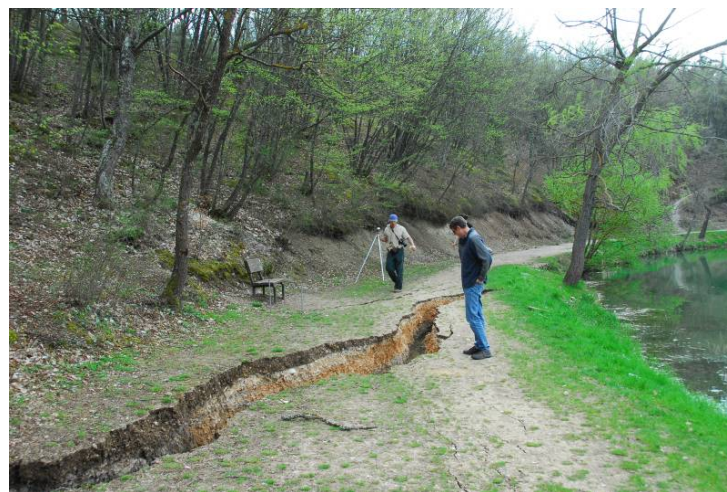
Figure 159. Ground cracks along the eastern perimeter of Lake Sinizzo (42.291N, E13.576).

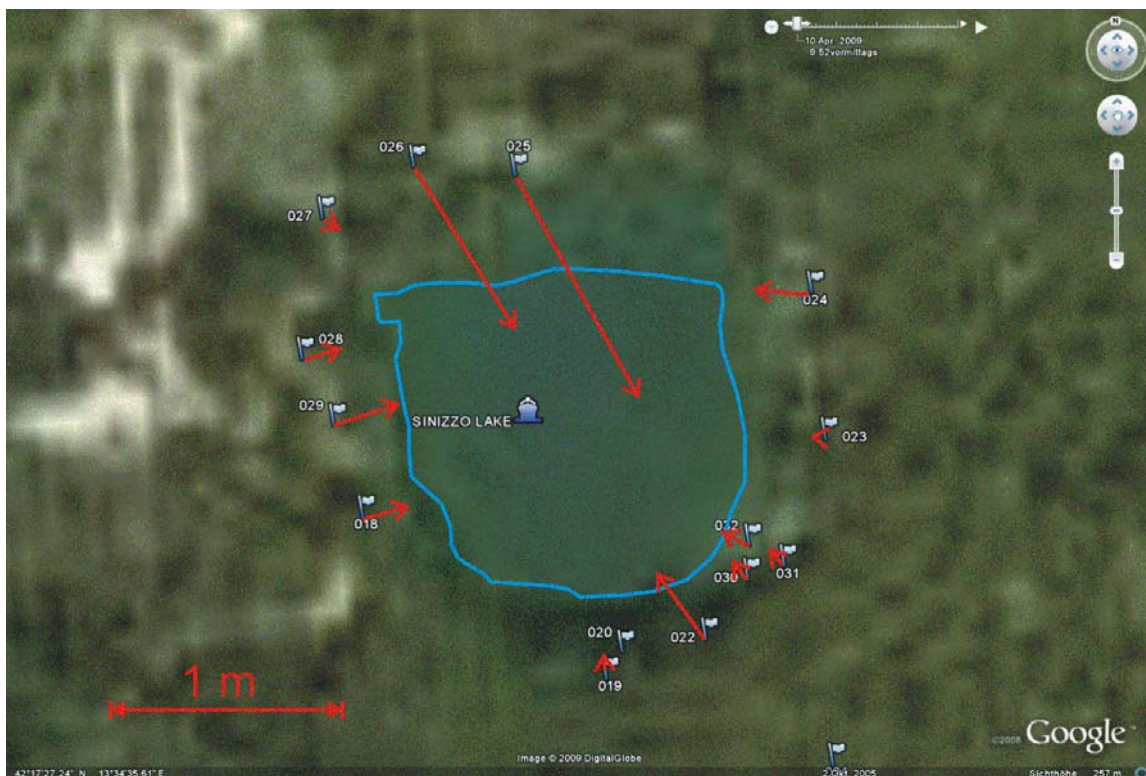
Figure 163. GPS way points indicating measurement locations around Lake Sinizzo. The red arrows indicate the orientation and maximum cumulative crack opening measured at each location.

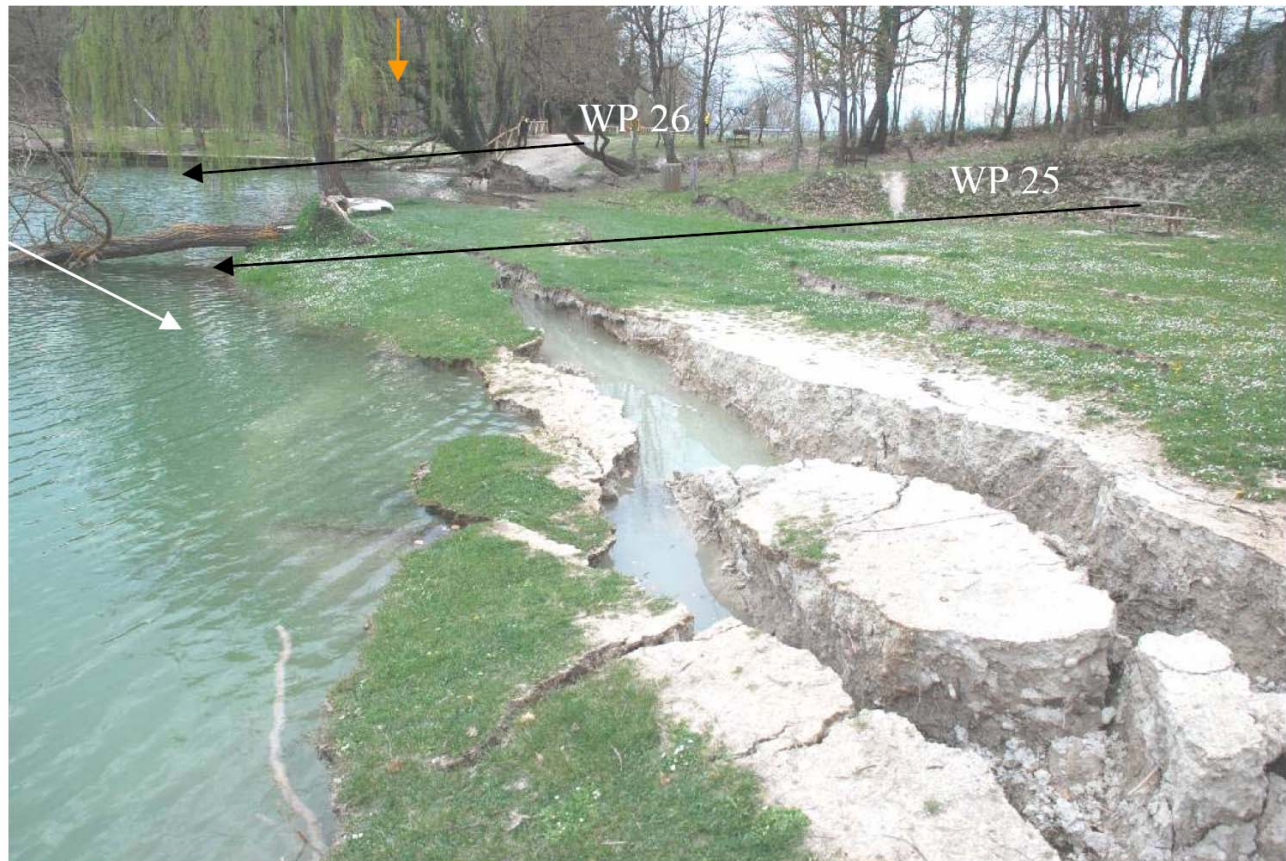
Figure 164. Blocks lying under the water (white arrow) were not included in the traverses (WP 25 and WP26). The orange arrow shows where the fence (and the slump below it) truncated the traverse at WP 27. (Photo E. Button).

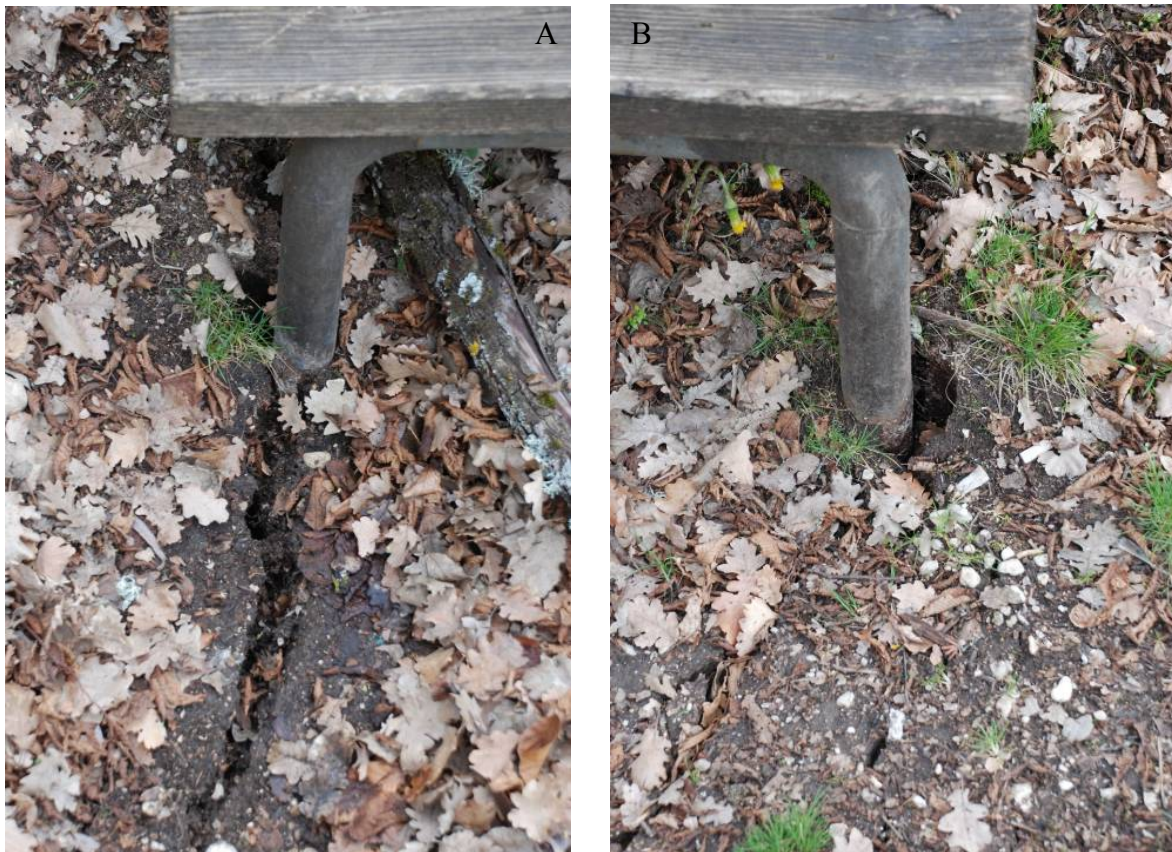
Figure 167. Characteristic deformations associated with the corners of the park bench at WP 31. (A) corner C2, (B) corner C3.

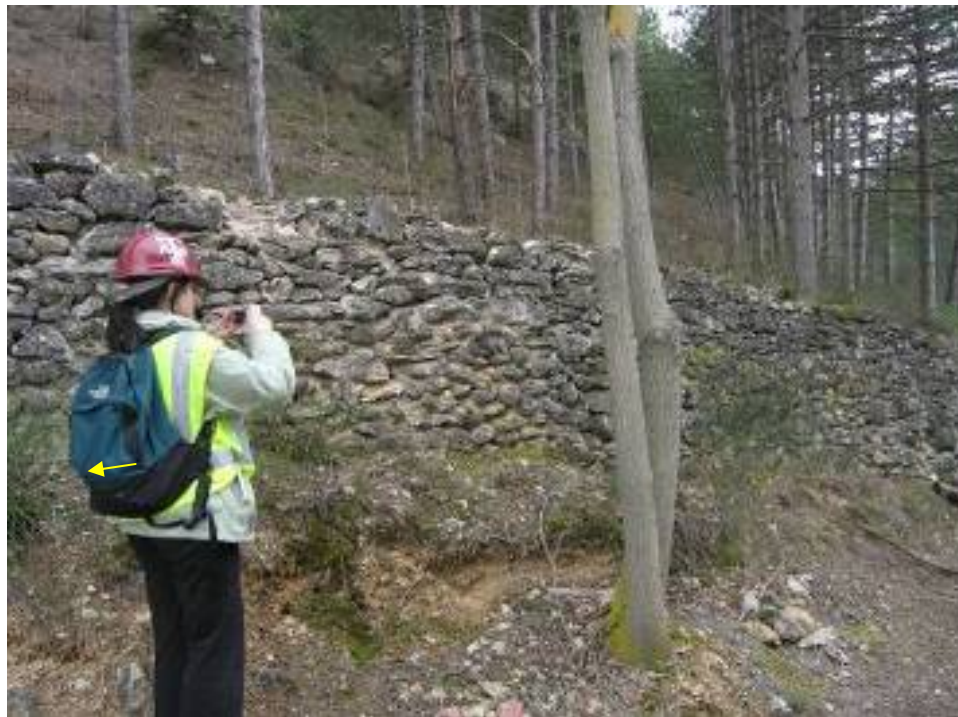
Figure 185. Minor damage on masonry wall in severely shaken Pettino area (42.374011°N, 13.367498°E).

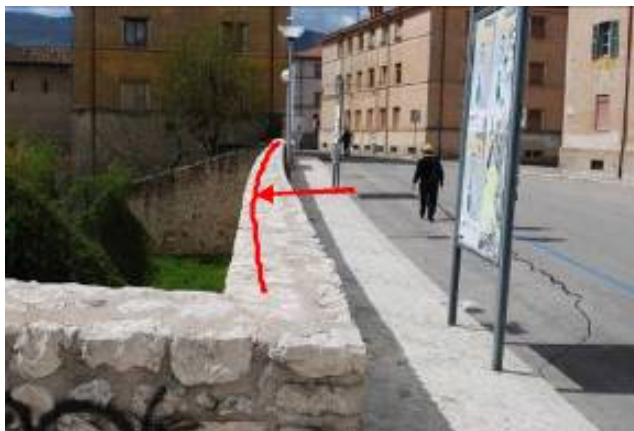
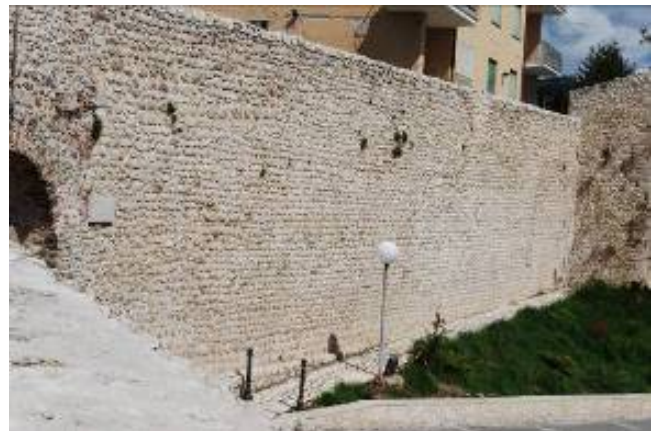
Figure 186. Stone masonry wall at L'Aquila city (42.348710°N, 13.403900°E). Note the (tolerable) outward movement at the center of the wall and the pavement cracks behind the wall.

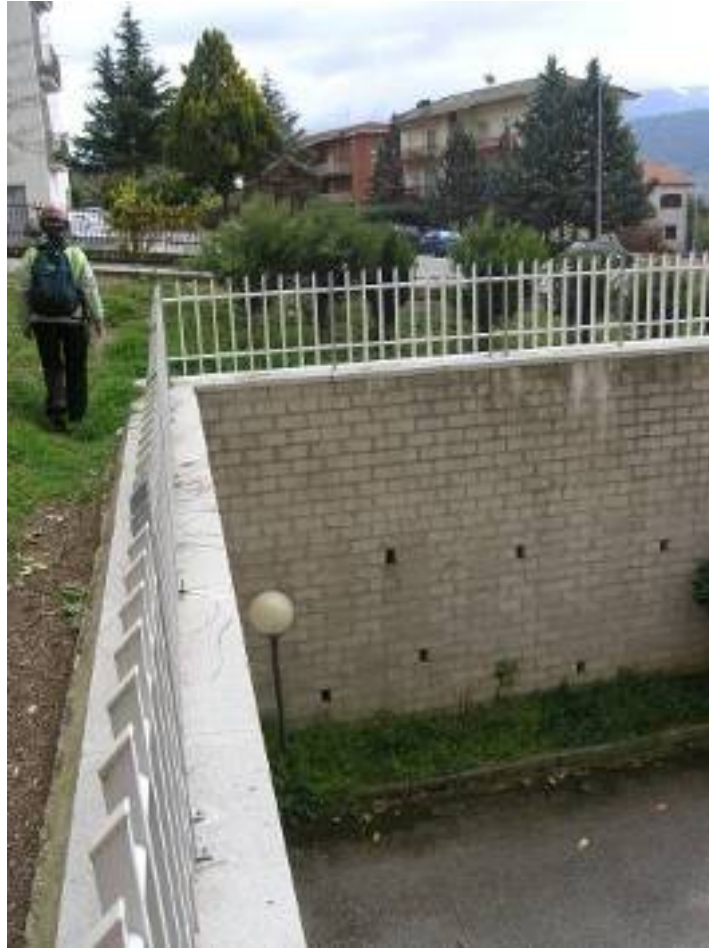
*Figure 187. Undamaged wall at the severely shaken Pettino area (42.373050°N, 13.366106°E).*

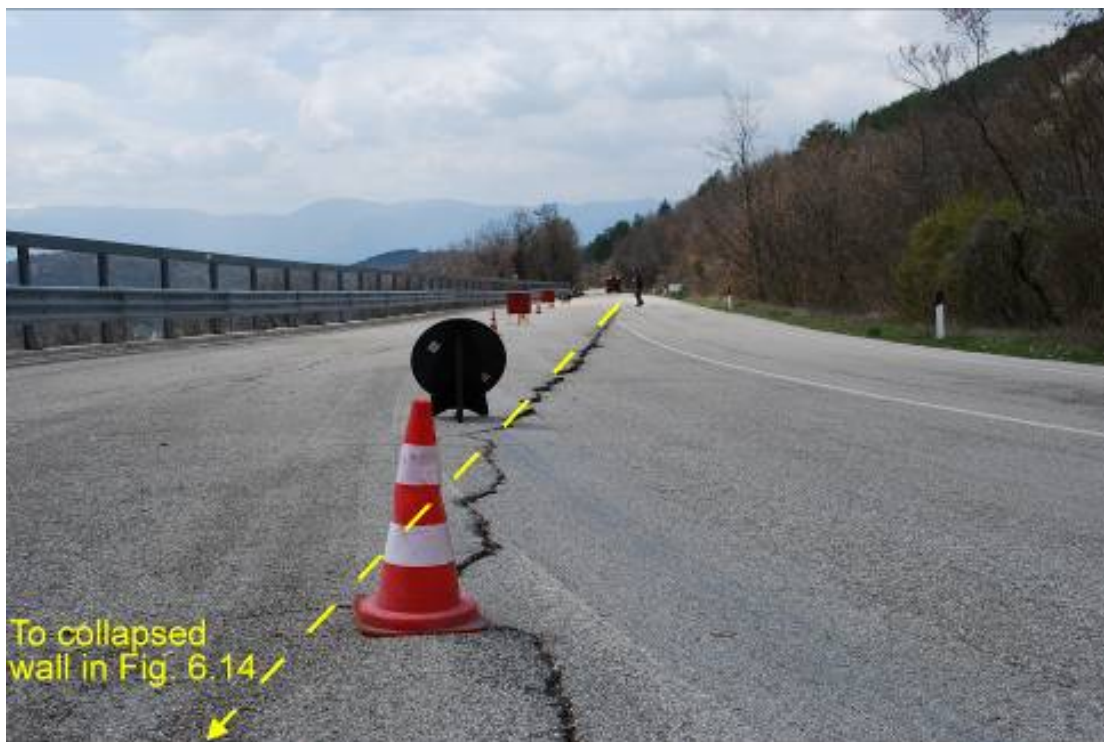
Figure 190. Pavement cracking in SS80 roadway (from L' Aquila to Campotosto) in the location of collapsed masonry retaining wall ( $42.420510^{\circ}\text{N}$ ,  $13.358394^{\circ}\text{E}$ ).

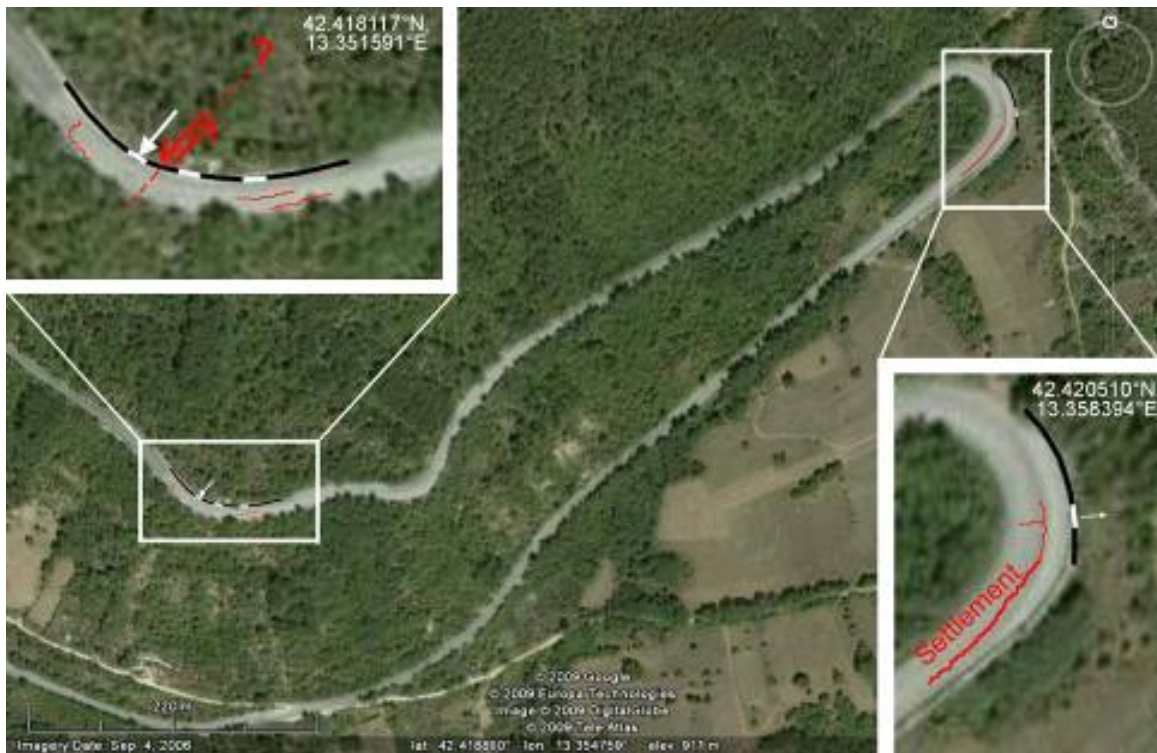
Figure 191. Locations of observed pavement cracking and associated retaining wall failures.

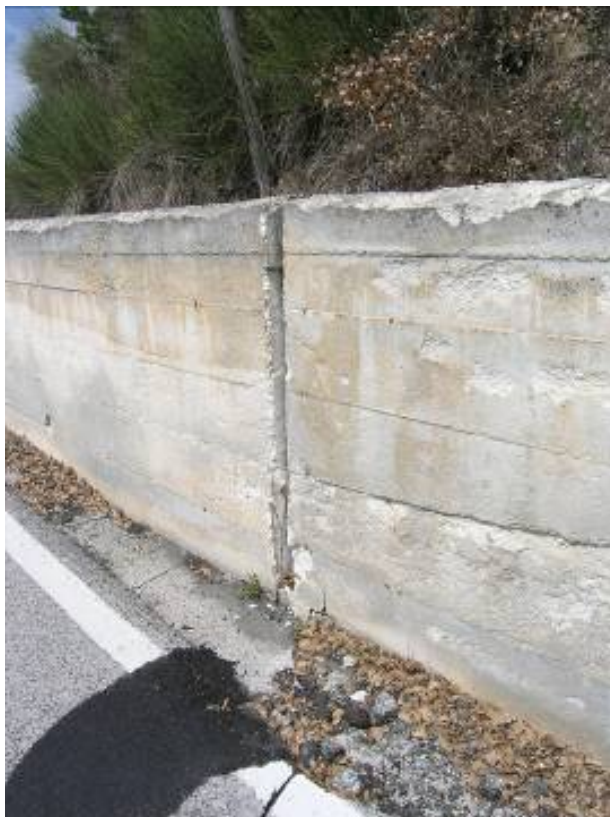
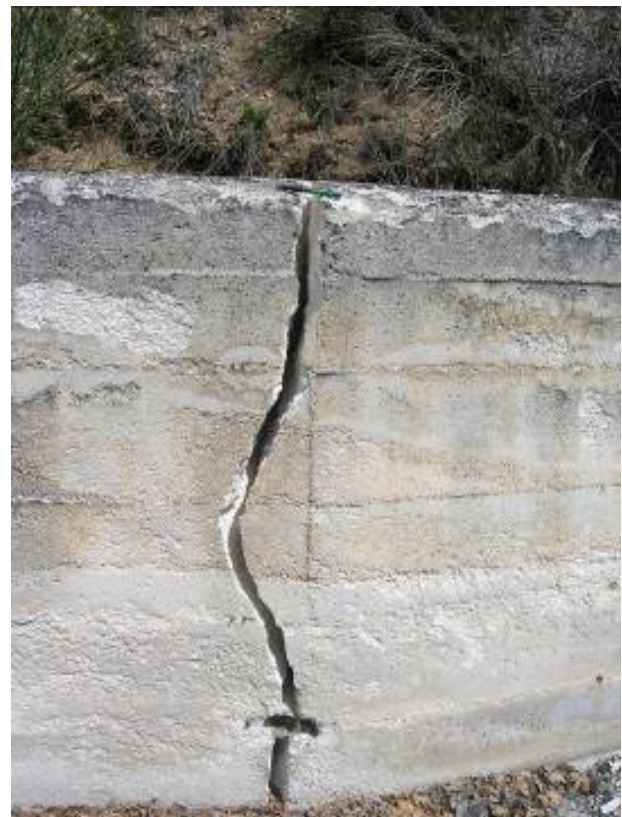
Figure 192. Ruptured retaining wall due to slope instability at SS80 highway between L'Aquila and Campotosto (42.418117°N, 13.351591°E).

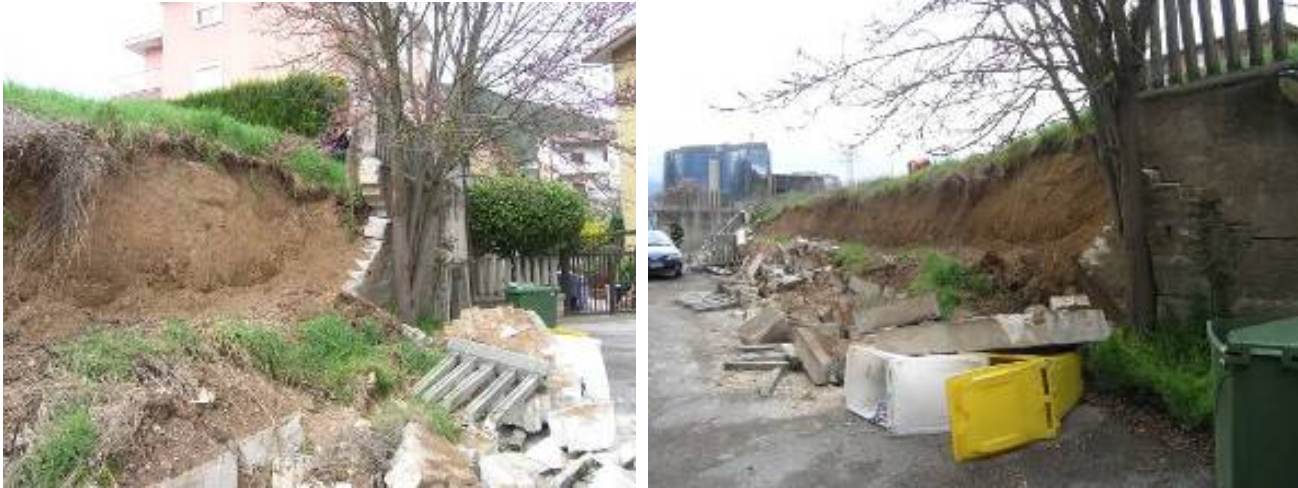
Figure 193. Toppling of masonry retaining wall at the outskirts of L'Aquila (42.366803°N, 13.376561°E).
