Seismological and geotechnical aspects of the $M_w=6.3$ L'Aquila earthquake in central Italy on 6 April 2009

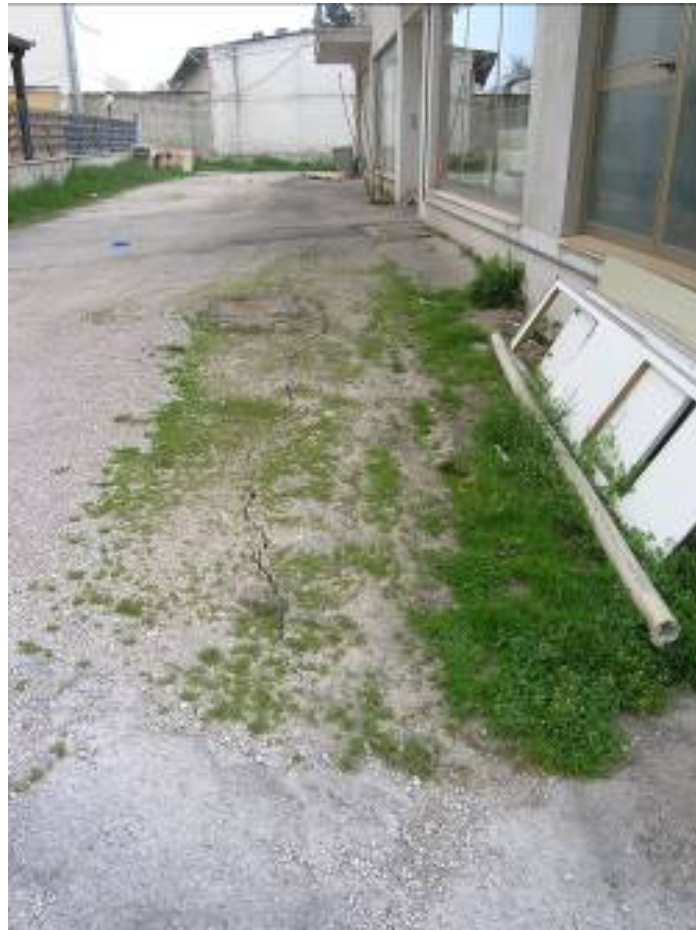
Figure 31. Ground fissures at the side of the building (42.359817°N, 13.468649°E).

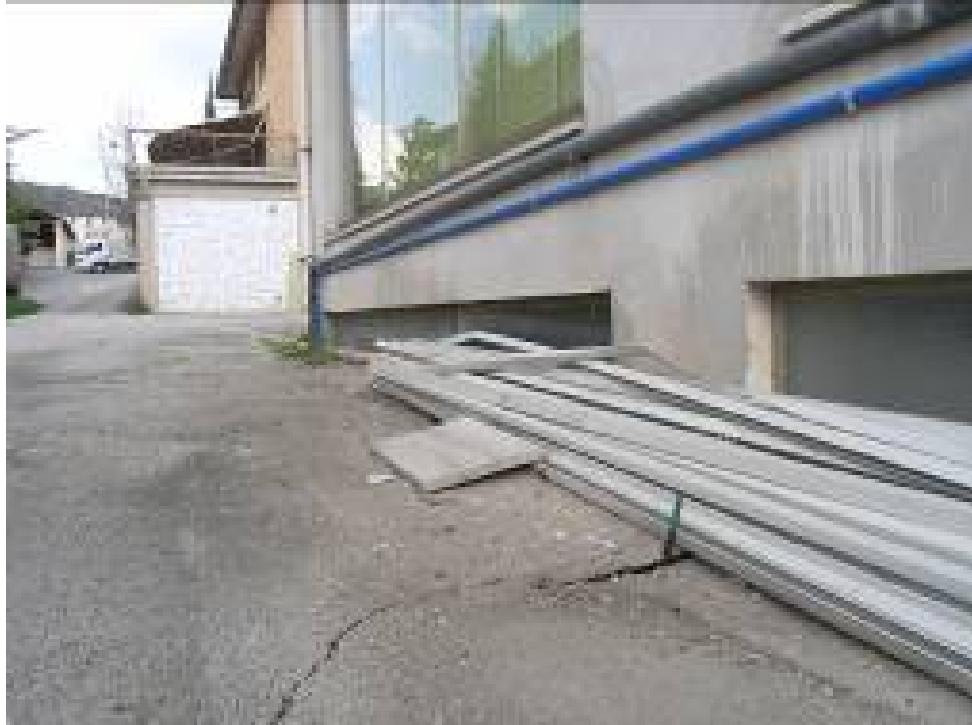
Figure 32. Ground fissures and settlement at the side of the building (42.359817°N, 13.468649°E).

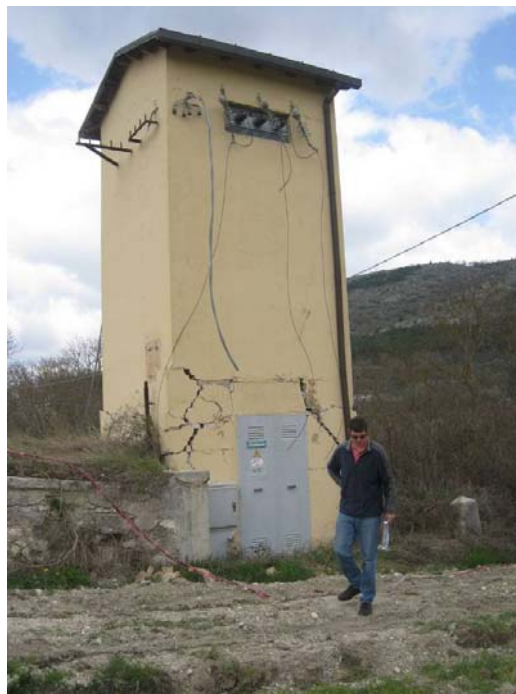
Figure 57. Heavily damaged seismometer station box (not in use at the time of the earthquake, no recording) on the northeast valley beneath the town of Castelnuovo. (42.2982°, 13.6295°).

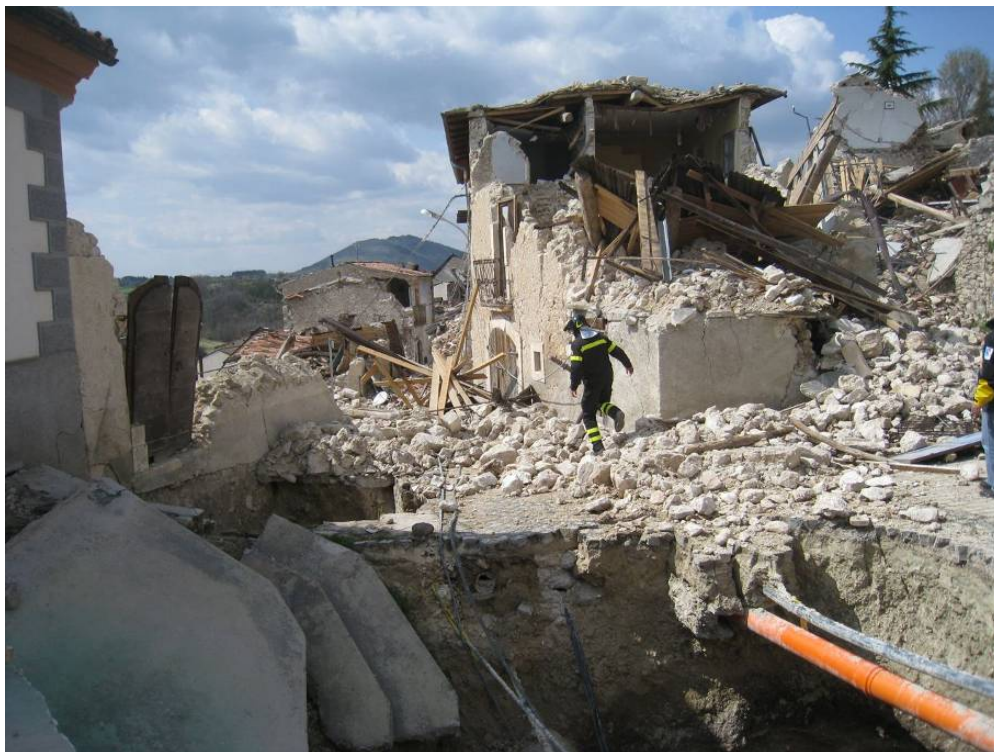
Figure 59. At the highest elevation of the hilltop town of Castelnuovo, almost all of the structures collapsed (D5) or were near collapse (D4). (42.2947°, 13.629°).

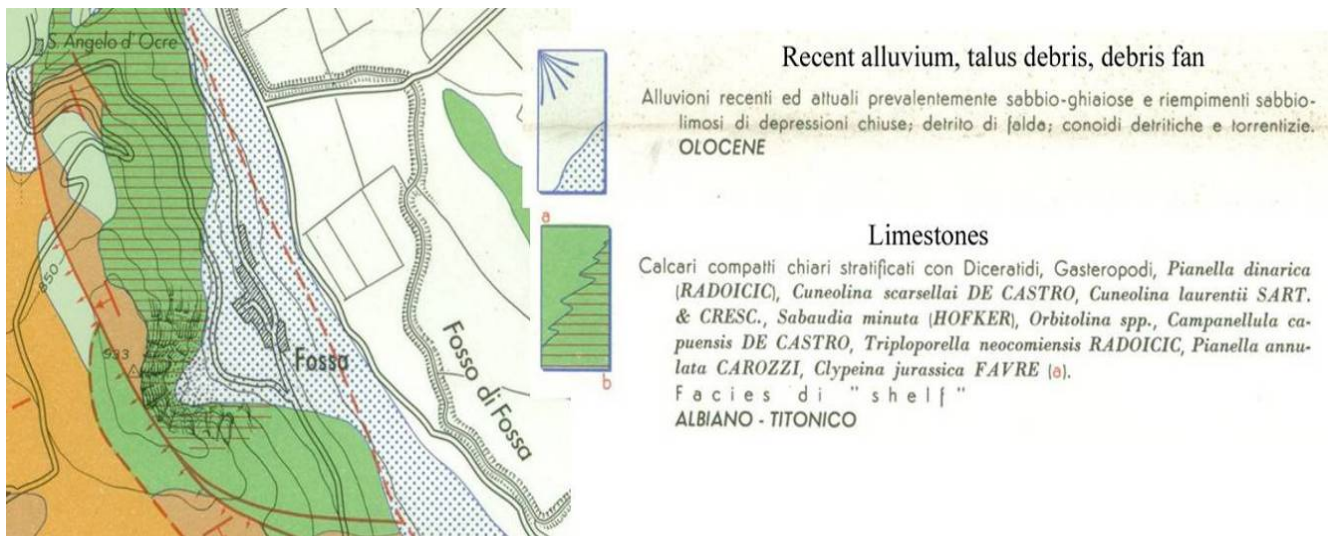
Figure 76. Geological map of Fossa (after Bosi and Bertini, 1970).

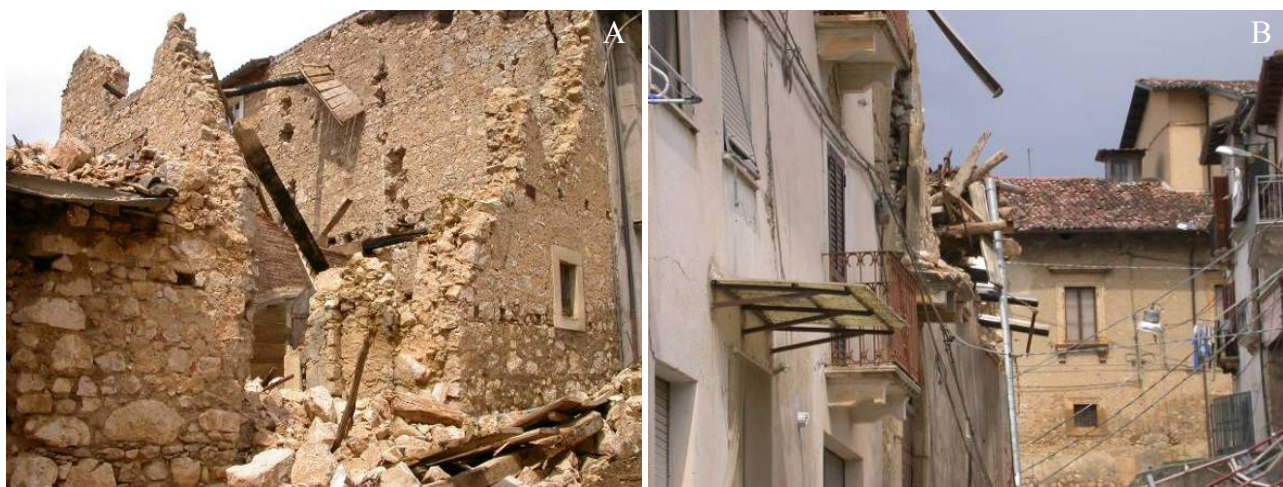
Figure 80. S. Eusanio Forconese. (A) Collapse of old masonry building (D5), (B) Partial collapse of masonry building (D4).

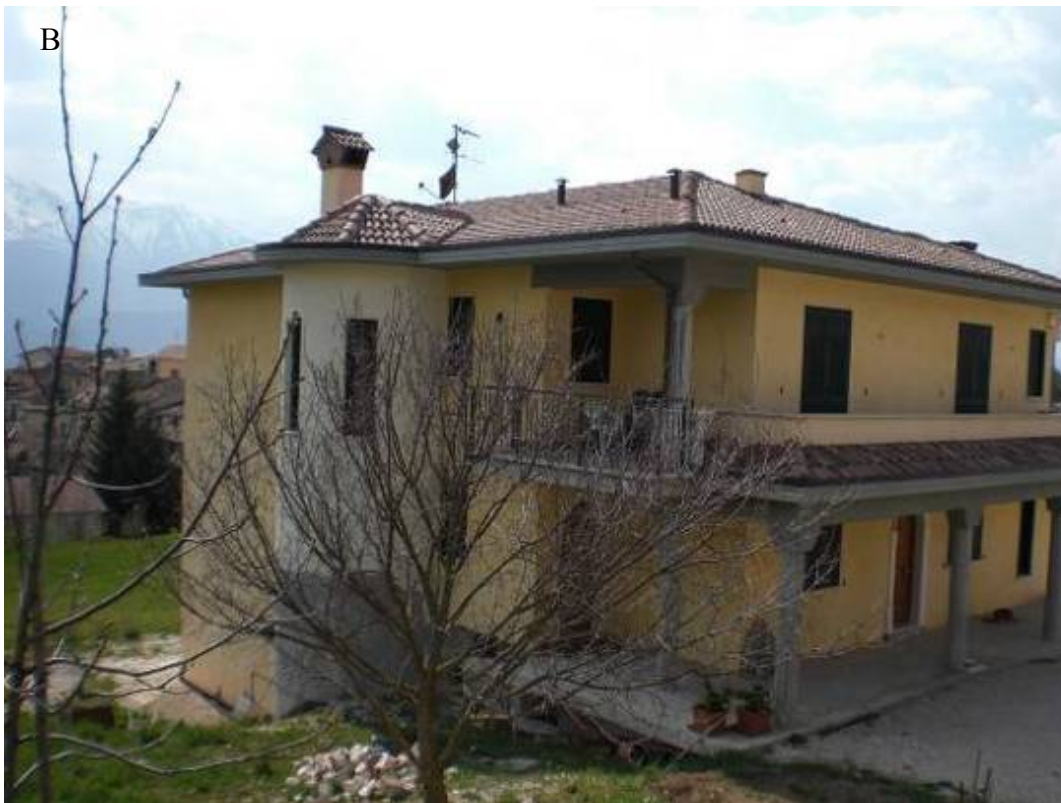
Figure 86. Poggio Picenze. (B) Undamaged RC house (D0) close to the (C) monumental church (D3).

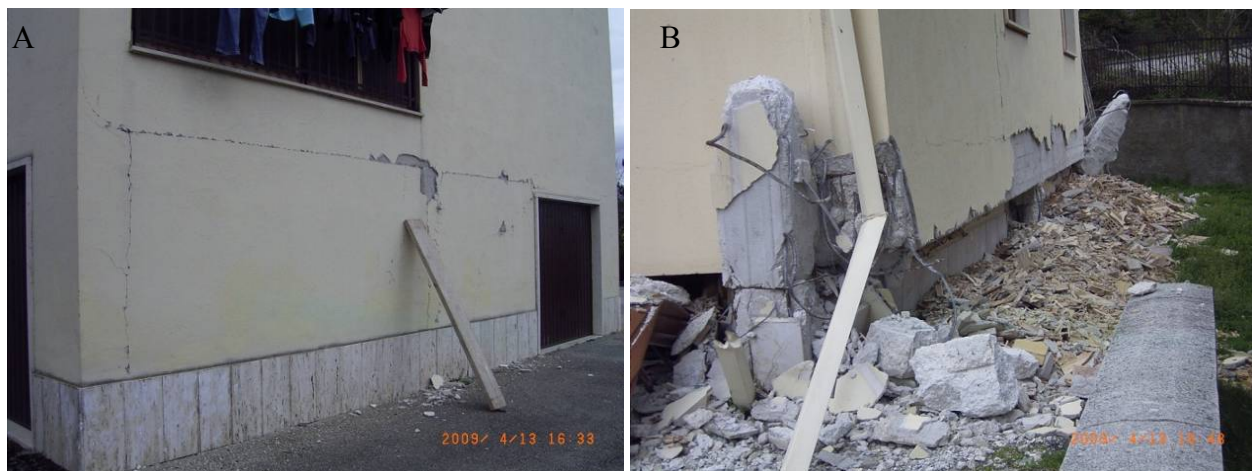
Figure 109. Damage on the structures in the cluster in zone (d). (A) Waypoint GB-22-1 (D1), (B) Waypoint GB-23-1 (D5).

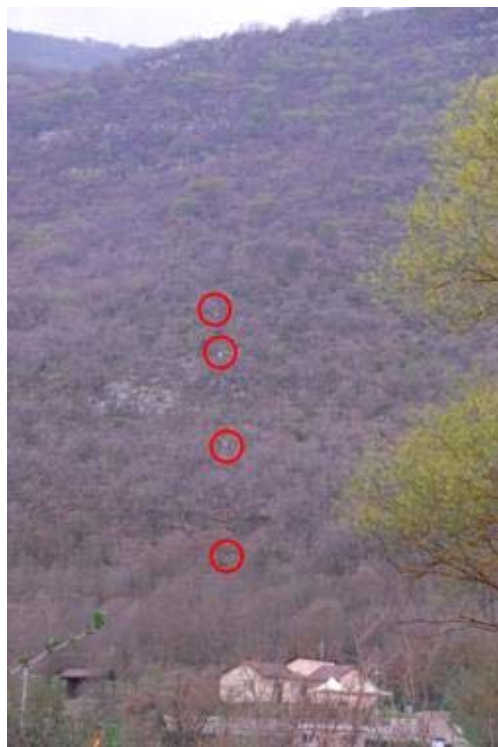
Figure 116. Additional impact marks as indicated by an alignment of fresh scars (42.255N 13.547E).

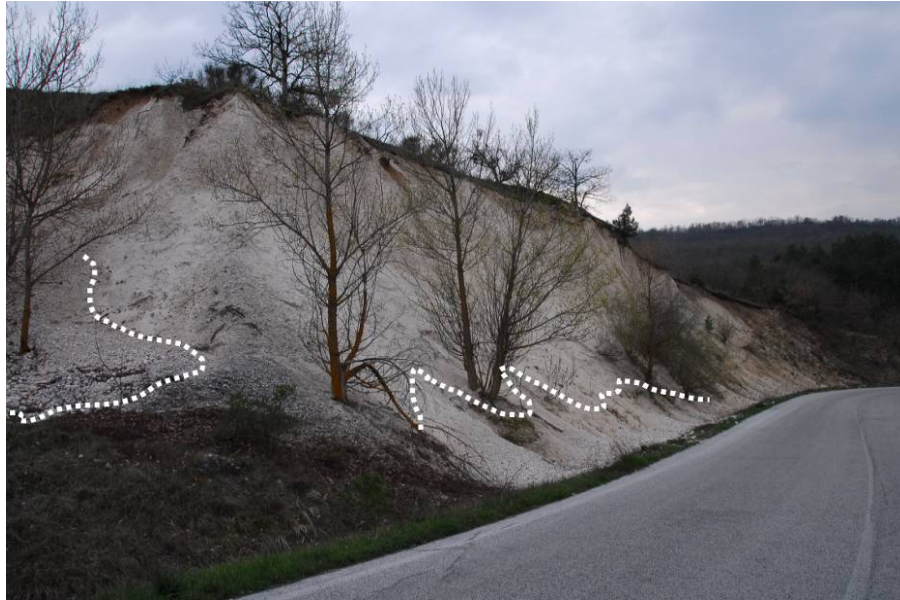
Figure 121. Minor ravelling of weakly cemented sand and gravel; dashed lines indicate the extent of freshly deposited talus along the base of road cut (Via Opi N42.261, E13.581).

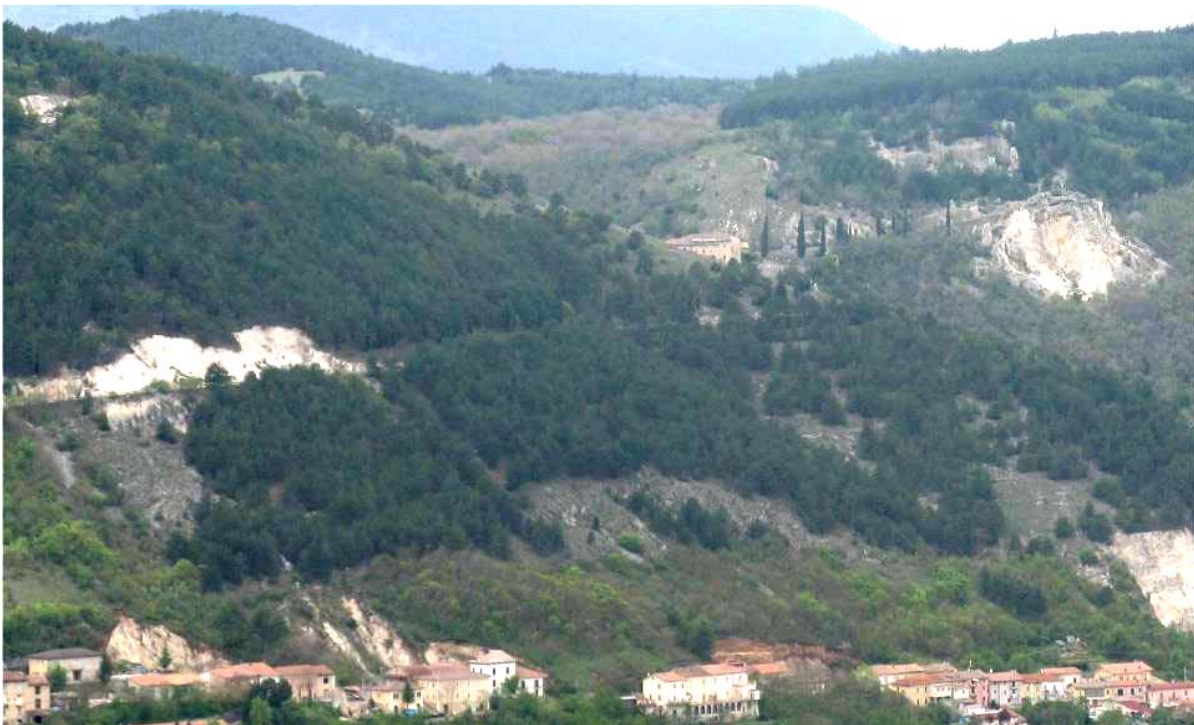
Figure 134. Slides in cataclasites along the road from Fossa to S. Angelo d'Ocre. Detail of the spur on the right is in fig 5.24 (42.29694N, 13.48469E).

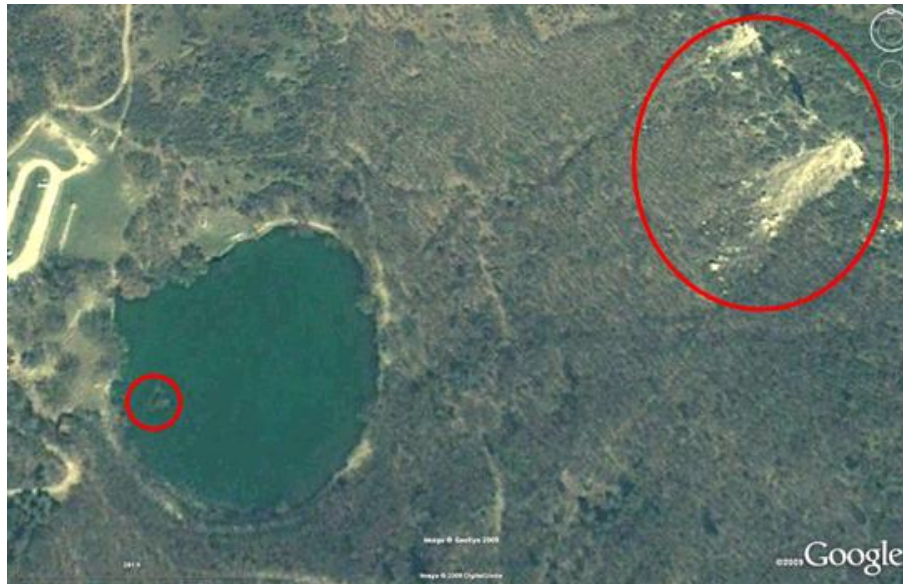
Figure 161. Post earthquake satellite imagery showing submerged trees within small circle and rock slope failures within large circle; compare to pre-earthquake imagery shown in Figure 146 (42.291N 13.576).

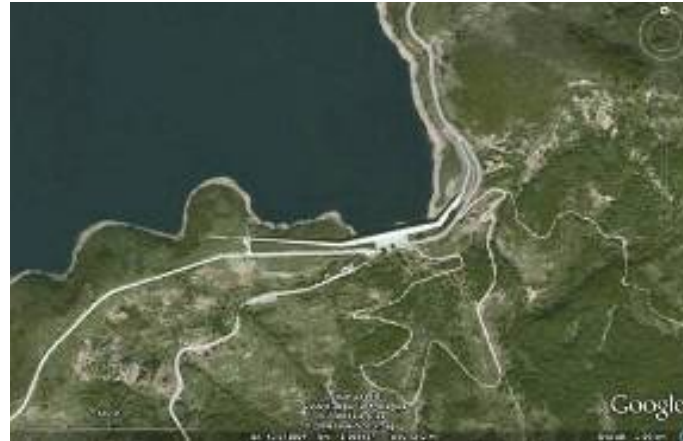
Concrete Dam Cross Section

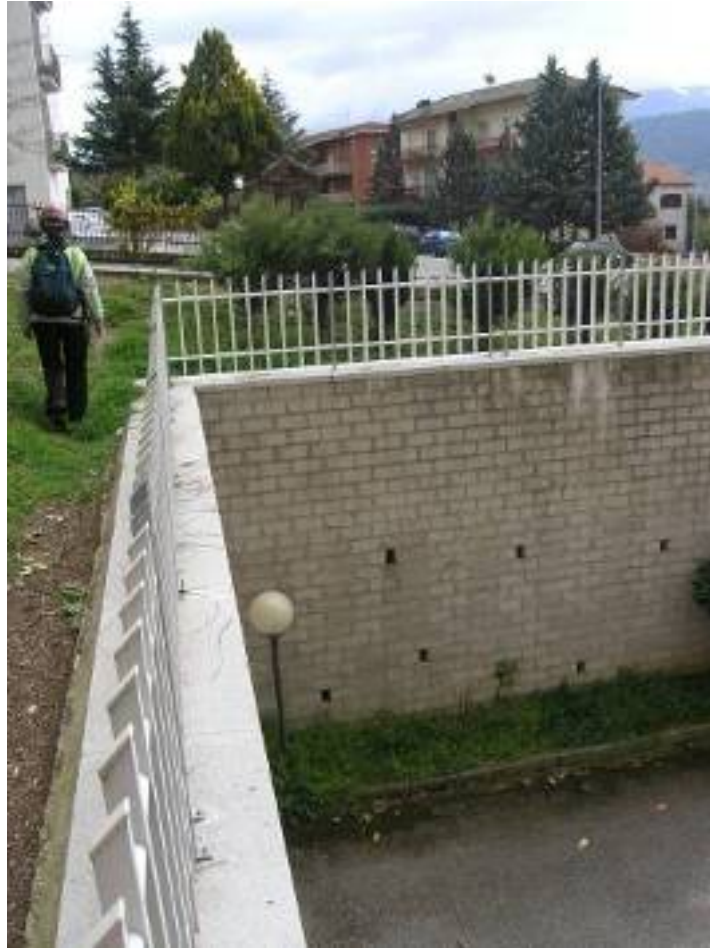
Figure 187. Undamaged wall at the severely shaken Pettino area (42.373050°N, 13.366106°E).

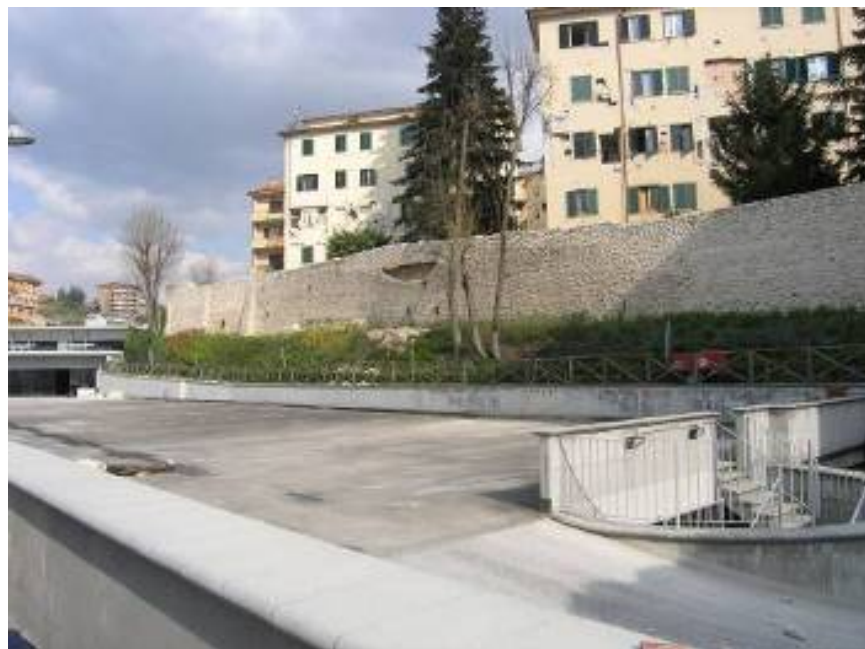
Figure 188. Damaged wall at downtown L'Aquila (42.356056°N, 13.389524°E).

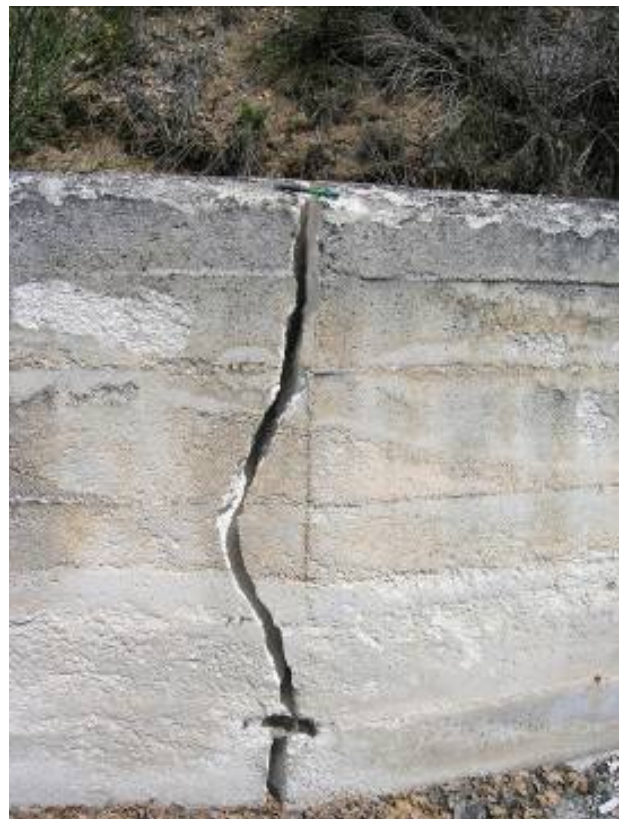
Figure 192. Ruptured retaining wall due to slope instability at SS80 highway between L'Aquila and Campotosto (42.418117°N, 13.351591°E).
