Seismological and geotechnical aspects of the $M_w=6.3$ L'Aquila earthquake in central Italy on 6 April 2009

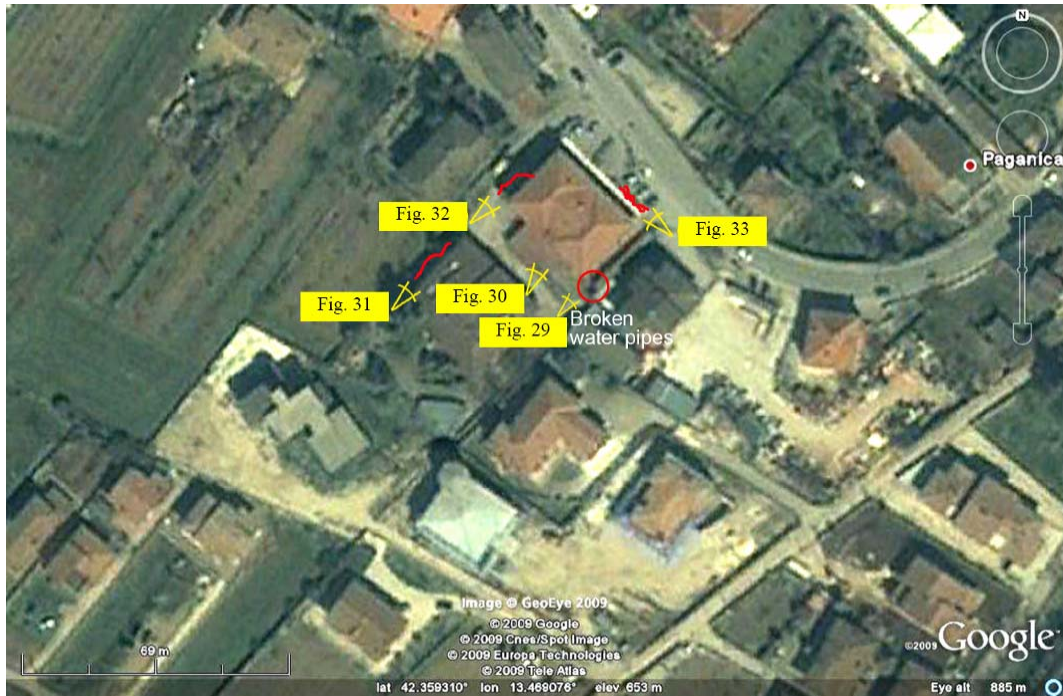
Figure 28. Plan view of Paganica site with marked positions of ground fissures, paved walkway cracks and broken water pipes. Directions of photo shots are indicated by yellow signs.

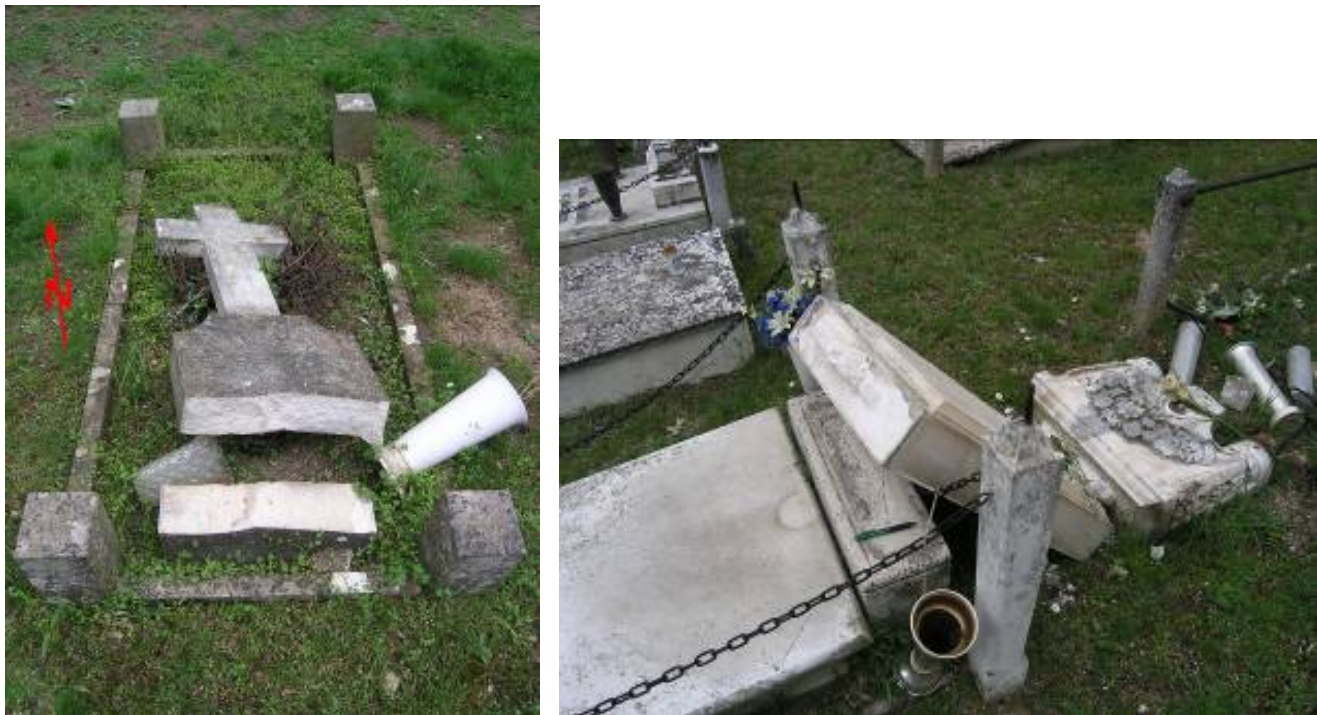
Figure 49. Grave markers breakage.

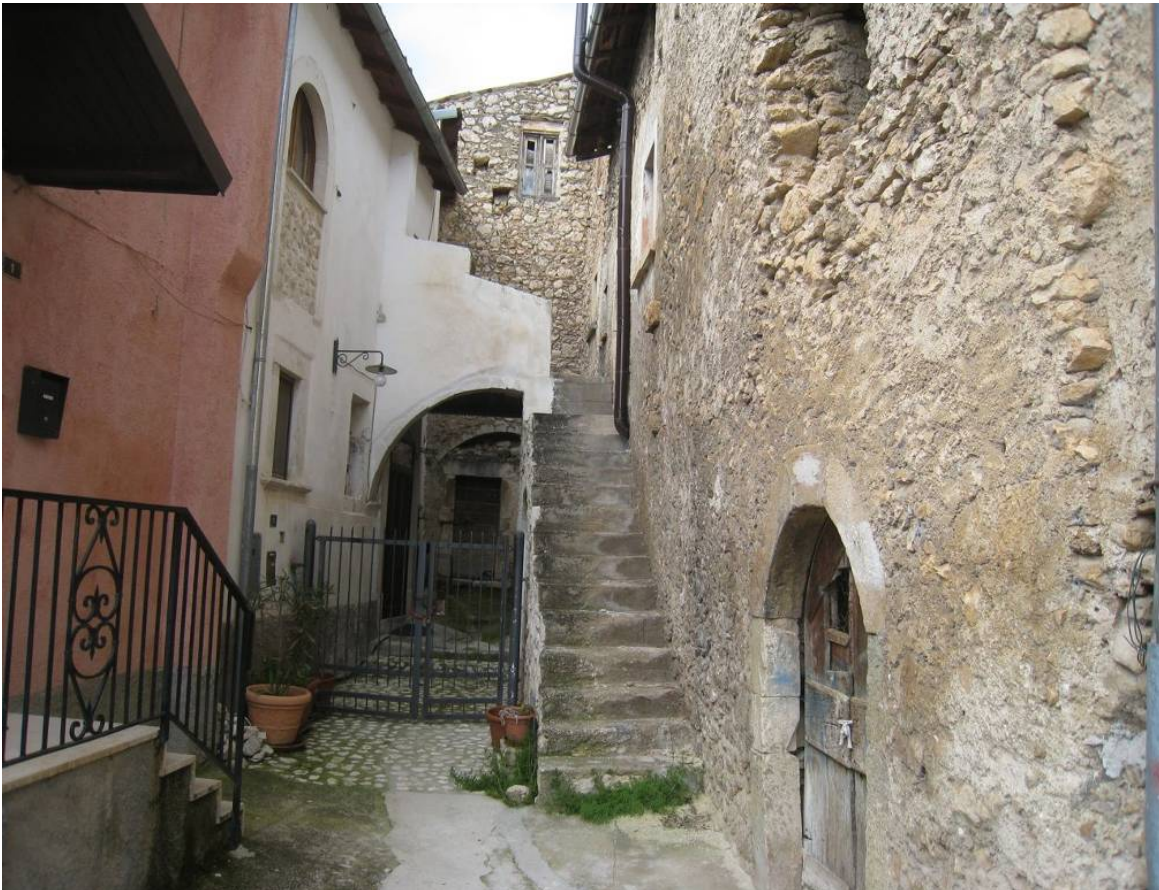
Figure 62. Typical unreinforced masonry structures in the village of San Pio delle Camere suffered no damage (D0), or slight cracking (D1). Structures in this village are similar to those in Castelnuovo. San Pio delle Camere is built on limestone bedrock.

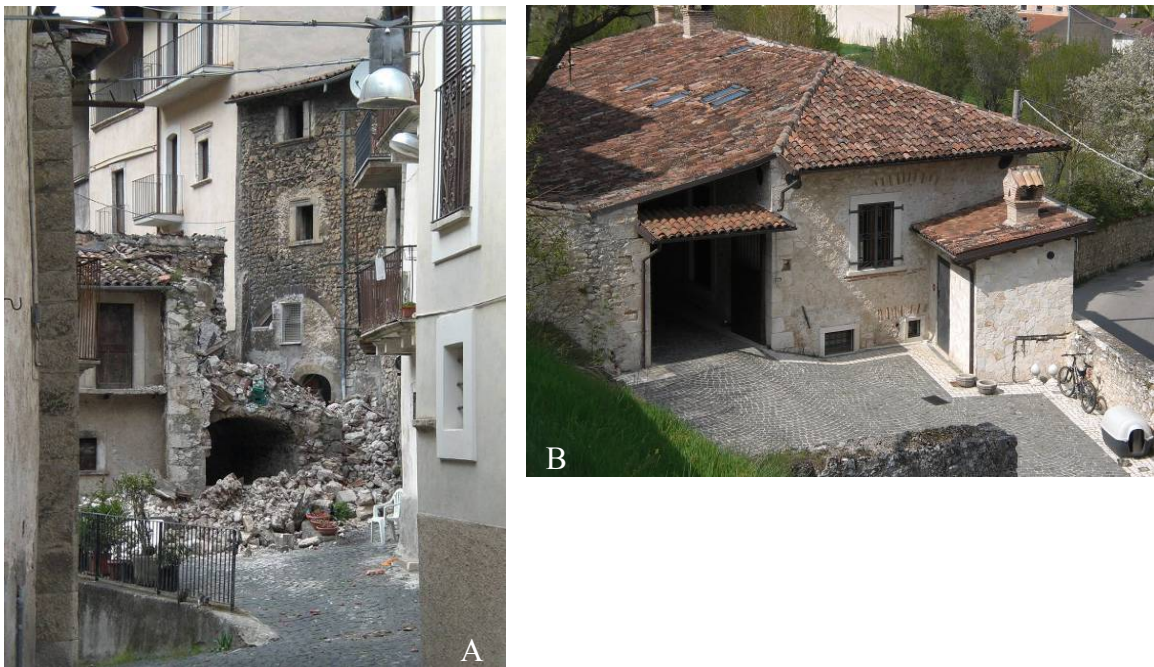
Figure 77. Fossa. (A) Collapse of masonry constructions in the historic center, (B) Strengthened masonry construction with no damage.

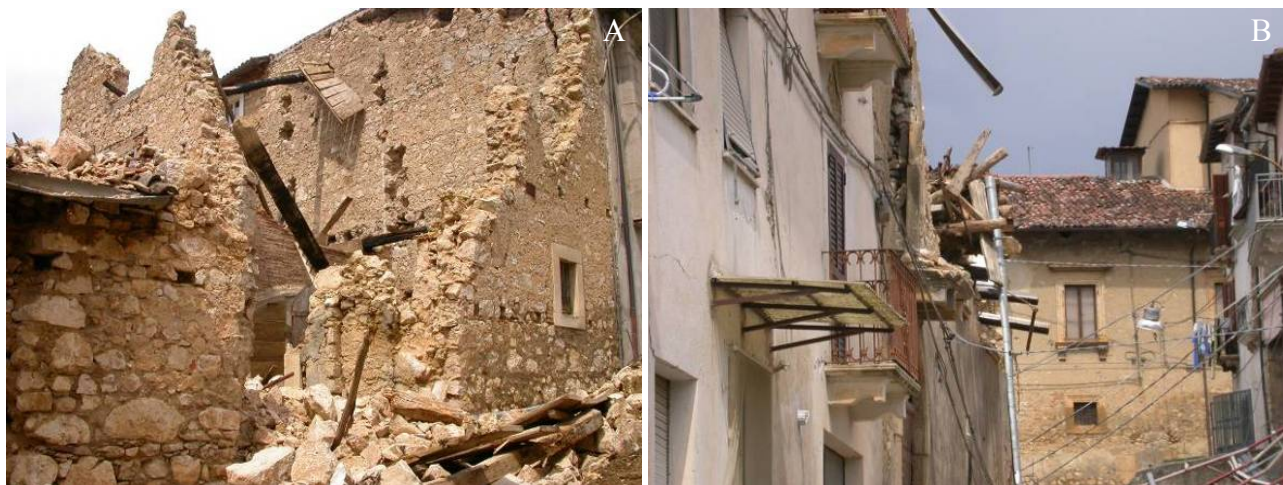
Figure 80. S. Eusanio Forconese. (A) Collapse of old masonry building (D5), (B) Partial collapse of masonry building (D4).

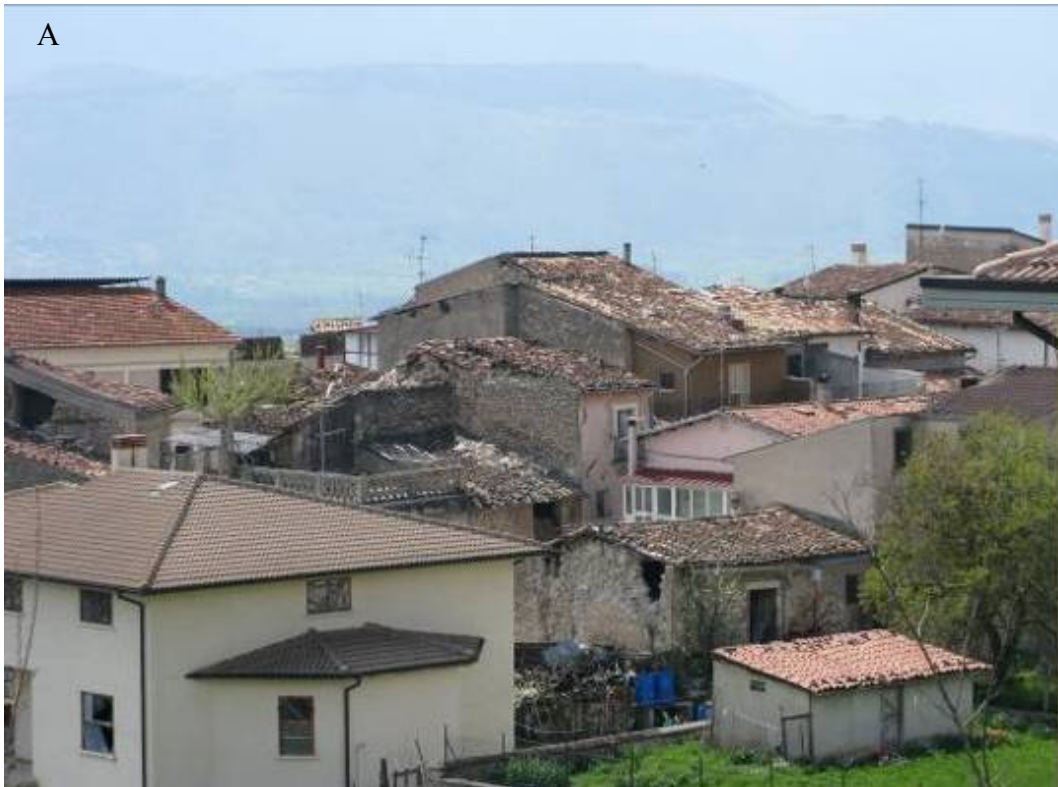
Figure 86. Poggio Picenze. (A) Variable damage (D3-D4) on masonry buildings of different style.

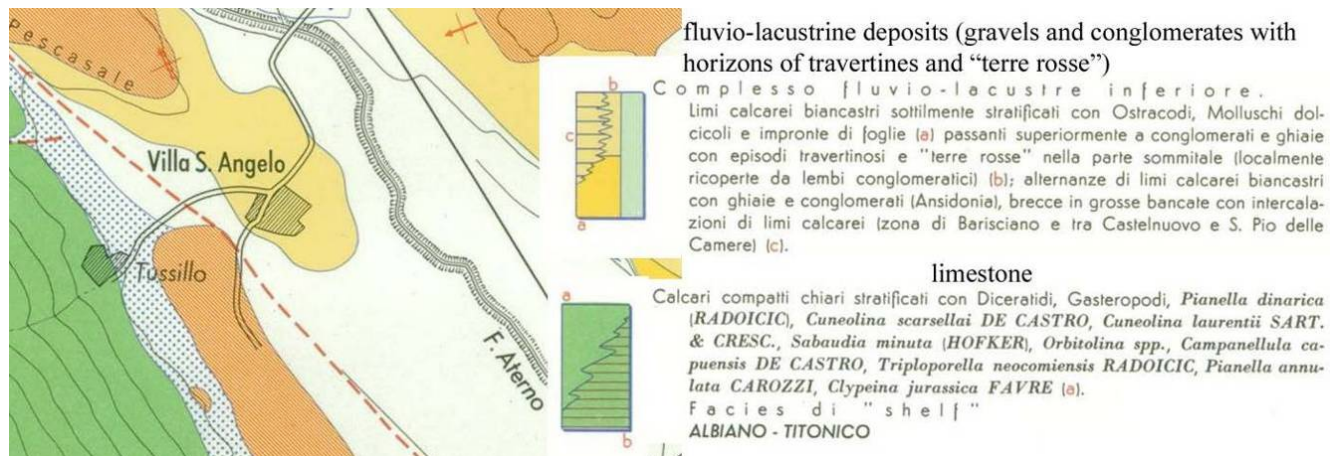
Figure 87. Geological map of Villa S. Angelo (after Bosi and Bertini, 1970).

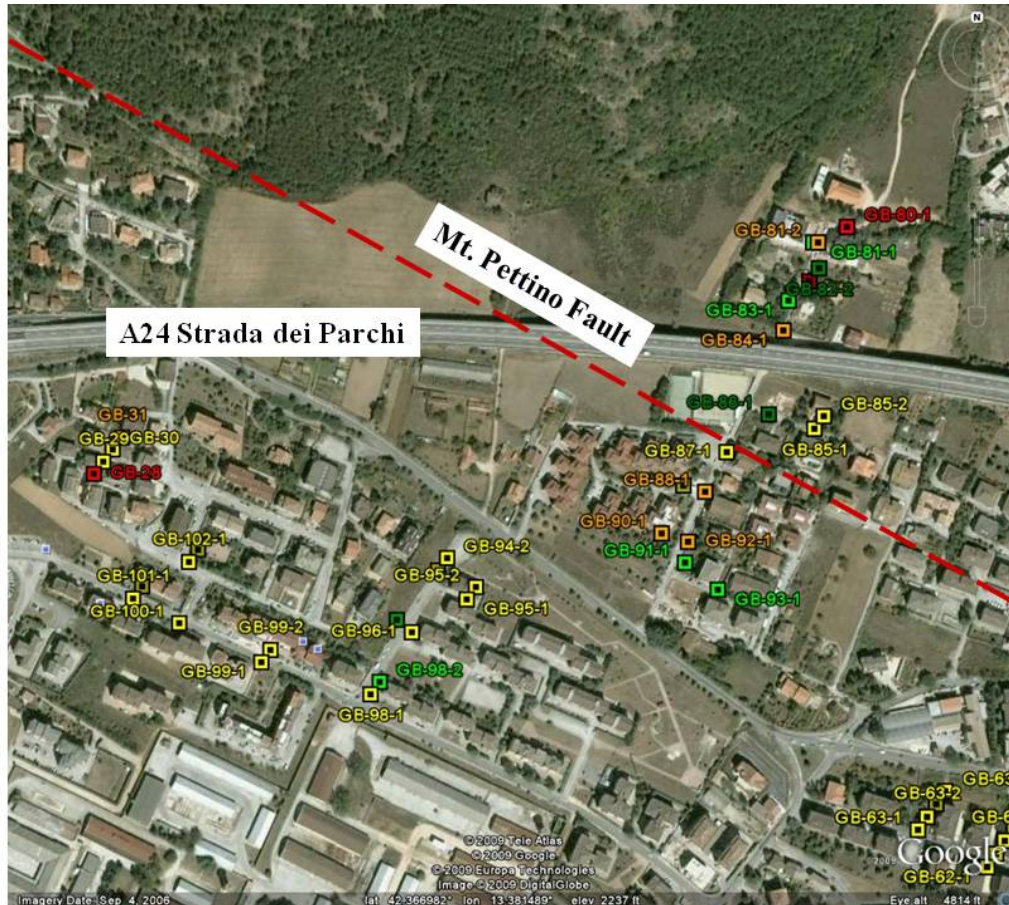
Figure 103. Zone (a) of the building damage survey along the Mt. Pettino Fault.

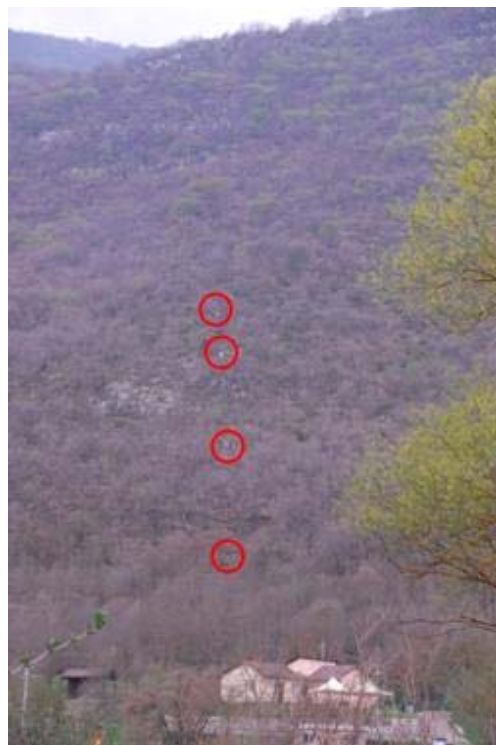
Figure 116. Additional impact marks as indicated by an alignment of fresh scars (42.255N 13.547E).

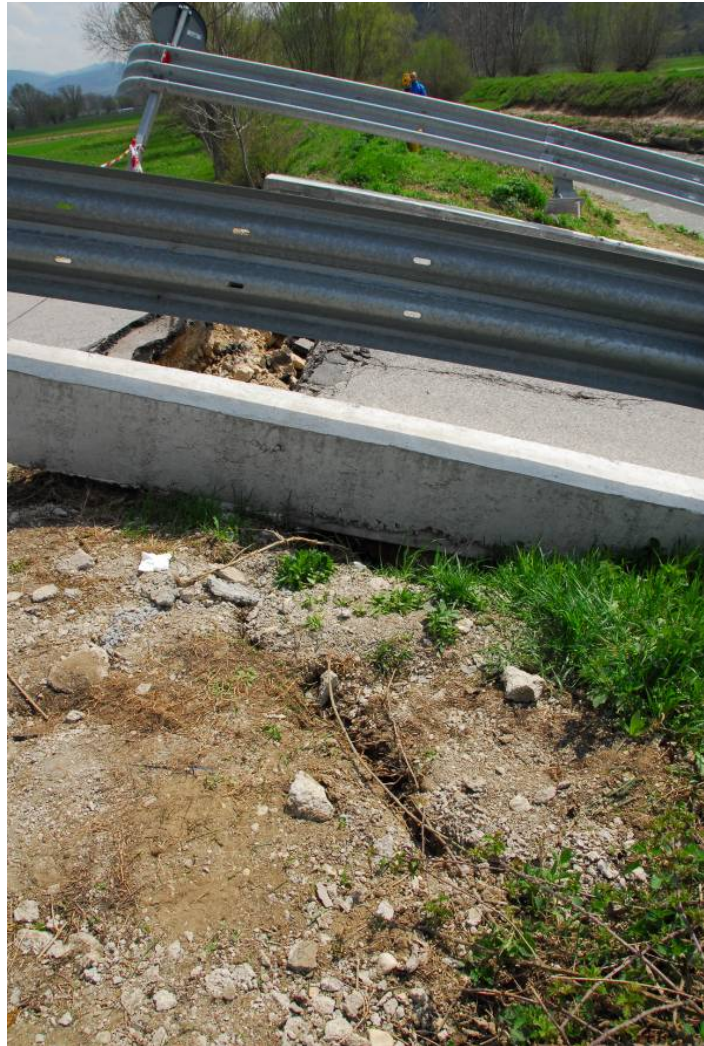
Figure 148. Ground cracking in levee directly beneath western abutment along northern side of Aterno River (42.325N, 13.463E).

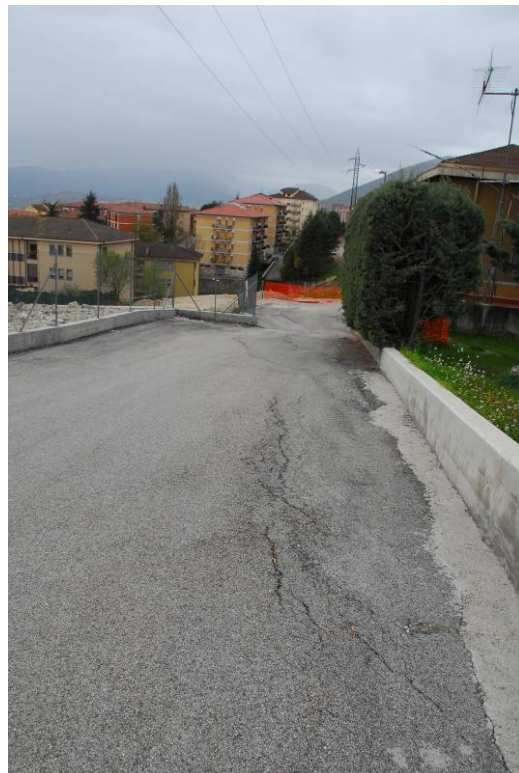
Figure 154. Cracks in the overlying asphaltic surfaces and a narrow settlement trend along the sidewall of the cut-and-cover structure (42.358N 13.415E).
