Seismological and geotechnical aspects of the $M_w=6.3$ L'Aquila earthquake in central Italy on 6 April 2009

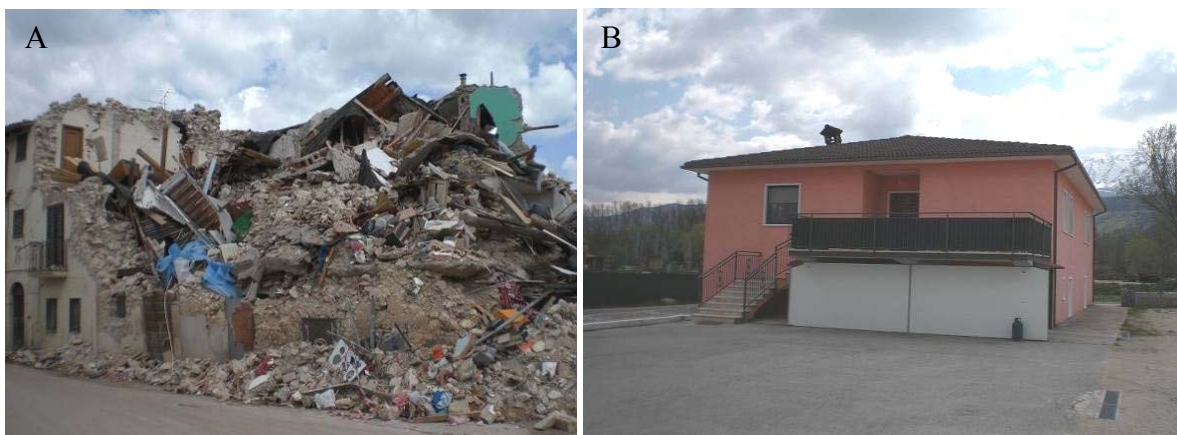
Figure 67. Onna. (A) D5 damage level on masonry building structures, (B) D0 damage on a RC building (except for the tilting of the chimney).

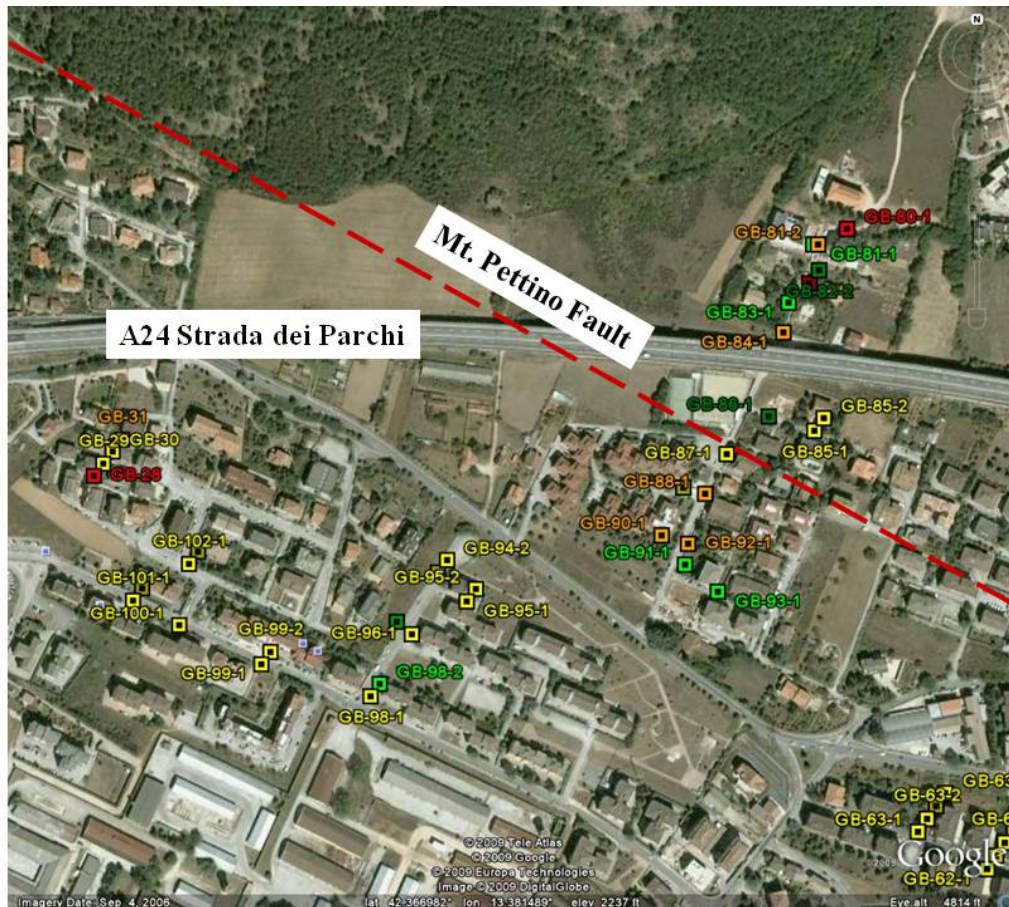
Figure 103. Zone (a) of the building damage survey along the Mt. Pettino Fault.

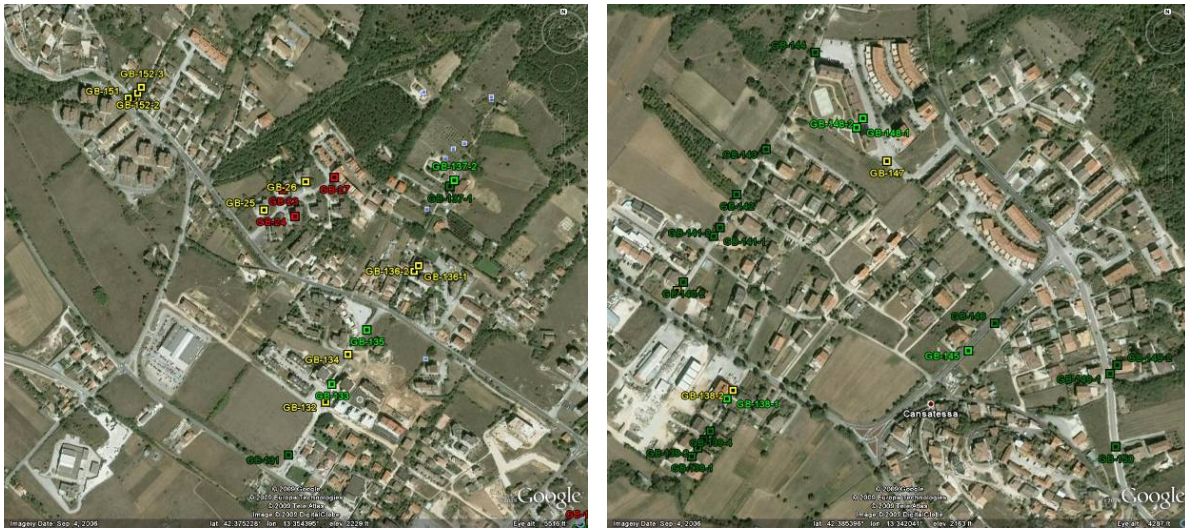
Figure 107. Results of the building damage survey along the Mt. Pettino Fault: Zones b, c, d, and e.
