Seismological and geotechnical aspects of the $M_w=6.3$ L'Aquila earthquake in central Italy on 6 April 2009

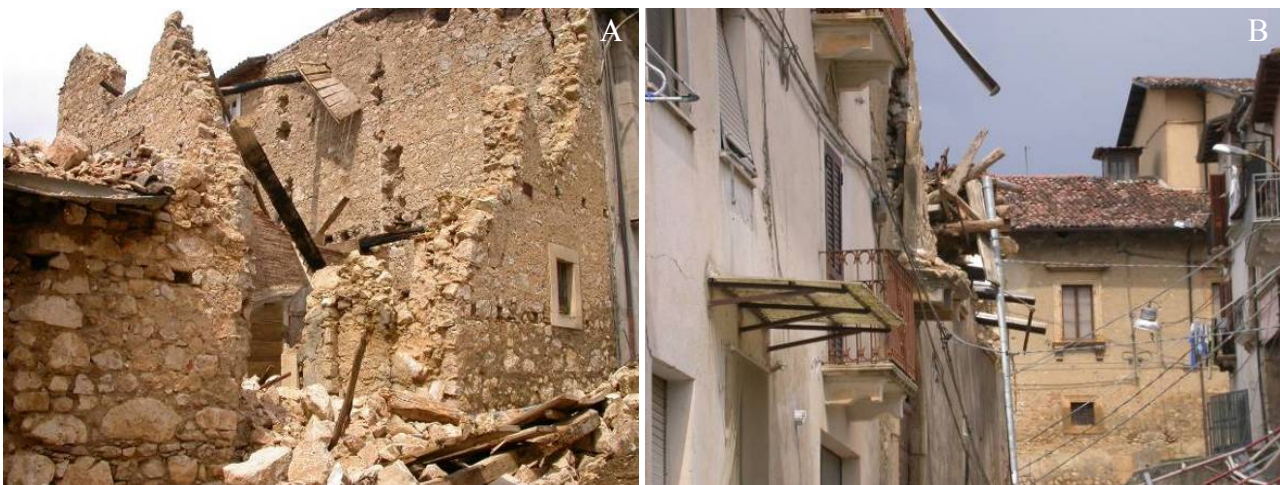
Figure 80. S. Eusanio Forconese. (A) Collapse of old masonry building (D5), (B) Partial collapse of masonry building (D4).

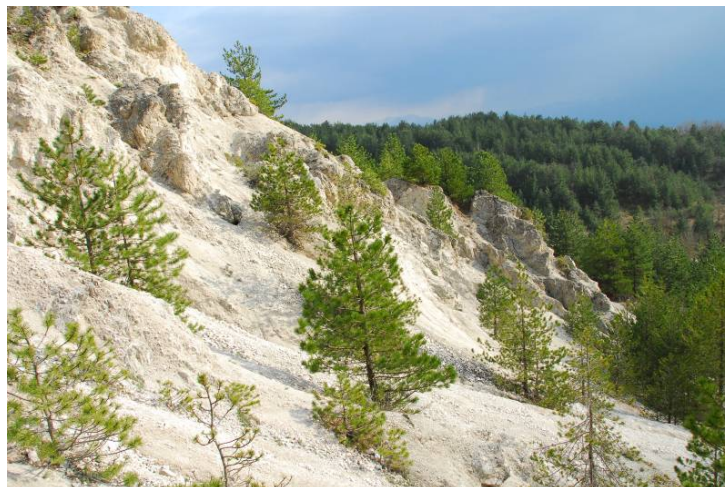
Figure 132. Characteristic erosional scars developed in cataclasite (42.434N, 13.334E).

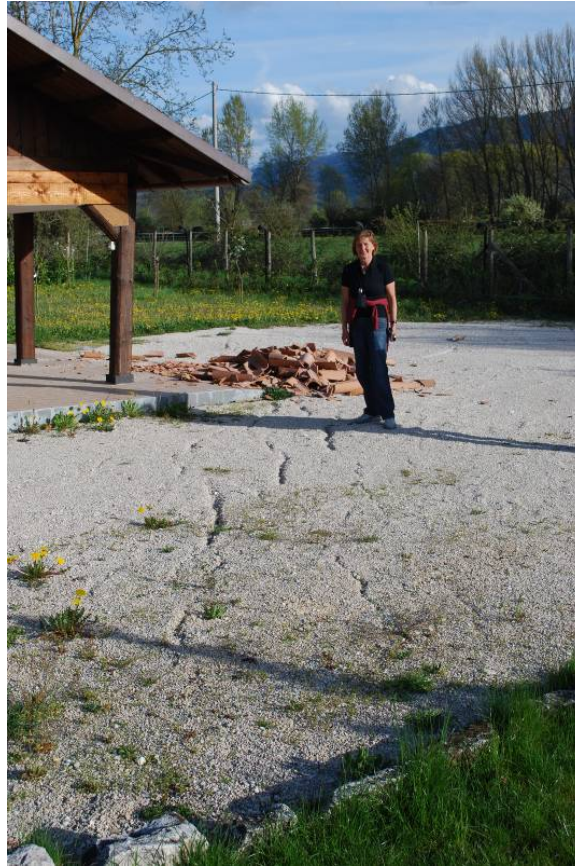
Figure 140. Ground fissures developed in alluvial floodplain directly south of central Onna and approximately 150 m from the Aterno River. Orientation of fissures is approximately parallel to the river (42.325N, 13.480E).

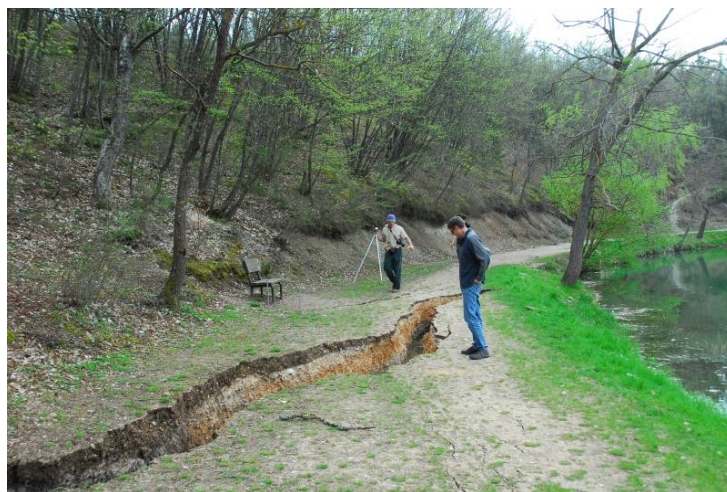
Figure 159. Ground cracks along the eastern perimeter of Lake Sinizzo (42.291N, E13.576).

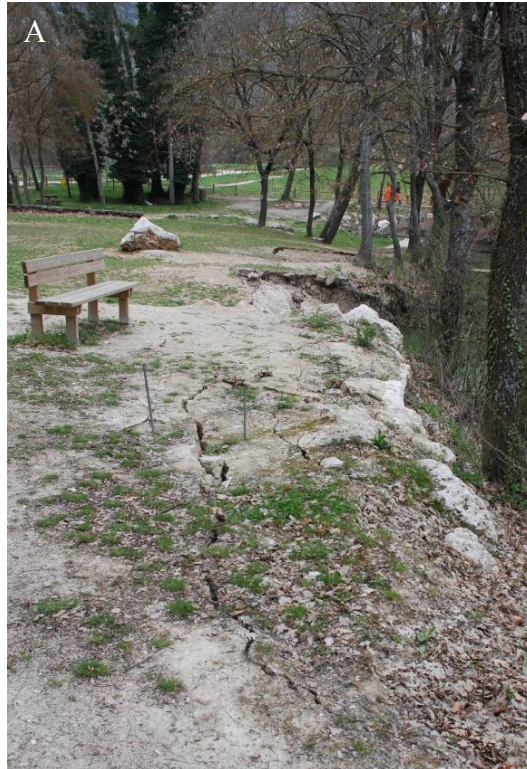
Figure 162. Ground cracks at the southwest corner of Lake Sinizzo (location WP 18) as observed on (A) 11 April 2009.

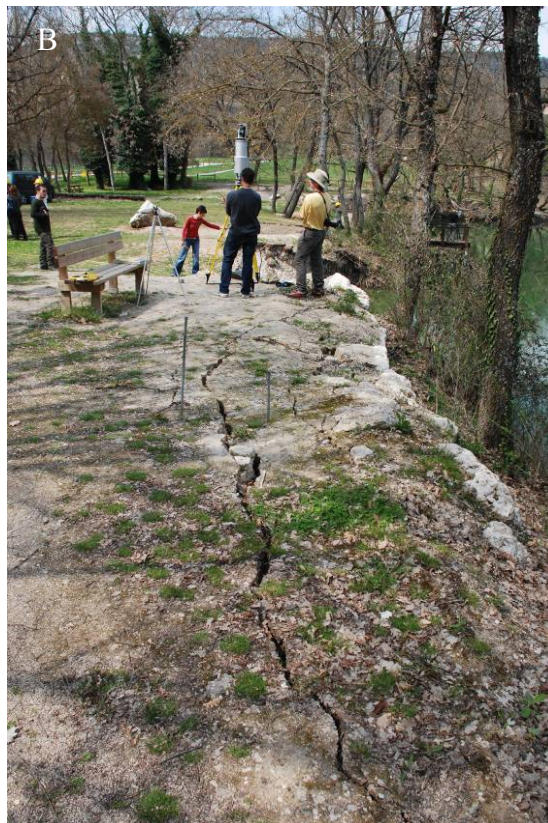
Figure 162. Ground cracks at the southwest corner of Lake Sinizzo (location WP 18) as observed on (B) 15 April 2009.
