## Seismological and geotechnical aspects of the $M_w=6.3$ L'Aquila earthquake in central Italy on 6 April 2009

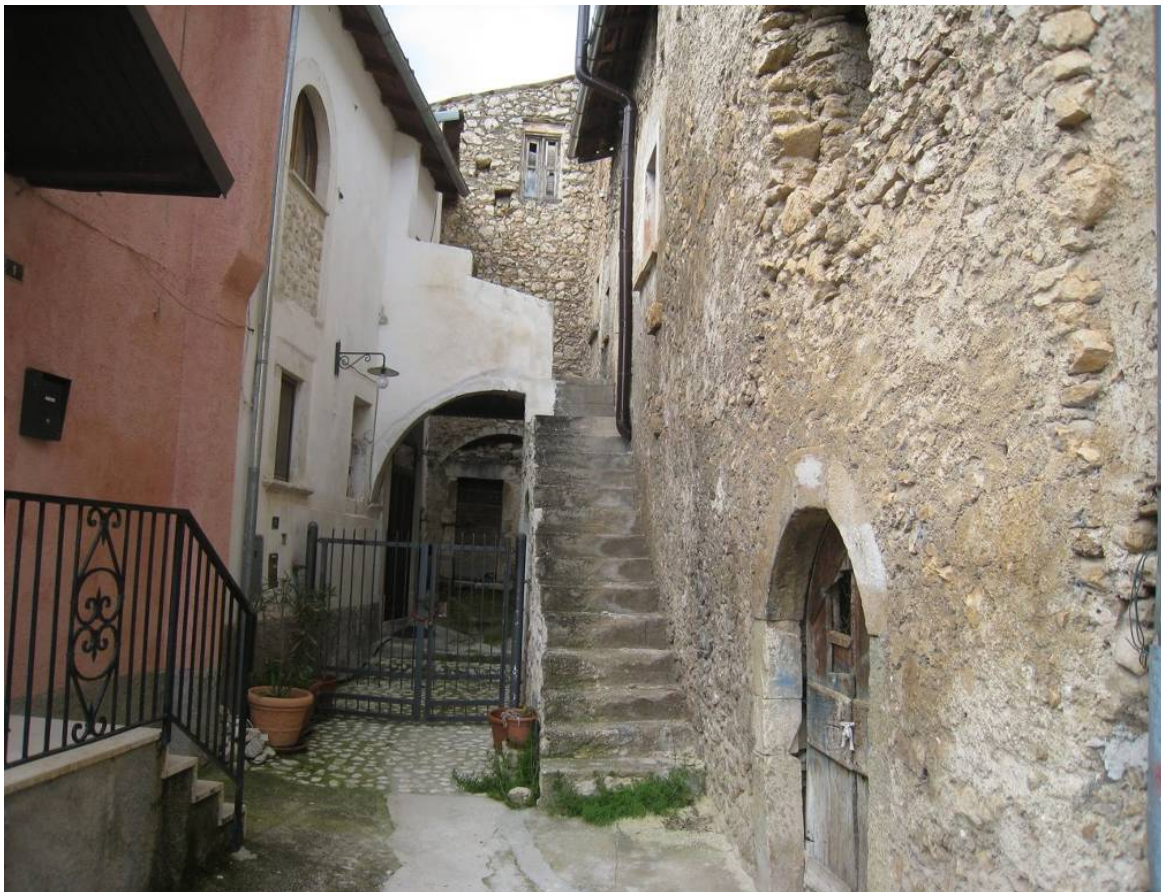
Figure 62. Typical unreinforced masonry structures in the village of San Pio delle Camere suffered no damage (D0), or slight cracking (D1). Structures in this village are similar to those in Castelnuovo. San Pio delle Camere is built on limestone bedrock.

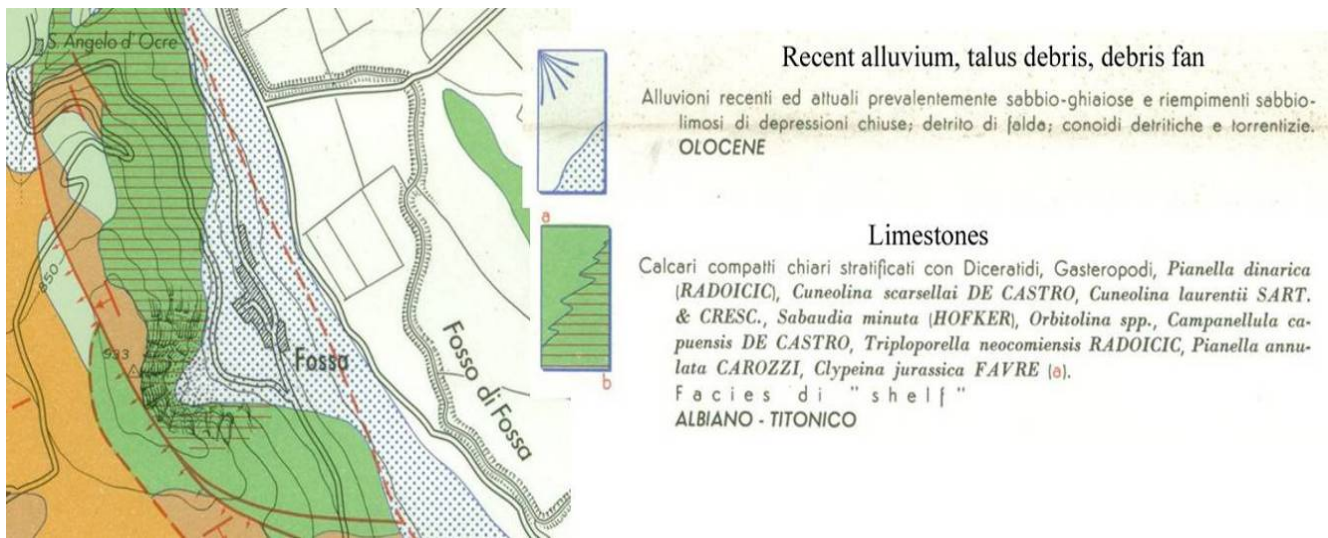
Figure 76. Geological map of Fossa (after Bosi and Bertini, 1970).

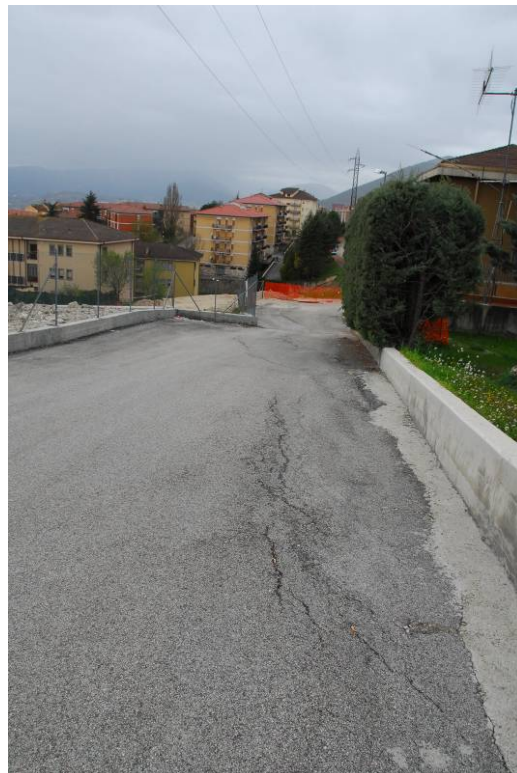
*Figure 154. Cracks in the overlying asphaltic surfaces and a narrow settlement trend along the sidewall of the cut-and-cover structure (42.358N 13.415E).*
