Seismological and geotechnical aspects of the $M_w=6.3$ L'Aquila earthquake in central Italy on 6 April 2009

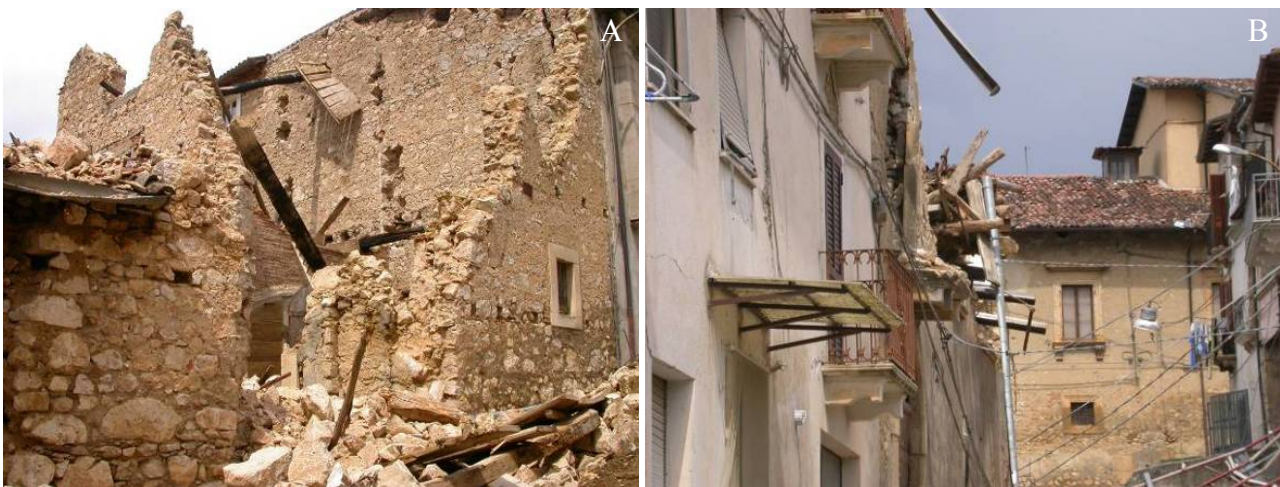
Figure 80. S. Eusanio Forconese. (A) Collapse of old masonry building (D5), (B) Partial collapse of masonry building (D4).
