## Mississippi River Levee Failures: June 2008 Flood

**ABSTRACT:** *During the spring and summer of 2008, record rainfall in the Midwest United States led to severe flooding as water overtopped the levees bordering the Mississippi River and its tributaries. The erosion associated with the overtopping resulted in levee breaches in many places. After the flooding, a field reconnaissance team was sent to collect time-sensitive data and provide a comprehensive overview of the performance of the levees during the flooding.*

Reference: Bernhardt, M., Briaud, J.L., Kim, D., Leclair, M., Storesund, R., Lim, S.G., Bea, R.G., Rogers, J.D., (2011). *Mississippi River Levee Failures: June 2008 Flood*. International Journal of Geoengineering Case Histories, <http://casehistories.geoengineer.org>, Vol.2, Issue 3, p. 127-162. doi: 10.4417/IJGCH-02-02-03.

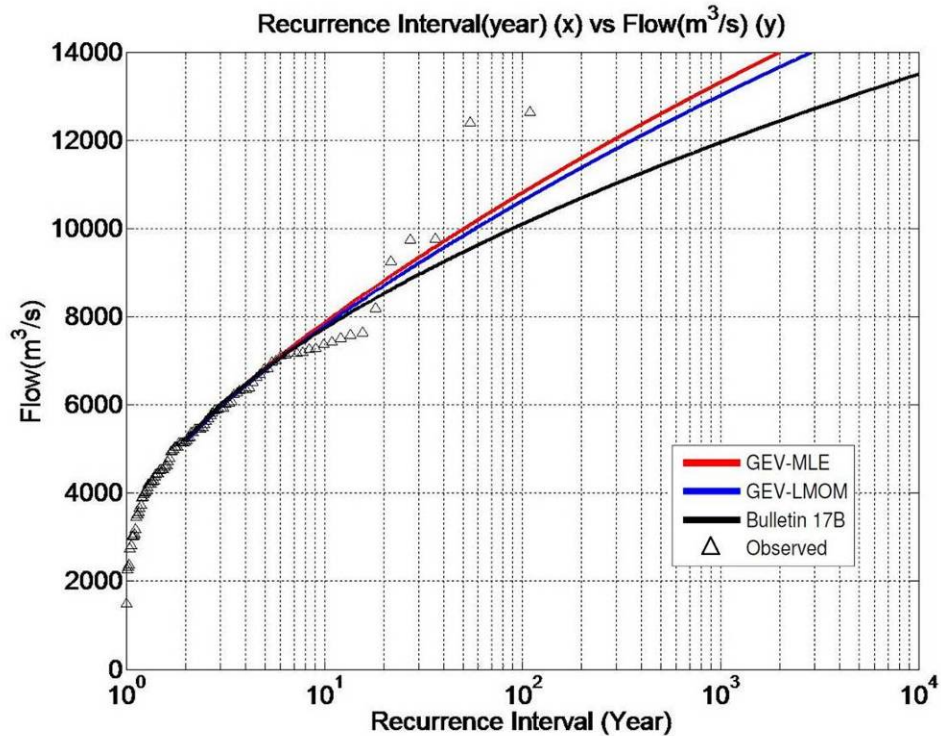
Figure 6. Observed flow peaks versus their recurrence intervals, gage 05474500.

The recurrence interval of the June 2008 flood based on the three different methods can be read on a fitted curve for the observed value of the flow, such as shown for gage 05474500 in Figure 6. To obtain the estimated recurrence intervals, a horizontal line is drawn from the data point with a flow value of 12,400 m<sup>3</sup>/s through the regression lines. Each intersection point represents the recurrence interval for that respective estimation method. The results for the 4 gages of Figure 5 are shown in Table 1. As can be seen from Table 1, the predicted recurrence interval for Gage 05474500 varies significantly

among the three methods due to the fact that the data is extrapolated to extreme values. It is clear however, that at this location the flood was very large and in the vicinity of a 1000-year flood.

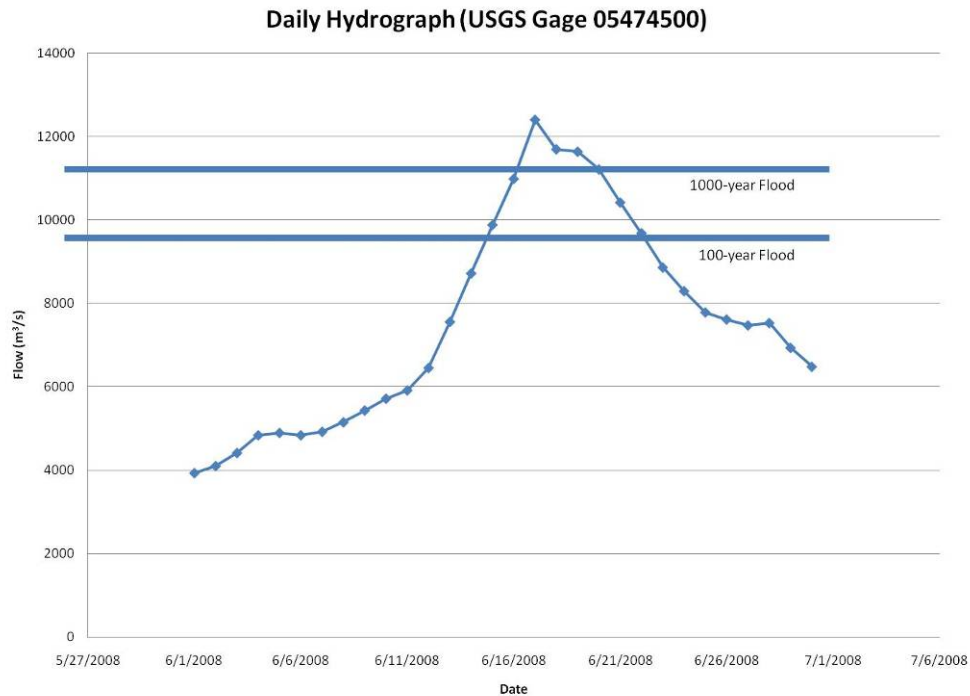
Figure 7. Daily flow hydrograph for USGS gage 05474500.

The daily flow hydrographs (flow versus time) during the 2008 flood observed at USGS gage 05474500 and USGS gage 05587450 are shown on Figure 7 and Figure 8 along with the reference floods based on the Bulletin 17B flood frequency method. Note that at the location of USGS gage 05474500, the Mississippi River stayed at a stage level equal to or higher than the 100-year flood for approximately 8 days.

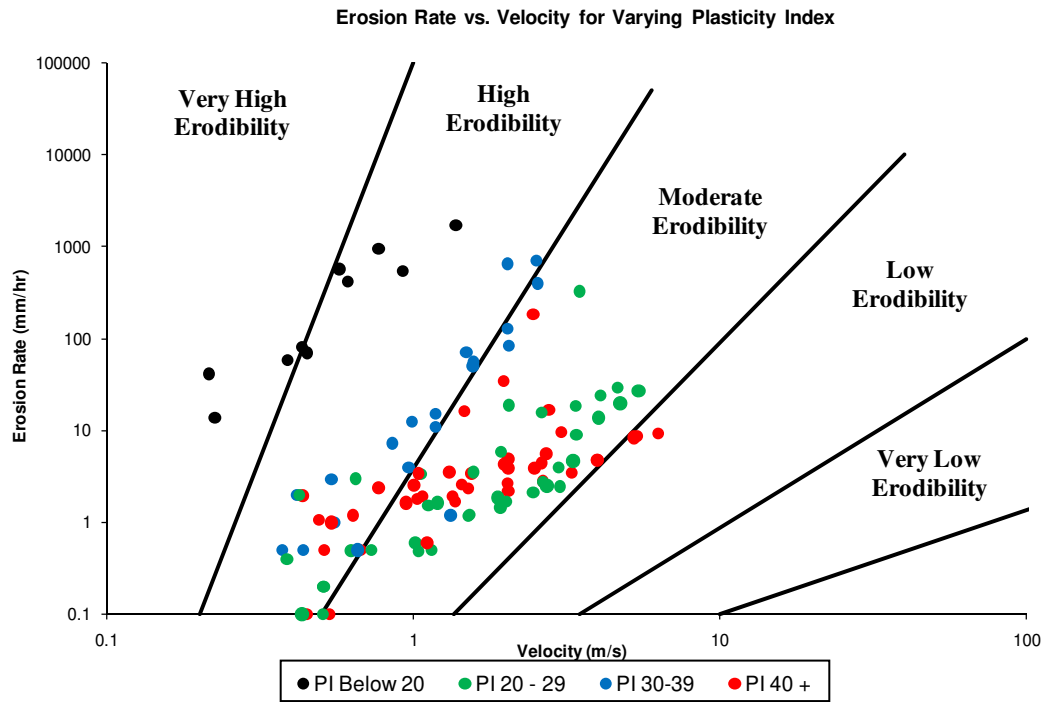
Figure 27. EFA comparison of PI for all sites.

A weak trend seems to exist with the more erosion resistant soils having higher PIs. The trend is not obvious which indicates that plasticity is not the only factor that influences erosion. It should also be noted that other factors varied for the samples plotted and therefore, the influence of plasticity is not singled out by the graphs shown.

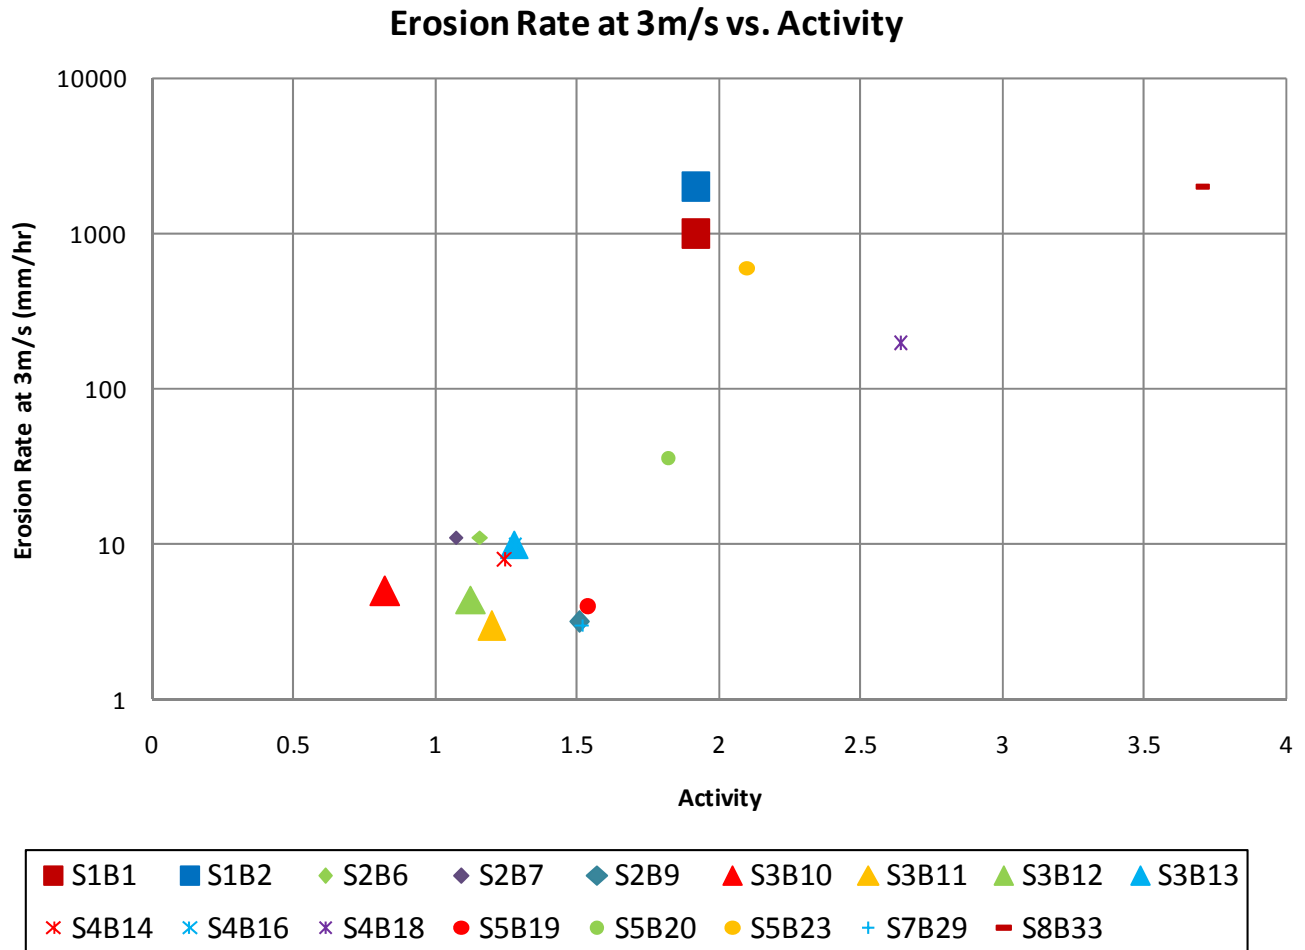
Figure 32. Erosion rate at 3m/s vs. activity.

While most of the correlations did not exhibit a clear trend, it was noticed that as the clay content increased, the erodibility of the soil decreased. A more noticeable trend appeared in the plot of erosion rate versus activity (Figure 32). As activity increases, so does the erosion rate. Activity is the ratio of the Plasticity Index over the percent finer than  $2\mu\text{m}$  (clay fraction).
