Expedient Mitigation of Collapsible Loess in Northern Afghanistan

Christopher T. Senseney, Assistant Professor, U.S. Air Force Academy, Colorado, 80840-6232, USA; email: christopher.senseney@usafa.edu

Reference: Senseney, C. (2013). *Expedient Mitigation of Collapsible Loess in Northern Afghanistan*

International Journal of Geoengineering Case histories,

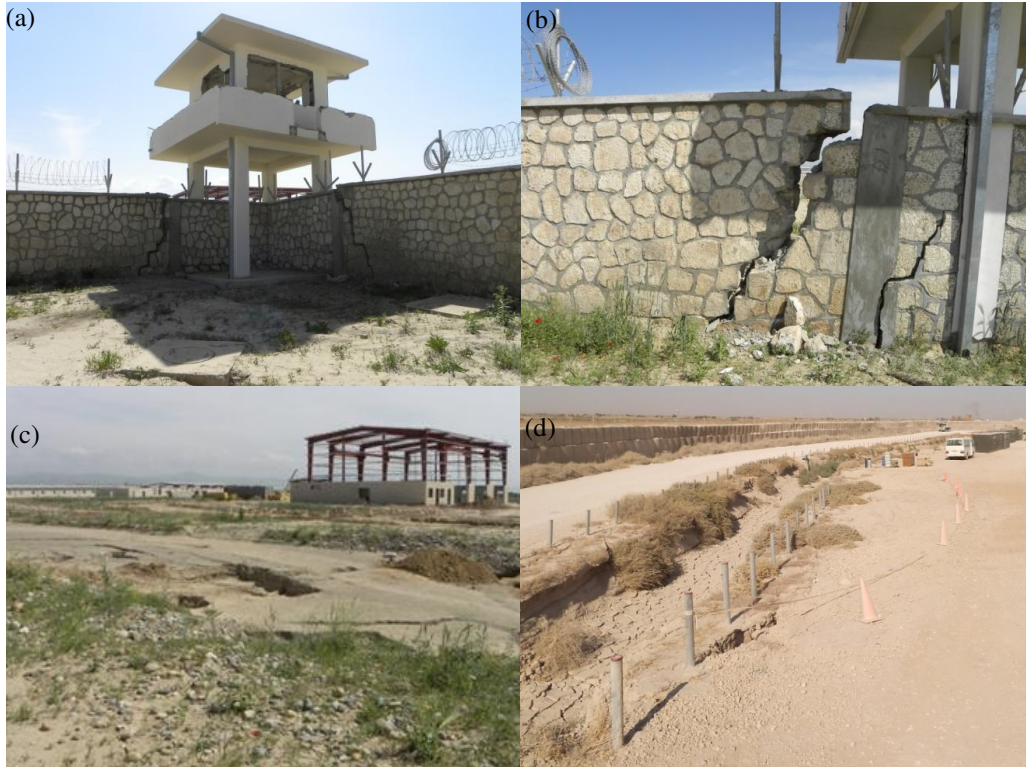
Figure 2. a. Damaged guardhouse and security wall in Kunduz, b. security wall damaged in Kunduz, c. settlement basin through a road in Kunduz, d. slope failure next to earthen drainage ditch in Mazar-e-Sharif as evidenced by coned off area.

The magnitude of collapse and resulting damage to infrastructure and facilities is primarily dependent on the amount of wetting. In low lying areas where water pools or flows after heavy rains, soil collapse often manifests itself in settlement basins or slope failure. Settlement basins typically occur near the perimeter of a facility beneath downspouts or on the edge of roads near drainage ditches. The facilities, in turn, experience differential settlement and structural damage, as evidenced by building settlements up to 10 cm (4 in) around Mazar-e-Sharif and Kunduz (Meier et al. 2009, SIGAR 2010). Settlement basins also cause failure to security walls (Fig. 2a-b) and damage roads (Fig. 2c). Slope failures damage the drainage system and render limited real estate unusable (Fig. 2d). Repairing damage wastes valuable resources that could be better utilized elsewhere.

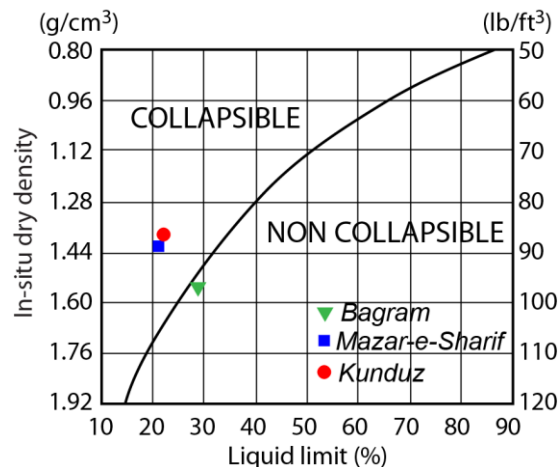
Figure 3. Gibbs and Bara (1962) criteria for determining collapsibility.

Of the methods to identify collapsible soil, two of the most common are the dry density and liquid limit graph (Gibbs and Bara 1962) and the one-dimensional compression test using an oedometer (Lutenegger and Saber 1988). By studying alluvial fan deposits in California with low dry density, Gibbs and Bara (1962) showed that when the saturated moisture content exceeds the liquid limit, the soil will likely collapse. Using this relationship, they developed the dry density versus liquid limit criteria in Fig. 3. The Gibbs and Bara approach is most applicable to clayey sands and sandy clays (NAVFAC 1986), but in the absence of a collapse test, it is a reasonable preliminary assessment for loess soils. Lutenegger and Saber (1988) introduced a collapse test that applies a vertical stress to a laterally confined, undisturbed sample of loess at its natural water content, and then introducing water to the specimen. A decrease in volume at a constant vertical stress is an indication of the collapse potential of the soil.

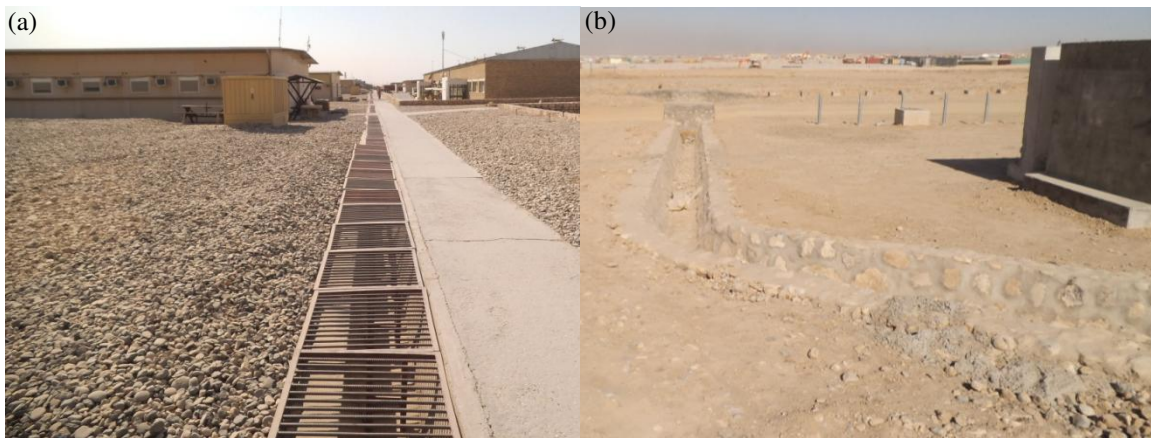
Figure 5.a. Cast in place concrete trench drain and gravel cover over the ground surface, b. grouted stone channel constructed with locally available cobble stones.

A suitable drainage design at expedient military bases is open channel drains and a gravel cover over the ground surface. Cast in place concrete trench drains (as shown in Fig. 5a) should be trapezoidal or rectangular with depths generally ranging from 0.15-1.0 m (0.5-3.3 ft), depending on local hydrological conditions. The drain bottom and side walls must be reinforced to withstand earth pressure and anticipated loads. Grouted stone channels (see Fig. 5b) are also acceptable. Such channels are common in Afghanistan given the abundance of naturally occurring cobble stone deposits in river beds. Downspouts from buildings should feed into the drains. Ungrouted riprap-lined channels or earthen drainage ditches (see Fig. 2d) are not recommended because water infiltration may cause collapse and/or slope failure.
