Expedient Mitigation of Collapsible Loess in Northern Afghanistan

Christopher T. Senseney, Assistant Professor, U.S. Air Force Academy, Colorado, 80840-6232, USA; email: christopher.senseney@usafa.edu

International Journal of Geoengineering Case histories,

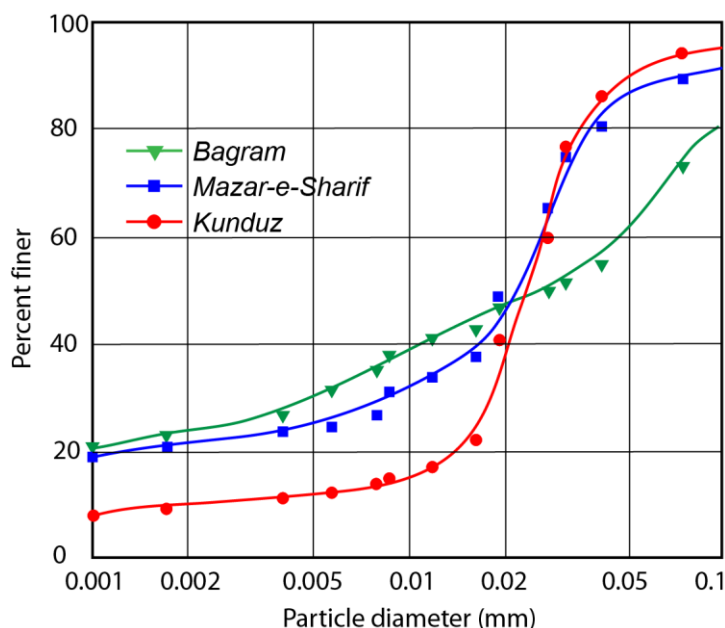
Figure 4. Particle size distributions of Kunduz, Mazar-e-Sharif and Bagram soil.

Soils from Afghanistan military bases in Kunduz, Mazar-e-Sharif and Bagram were evaluated for collapse using Gibbs and Bara's criteria and Handy's criteria. Sand cone tests were conducted and disturbed soil samples were collected at a depth of 0.5 m (20 in). Three sand cone tests and three samples were obtained from Kunduz and two sand cone tests and two samples each were obtained from Mazar-e-Sharif and Bagram. An average of the soil properties are given in Table 1 and an average of the particle size distributions in Fig. 4, where fine content less than 0.075 mm was determined using a hydrometer apparatus (ASTM 2007). The Kunduz and Mazar-e-Sharif soil exhibit a uniform distribution with particles concentrated in the range 0.01 to 0.06 mm, indicating the soils are loessial and will not compact well. On the contrary, the Bagram soil exhibits a more well-graded distribution, indicating the soil is not loessial and has higher potential for compaction. According to Gibbs and Bara's criteria, the Kunduz and Mazar-e-Sharif soil is collapsible, while the Bagram soil would fall just inside the non-collapsible region (see Fig. 3). According to Handy's criteria, the Kunduz soil has high probability of collapse, the Mazar-e-Sharif soil will probably collapse, and the Bagram soil has less than 50% probability. These results match what military forces have observed. As many as 48 sites in and around the Kunduz Airfield show signs of collapsed soil (SIGAR 2010) and an earthen drainage ditch near the Mazar-e-Sharif Airfield experienced slope failure from collapsible soil. No evidence of collapse has been observed at Bagram. Lutenegeger and Saber's collapse test or other collapse tests were not used in this study because the equipment to obtain undisturbed samples and equipment to conduct necessary laboratory tests are not available in Afghanistan.
