Expedient Mitigation of Collapsible Loess in Northern Afghanistan

Christopher T. Senseney, Assistant Professor, U.S. Air Force Academy, Colorado, 80840-6232, USA; email: christopher.senseney@usafa.edu

International Journal of Geoengineering Case histories,

<http://casehistories.geoengineer.org>, Vol.2, Issue 4, p.252-257. doi: 10.4417/IJGCH-02-04-01

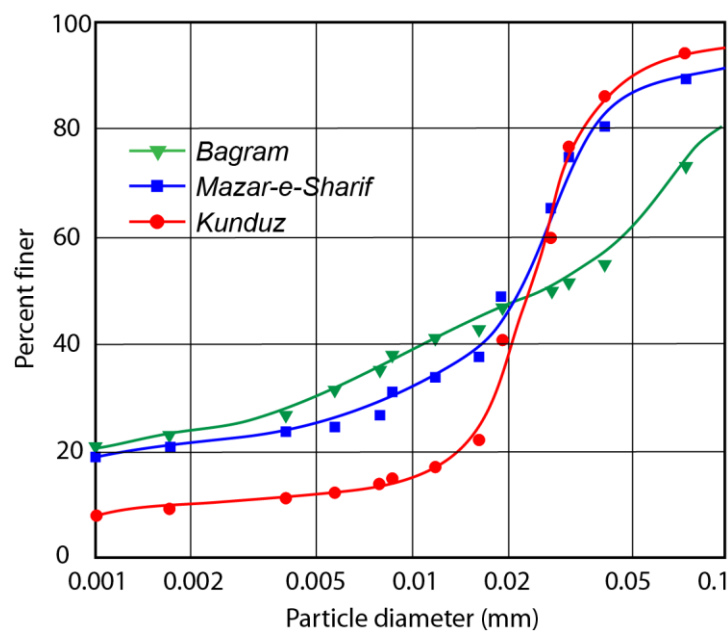
Figure 4. Particle size distributions of Kunduz, Mazar-e-Sharif and Bagram soil.

Soils from Afghanistan military bases in Kunduz, Mazar-e-Sharif and Bagram were evaluated for collapse using Gibbs and Bara's criteria and Handy's criteria. Sand cone tests were conducted and disturbed soil samples were collected at a depth of 0.5 m (20 in). Three sand cone tests and three samples were obtained from Kunduz and two sand cone tests and two samples each were obtained from Mazar-e-Sharif and Bagram. An average of the soil properties are given in Table 1 and an average of the particle size distributions in Fig. 4, where fine content less than 0.075 mm was determined using a hydrometer apparatus (ASTM 2007). The Kunduz and Mazar-e-Sharif soil exhibit a uniform distribution with particles concentrated in the range 0.01 to 0.06 mm, indicating the soils are loessial and will not compact well. On the contrary, the Bagram soil exhibits a more well-graded distribution, indicating the soil is not loessial and has higher potential for compaction. According to Gibbs and Bara's criteria, the Kunduz and Mazar-e-Sharif soil is collapsible, while the Bagram soil would fall just inside the non-collapsible region (see Fig. 3). According to Handy's criteria, the Kunduz soil has high probability of collapse, the Mazar-e-Sharif soil will probably collapse, and the Bagram soil has less than 50% probability. These results match what military forces have observed. As many as 48 sites in and around the Kunduz Airfield show signs of collapsed soil (SIGAR 2010) and an earthen drainage ditch near the Mazar-e-Sharif Airfield experienced slope failure from collapsible soil. No evidence of collapse has been observed at Bagram. Lutenegeger and Saber's collapse test or other collapse tests were not used in this study because the equipment to obtain undisturbed samples and equipment to conduct necessary laboratory tests are not available in Afghanistan.
