## Stability Analyses of the 1981 San Luis Dam Slide

**ABSTRACT:** *The 1981 upstream slope failure in San Luis Dam in California, USA, is analyzed for stability and deformations in two- and three-dimensions using continuum-mechanics-based analysis procedures implemented in the computer programs FLAC and FLAC3D. The analysis results (failure surface, factor of safety, and displacements) from the continuum models are in general agreement with the field data. In addition, two-dimensional slope stability analysis results using a modified form of limit-equilibrium-based Spencer's procedure for variable factor of safety implemented in the computer program SSTAB2 are included. Overall, the analysis results supplement the previously reported failure analyses. The paper serves three primary functions: (1) it documents results of a different analysis of the 1981 San Luis Dam slope failure; (2) it demonstrates the use of 2-D and 3-D continuum models to study the onset of instability, failure surface geometry and location, and permanent displacements associated with slope failures; and (3) it demonstrates the use of variable factor of safety to identify location of instability initiation, an

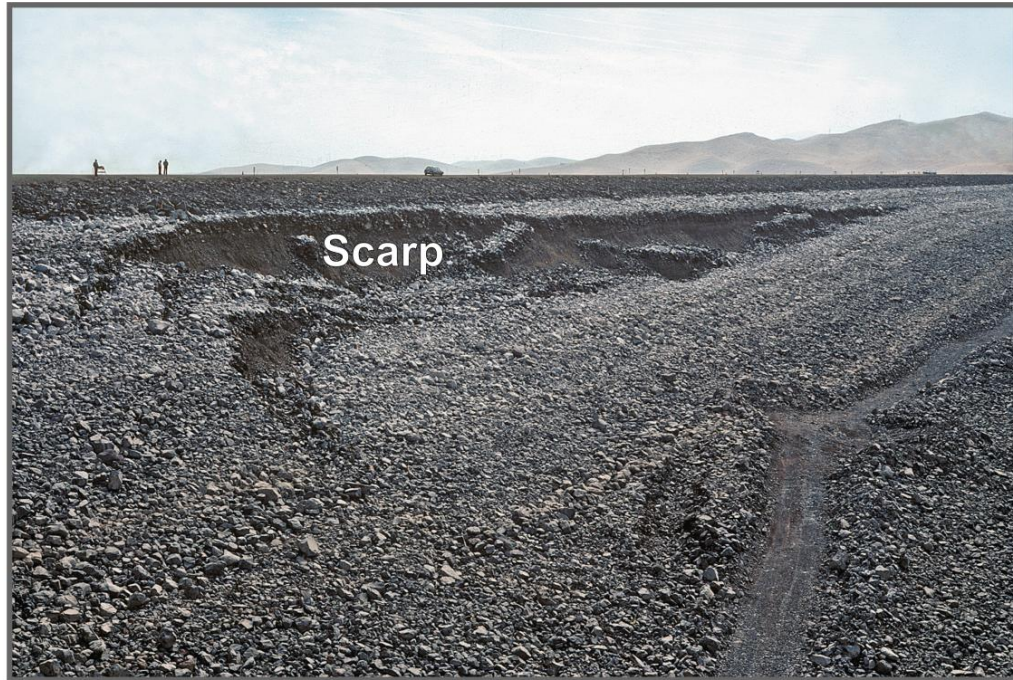
Figure 1. San Luis Dam site: (a) Elevation view of the 1981 slide; (b) Reservoir operational history.

*1. Observations prior to the 1981 slide:* Since the first filling of the reservoir in 1967, the San Luis Dam had displayed persistent, unexplained, minor cracks on the crest of the dam preceding the 1981 slide. Crest cracking had also been observed in other regions (outside the reach of the 1981 slide) where the dam was founded on similar landforms. The cracks were taken to be typical of performance of large dams after first filling of reservoir. Also, during 1975 – 1978, three significant drawdowns of the reservoir had occurred without incidence, see Figure 1(b).

*2. Observations of the 1981 slide:* The following field observations of the slide were noted by VonThun (1985) – see Figures 1(a), 2, and 3: First cracking occurred about 30 m (100 ft) down the u/s slope near the crest of an enveloped hill (near station 135) and progressed down the abutment towards more voluminous cross sections. The characteristics and progression of the slide mass are summarized as: (a) began as an arc-shaped crack, with ends of the arc parallel and perpendicular to the dam axis; (b) progressed from the initial length of about 150 m (500 ft) to an ultimate length of about 450 m (1475 ft); (c) took about two months to fully develop and stabilize; (d) formed a distinct pressure ridge at the toe moving over a portion of the toe of the dam for a distance of about 10 m (30 ft); and (e) moved on the order of 20 m (65 ft) with a 15 m (50 ft) vertical scarp. In view of the size of objects in Figure 1(a), the 15 m (50 ft) dimension for the vertical scarp seems to be in error (an over-estimate) – it is listed as 7.6 to 9.1 m high in Penman (1986) and 10 m high in Duncan and Wright (2005).

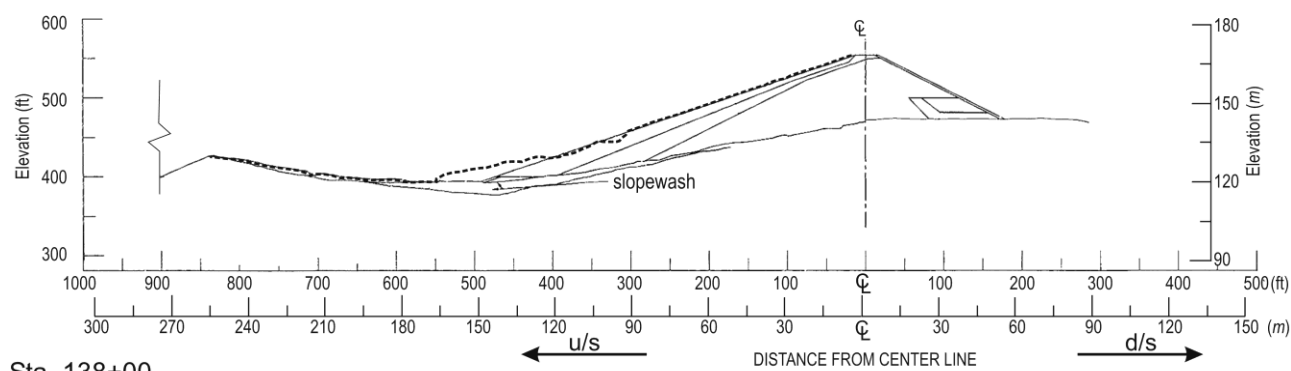
Figure 3. Cross section views of the San Luis Dam from station 120 to station 138 showing the original and deformed configuration of the dam.

Sta. station;  $\odot$  Dam zone no. for  $i = 1$  to 5;  $\beta$ , natural ground slope angle for  $i =$  Sta. 120 to Sta. 138

The dam zones are identified on cross section at Station 120 in Figure 3, the same zoning identification applies to all cross sections included in this figure. All materials were placed in lifts and compacted with appropriate equipment typical of the period (1963 - 1967).

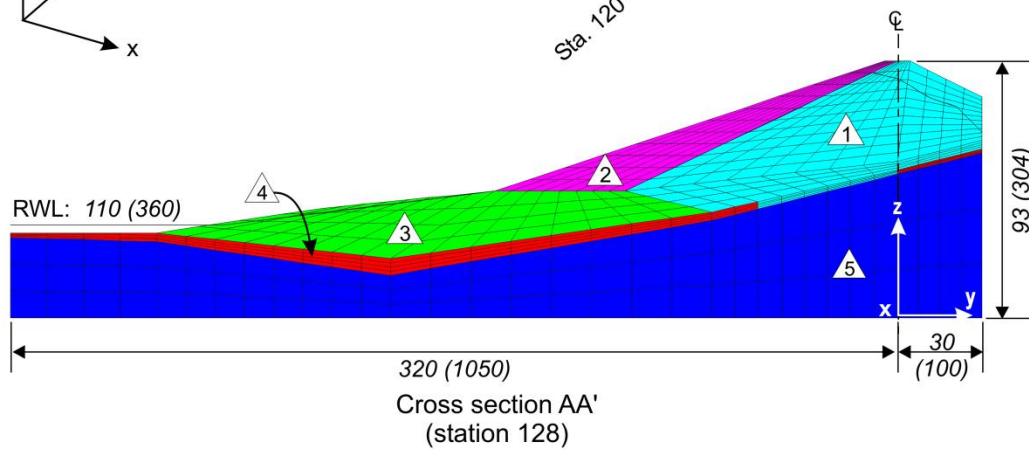
- RWL reservoir water level
- ↓ ↓ reservoir pressure loading
- ☐ pore pressure contours
- △<sub>i</sub> Material ID for  $i = 1$  to 5 (Table 1)
- $u, v, w$  displacements in  $x, y, z$  coordinate directions
- b.c. boundary conditions
- Sta. station
- all dimensions are in meters (feet)

Figure 7(a) shows the perspective view of the 3-D numerical model of the San Luis Dam between stations 120 and 138. Figures 7(b and c) show the cross section view of the model, the reservoir pressure loading, and the pore pressure contours for a cross section located at station 128 for RWL = 110 m (360 ft). The reservoir pressures shown in Figure 7(c) are modeled as nodal forces. The force vectors for the end-nodes are half as big as for the central nodes because the contributing area is half as big. The boundary conditions for the 2- and 3-D analyses are shown on Figure 7(a).

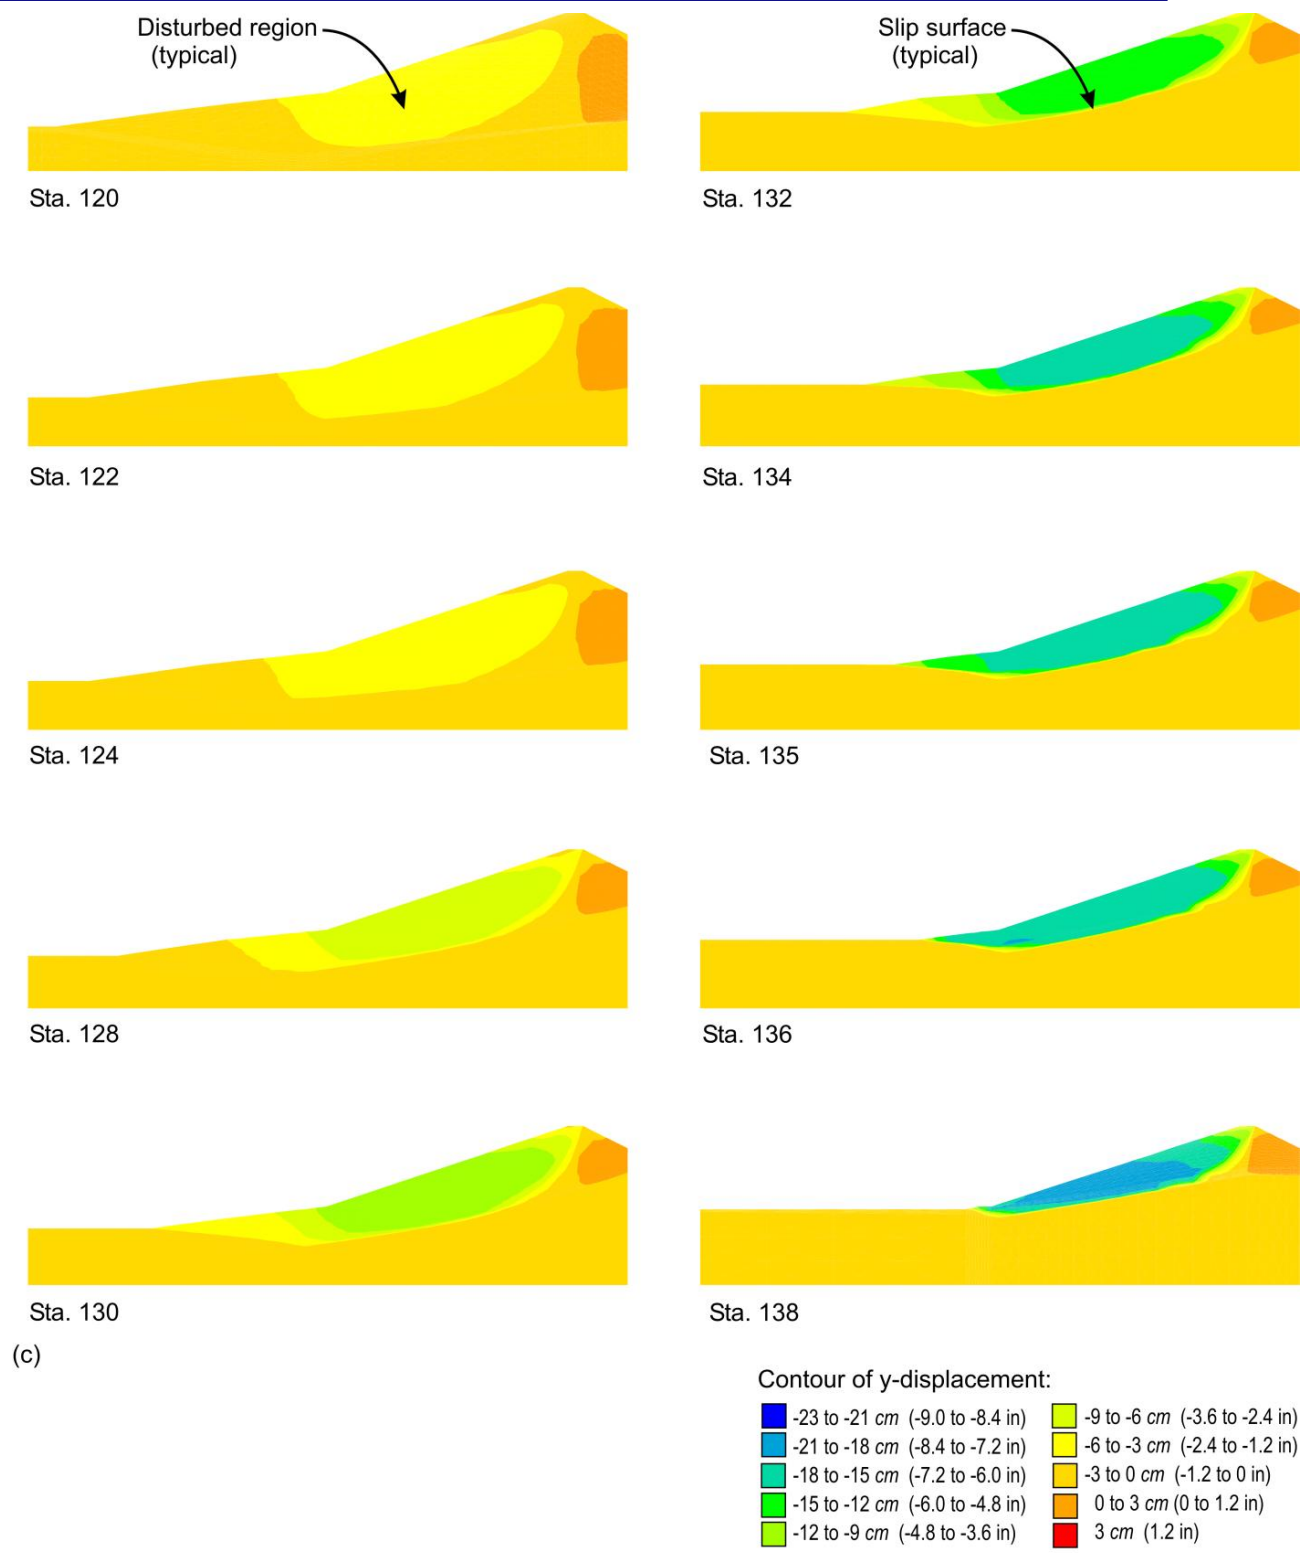
(a) FoS = 1.08

Figure 9. Slope stability analysis results of three-dimensional continuum model between stations 120 and 138. Reservoir water level is 110 m (360 ft), angle of internal friction for slopewash is  $22^\circ$ , and the slip surface geometry is determined by the continuum-mechanics-based computer program FLAC3D.  
(a) Spatial distribution of y-displacement contours; (b) Spatial distribution of surface cracks in longitudinal direction; (c) Planar views of slip surface geometry from station 120 to station 138.
