Estimation of the Hydroconsolidation Susceptibility of the Anthropogenic Fill of the Historical Center of Thessaloniki, Greece

Reference: Hatzigogos, N.P.T., Makedon, T.K., Tsindaris, G.E., Tsotsos, S.C. and Christaras B.C. (2016). *Estimation of the Hydroconsolidation Susceptibility of the Anthropogenic Fill of the Historical Center of Thessaloniki, Greece*. International Journal of Geoengineering Case histories, Vol.4, Issue 1, p.46-56. doi: 10.4417/IJGCH-04-01-04

The scope of this paper is the estimation of hydroconsolidation susceptibility of Thessaloniki's historical fill formations through laboratory simulation for the interpretation of settlement measurements at a building of the historical centre of the city.

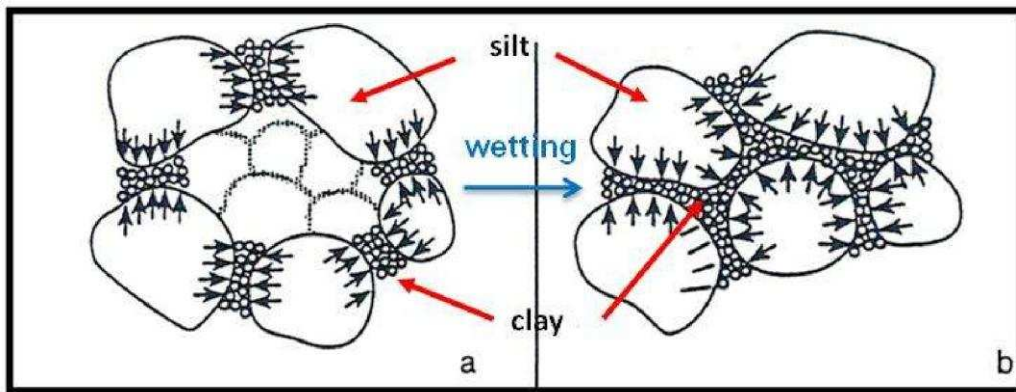
Figure 1. Collapse of a soil structure under load due to wetting (Knight, 1961).

The volumetric change behavior of a saturated soil is generally controlled by effective stress. However this behavior under unsaturated conditions cannot be estimated on the basis of effective stress alone but it is controlled by the changes of the soil moisture that result in changes of soil's matric suction (Khalili et al, 2004). The phenomenon of soil collapse can be manifested gradually and not necessarily as an immediate settlement, depending on the initial moisture content and the moisture variation range. If the soil is loaded under saturated conditions then it will consolidate without collapsing. If however its moisture content under constant loading is initially low (partially saturated) and is subsequently increased, then for low stress levels the soil will swell, whereas for higher stress levels it will sustain volume decrease due to structure collapse. Figure 1 shows the phenomenon of gradual collapse with increased wetting which is called hydroconsolidation; it occurs once and results in a new more stable soil structure (Knight, 1961).

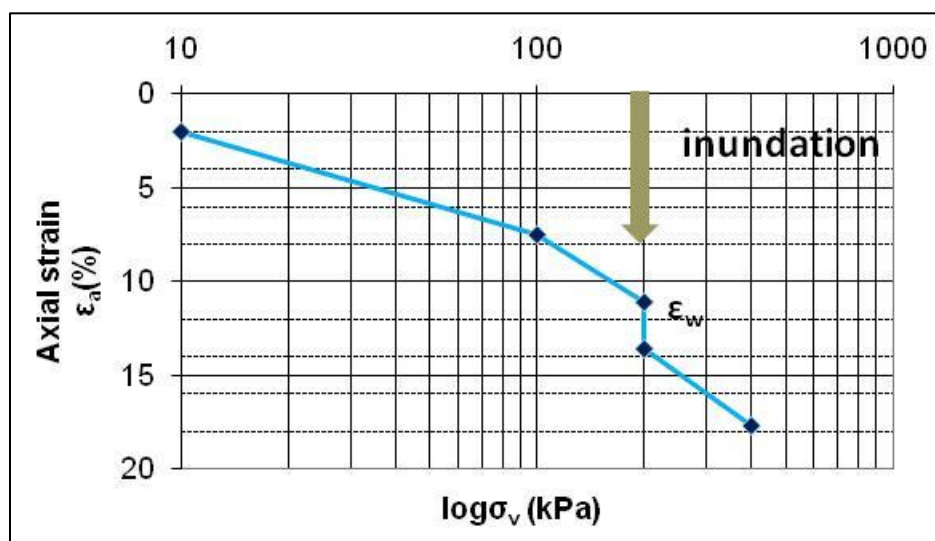
Figure 9. Axial strain due to wetting under constant load of 200 kPa.

The test program was carried out for samples from the historical layer and Table 1 presents the results for ϵ_w values due to wetting of the samples under constant load. Figure 9 shows the change of void ratio due to hydroconsolidation of sample 4 for constant load (200 kPa) during wetting. The results of Table 1 produced the characteristic hydroconsolidation curve of the studied layer as seen in Figure 10, which describes the volume change behavior of the layer after wetting under constant load. There is swelling of the layer for stress <95 kPa and volume decrease for stress >95 kPa. As an example, the volume change calculated due to wetting under constant stress of 400 kPa is $\epsilon_w=4.1\%$.

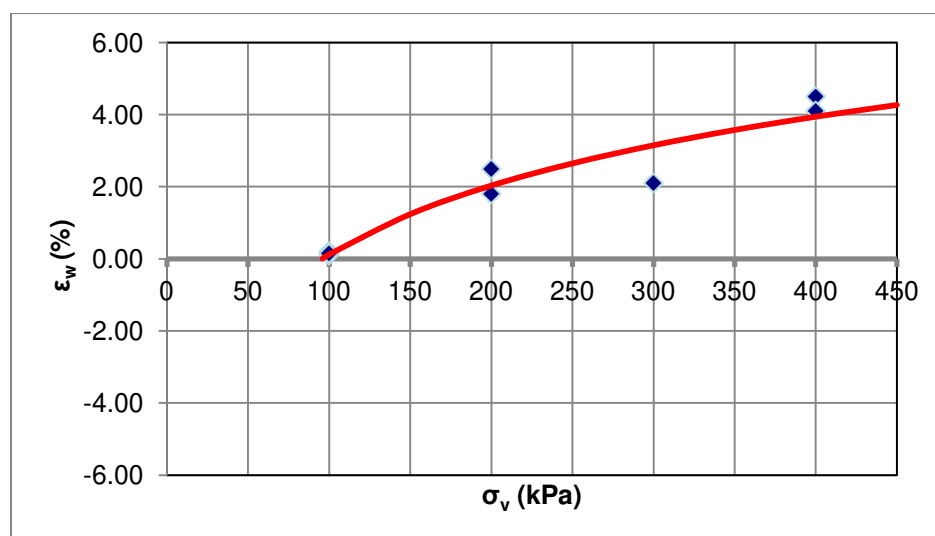
Figure 10. Axial strain due to wetting of Thessaloniki's historical fill at different stresses

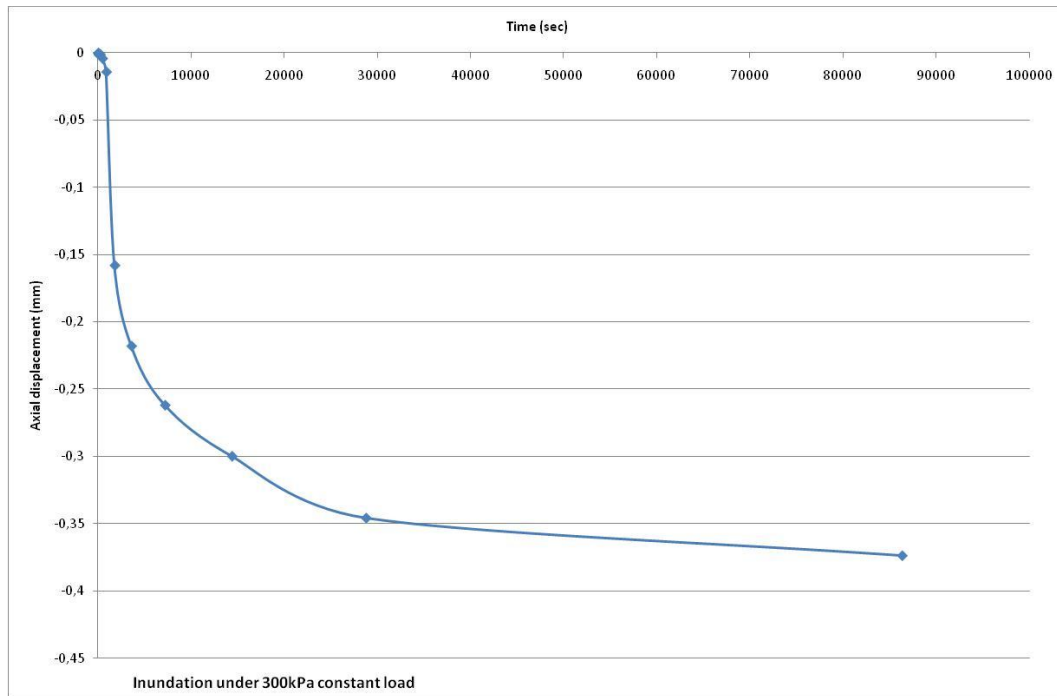
Figure 12. Laboratory displacement-time curves after inundation.
