Estimation of the Hydroconsolidation Susceptibility of the Anthropogenic Fill of the Historical Center of Thessaloniki, Greece

KEYWORDS: hydroconsolidation, anthropogenic historical fill, collapse settlement, oedometer simulation, Thessaloniki's Metro

Reference: Hatzigogos, N.P.T., Makedon, T.K., Tsindaris, G.E., Tsotsos, S.C. and Christaras B.C. (2016). *Estimation of the Hydroconsolidation Susceptibility of the Anthropogenic Fill of the Historical Center of Thessaloniki, Greece*. International Journal of Geoenvironmental Engineering Case histories, Vol.4, Issue 1, p.46-56. doi: 10.4417/IJGCH-04-01-04

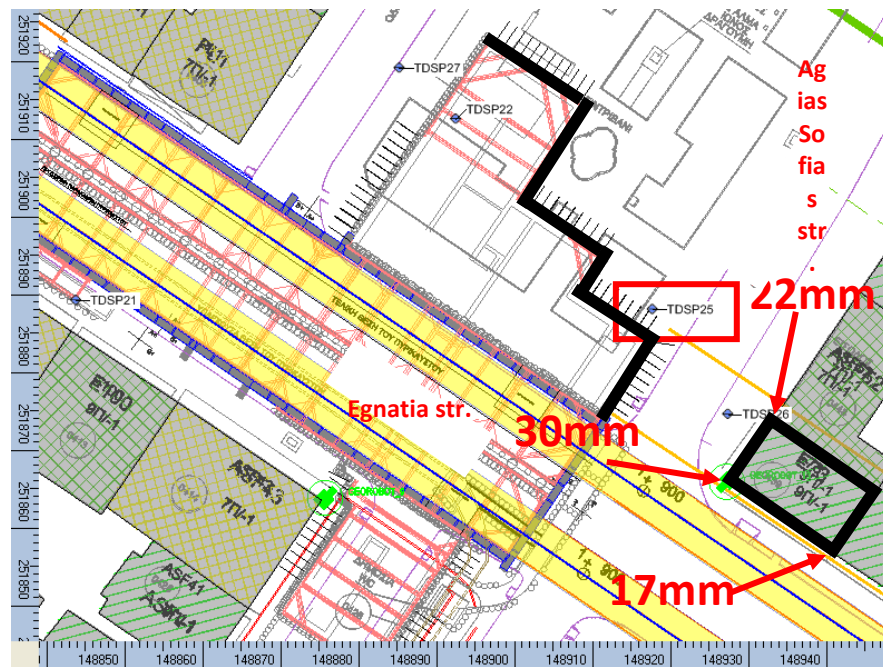
Figure 8. In situ measurements of vertical displacements .

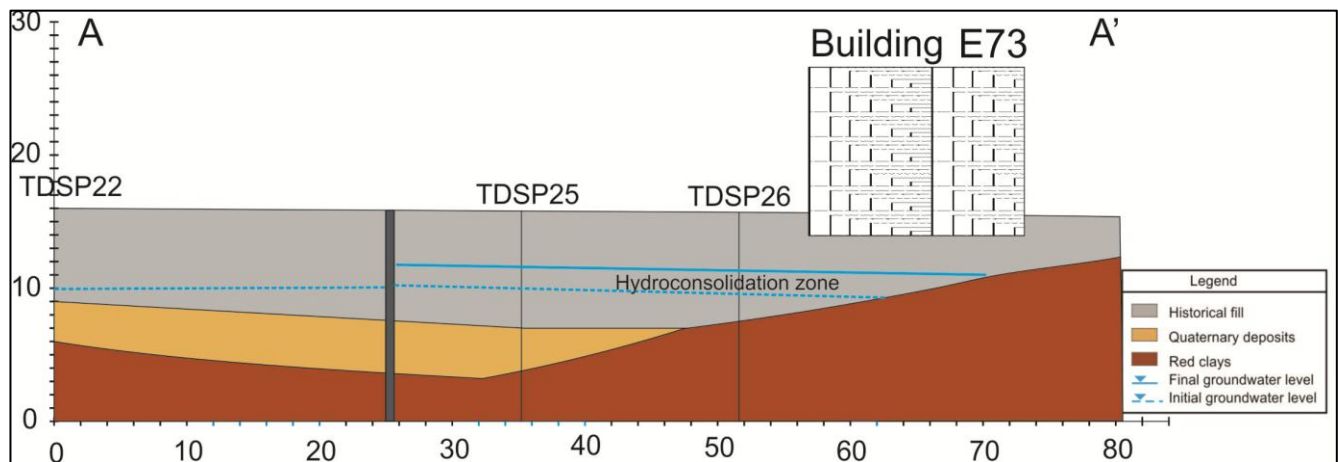
Figure 14. A-A' geological cross-section pointing the hydroconsolidation region.

The differential distribution of settlements is due to the fact that the thickness of the susceptible historical layer (which experienced a maximum groundwater level rise of 1.5 m) is uneven because of its SW dip. Therefore the layer is located

higher towards the NE in respect to the groundwater level and consequently the hydroconsolidated part of the layer becomes less at this direction. Figure 14 shows a characteristic cross section of NW-SE direction that depicts the hydroconsolidated area below the building.
