# Estimation of the Hydroconsolidation Susceptibility of the Anthropogenic Fill of the Historical Center of Thessaloniki, Greece

**ABSTRACT:** The collapse of soil structure due to wetting is called hydroconsolidation and occurs only once under constant loading, in cases of perturbation of the soil's moisture content. It is encountered usually in non-sedimentary soils such as anthropogenic fills and residual materials. This paper presents an interpretation of hydroconsolidation settlements of a building in the historical center of Thessaloniki after a rise of the water table. The interpretation is based on the results of laboratory evaluation of hydroconsolidation properties, in conjunction with in situ measurements of settlements.

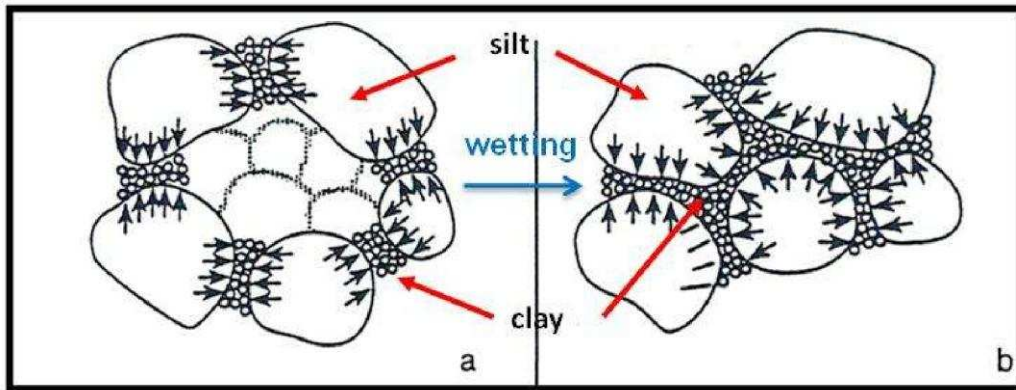
Figure 1. Collapse of a soil structure under load due to wetting (Knight, 1961).

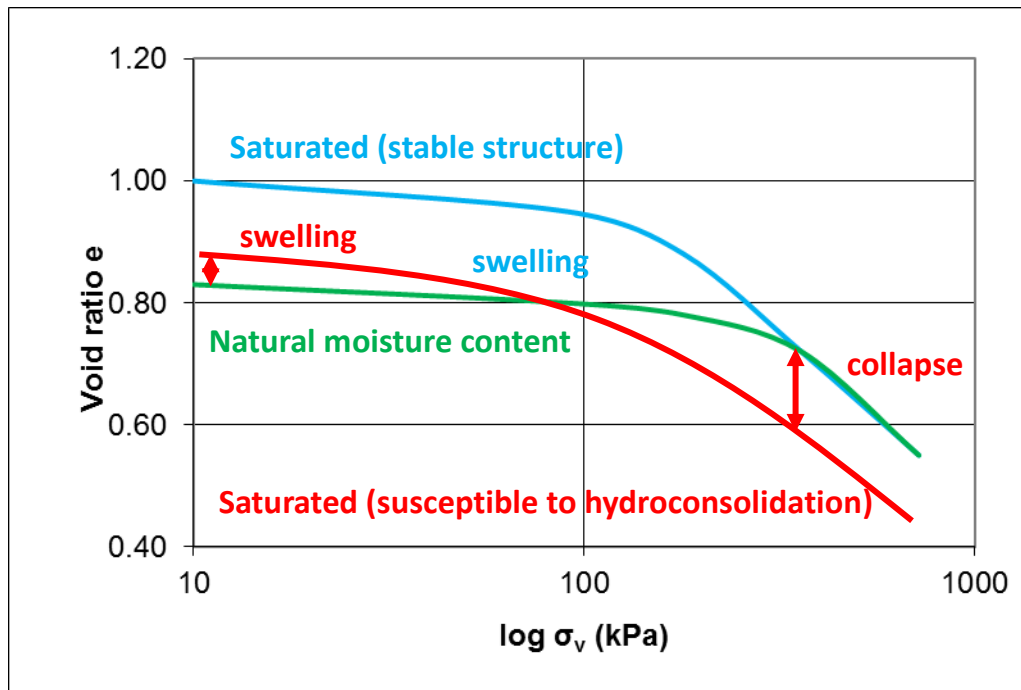
Figure 2. Soil swelling and collapse behavior after wetting under constant load (modified from Jennings & Knight, 1975).

Hydroconsolidation usually occurs in cases of wetting in soils of unstable granular structure due to technical interventions, in residual soils and in non cohesive man-made historical and urban non-engineered fills. The magnitude of settlements due to soil collapse depends on the soil's void ratio as well as the applied load. For low foundation stress levels from 100-300 kPa, research shows observed volume changes up to 10% and settlement as much as 15% of the thickness of the susceptible layers (Tromp, 1985). Hydroconsolidation is estimated via oedometer test with simulation of the loading procedure followed by sample inundation as in Figure 2 (Jennings & Knight, 1975).

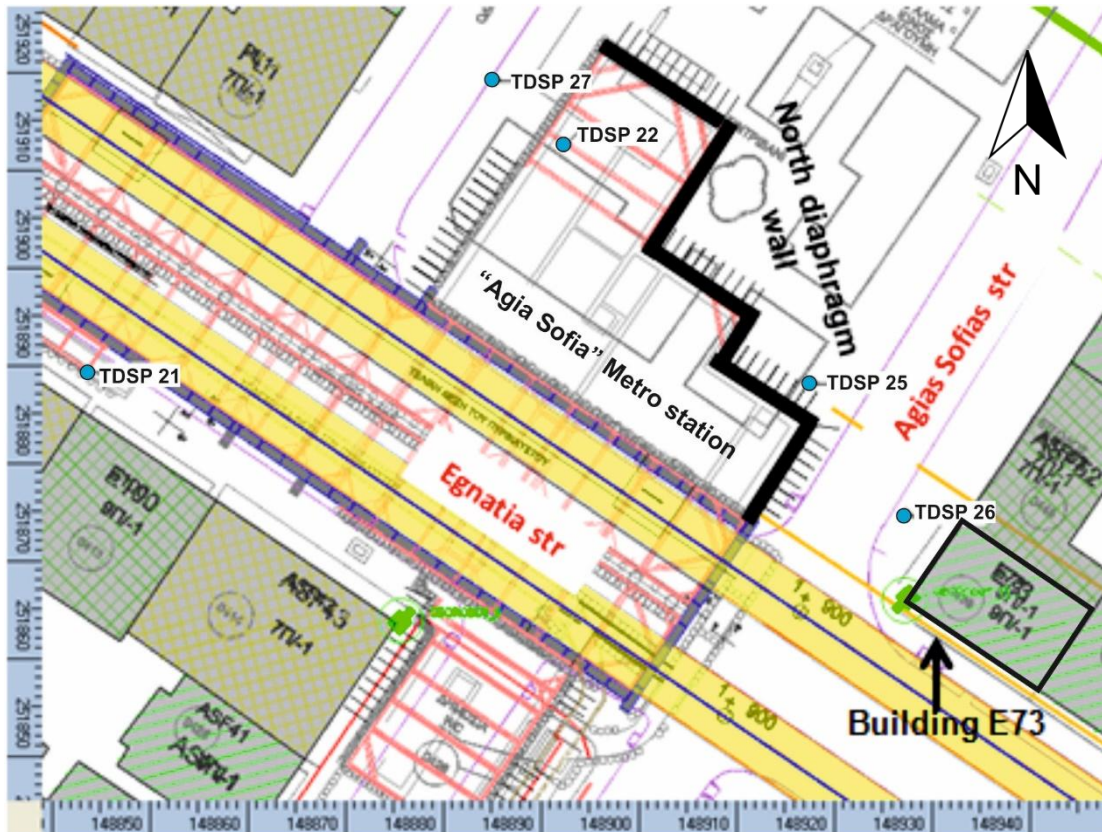
Figure 3. Planar view of the construction of diaphragm walls and piezometers (TDSP 21-27) in "Agia Sofia" Metro Station, along with building E73.

The area of investigation is adjacent to the construction site of the "Agia Sofia" station of Thessaloniki's Metro. During the construction of the station's north diaphragm walls displacements were observed on an adjacent block of flats at the corner of Agia Sofia and Egnatia streets (building E73). The displacements resulted in the deflection of the building towards SW. Systematic measurements of the displacements on the foundation ground were carried out to investigate the phenomenon as well as measurements of the groundwater level in piezometers of the construction area as shown in Figure 3.

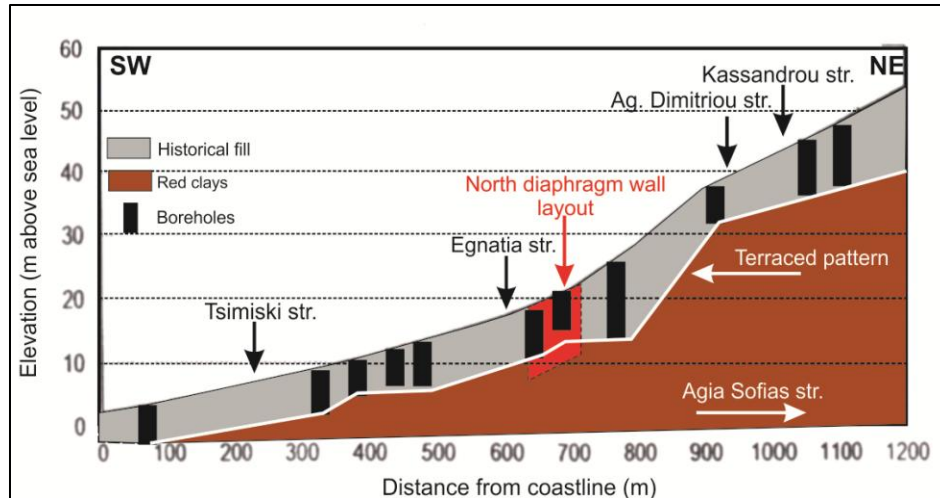
Figure 4. Cross section along Agias Sofias street indicating the terraced pattern of the soil strata underneath the historical fill (modified from Chatzigogos et al, 2006).

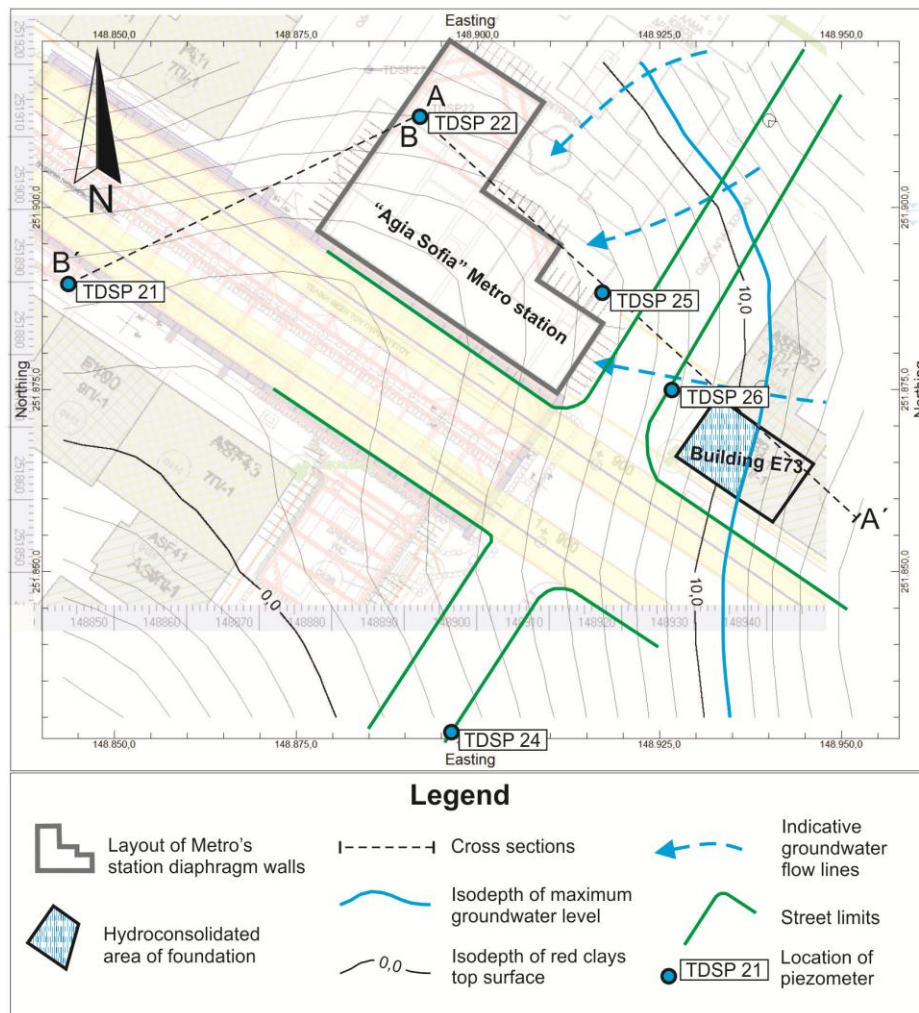
Figure 5. Map of the investigation area with the isodepths of the red clays.

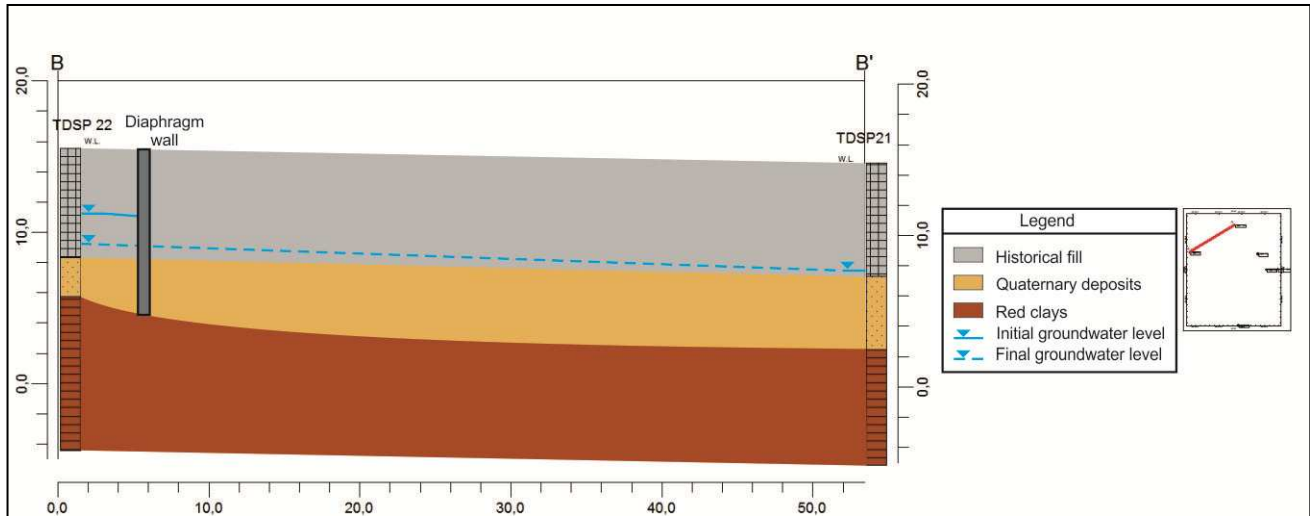
Figure 6. Geological cross section in NE-SW direction along boreholes TDSP22-TDSP21.

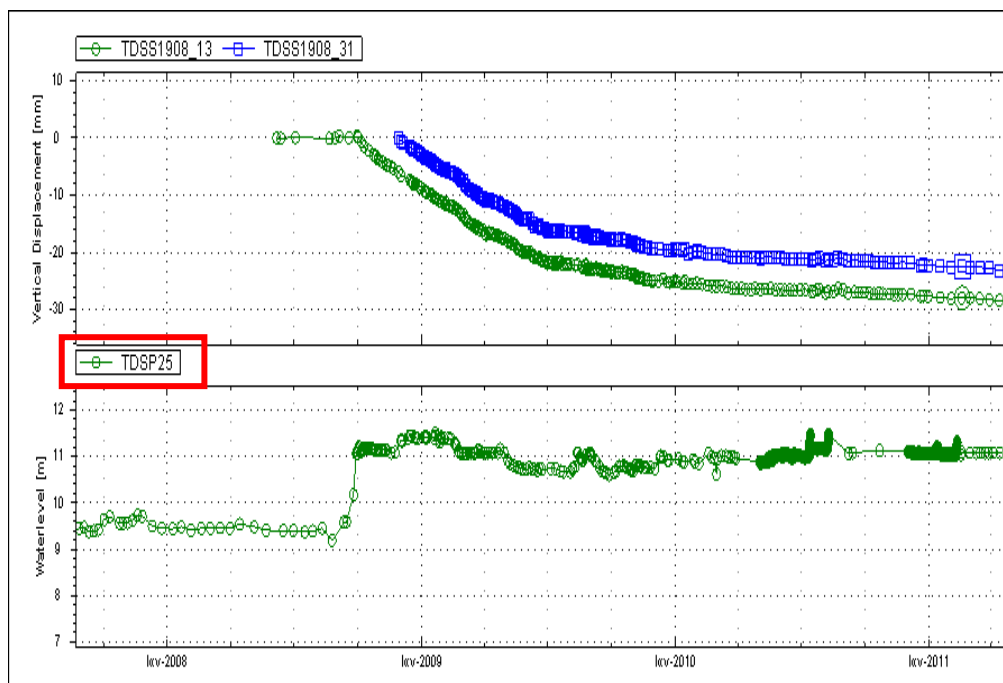
Figure 7. Settlement in building E73 following the rise of the water table (borehole TDSP25).

The works in the station begun with the construction of the northern side diaphragm walls. This created a cutoff barrier to the underground flow of the perched water table resulting to a significant local rise in piezometers TDSP22, TDSP25, TDSP26 and TDSP27 shown in Figure 7, as water flow is bypassing around the diaphragm walls. After the bypass to the SW the water level drops back to the normal level and that is why no rise is detected in piezometers TDSP21 and TDSP24 that are located S-SW of the diaphragm walls. The total rise reached 1.5 m and displacements - settlements were simultaneously observed on the aforementioned building (E73) at the corner of Egnatia and Agia Sofia streets. These displacements resulted in a deflection (inclination) of the building towards Egnatia str. (the free face of the building). The displacement reached 30 mm in a time period of 3 years starting from September 2008 (Figure 8). An additional issue that required interpretation was that the displacements did not affect equally the entire area of the building foundation but only its W-SW section and they were observed during a rise and not a drop of the groundwater level.

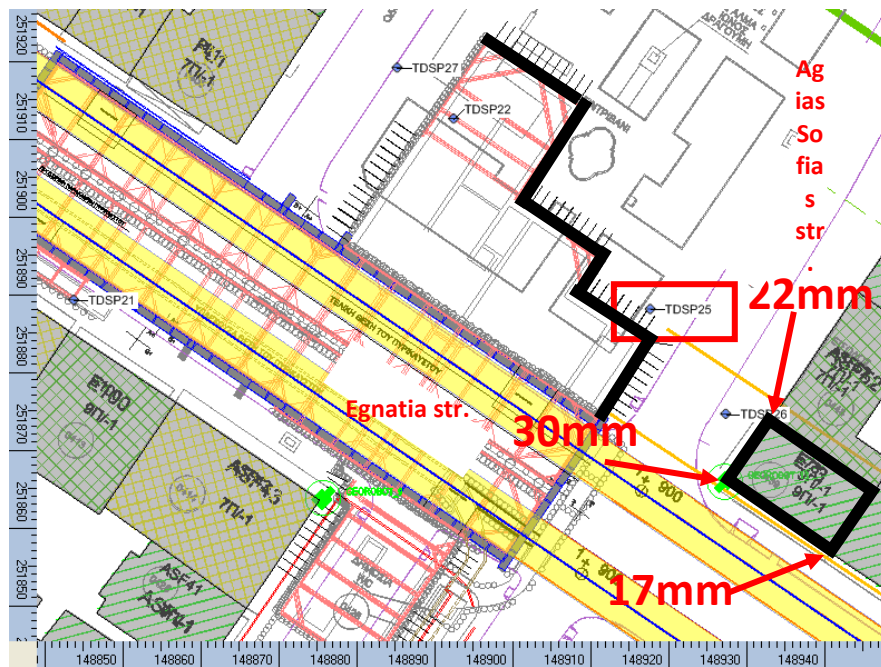
Figure 8. In situ measurements of vertical displacements .

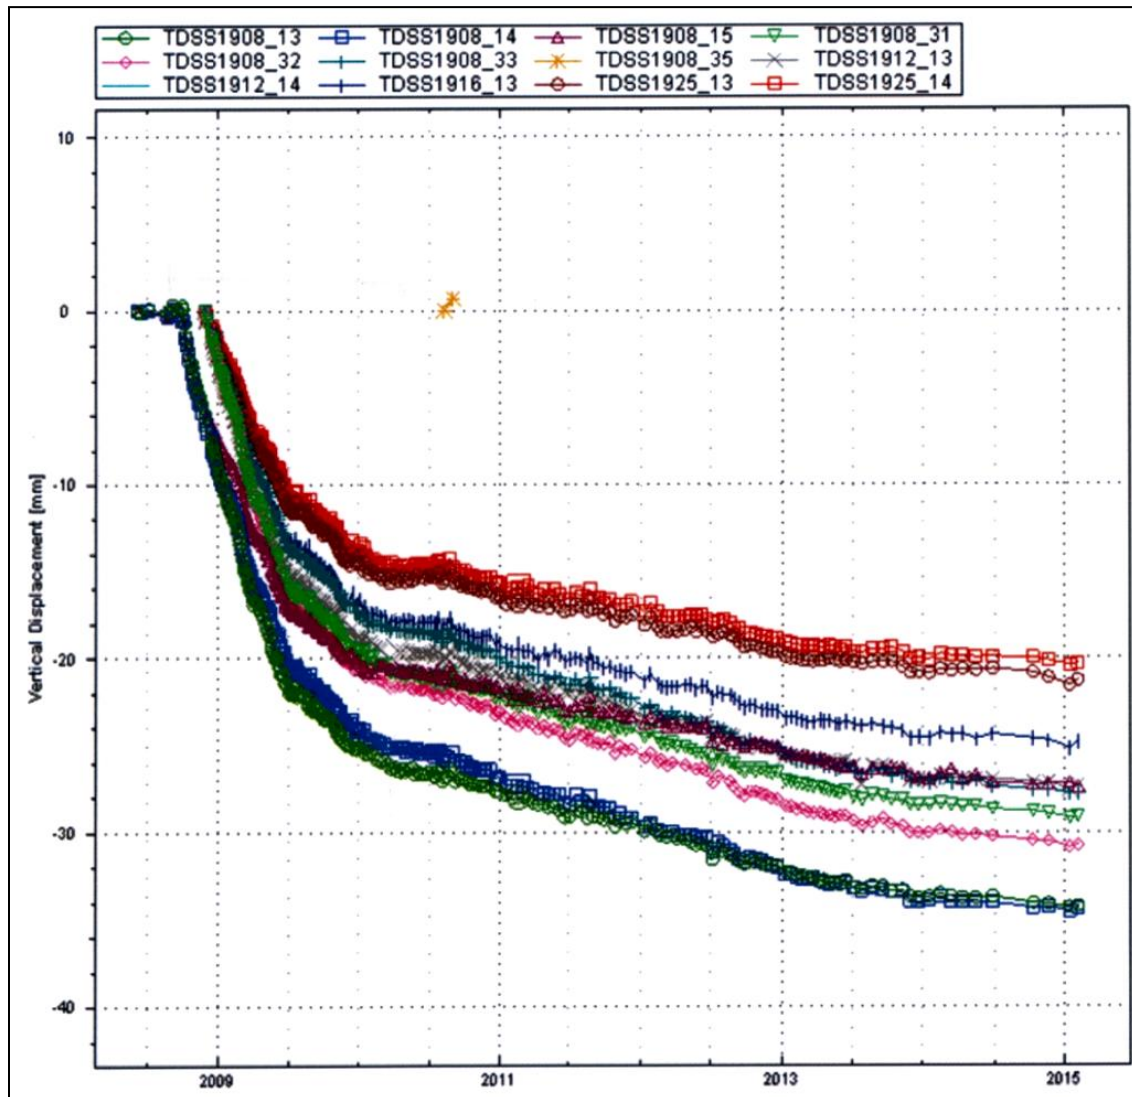
Figure 11. In situ measurements of vertical displacements in the perimeter of building E73.

The in situ measured displacements shown in Figure 11 correspond to a maximum deformation of approximately 2.25% due to hydroconsolidation for a groundwater level rise of 1.5 m. The maximum displacement measured at the SW corner of the building for a time period of more than 5 years is 34 mm and still increases. Despite the fact that all measuring points show different magnitude of displacement they all produce displacements of relatively high rate for the initial 9 months and then the rate decreases dramatically. The same mechanism is displayed in the displacement-time curves after inundation in the laboratory tests in Figure 12. An initial deformation at high rate takes place representing the collapse of the structure after wetting and then the soil is consolidated at a much slower rate.

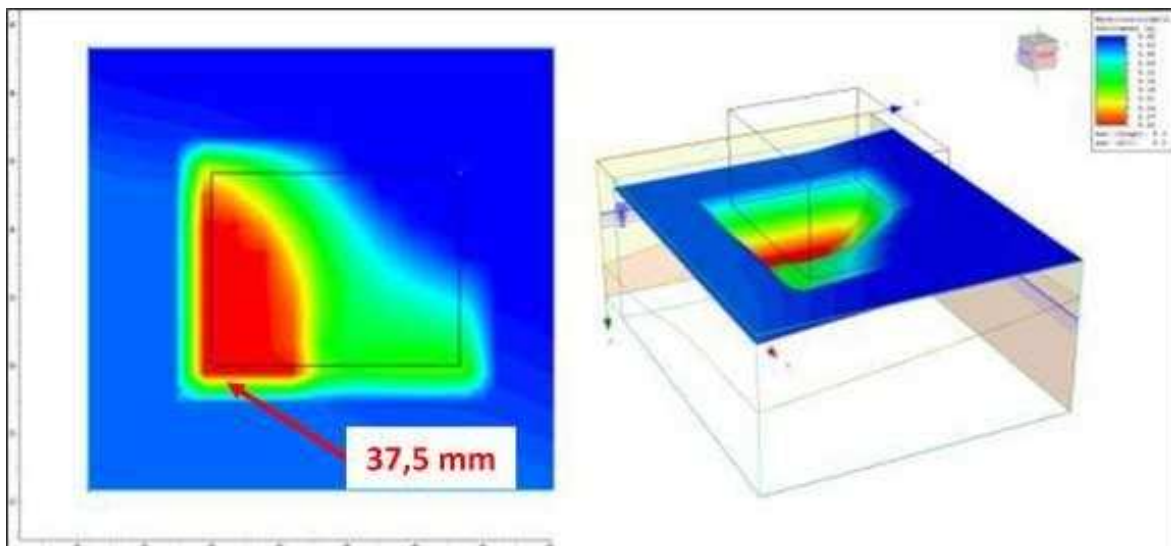
Figure 13. 2D and 3D analysis of hydroconsolidation settlement in building E73.

In comparison to the in situ measurements, the anticipated settlements were calculated introducing the layer parameters from the geological model, the groundwater level rise and the hydroconsolidation characteristics of the layer estimated from the laboratory tests in Settle 3D and the results are shown in Figure 13. As seen from the results there is an uneven distribution of settlements with increased values for the Agia Sofia str. side of the building with a maximum value of 3,75 cm on the SW corner (Figure 13). The Egnatia str. side shows decreasing values of displacements towards E. The calculations correspond to the in situ measurements which also show a gradual decrease of the displacements on the building from SW to NE.

The differential distribution of settlements is due to the fact that the thickness of the susceptible historical layer (which experienced a maximum groundwater level rise of 1.5 m) is uneven because of its SW dip. Therefore the layer is located

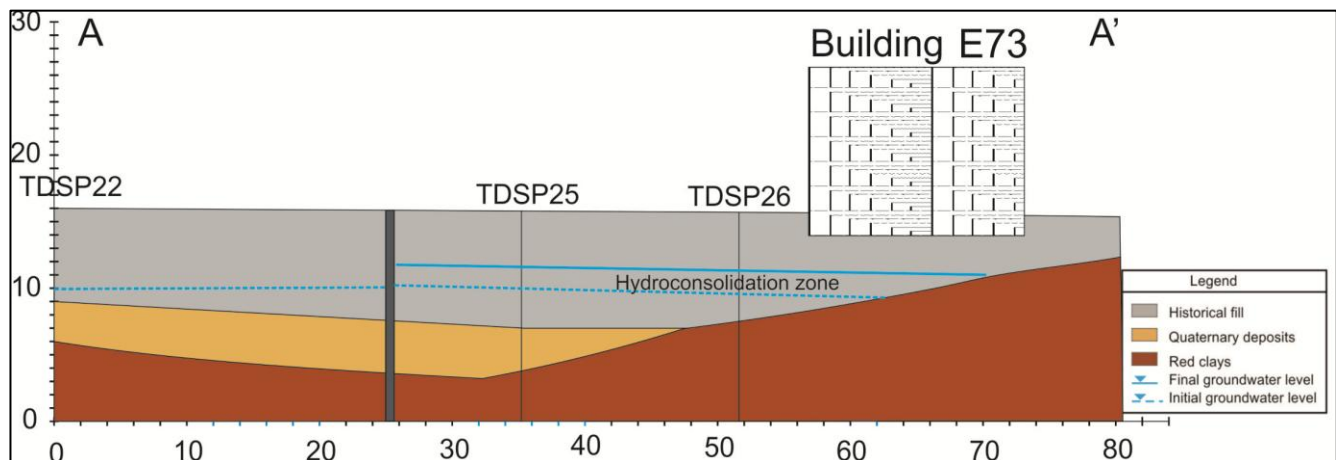
Figure 14. A-A' geological cross-section pointing the hydroconsolidation region.

higher towards the NE in respect to the groundwater level and consequently the hydroconsolidated part of the layer becomes less at this direction. Figure 14 shows a characteristic cross section of NW-SE direction that depicts the hydroconsolidated area below the building.
