# Remediation of The Pissouri Landslide in Cyprus

**ABSTRACT:** During the winter of 2001-2002, a landslide of 80.000 m<sup>3</sup> was activated and moved downslope at the Northeast outskirts of the Pissouri village in Cyprus (Limassol prefecture), displacing a section of a country road that was crossing the upper part of the sliding mass and destroying three newly built residences. This paper presents the geologic and hydrogeologic regime of the landslide and its implication on the landslide's mobilization. Geotechnical site investigation and post failure monitoring, in conjunction with slope stability back analysis formed the basis for the study of the slide and subsequently guided the remediation strategy. Various possible interventions to stabilize the slope and allow the safe reconstruction of the displaced road have been investigated and compared considering both economic and environmental criteria. The performance of the remediation measures has been studied in terms of stability safety, using numerical models previously calibrated via back analyses. Observations made during the execution of the stabilization works provided additional data verifying and supplementing the o

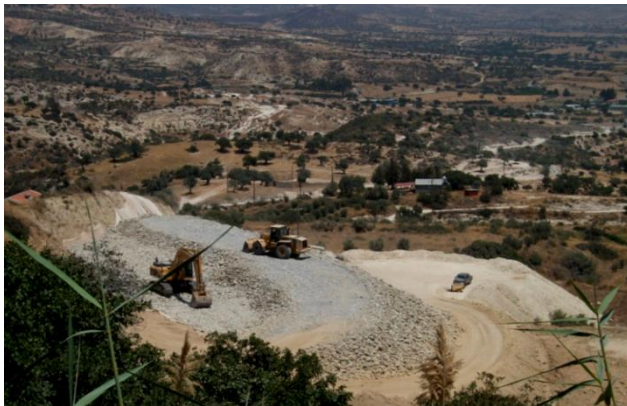
*Figure 18. Construction of the Buttress fill*

The construction activities started by constructing the toe buttress (Figure 18) and this stage was followed by the trimming of the upper part of the sliding mass and the subsequent construction of the bored piles (Figure 19). During the execution of the earthworks at the back scarp area, groundwater seepage continuously recharging the sliding mass was indeed encountered as shown in the photograph of Figure 20. Continuous gravel subdrains protected by geotextile shown in Figure 21, were constructed upslope all along the discharging zones, in order to collect and dispose the groundwater before it enters the landslide area. The next construction stage involved the building of a temporary fill ramp, necessary to reach high up to the back scarp area and construct the piles for the anchored wall (Figure 22). The last stage was the removal of the temporary fill, the anchoring and surfacing of the wall and the paving of the road. Figure 23 presents the landscaping before and after the interventions which shows that the works although substantial, had a limited visual impact in the landscape. Monitoring of the structures during the first two years after construction, showed that ground movements were completely ceased.

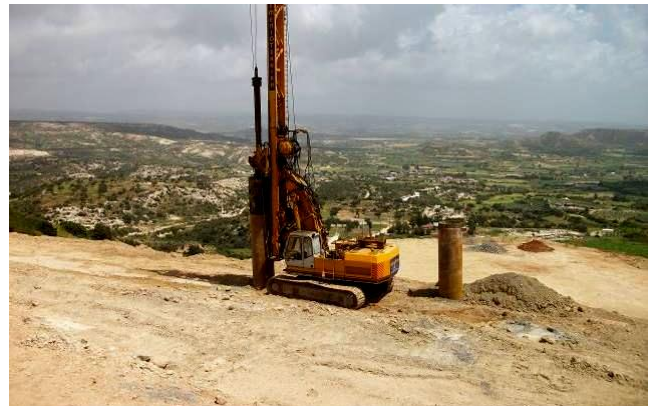
*Figure 19. Installation of bored piles at the trimmed slope surface.*

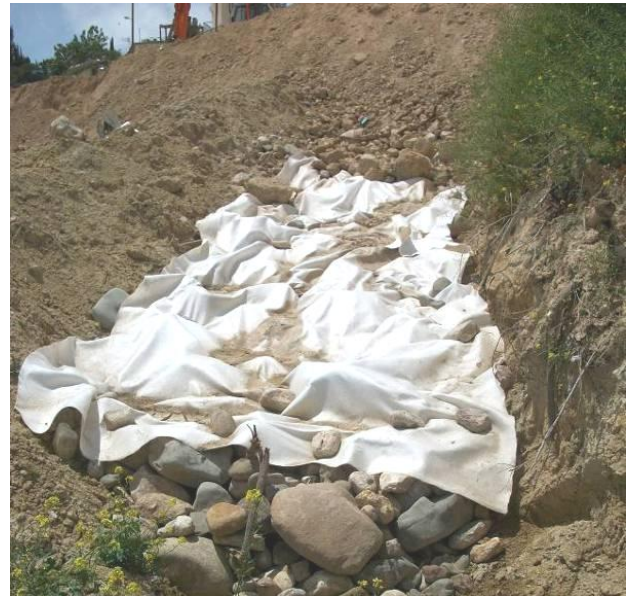
Figure 21. Trench drains filled with cobles wrapped in geotextile filter collect and dispose the groundwater.
