## St. Isaac Cathedral (St. Petersburg, Russia): A Case History

**ABSTRACT:** *St Isaac's Cathedral in St. Petersburg was completed in 1858 after 40 years of construction; it is today the fourth largest domed Cathedral in Europe. The underlying soil is a relatively soft saturated sediment and carries this 3155 MN structure that is 100 meters high with an imprint of 92 m by 100 m. It is founded on a 7.5 m thick mat of granite and limestone blocks resting on relatively short timber piles of different lengths. The Cathedral has progressively experienced significant deformation including differential settlement causing cracks in the pillars and tilting of the porticoes. The paper summarizes the available geotechnical engineering and engineering geology aspects of the soil on which the Cathedral is built as well as classical issues such as foundation ultimate capacity and settlement analysis through simple calculations and numerical simulations. It also includes some less classical issues such as the influence of microbial activity on the behavior of the Cathedral through the changes the microbes and their activity create in the engineering properties of the soil and in the groundwater

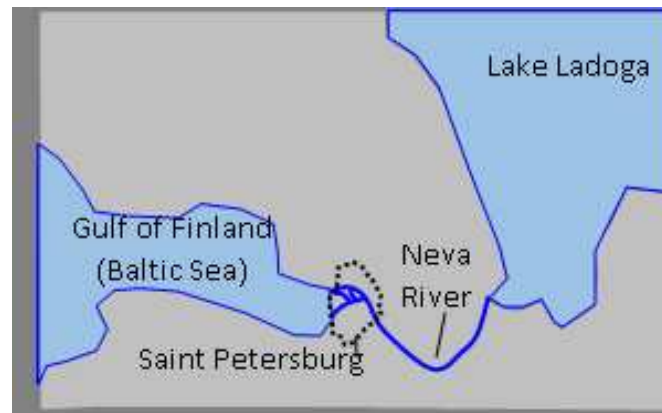
Figure 1. Map of the Neva River delta.

St. Petersburg is a relatively young city, by both Russian and European standards as it was only founded on May 27, 1703 by Tsar Peter the Great in the Neva River delta (Fig. 1). The Neva River runs from Lake Ladoga to the Gulf of Finland (Baltic Sea). For a long time prior to 1700, the Neva River delta area was ruled alternatively by Sweden and Russia. By the end of the 17th century Peter the Great was determined to change the status quo, to regain access to the Baltic Sea and to establish stronger ties with the West. In the hope of achieving these goals he embarked on the Northern War with Sweden (1700-1721) and finally gained control over the Neva River.

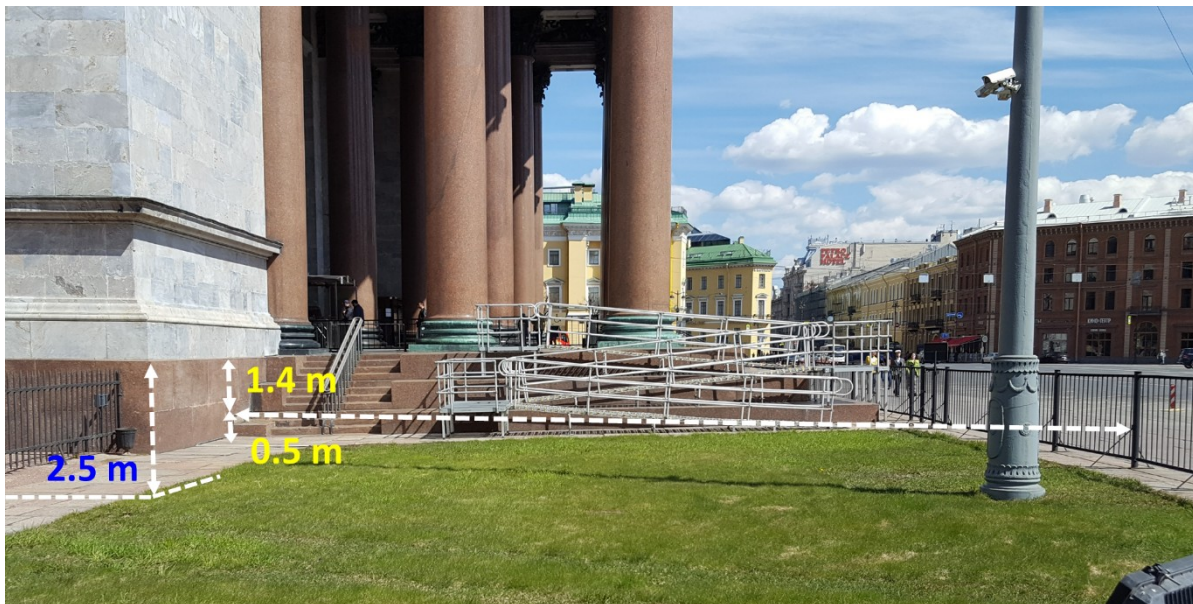
Figure 15. Settlement measurements at the southwest corner.

Settlement calculations are usually done by using the results of consolidation tests or by using the modulus of drained triaxial tests as the settlement has taken place over the last 150 years. None of this data was available to the authors. However, settlement measurements were made as follows (Fig. 15, 16): At the time of construction the 7.5-m thick mat was 2.5 m above the ground surface. Today the mat was measured to be 1.9 m above the ground surface at the southwest corner and 1.8 m above the ground surface at the northwest corner. This indicates that the Cathedral has sunk 0.6 and 0.7 m at those corners respectively. Furthermore, the ground surface at the base of the Cathedral is lower than the street level by 0.5 m at the southwest corner and 0.35 m at the northwest corner. These simple measurements allow one to conclude that the total settlement of the Cathedral is of the order of 1 m.
