# Geobarrier System for Protection Against Rainfall-induced Slope Failure

Reference: Rahardjo, H., Satvanaga, A., Gofar, N., Leong, E.C., Kew, J.H., Wang, C.L. and Wong, J.L.H. (2019). Geobarrier System for Protection Against Rainfall-induced Slope Failure. *International Journal of Geoengineering Case Histories*, Vol.5, Issue 1, p. 26 - 42. doi: 10.4417/IJGCH-05-01-03

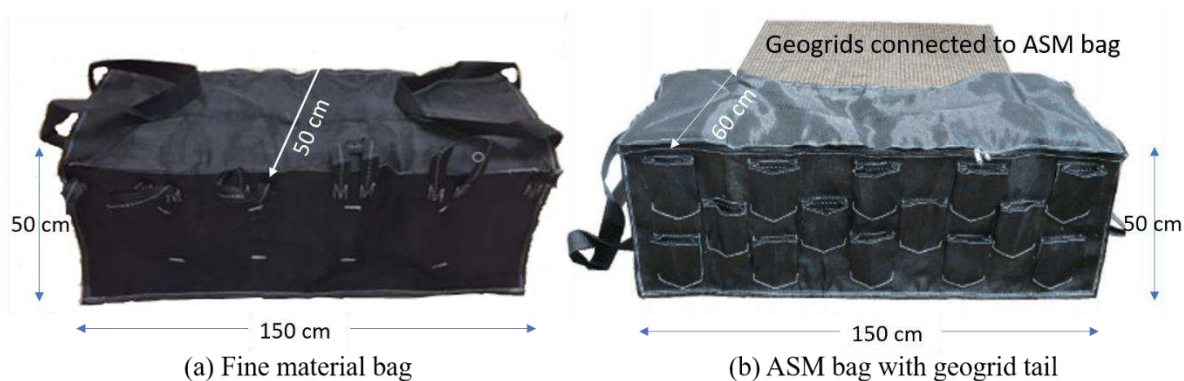
Figure 2 shows the geobags used for fine-grained material and ASM. The dimension of ASM geobag is 0.6 m width  $\times$  0.5 m height  $\times$  1.5 m length while the dimension of the geobag for the fine-grained material is 0.5 m width  $\times$  0.5 m height  $\times$  1.5 m length. The ASM bag is supported by specially designed pockets for planting different types of plants. The ASM bag is also connected to geogrids used as a reinforcing element. The bi-axial geogrids should be made from high-quality polyester yarn fibres with high tensile strength with a design life of 120 years and a tensile strength of 12 kN/m @ 2% strain and 30 kN/m @ 5% strain.

Figure 2. Geotextile bags for fine material and ASM.

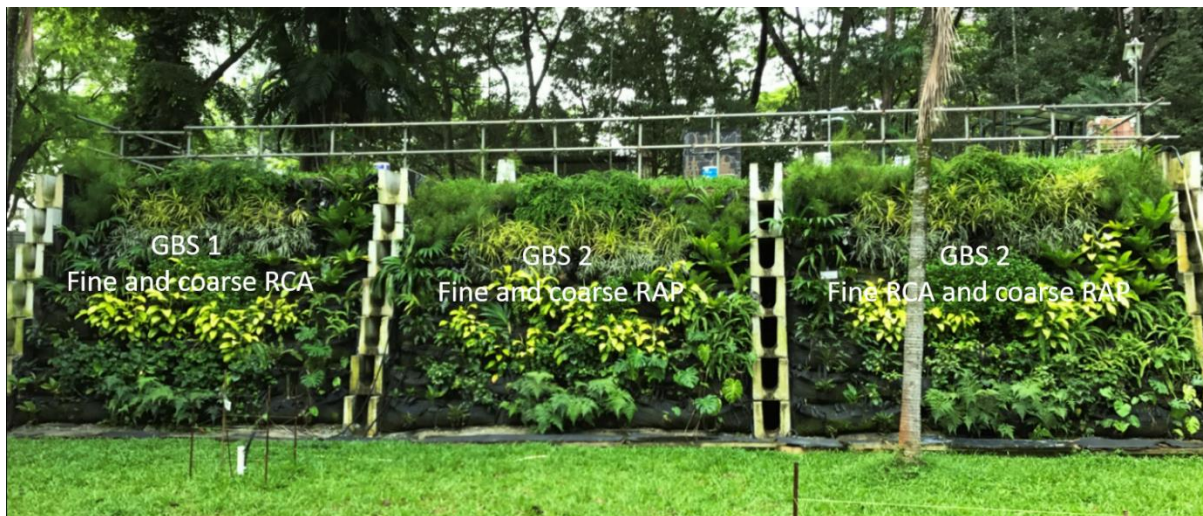
Three GBSs were constructed at Orchard Boulevard in Singapore with a slope height of 4 m and a slope angle of 70° (Figure 4). The original slope was inclined at 35°, thus the construction of the GBSs involved excavation of the slope to the designed slope angle. Preliminary site investigation indicated that the groundwater table was located at about 2 m and 6 m below the ground surface at the toe and crest, respectively. In other words, the residual soil below and behind the slope was in an unsaturated condition. The results from index properties for residual soil at Orchard Boulevard indicated that the residual soil

*Figure 4. GBS at Orchard Boulevard.*

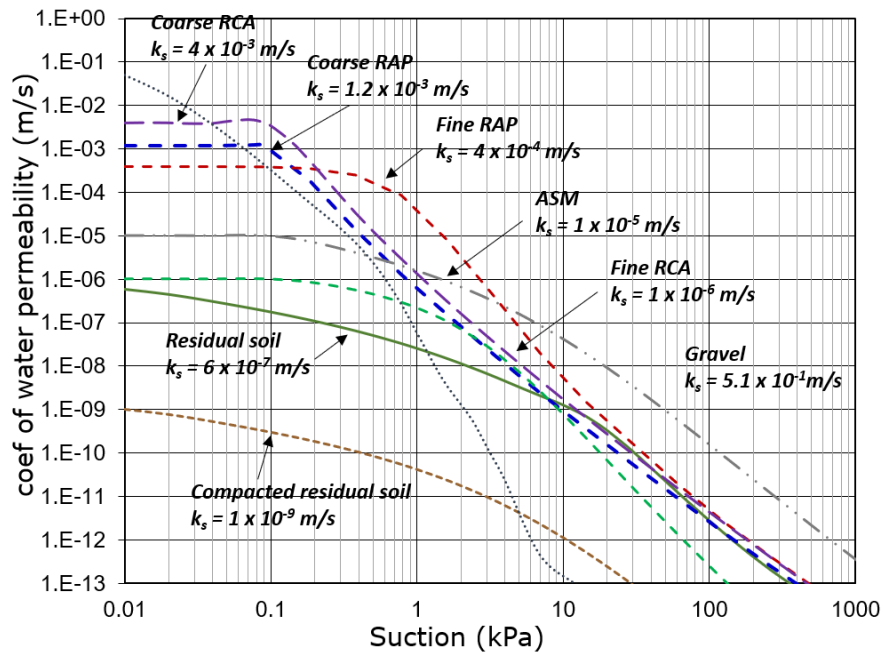
The drying and wetting SWCCs of the residual and compacted residual soils as well as the ASM and gravel are shown in Figure 13 while the drying and wetting SWCCs of the fine and coarse RCA as well as the fine and coarse RAP are shown in Figure 7. Wetting SWCCs were used in the numerical analysis to replicate the wetting process due to the extreme rainfall. In addition, Bashier et al. (2016) indicated that the use of wetting SWCC and permeability function is associated with worst scenario since the numerical analysis results predicted a higher infiltration rate. Hence, the factor of safety is the lowest if the numerical analysis incorporates wetting SWCC and permeability function. The wetting permeability function was determined from the SWCC wetting curves of all materials using a statistical method (Child and Collis-George, 1950) are shown in Figure 14.

Figure 14. Permeability functions of all materials used in GBS.
