Geobarrier System for Protection Against Rainfall-induced Slope Failure

The objective of this paper is to present a case study of a GBS system that was constructed at Orchard Boulevard, Singapore. The paper presents the overall design, and construction procedures of GBS for slope at Orchard Boulevard. Furthermore, the performance of the GBS in response to rainfall infiltration is discussed in the paper based on the field monitoring data and the results of the finite element seepage and slope stability analyses.

Reference: Rahardjo, H., Satvanaga, A., Gofar, N., Leong, E.C., Kew, J.H., Wang, C.L. and Wong, J.L.H. (2019). Geobarrier System for Protection Against Rainfall-induced Slope Failure. *International Journal of Geoengineering Case Histories*, Vol.5, Issue 1, p. 26 - 42. doi: 10.4417/IJGCH-05-01-03

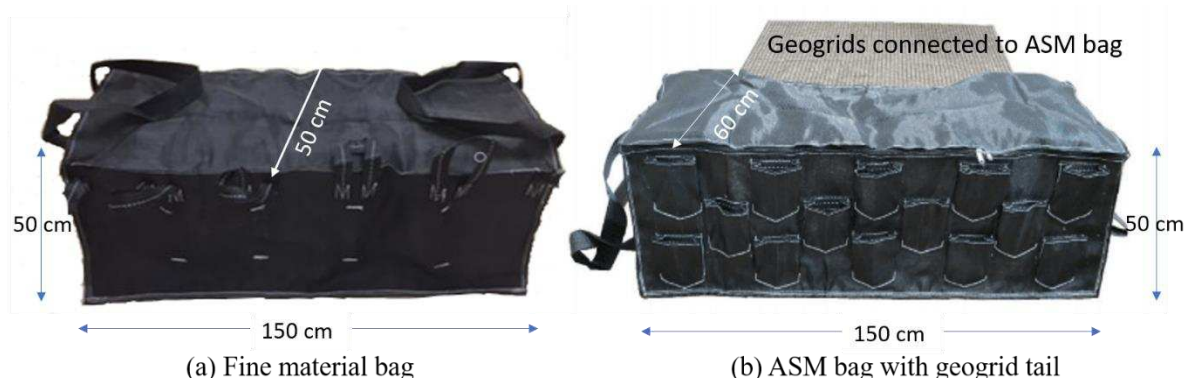
Figure 2 shows the geobags used for fine-grained material and ASM. The dimension of ASM geobag is 0.6 m width \times 0.5 m height \times 1.5 m length while the dimension of the geobag for the fine-grained material is 0.5 m width \times 0.5 m height \times 1.5 m length. The ASM bag is supported by specially designed pockets for planting different types of plants. The ASM bag is also connected to geogrids used as a reinforcing element. The bi-axial geogrids should be made from high-quality polyester yarn fibres with high tensile strength with a design life of 120 years and a tensile strength of 12 kN/m @ 2% strain and 30 kN/m @ 5% strain.

Figure 2. Geotextile bags for fine material and ASM.
