# Electrical Resistivity at Internal Erosion Locations in Levees

**ABSTRACT:** *Internal erosion through or beneath levees frequently occurs during flood events, resulting in sand boils. Determining the extent of damage from the seepage channels that caused the sand boils remains difficult, and many sand boils are simply monitored in subsequent floods. There is a need for a nondestructive methodology to map the voids caused by seepage channels so that needed repairs can be identified prior to the next flood. The objective of this study is to identify the electrical response of internal erosion pathways with electrical resistivity tomography (ERT). A case study using ERT on the Hager Slough Levee, which has experienced sand boils since the 1990s, is presented. Three ERT surveys were conducted along the levee in an area of apparent damage (i.e., crown settlement and sand boils) and where nearby boring logs were available. Laboratory resistivity tests provide support for the field ERT interpretations. The results indicate that ERT may be used to identify zones of damage within and beneath a levee. If used in practice, ERT has the potential to improve remediation of levees by identify

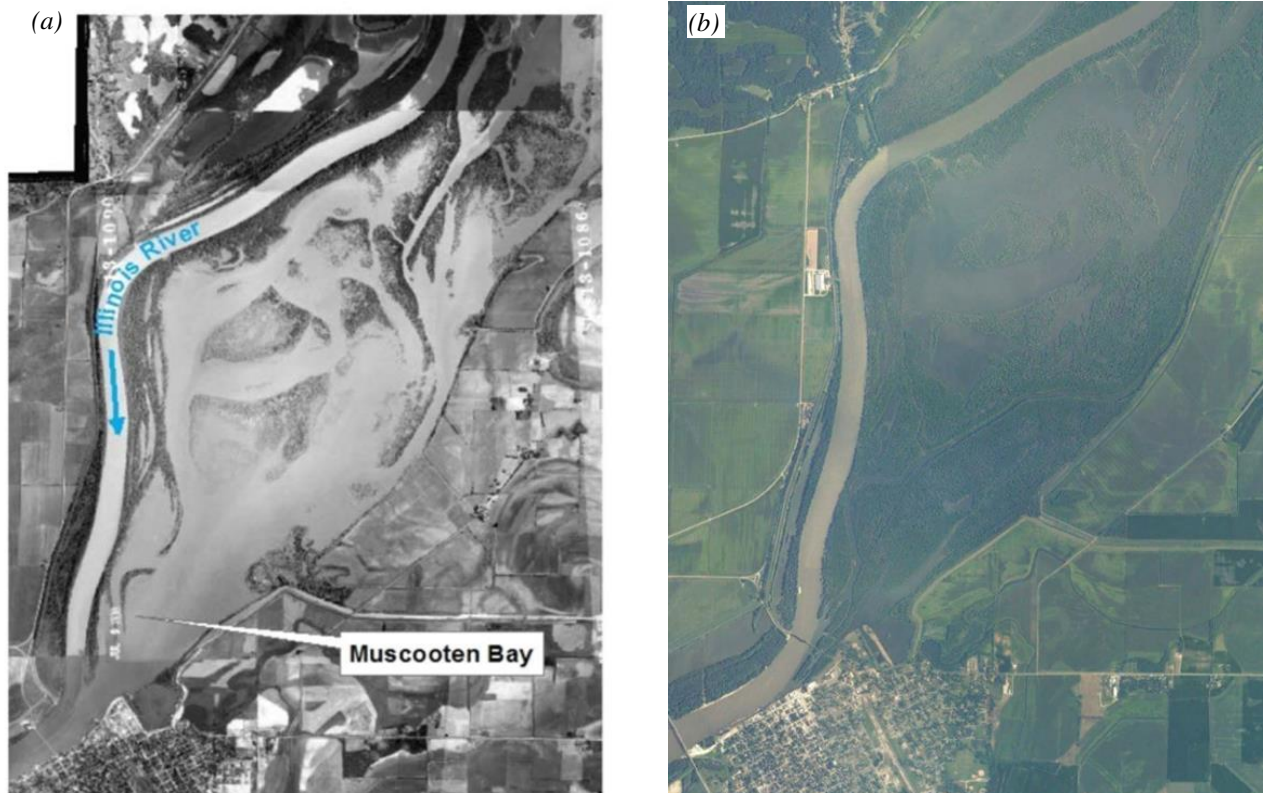
Figure 2. Sangamon River history: (a) Muscooten Bay pre-diversion (~1939); (b) Muscooten Bay post-diversion (~2011) (Bishop et al. 2015).

The historic channel of the Sangamon River was originally 101 km long with a slope of 0.09 m/km. The river was channelized, and levees were built by local farmers to create drainage for the agricultural lands surrounding the river between 1905 and 1909. In 1949, the U.S. Army Corps of Engineers (USACE) diverted the lower 9.7 km of the river south through Muscooten Bay (Figure 2). In the 1980s, the river was straightened by the USACE to help with the silting of the Beardstown marina. Currently, the river channel is only 57.9 km long with an average channel slope of 0.19 m/km (Bishop et al. 2015). As a result of the straightening of the channel and diversion, the sediment load carried by the Sangamon River has been deposited in Muscooten Bay and its adjacent areas (Lee 1982). This caused silt and sandbars to form along the riverfront of Beardstown, causing issues with boating access in the marina (Jangea 2003) and the formation of log jams along the Sangamon River (Blanchette 2016). The USACE studied the problem by modeling the watershed and sediment transport, leading to a recommended sediment management plan (Bishop et al. 2015).

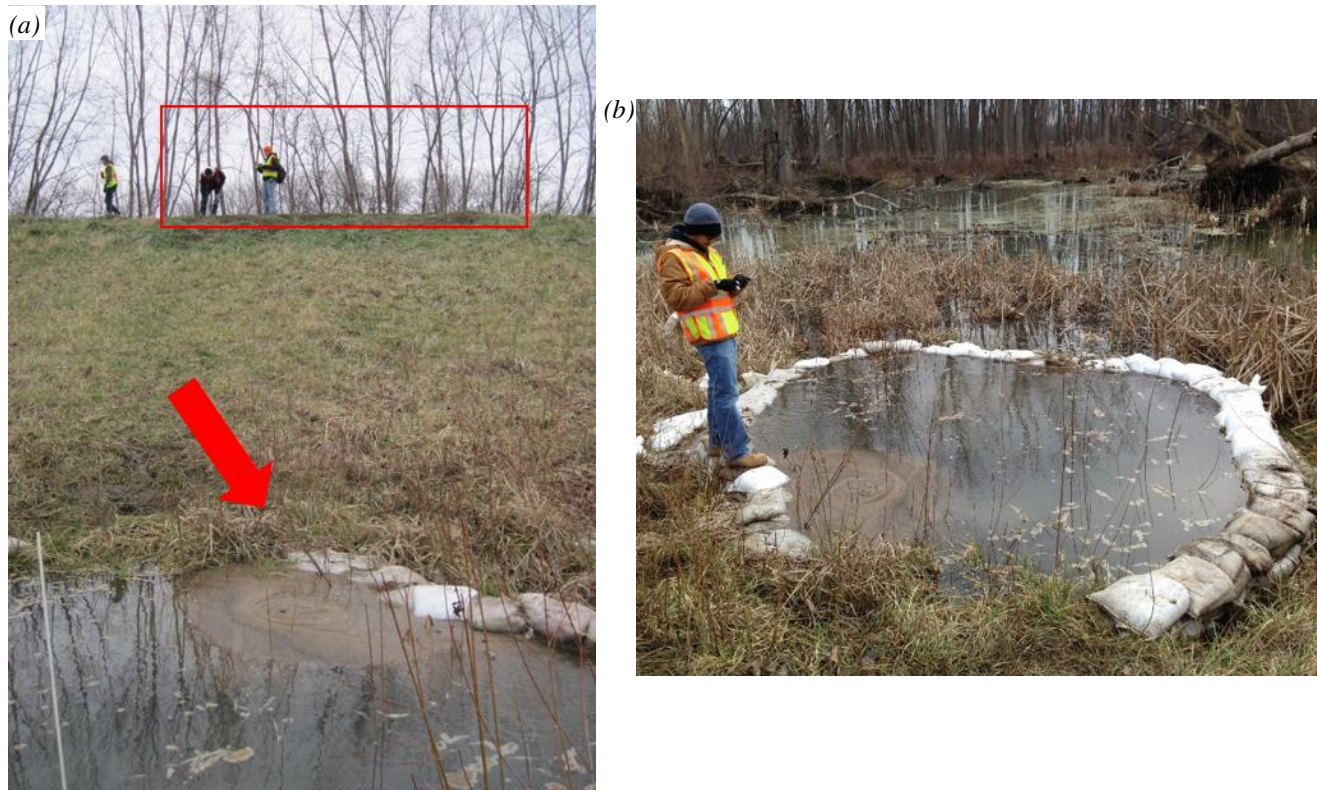
Settlement of the levee crown occurred in several locations during the 2015 flooding which required repair (repair images not available). Subsidence of the levee crown in these locations was observed to be adjacent to sand bag rings (Figure 5), suggesting that the subsidence was due to material loss. The objective of the geophysical investigation described in this study was to evaluate if ERT can be used as an imaging technique to detect zones of material loss within the levee. Such a system would enable improvement of remediation methodologies following flood events where sand boils occur. ERT may also be used to evaluate if a levee is damaged internally despite the lack of external physical evidence (e.g., sand boils). Following this introduction are a brief background on ERT and the research methodology. The ability of ERT to identify material removal has been investigated by performing a series of ERT surveys and supported with soil borings and a laboratory electrical resistivity measurement of the material in the sand boils. A discussion of the field and laboratory results is presented, including limitations of this case history, followed by conclusions and recommendations.

Figure 5. December 2015 flood reconnaissance: (a) settlement of crown with active sand boil at toe of levee, (b) active sand boil with sand bag ring (Rutherford et al. 2016).

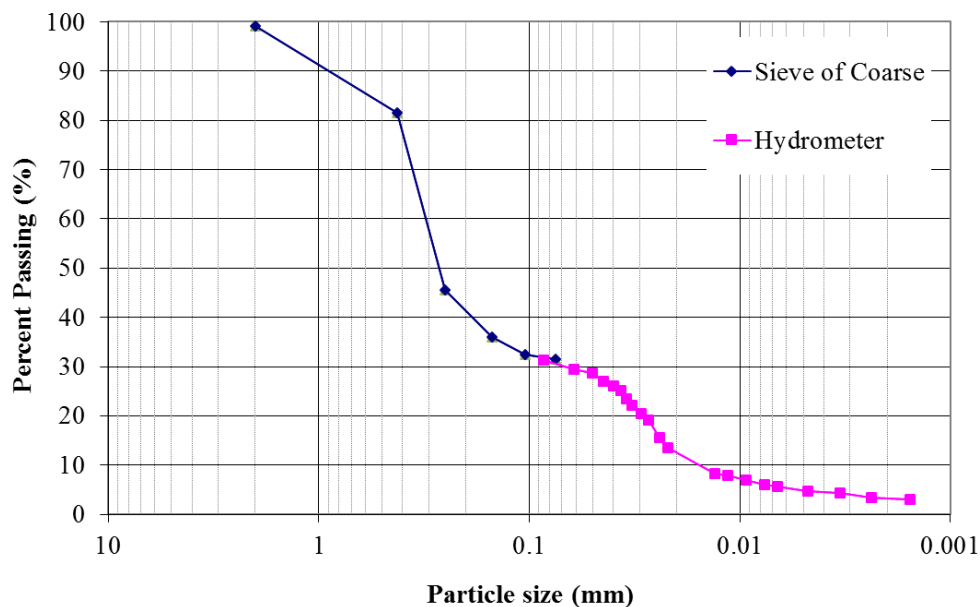
Sample B1 classified as a silty sand (SM) based on the USCS classification (ASTM D2487 2011); however, there was no SM identified in the soil borings by the USACE. Determination of the percent fines by washing (ASTM D1140 2017), particle size analysis of the coarse fraction by sieve (ASTM D6913 2017), and particle size analysis of the fine-grained fraction by hydrometer (ASTM D7928 2017) were conducted to determine whether this soil was a mixture of the sand fill and clay levee material shown in the boring log or a foundation soil located deeper than what was captured in the USACE boring. Figure 11 shows the particle size distribution curve for sample B1. The soil contained approximately 68% sand particles and 32% fine-grained particles passing the No. 200 sieve, of which approximately 3.5% were clay sized particles (i.e., < 0.002 mm). This soil was comprised of approximately 28% silt sized particles. The large fraction of silt size particles and the fact that a silty soil was not identified on the boring log suggested that the soil came from locations deeper than what was captured by the available boring. The low percentage clay fraction obtained also indicated that this soil was a different soil altogether and was not a mixture of the sand and clay soils resulting in a SM classification. The liquid limit and plastic limit of sample B1 were determined to both be 19 (following ASTM D4218 2017), resulting in a non-plastic designation for the fines.

Figure 11. Particle size distribution for sample B1 retrieved from Sand Boil 1.
