Electrical Resistivity at Internal Erosion Locations in Levees

Reference: Tucker-Kulesza, S., Rutherford, C. and Bernhardt-Barry, M. (2019). Electrical Resistivity at Internal Erosion Locations in Levees. *International Journal of Geoenvironmental Engineering Case Histories*, Vol.5, Issue 2, p. 55 - 69. doi: 10.4417/IJGCH-05-02-01

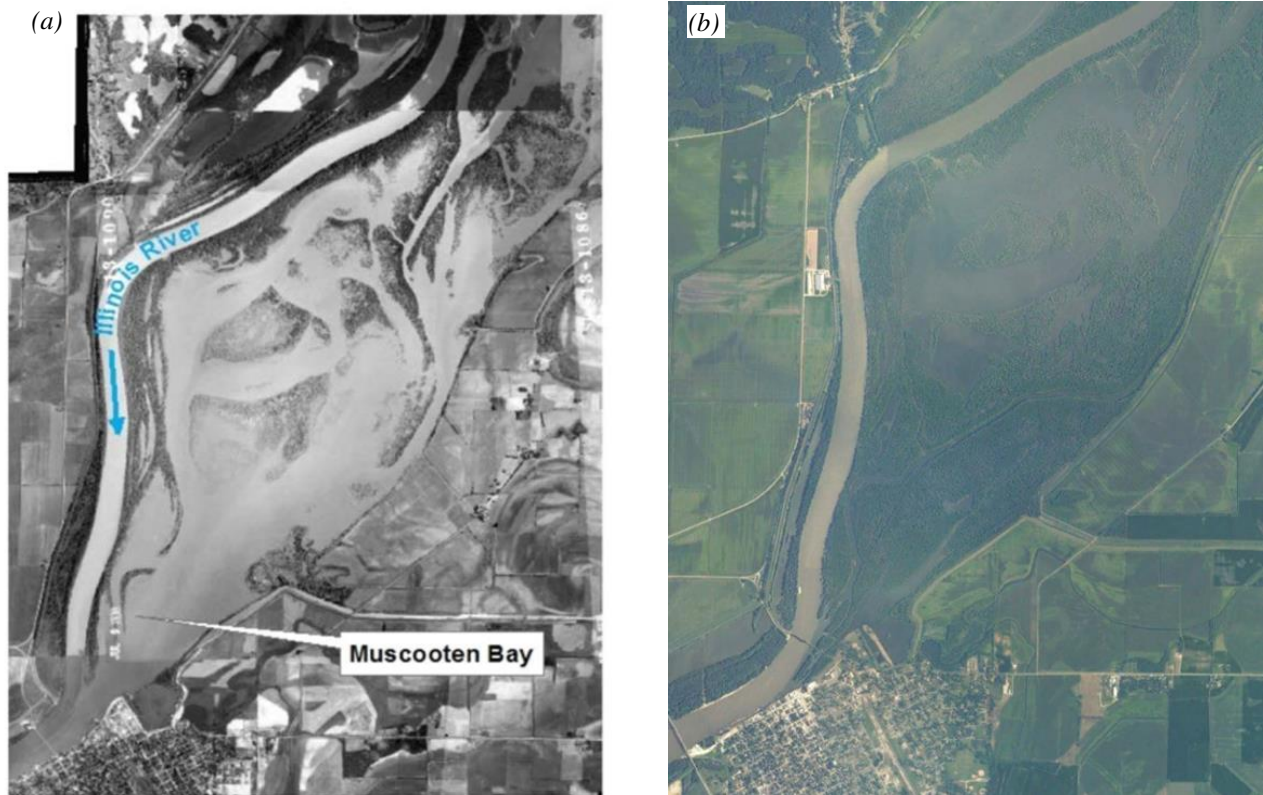
The historic channel of the Sangamon River was originally 101 km long with a slope of 0.09 m/km. The river was channelized, and levees were built by local farmers to create drainage for the agricultural lands surrounding the river between 1905 and 1909. In 1949, the U.S. Army Corps of Engineers (USACE) diverted the lower 9.7 km of the river south through Muscooten Bay (Figure 2). In the 1980s, the river was straightened by the USACE to help with the silting of the Beardstown marina. Currently, the river channel is only 57.9 km long with an average channel slope of 0.19 m/km (Bishop et al. 2015). As a result of the straightening of the channel and diversion, the sediment load carried by the Sangamon River has been deposited in Muscooten Bay and its adjacent areas (Lee 1982). This caused silt and sandbars to form along the riverfront of Beardstown, causing issues with boating access in the marina (Jangea 2003) and the formation of log jams along the Sangamon River (Blanchette 2016). The USACE studied the problem by modeling the watershed and sediment transport, leading to a recommended sediment management plan (Bishop et al. 2015).

Figure 2. Sangamon River history: (a) Muscooten Bay pre-diversion (~1939); (b) Muscooten Bay post-diversion (~2011) (Bishop et al. 2015).
