# Electrical Resistivity at Internal Erosion Locations in Levees

Reference: Tucker-Kulesza, S., Rutherford, C. and Bernhardt-Barry, M. (2019). Electrical Resistivity at Internal Erosion Locations in Levees. International Journal of Geoenvironment Case Histories, Vol.5, Issue 2, p. 55 - 69. doi: 10.4417/IJGCH-05-02-01

The objective of this paper is to identify the electrical response of suspected internal erosion pathways with electrical resistivity tomography (ERT), a near-surface geophysical method. A case study using ERT on the Hager Slough Levee, which has experienced issues with seepage and sand boils since the 1990s, is presented. Soil boring logs taken in the area and laboratory electrical resistivity tests on samples collected from the sand boils provide support for the field electrical resistivity interpretations.

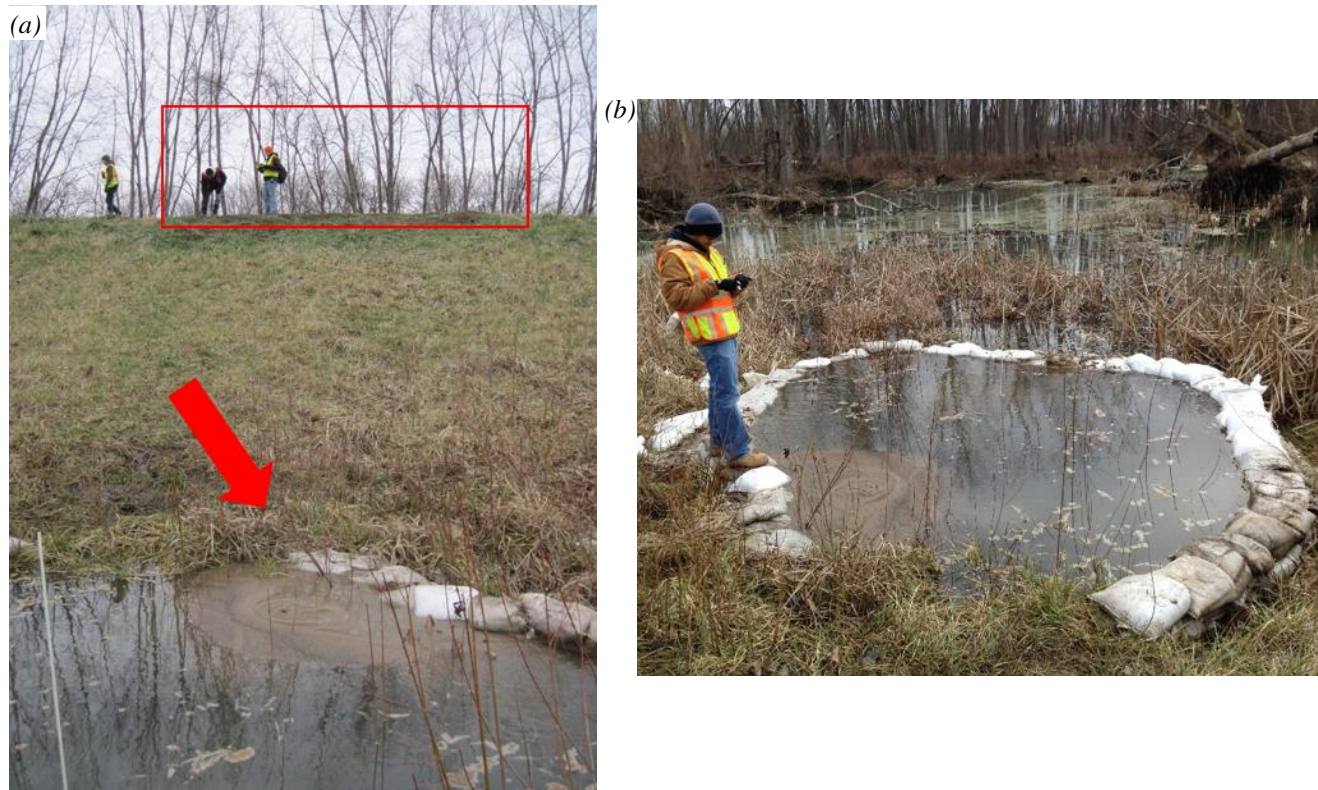
Figure 5. December 2015 flood reconnaissance: (a) settlement of crown with active sand boil at toe of levee, (b) active sand boil with sand bag ring (Rutherford et al. 2016).

Settlement of the levee crown occurred in several locations during the 2015 flooding which required repair (repair images not available). Subsidence of the levee crown in these locations was observed to be adjacent to sand bag rings (Figure 5), suggesting that the subsidence was due to material loss. The objective of the geophysical investigation described in this study was to evaluate if ERT can be used as an imaging technique to detect zones of material loss within the levee. Such a system would enable improvement of remediation methodologies following flood events where sand boils occur. ERT may also be used to evaluate if a levee is damaged internally despite the lack of external physical evidence (e.g., sand boils). Following this introduction are a brief background on ERT and the research methodology. The ability of ERT to identify material removal has been investigated by performing a series of ERT surveys and supported with soil borings and a laboratory electrical resistivity measurement of the material in the sand boils. A discussion of the field and laboratory results is presented, including limitations of this case history, followed by conclusions and recommendations.
