Forensic Analysis of Levee Failures: The Breitenhagen Case

ABSTRACT: *Forensic analysis of past failures is valuable to improve our understanding of levee behavior. In this article a new systematic approach of forensic analysis for levee failures is proposed and applied to the Breitenhagen levee breach that occurred along the river Saale in Germany in 2013. The purpose of this study is to identify the cause of the breach based on the proposed approach, even though limited data is available. Based on the information prior, during and after the breach of the levee, a slope stability model is developed for the entire event. First, results from this model are obtained based on the expected values of the uncertain parameters and the best estimates of the situation. Uncertainty of the model is included in the calculation subsequently by defining possible failure scenarios. The most likely failure scenarios are derived from the data and included into the model so that it is possible to eliminate or validate all possible causes by means of a sensitivity calculation. It is concluded that the levee breach is likely caused by locally weak soil conditions, unexpected high water pressures due

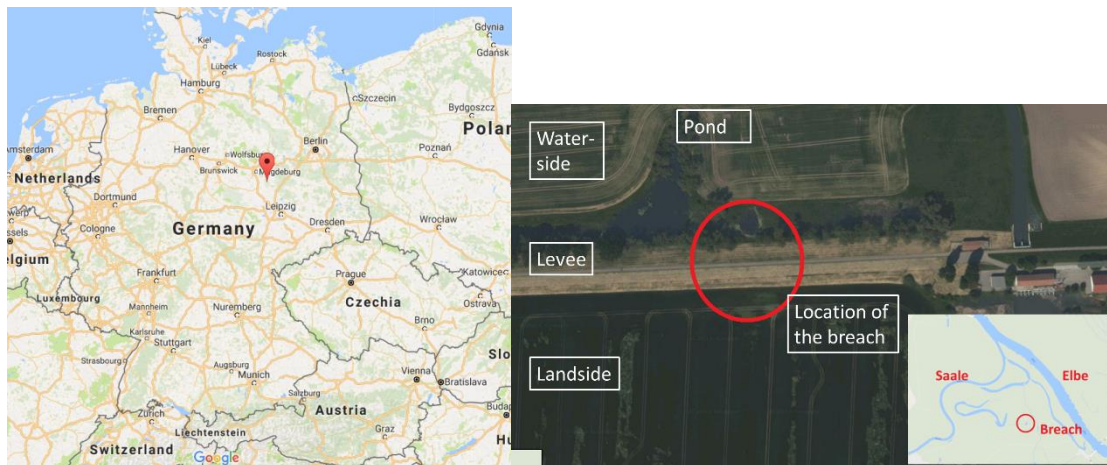
Figure 2. Overview of the location of the breach (GeoBasis-DE/BKG, 2009).

The data collected prior to the breach provide an indication of the condition of the levee prior to the breach. The overview photo shows a pond in front of the levee possibly caused by an earlier breach (Figure 2). This indicates the possibility of a direct connection between the outside water level and the aquifer below the levee. The photos show a row of trees at the riverside toe of the levee which might influence the conductivity of the levee due to the intrusion of the roots inside the levee, or might indicate the presence of a more conductive layer inside the levee (Figure 2). The slope of the levee is very steep (about 1:2.1 vertical to horizontal) with a gradient that exceeds the friction angle of most soil types. The slope at the landside is prone to instability (Figure 5).

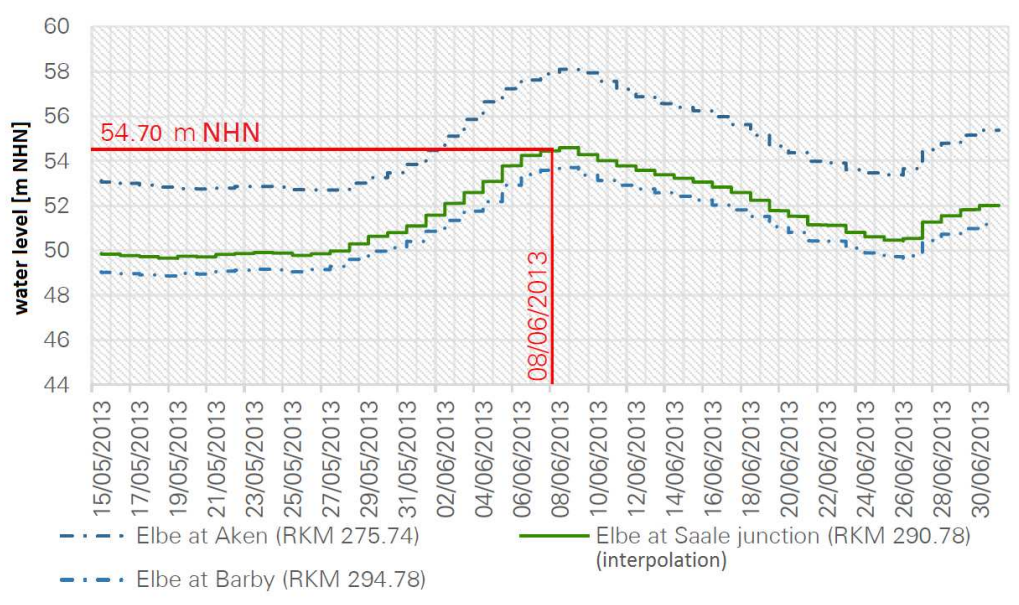
Figure 3. Graphs with water levels over time of the Elbe and Saale near Aken and Barby. Water level at Elbe and Saale junction, RKM 290.8, is NHN+54.7 m (Drews, 2017; Grubert, 2013)

In the summer of 2013 both the Elbe and the Saale river experienced high water levels due to heavy rainfall upstream. The peaks of the high water levels met each other at the intersection of the Saale and the Elbe near Breitenhagen. The actual water height was not measured at the location of the breach, but the water levels were measured at the nearest upstream and downstream measurement station and the levels at Breitenhagen were interpolated (Figure 3) (Drews, 2017). The elevation of the (water) level is expressed as a standard reference level called the NormalHohenNull (NHN) which is approximately equal to mean sea level. The breach occurred just at the moment that the water levels in both rivers reached their peak on June 8th, 2013. It appeared that the water levels of 2013 were the highest water levels ever measured in both the Saale and the Elbe (Drews, 2017). Both water levels have a return period of 100 to 200 years (Drews, 2017; Elbe, 2014).

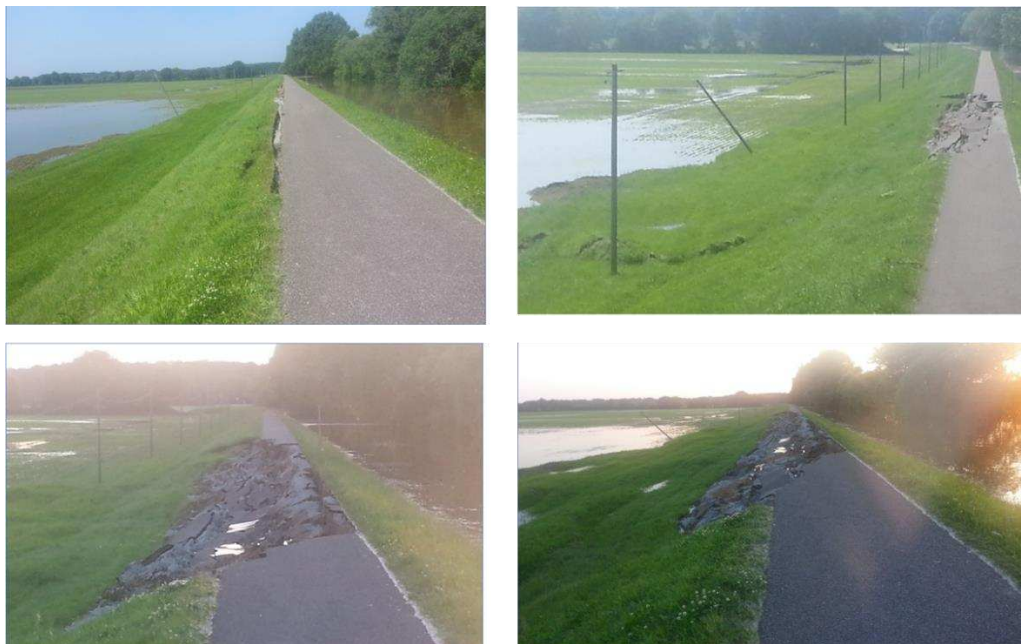
Figure 6. Photo series over time (upper left: 08.06.2013-10:37, initial break at the edge of the slope, upper right: 08.06.2013-14:10, horizontal shifts, bulge of the toe, lower left: 08.06.2013-20:51 continuing failure, lower right, 08.06.2013-20:55, continuing failure with the visual predictors (Grubert, 2013). Riverside of the levee is on the right for all photos.

Photo data were collected during the breaching process as well, showing recognizable indications of the levee failure. The indicators were used to identify the deformations and the geometry of the slip circle (Figure 6). Also, ponding due to possible seepage of water at the landside is shown. Possible high water pressures in the aquifer may cause seepage and saturation of the soil at the landside of the levee.

On the left side of the picture an electricity pole is recognized which seems to tilt over time, until it is almost completely horizontal (Figure 6). Also the slip circle is expanding until the road is completely damaged indicating an increasing deformation over time. The initial failure is considered to have weakened the levee to such a level that the levee lost all its retaining capacity.

Introducing undrained soil behavior for the clay, scenario D, results in FoS between 1.66 and 1.28. The slip circle of the actual failure (Figure 6) and the calculated slip circle (for example with the use of Bishop with undrained soil behavior and Spencer with drained soil behavior) differ in geometry. The slip circle of the Spencer method seems to show more realistic geometry of slip circle than the Uplift Van method and Bishop’s method in case of low effective soil pressures at the interface between sand and clay (Figure 14).
