Forensic Analysis of Levee Failures: The Breitenhagen Case

ABSTRACT: *Forensic analysis of past failures is valuable to improve our understanding of levee behavior. In this article a new systematic approach of forensic analysis for levee failures is proposed and applied to the Breitenhagen levee breach that occurred along the river Saale in Germany in 2013. The purpose of this study is to identify the cause of the breach based on the proposed approach, even though limited data is available. Based on the information prior, during and after the breach of the levee, a slope stability model is developed for the entire event. First, results from this model are obtained based on the expected values of the uncertain parameters and the best estimates of the situation. Uncertainty of the model is included in the calculation subsequently by defining possible failure scenarios. The most likely failure scenarios are derived from the data and included into the model so that it is possible to eliminate or validate all possible causes by means of a sensitivity calculation. It is concluded that the levee breach is likely caused by locally weak soil conditions, unexpected high water pressures due

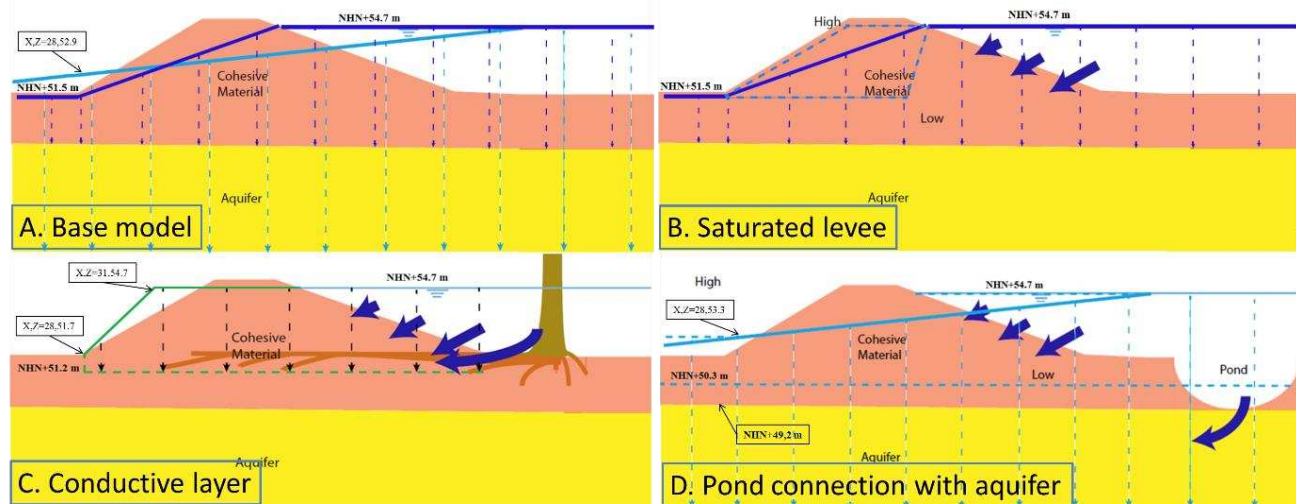
Figure 10. View of the four possible scenarios derived from the data analysis. Scenario A: Best estimate of phreatic line inside the levee (solid dark blue) and best estimate hydraulic head in the aquifer (solid light blue), called "Base model". The river head (NHN+54.7m) and locally heightened polder head (NHN+51.5m). Scenario B: Infiltration of water through the levee slope which is called "Saturated levee" (dashed light blue lines); Scenario C: Infiltration through a conductive layer related to the tree roots which is called "Conductive layer, indicated by the tree roots" (situated at NHN+51.2m) (the hydraulic head in green is the head at the location of the roots, the phreatic line is the same as the Base model. Inside the levee, water pressures in the levee are interpolated between the phreatic line and the green line); and Scenario D: Infiltration through the connection between the outside water level and the aquifer which is called "Pond connection with aquifer" (polder head of NHN+51.5m) with an upper and lower head (dashed light blue lines);.

In the scenario of the “Saturated levee” (scenario B), the only phenomenon that is taken into account is the development of the phreatic line in the levee body (Figure 10). The development of the phreatic line in the levee itself is caused by the infiltration of the high water wave from the river in the levee body. Due to the low permeability of the cohesive material, the infiltration of the water in the levee is a relatively slow process. The intrusion length of the high water wave is limited by the width of the levee. The extreme low and high boundary of the phreatic line are based on standard phreatic models to represent infiltration (upper extreme boundary) and transient (lower extreme boundary) flow are suggested by literature (TAW, 2004). The models incorporate the influence of the dominant factors that influence the phreatic lines, i.e. infiltration and groundwater flow in order to simulate the transient flow and the different possibilities of steady state flow.

In the scenario of the “Conductive soil” (scenario C.), the roots inside the levee indicate a more conductive layer due to a relatively large permeability (Figure 10). Therefore, the intrusion length of the water wave is increased in this layer. This causes a local increase in water pressure. Moreover, the velocity of the high water pressure wave in the conductive layer is relatively fast compared to the levee body. In this area, the water potential equals the outside water level. At the inside toe of the levee, the potential inside the rooted area is limited by the covering soil. The analysis of Scenario C. is executed as a direct relation to Scenario B. to show its influence on the upper, mean and lower bound of the phreatic line. The water pressure inside the levee is interpolated between the phreatic line and the hydraulic head inside the conductive soil layer.

In the scenario of the “Pond connection with aquifer” (scenario D), the pond in front of the levee might introduce a connection between the aquifer layer and the outside water level (Figure 10). This causes a local increase in water pressure in the aquifer compared to the water pressure corresponding to the phreatic line. Because of a relatively large leakage length of the outside water level, the water pressures inside the aquifer might cause a shear strength reduction at the landside. The weight of the blanket layer limits the hydraulic head in the aquifer. The water pressure inside the levee and the blanket layer is interpolated between the phreatic line and the (limited) hydraulic head at the interface between sand and clay.
