Forensic Analysis of Levee Failures: The Breitenhagen Case

ABSTRACT: *Forensic analysis of past failures is valuable to improve our understanding of levee behavior. In this article a new systematic approach of forensic analysis for levee failures is proposed and applied to the Breitenhagen levee breach that occurred along the river Saale in Germany in 2013. The purpose of this study is to identify the cause of the breach based on the proposed approach, even though limited data is available. Based on the information prior, during and after the breach of the levee, a slope stability model is developed for the entire event. First, results from this model are obtained based on the expected values of the uncertain parameters and the best estimates of the situation. Uncertainty of the model is included in the calculation subsequently by defining possible failure scenarios. The most likely failure scenarios are derived from the data and included into the model so that it is possible to eliminate or validate all possible causes by means of a sensitivity calculation. It is concluded that the levee breach is likely caused by locally weak soil conditions, unexpected high water pressures due

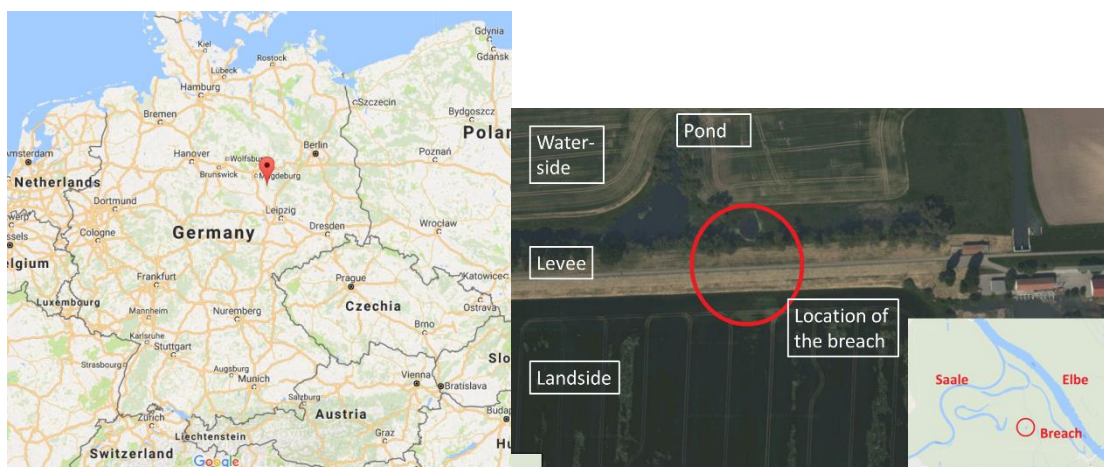
Figure 2. Overview of the location of the breach (GeoBasis-DE/BKG, 2009).

The data collected prior to the breach provide an indication of the condition of the levee prior to the breach. The overview photo shows a pond in front of the levee possibly caused by an earlier breach (Figure 2). This indicates the possibility of a direct connection between the outside water level and the aquifer below the levee. The photos show a row of trees at the riverside toe of the levee which might influence the conductivity of the levee due to the intrusion of the roots inside the levee, or might indicate the presence of a more conductive layer inside the levee (Figure 2). The slope of the levee is very steep (about 1:2.1 vertical to horizontal) with a gradient that exceeds the friction angle of most soil types. The slope at the landside is prone to instability (Figure 5).
