## Forensic Analysis of Levee Failures: The Breitenhagen Case

**ABSTRACT:** *Forensic analysis of past failures is valuable to improve our understanding of levee behavior. In this article a new systematic approach of forensic analysis for levee failures is proposed and applied to the Breitenhagen levee breach that occurred along the river Saale in Germany in 2013. The purpose of this study is to identify the cause of the breach based on the proposed approach, even though limited data is available. Based on the information prior, during and after the breach of the levee, a slope stability model is developed for the entire event. First, results from this model are obtained based on the expected values of the uncertain parameters and the best estimates of the situation. Uncertainty of the model is included in the calculation subsequently by defining possible failure scenarios. The most likely failure scenarios are derived from the data and included into the model so that it is possible to eliminate or validate all possible causes by means of a sensitivity calculation. It is concluded that the levee breach is likely caused by locally weak soil conditions, unexpected high water pressur

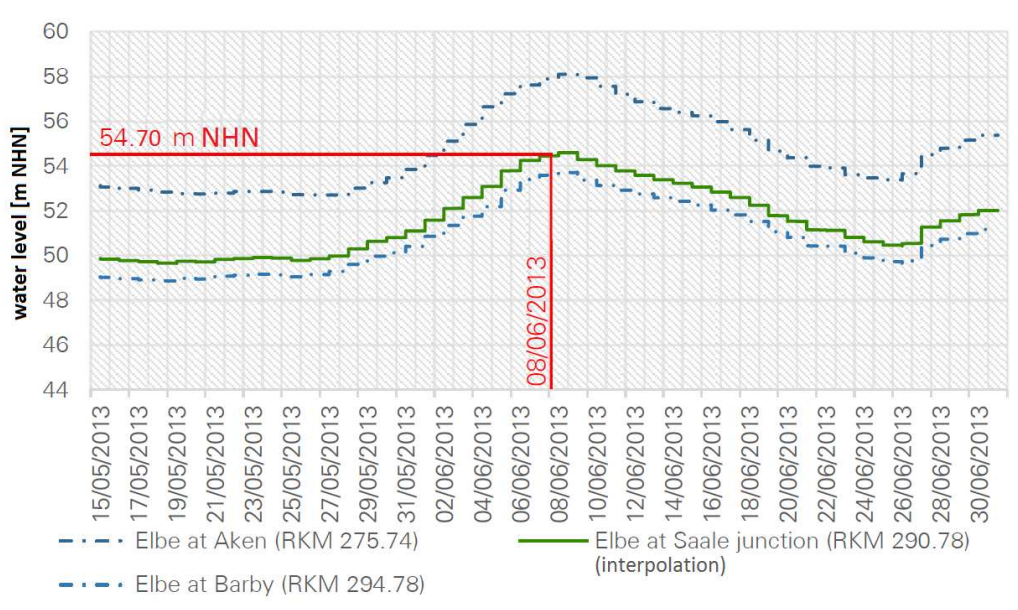
In the summer of 2013 both the Elbe and the Saale river experienced high water levels due to heavy rainfall upstream. The peaks of the high water levels met each other at the intersection of the Saale and the Elbe near Breitenhagen. The actual water height was not measured at the location of the breach, but the water levels were measured at the nearest upstream and downstream measurement station and the levels at Breitenhagen were interpolated (Figure 3) (Drews, 2017). The elevation of the (water) level is expressed as a standard reference level called the NormalHohenNull (NHN) which is approximately equal to mean sea level. The breach occurred just at the moment that the water levels in both rivers reached their peak on June 8th, 2013. It appeared that the water levels of 2013 were the highest water levels ever measured in both the Saale and the Elbe (Drews, 2017). Both water levels have a return period of 100 to 200 years (Drews, 2017; Elbe, 2014).

Figure 3. Graphs with water levels over time of the Elbe and Saale near Aken and Barby. Water level at Elbe and Saale junction, RKM 290.8, is NHN+54.7 m (Drews, 2017; Grubert, 2013)

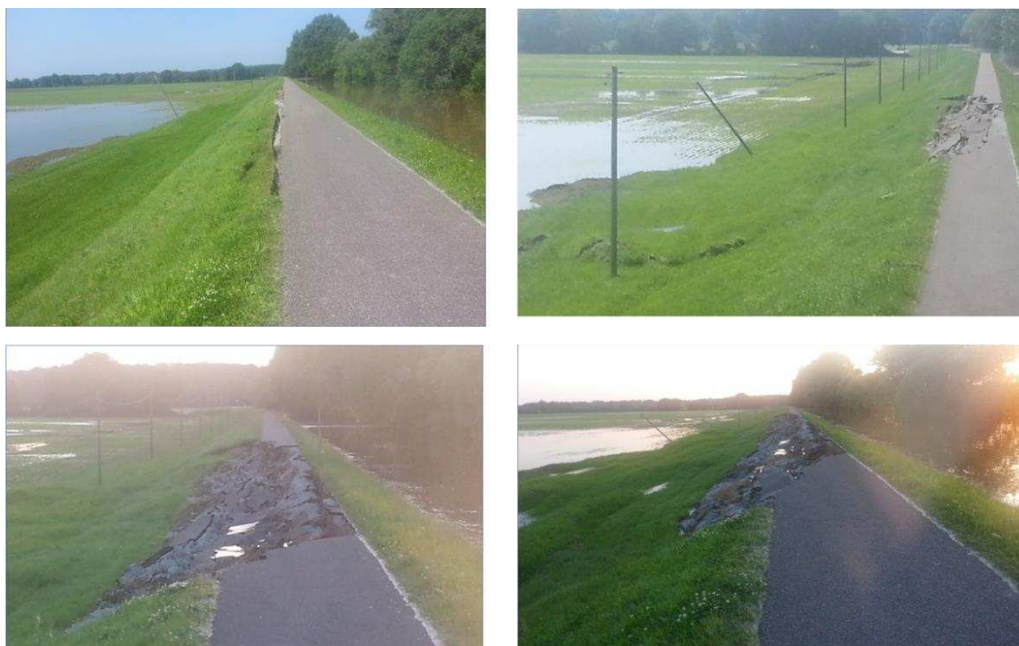
*Figure 6. Photo series over time (upper left: 08.06.2013-10:37, initial break at the edge of the slope, upper right: 08.06.2013-14:10, horizontal shifts, bulge of the toe, lower left: 08.06.2013-20:51 continuing failure, lower right, 08.06.2013-20:55, continuing failure with the visual predictors (Grubert, 2013). Riverside of the levee is on the right for all photos.*

On the left side of the picture an electricity pole is recognized which seems to tilt over time, until it is almost completely horizontal (Figure 6). Also the slip circle is expanding until the road is completely damaged indicating an increasing deformation over time. The initial failure is considered to have weakened the levee to such a level that the levee lost all its retaining capacity.
