Forensic Analysis of Levee Failures: The Breitenhagen Case

ABSTRACT: *Forensic analysis of past failures is valuable to improve our understanding of levee behavior. In this article a new systematic approach of forensic analysis for levee failures is proposed and applied to the Breitenhagen levee breach that occurred along the river Saale in Germany in 2013. The purpose of this study is to identify the cause of the breach based on the proposed approach, even though limited data is available. Based on the information prior, during and after the breach of the levee, a slope stability model is developed for the entire event. First, results from this model are obtained based on the expected values of the uncertain parameters and the best estimates of the situation. Uncertainty of the model is included in the calculation subsequently by defining possible failure scenarios. The most likely failure scenarios are derived from the data and included into the model so that it is possible to eliminate or validate all possible causes by means of a sensitivity calculation. It is concluded that the levee breach is likely caused by locally weak soil conditions, unexpected high water pressures due

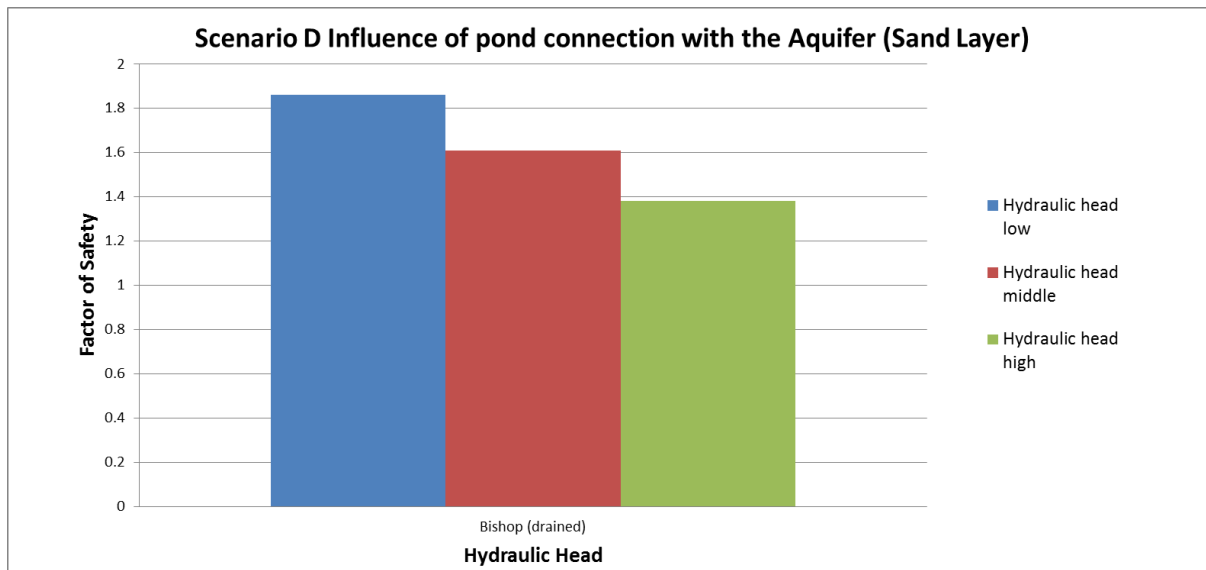
The stratigraphy shows an aquifer below the levee which might be in direct contact with the water level at the riverside by means of a pond in front of the levee (Figure 10). Similar to the phreatic line, the different water pressures in the aquifer influence the shear strength as well. For the analysis of the contribution of the aquifer to the cause of failure, the model uses three scenarios for the water pressure. The results are shown in Figure 13.

Figure 13. Influence of the rise of the hydraulic head in the aquifer with three different levels in hydraulic head in scenarios D.

Due to the rise of the hydraulic head in the aquifer, the range of the FoS overall is between 1.86 and 1.38. The shape of the slip circle shows realistic similarities with the actual slip circle. However the slip circle still intersects the levee crest instead of starting from the landside of the levee.
