Geotechnical Effects and a 6-Year Outlook of the 2012 Hurricane Sandy in the Eastern United States

ABSTRACT: Hurricane Sandy was the deadliest and most destructive event of the 2012 Atlantic hurricane season. It originated as a storm off the coast of West Africa that turned into a tropical wave in the southwestern Caribbean Sea, and then into a hurricane that moved slowly north along the United States East Coast. Numerous regional coastal communities and urban centers in New Jersey (NJ) and the New York City (NYC) metropolitan area experienced widespread flooding, extreme winds, and heavy damage that disrupted daily life and business in Lower Manhattan, the world's financial capital. Consequences with great geotechnical engineering interest include: (i) modification of the regional coastal geomorphology due to storm surge, with the birth of new inlets, erosion, scour of soil at the shorelines; (ii) damage in coastal communities that revealed the vulnerability of residential building foundations not designed according to modern flood protection standards; and (iii) interruption of service of buried structures and below ground infrastructure due to flood damage to non-structural com

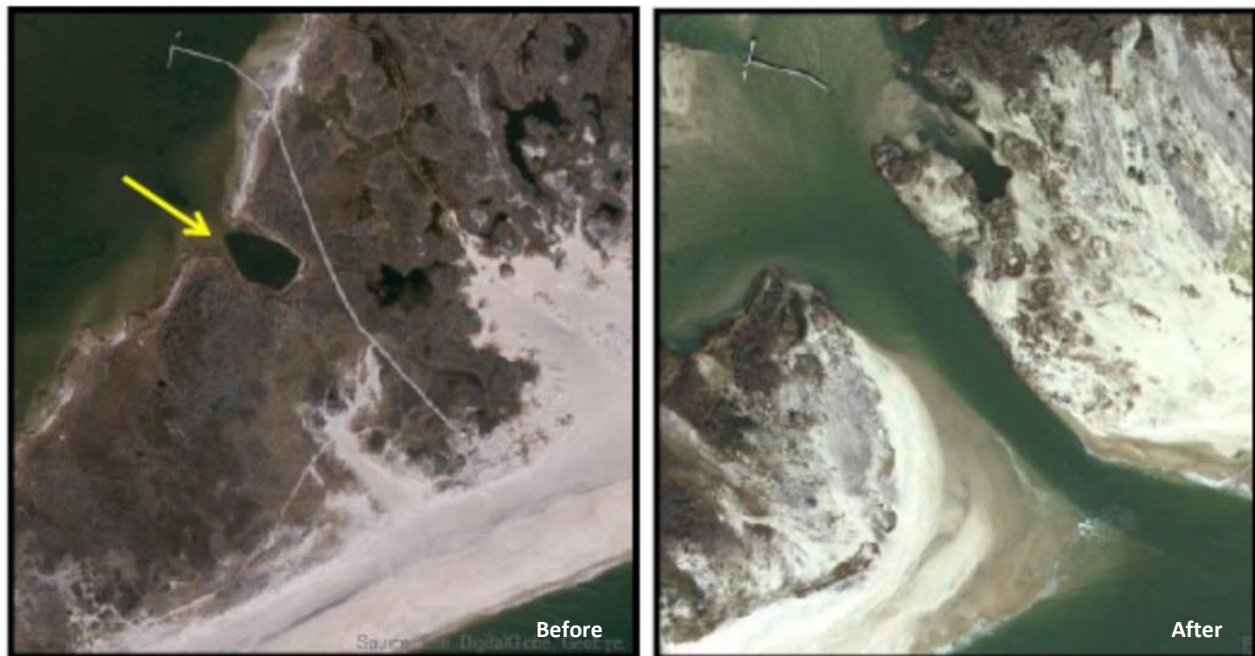
Figure 7. Fire Island, LI: New inlet with narrowing point by embayment in yellow arrow (Ref: tmappsevents.esri.com/).

The storm surge significantly modified the coastal NY/NJ geomorphology, with the birth of new inlets and severe erosion and scour of soil on the shorelines (Fig. 7). While devastating in their path, these effects were largely consistent with predictions.

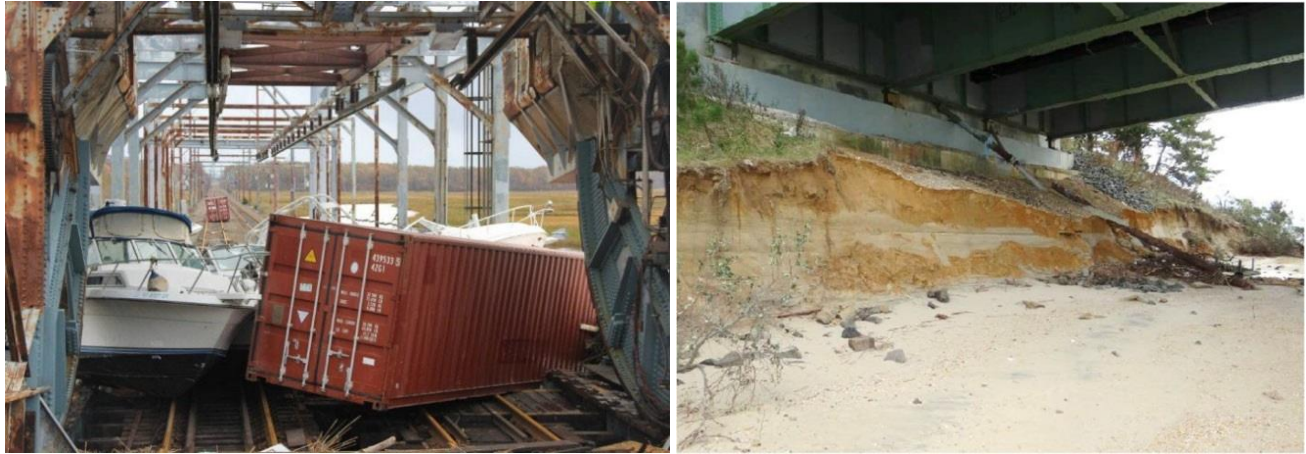
Figure 8. Morgan Drawbridge (left; NJ Transit) and Rt. 72 abutment erosion, looking south-east (right; NJDoT).

GEER observations of seven NJ bridges (NJ 35 - Cheesequake/Manasquan River Drawbridges; Railroad Drawbridge - Manasquan River; NJ 70 - Metedeconk River; NJ 37 - Mathis/Stanley Tunney; NJ 528 - Mantoloking; NJ 72 - Henderson Memorial) and data by the NJ Department of Transportation, Transit Authority, and Ocean County Engineering suggest that bridges remained mostly serviceable immediately or soon after the storm. Two primary themes of damage were identified: (i) flooding effects to drawbridges (e.g., Morgan Drawbridge, Fig. 8) and their electrical systems, and (ii) soil erosion at approaches and abutments (often supported on structures formed by fill within a perimeter soldier pile wall) in several bridges, averaging at 1.5 m (5 ft) of soil removal (e.g., Fig. 8: Rt. 72 Bridge, Fig. 9: Mathis Bridge). The exception was the Mantoloking Bridge that was unserviceable for a long period due to undermining of its abutments and approaches. Figs. 10 and 11 show large floating debris, including houses, that destroyed the T-wall, forcing the coping and sidewalk to cantilever out by about 3 m (10 ft).

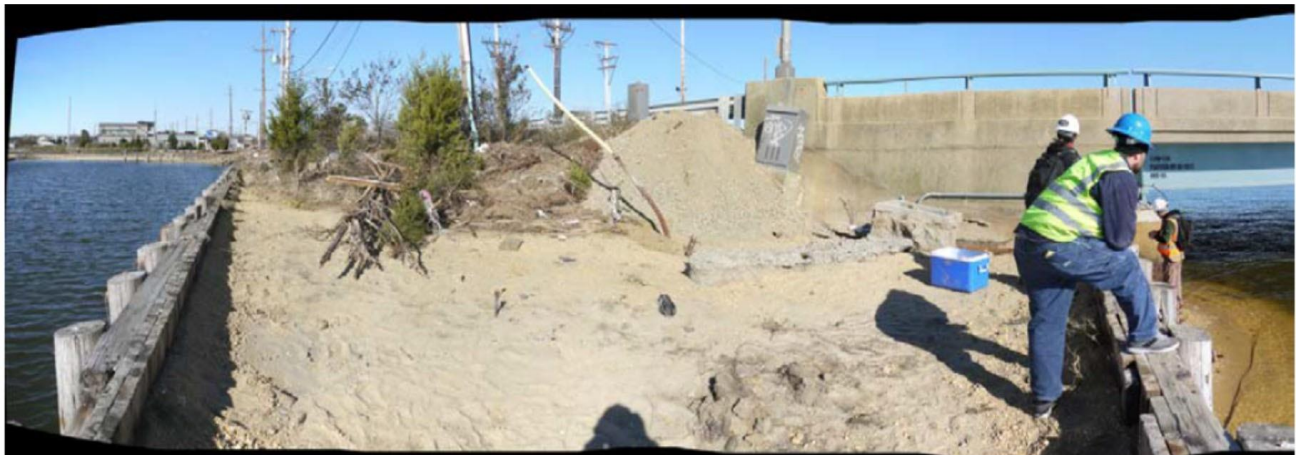
Figure 9. Erosion at Mathis Bridge southwest abutment (eastbound Rt37) ($39.949350^{\circ}\text{N}$, $74.113902^{\circ}\text{W}$; GEER 2014).

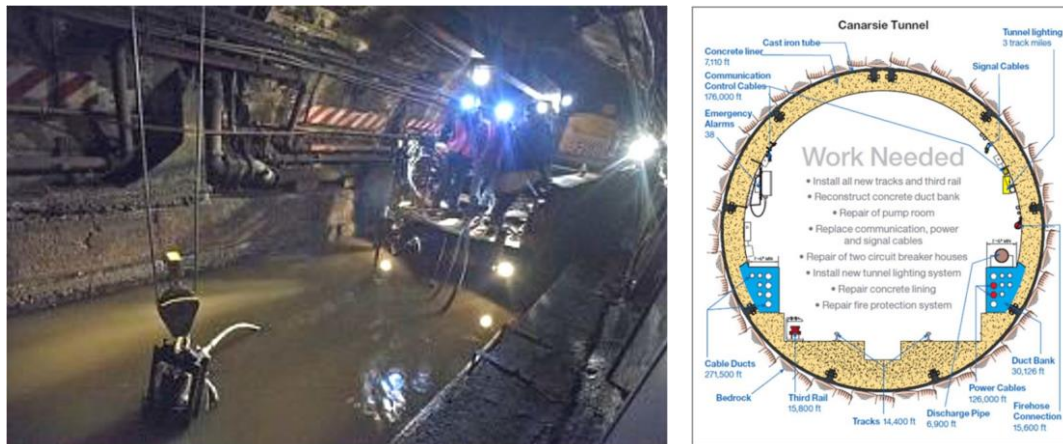
Figure 15. Canarsie tube of [L] line: damage from Sandy (left) and work needed to repair it (right) (MTA, 2017).

While most tunnels experienced minimal structural damage, utilities and ventilation systems were severely damaged and required lengthy repairs. Indicatively, the [R] Montague St. subway and the World Trade Center PATH tunnels were out of service for 2-3 months. The R line was taken out of service again in 2013 for lingering flood damage repairs. The Canarsie Tube of the [L] subway line was inundated with 265,000 m³ (7M gallons) of saltwater that caused corrosion of cabling, circuit breakers, and disabling of power/track equipment. The duct bank alongside the track, which provides walkway for emergency egress, sustained heavy damage and exhibited a partial collapse. With an initial 15-month shutdown plan, a complete overhaul is still necessary today, in 2020 (Fig. 15), as the L line is critical with a large portion of its daily 400,000 riders travelling to 14th Street stations, some of which are not easily reached by other lines. The Queens [A] Rockaway subway line was out of service for nearly seven months due to two major washouts at the earth embankment crossing Jamaica Bay, which exposed the old Long Island Rail Road (LIRR) infrastructure (Fig. 16).

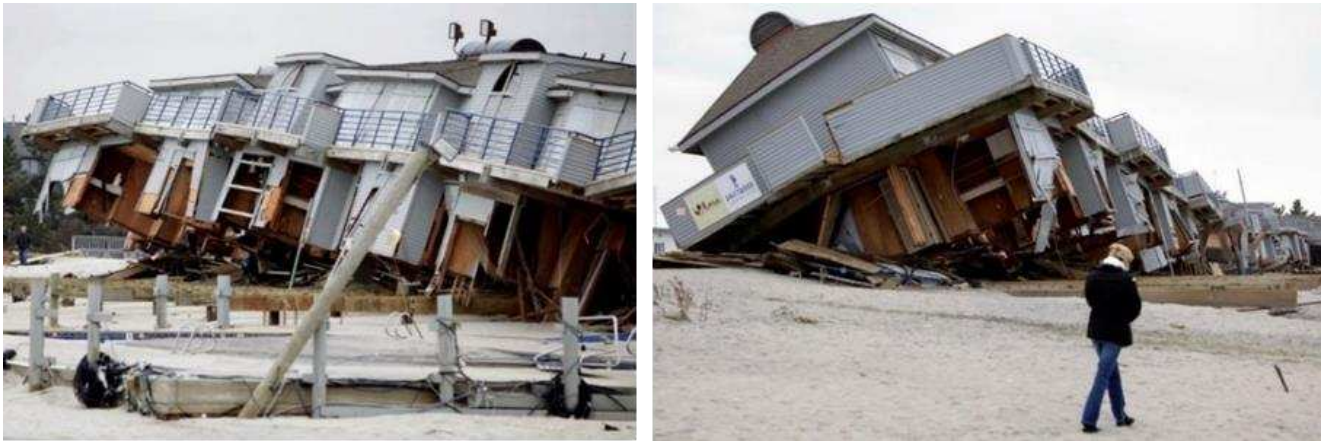
Figure 19. Sea Bright, NJ, beach cabana (40.350086°N, 73.972954°W) pulled off its base (Photo by AP/Wenig; 11/19/12).

A common damage pattern among wood frame houses was the pulling off their foundation due to inadequate anchorage (e.g., Sea Bright, NJ, Fig. 19). These house were subject to flotation, which not only causes distress, but removes dead load from foundations, making them more susceptible to breakage. Particularly, Concrete Masonry Unit (CMU) wall foundations and piers performed poorly, and were found buckled, broken, or completely removed, causing tilt, dislocation, or collapse of the superstructure (Fig. 19). In Sea Gate, Brooklyn, a concrete beachfront retaining wall foundation was undermined by erosion and subsequently broke, while the soil behind the wall was washed out (Fig. 20). In Breezy Point and Roxbury, Queens, two-story wood-frame homes, on CMU block wall and pier foundations, sustained major structural damage, including being pulled off their partially or completely destroyed foundations (Fig. 20). On the other hand, foundations of high-rise residential buildings (typically piles) generally performed well.

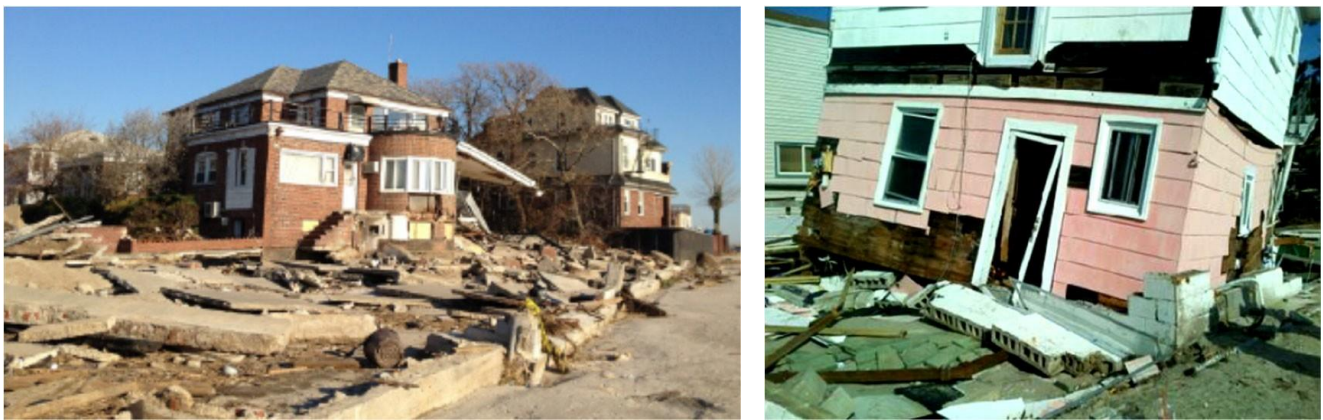
Figure 20. Undermining of beachfront retaining wall and loss of retained soil, Sea Gate, Brooklyn (left, 11/9/12); Destroyed CMU wall foundation, Breezy Point, Queens (right, 11/12/12). Photos by NYCDob (GEER, 2014).

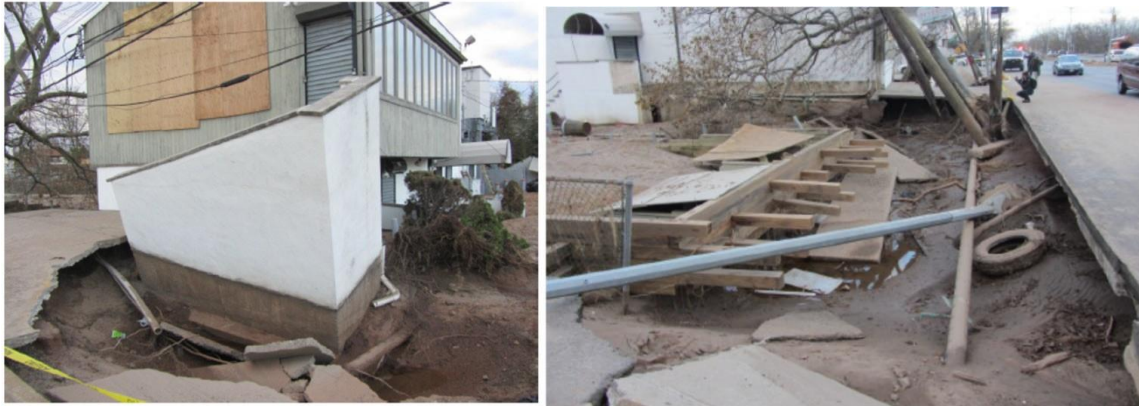
Figure 23. Scour undermining at Seaver Ave & Father Capodanno Blvd, SI (40.575944° N, 74.083015° W, 11/4/12). Damage to stair foundation and drain (left) and sidewalk, utilities, and light pole foundation (right). Photos by GEER (2014).

Severe soil erosion was observed along Father Capodanno Blvd in Midland Beach, Staten Island (SI), where sinkholes undermined the street, curb line, sidewalks, utility poles, and house foundations (Figs. 23, 24). Throughout the area, wood decks, trees, cars, and other debris had been deposited inland. Concrete wall foundations generally sustained little or no structural damage, though they sometimes experienced erosion and scour along their perimeter.

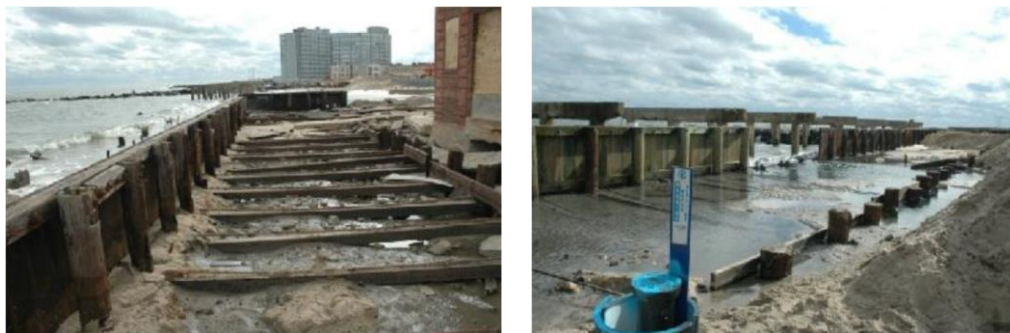
Figure 25. Bulkhead in Atlantic City, NJ: backfill soil washed away, exposing severely corroded tie rods (GEER, 2014).

along a section of the shore in Atlantic City, NJ, were breached.. The breaches were attributed to the destruction and washing away of the timber facing . The surge and water washing through the breaches exposed the tierods and anchors (Fig. 25).

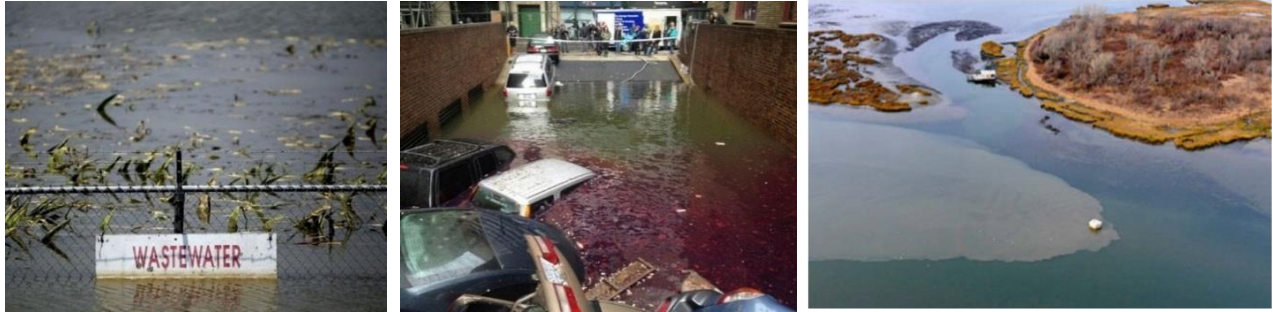
Figure 26. Untreated waste spilled in NY Harbor (left, photo Getty/Tama) and buried cars (middle, photo Bloomberg/Korby). Overflow from Bay Park Sewage Treatment Plant, East Rockaway (right, photo by D. Kuntz; Kenward et al., 2013).

to shut down or divert sewage into waterways due to power outages and flooding (e.g., Fig. 26 shows untreated waste spilled in the LI South Shore Estuary from the Bay Park Sewage Plant in East Rockaway). GEER visited the WWTP that processes waste water from Yonkers. Founded on filled land along the east bank of the Hudson River, it experienced one of the largest overflows with 4.5M m³ (1.2B gallons). The river frontage has a rip-rap revetment at the south and a steel seawall (Fig. 27) about 1.5 m (5 ft) higher than the north rip-rap. Normally, the plant handles daily 360 m³ (95M gallons) of waste water; during in Hurricane Irene in 2011, it processed 1,150 m³ (300M gallons). After Sandy, loss of gravity flow caused more than 2.8 m (9 ft) of tail water and therefore flooding of below-grade areas (Fig. 27), something that damaged equipment including boilers, the alarm system, pipes, and motors.
