Geotechnical Effects and a 6-Year Outlook of the 2012 Hurricane Sandy in the Eastern United States

ABSTRACT: Hurricane Sandy was the deadliest and most destructive event of the 2012 Atlantic hurricane season. It originated as a storm off the coast of West Africa that turned into a tropical wave in the southwestern Caribbean Sea, and then into a hurricane that moved slowly north along the United States East Coast. Numerous regional coastal communities and urban centers in New Jersey (NJ) and the New York City (NYC) metropolitan area experienced widespread flooding, extreme winds, and heavy damage that disrupted daily life and business in Lower Manhattan, the world's financial capital. Consequences with great geotechnical engineering interest include: (i) modification of the regional coastal geomorphology due to storm surge, with the birth of new inlets, erosion, scour of soil at the shorelines; (ii) damage in coastal communities that revealed the vulnerability of residential building foundations not designed according to modern flood protection standards; and (iii) interruption of service of buried structures and below ground infrastructure due to flood damage to non-structural com

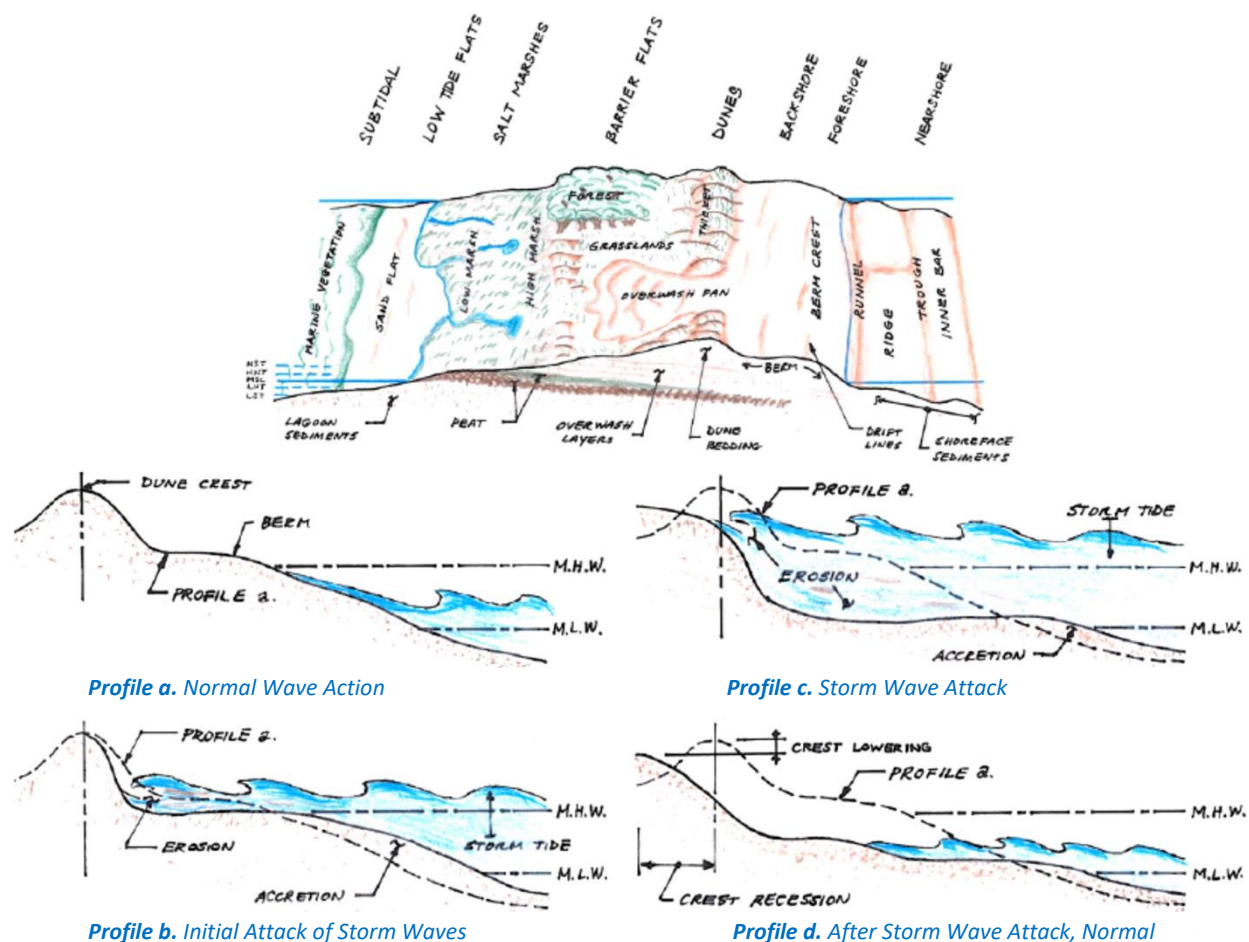
Figure 4. Barrier environments (top) and beach profile changes (bottom) in response to a coastal storm (Refs: A. Dyer from Leatherman, S.P., 1979; Godfrey, 1976; and U.S. Army Corps of Engineers, 1974).

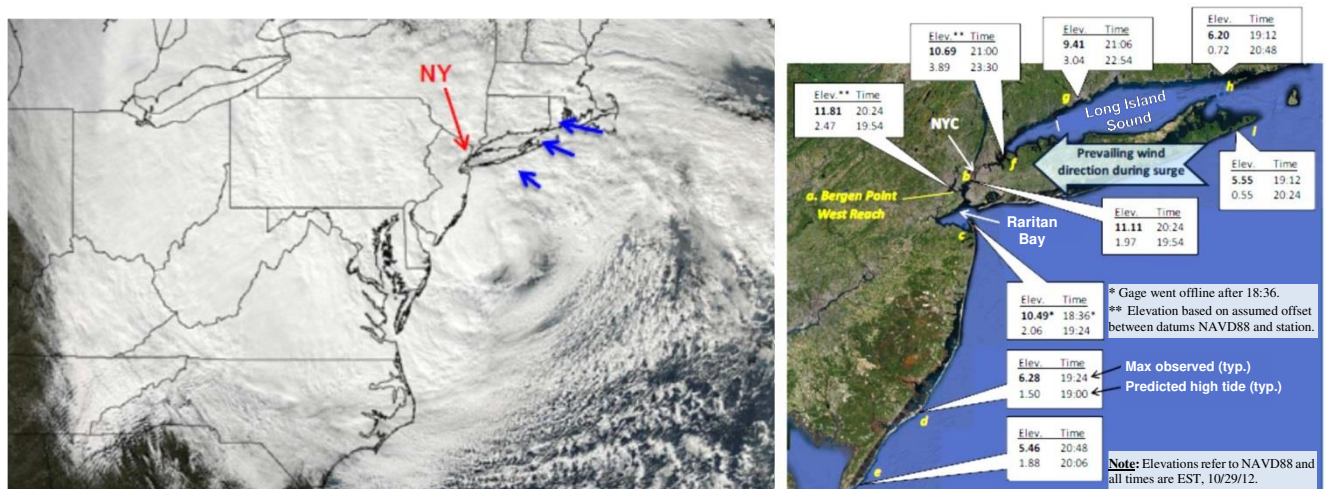
Figure 6. Hurricane Sandy's circulation on 10/29/12 at 2:20 pm EDT; blue arrows show wind direction close to landfall in southern NJ (left; nasa.gov/hurricanes/h2012/Sandy). Observed and predicted tide from NOAA stations (right).

Figure 6 depicts the wind direction, fetch, coastline shape, and normal tidal cycle. The counterclockwise wind currents caused an eastern high velocity wind direction over LI and NYC. This pattern was verified by the GEER team's observation that many of the thousands of fallen trees in LI fell to the west. The following factors contributed to an increase of the surge:

- The westward direction of the winds created a long fetch distance from the east towards Raritan Bay and LI Sound.
- The “constricted” shape of both the Raritan Bay and LI Sound narrowing to the west caused the surge height to increase as it moved into those areas due to a “funneling” effect.
- The slow storm movement resulted in the maximum surge being superimposed above the astronomical high tide.

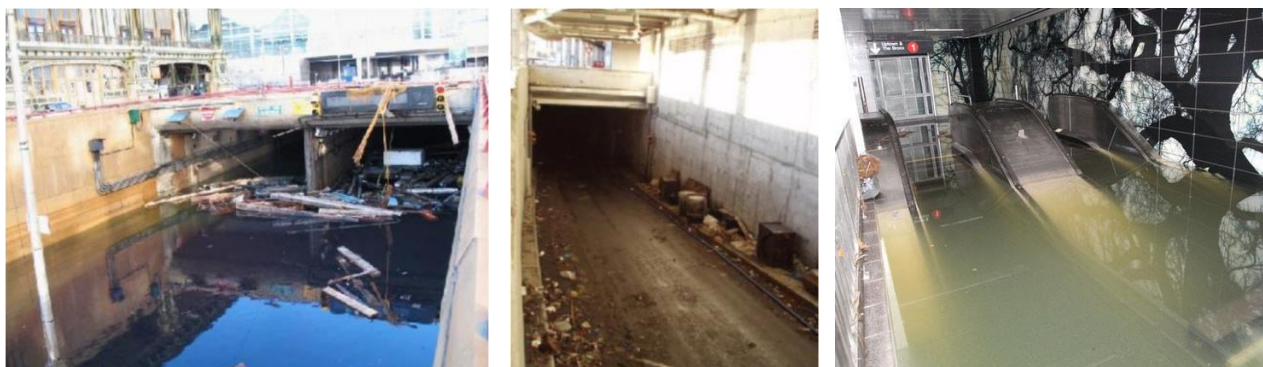
Figure 13. Flooded Battery Park underpass (40.701600°N, 74.011742°W) on 11/4/12 (left, by GEER 11/3/12); E30th St. (40.739830°N, 73.973263°W) Bellevue Hospital (middle, by GEER 11/3/12); South Ferry station (right, by MTA 10/30/12).

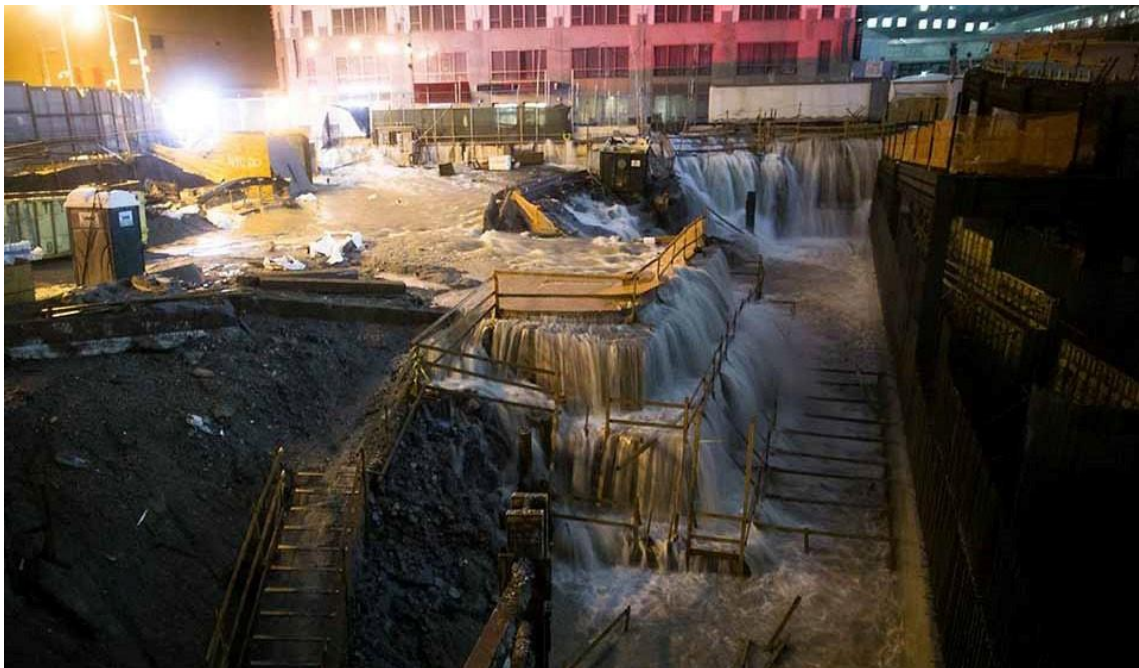
Figure 14. Open excavation flooding at the World Trade Center site (Photo: Associated Press).

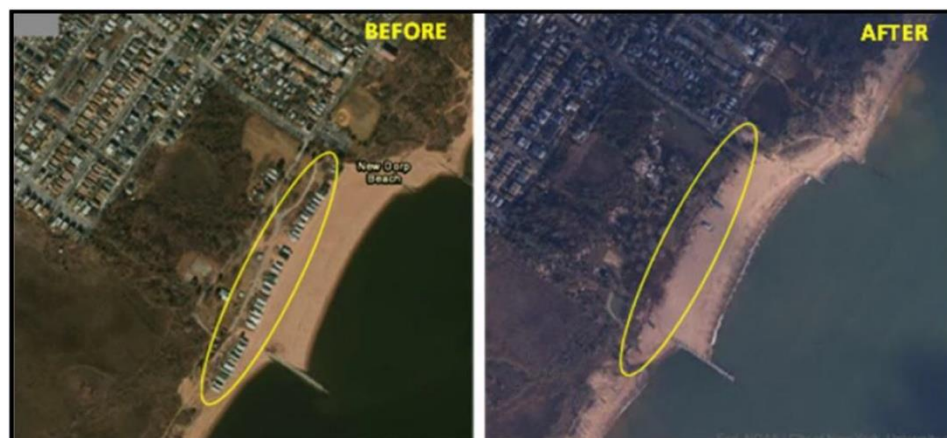
Figure 18. Aerial photographs from New Dorp Beach, SI, before and after Sandy. Row of houses completely removed and debris moved inland. (Images from tmappsevents.esri.com/website/swipe_sandy/).

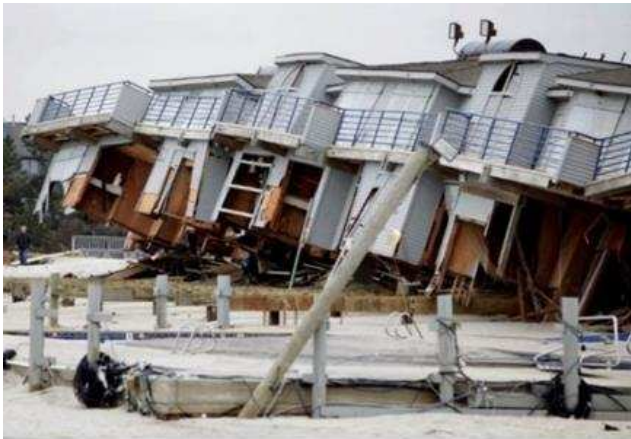
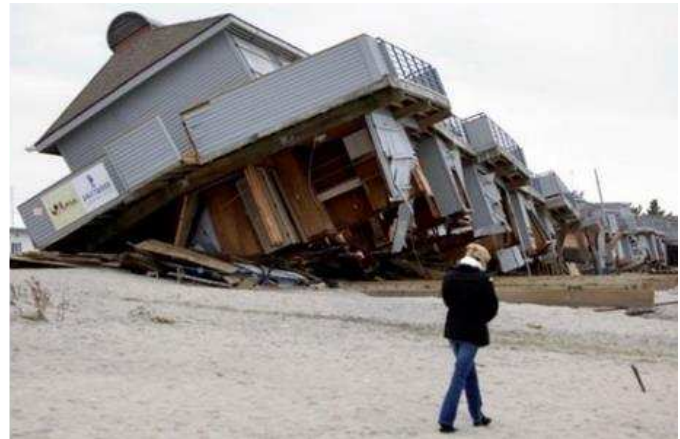
Figure 19. Sea Bright, NJ, beach cabana (40.350086°N, 73.972954°W) pulled off its base (Photo by AP/Wenig; 11/19/12).

A common damage pattern among wood frame houses was the pulling off their foundation due to inadequate anchorage (e.g., Sea Bright, NJ, Fig. 19). These house were subject to flotation, which not only causes distress, but removes dead load from foundations, making them more susceptible to breakage. Particularly, Concrete Masonry Unit (CMU) wall foundations and piers performed poorly, and were found buckled, broken, or completely removed, causing tilt, dislocation, or collapse of the superstructure (Fig. 19). In Sea Gate, Brooklyn, a concrete beachfront retaining wall foundation was undermined by erosion and subsequently broke, while the soil behind the wall was washed out (Fig. 20). In Breezy Point and Roxbury, Queens, two-story wood-frame homes, on CMU block wall and pier foundations, sustained major structural damage, including being pulled off their partially or completely destroyed foundations (Fig. 20). On the other hand, foundations of high-rise residential buildings (typically piles) generally performed well.

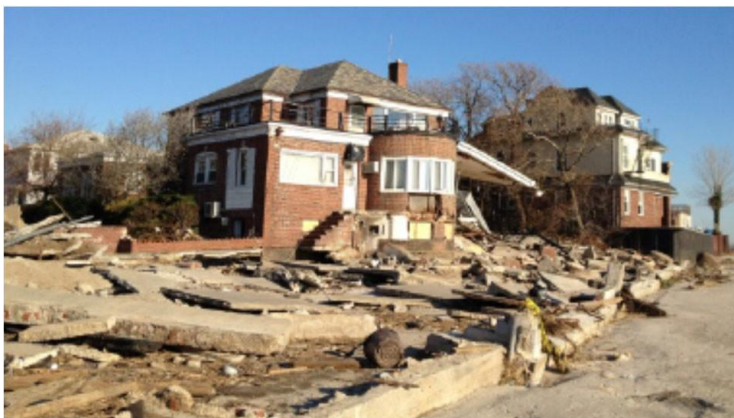
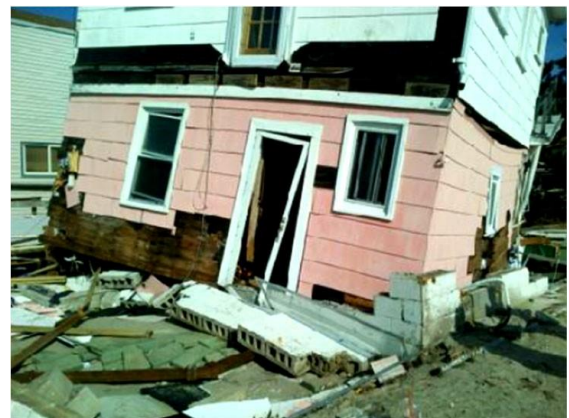
Figure 20. Undermining of beachfront retaining wall and loss of retained soil, Sea Gate, Brooklyn (left, 11/9/12); Destroyed CMU wall foundation, Breezy Point, Queens (right, 11/12/12). Photos by NYCDob (GEER, 2014).

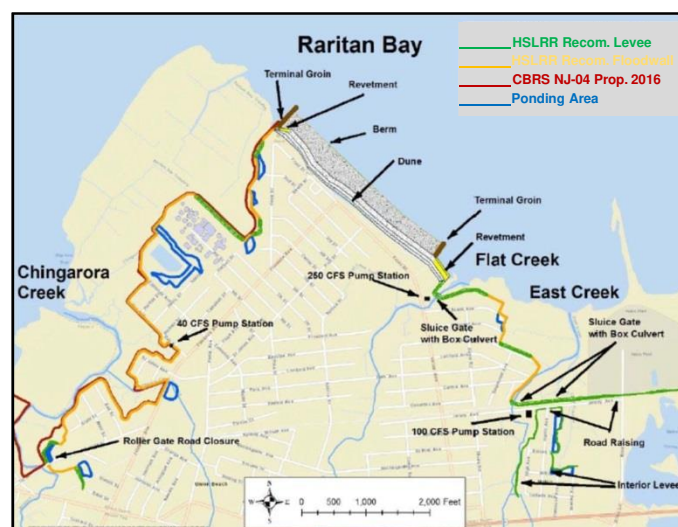
Figure 29. Union Beach plan overview from U.S. Army Corps of Engineering Limited Reevaluation Report (USACE, 2017).

The NJ State issued a report five years after Sandy with: (i) a record of damage and response; (ii) an agency-by-agency response/recovery playbook applicable to other states exposed to hurricanes; and (iii) rebuild measures co-funded by FEMA, the Departments of Interior and Housing and Urban Development (HUD), and Federal Highway Administration (FHWA), such as: Sea Bright wall, Mantoloking and Brick sheet piling, Belmar Lake Como discharge, Brigantine pump stations, Little Ferry tide gate, and Wildwood/Stone Harbor storm water/flood control. The Union Beach project in Raritan Bay (Fig. 29) would rebuild beaches and dunes and restore 100,000 m² (25 acres) of degraded wetlands to better absorb flood waters, with levees, flood walls, tide gates, and pump stations.

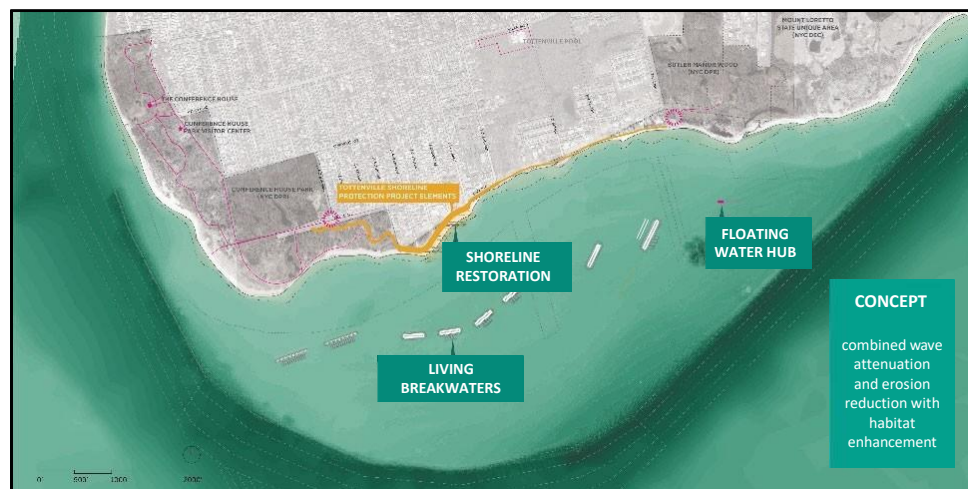
Figure 34. Living Breakwaters system: combined wave attenuation and erosion reduction with habitat enhancement.

added to the shoreline will protect vulnerable beaches, while breakwaters work to accrete beach elsewhere (Fig. 34). Similarly, in NJ, Rebuild by Design includes several projects, such as: (i) CDBG (\$380M) projects to be completed by 2022; (ii) Hudson River (\$230M) communities and critical infrastructure flood-resistance structures (e.g., N. Hudson Sewerage Authority); and (iii) protection of Meadowlands (\$150M) Little Ferry, Moonachie, Carlstadt, Teterboro, and S. Hackensack.

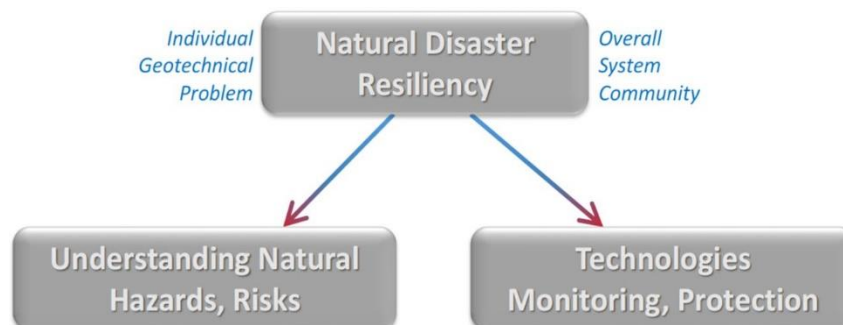
Figure 36. Framework for resilient-based design (Nikolaou et al., 2017).

and risk-based engineering framework which considers life cycle costs is needed to address both new infrastructure components and the (often aged) legacy components. A design framework as shown conceptually in Fig. 36 can address both the individual component as well as the overall system needs, while planning for cascading hazards (Nikolaou et al., 2017). The GEER-organized efforts and presentation of data highlighted key flaws, demonstrating to stakeholders and the public that geotechnical engineers should be involved early in the decision-making process after major events such as Hurricane Sandy.
