## Geotechnical Effects and a 6-Year Outlook of the 2012 Hurricane Sandy in the Eastern United States

**ABSTRACT:** Hurricane Sandy was the deadliest and most destructive event of the 2012 Atlantic hurricane season. It originated as a storm off the coast of West Africa that turned into a tropical wave in the southwestern Caribbean Sea, and then into a hurricane that moved slowly north along the United States East Coast. Numerous regional coastal communities and urban centers in New Jersey (NJ) and the New York City (NYC) metropolitan area experienced widespread flooding, extreme winds, and heavy damage that disrupted daily life and business in Lower Manhattan, the world's financial capital. Consequences with great geotechnical engineering interest include: (i) modification of the regional coastal geomorphology due to storm surge, with the birth of new inlets, erosion, scour of soil at the shorelines; (ii) damage in coastal communities that revealed the vulnerability of residential building foundations not designed according to modern flood protection standards; and (iii) interruption of service of buried structures and below ground infrastructure due to flood damage to non-structu

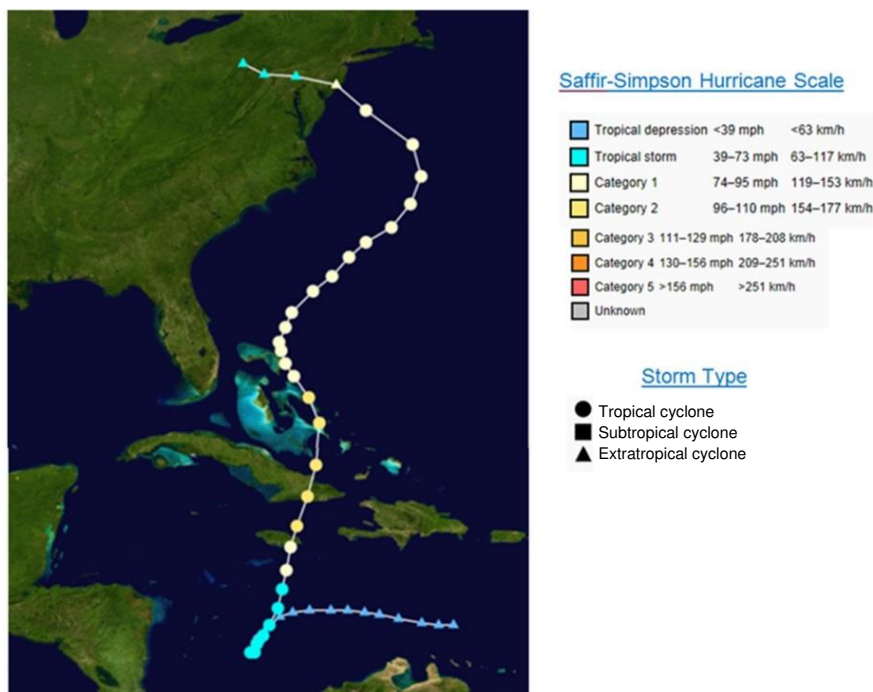
Figure 1. Map of Hurricane Sandy at six-hour intervals. Peak sustained wind speeds are colored per the Saffir-Simpson scale. The shape of points reflects the nature of the storm (based on Cyclonebiskit map with NOAA data and NASA background).

Sandy was a late-season cyclone or hurricane that started as a tropical disturbance off the coast of West Africa and later became a hurricane in the southwestern Caribbean Sea. It moved northeasterly along the U.S. East Coast and turned abruptly, becoming a superstorm as it made landfall near Brigantine, NJ, on October 29, 2012. As the storm approached, the counterclockwise rotation directed high velocity winds to be from the east, driving devastating storm surges into coastal areas of NJ, western LI, and the boroughs of Queens, Brooklyn, and Staten Island (SI). The maximum recorded storm surge (NOAA, 2013), defined as the observed water level (storm tide) minus the predicted astronomical tide levels, reached 3.855 meters or 12.65 feet (ft). Manhattan experienced an inundation of 1.7 m (5.5 ft) above ground from a surge of 3.5 m (11.4 ft). Blake et. al (2013) provide a detailed description of the storm and its path, which is shown in Fig. 1.

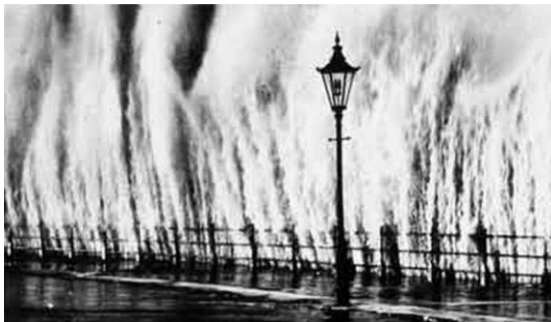
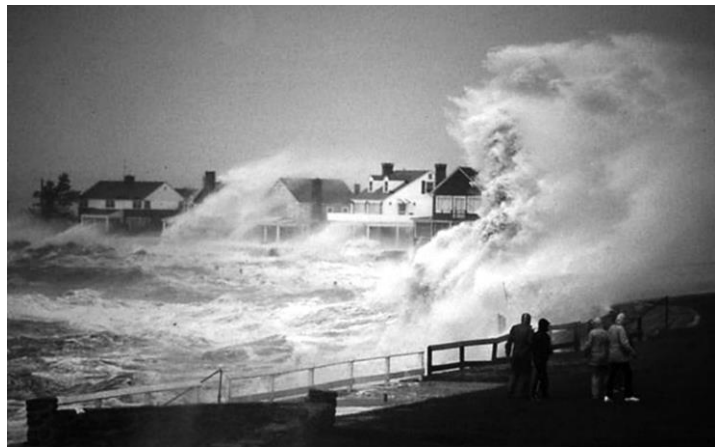
*Figure 2. Images from historic hurricanes in 1938 (left) and Hurricane Gloria in 1985 (right) (NYC Office of Emergency Management).*

Based on 100-year historic data, Category 1-3 storms that impact NYC coastal area (see Fig. 2), typically occur every six years. However, in the last 25 years, this frequency has been reduced to about three years. Older records from the 19<sup>th</sup> century identify occurrence every 14 years, which could be due to variations in data keeping. Major events have created wind gusts of 84-180 kilometers per hour (km/h), or 52-113 mph, and surges of 0.9-5.5 m (3-18 ft). The effect of many of these events was not as severe, as they occurred in low tide or were too far away from the city. Reported events by the NYC and Nassau Offices of Emergency Management are:

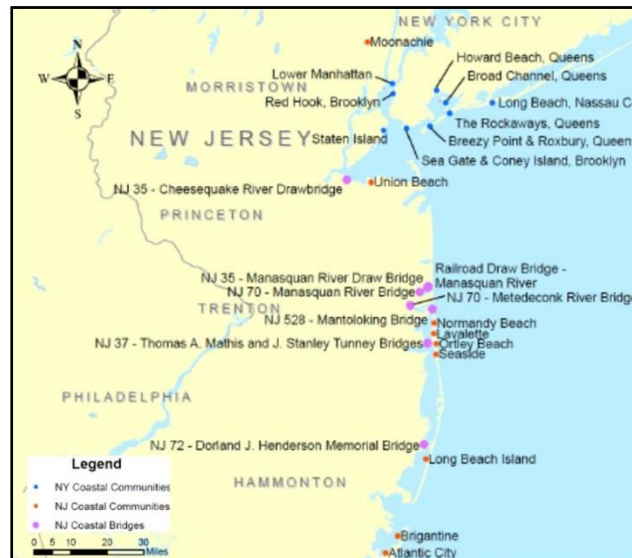
Figure 3. GEER NYC and NJ teams' observation locations following the storm, and sites of information gained through collaboration with city and state agencies over the subsequent weeks (GEER, 2014).

Following an initial meeting held on November 2, 2012, two major GEER reconnaissance groups were formed to cover the NYC boroughs and NJ, as some NYC subway and bus lines were only been partially restored and significant portions of the subway, road, and commuter rail network remained non-functional. The initial goal was to visit accessible areas and collect perishable data, which were later supplemented with background information. In the days following the storm and in subsequent weeks (in collaboration with the NYC Department of Buildings and other city and state agencies), the GEER-NYC team collected data in Manhattan (Lower West and East Sides and the Battery Park waterfront), Staten Island (beachfront), Brooklyn (Red Hook, Bridge Park), and Queens (Rockaways, Long Beach, Broad Channel). The GEER-NJ team visited the coastal area from Brigantine to Belmar, Atlantic and Ocean cities, Longport, Ship Bottom and Long Beach Island, Seaside Heights, and Ortley. The observation location sites are shown on the map of Fig. 3.

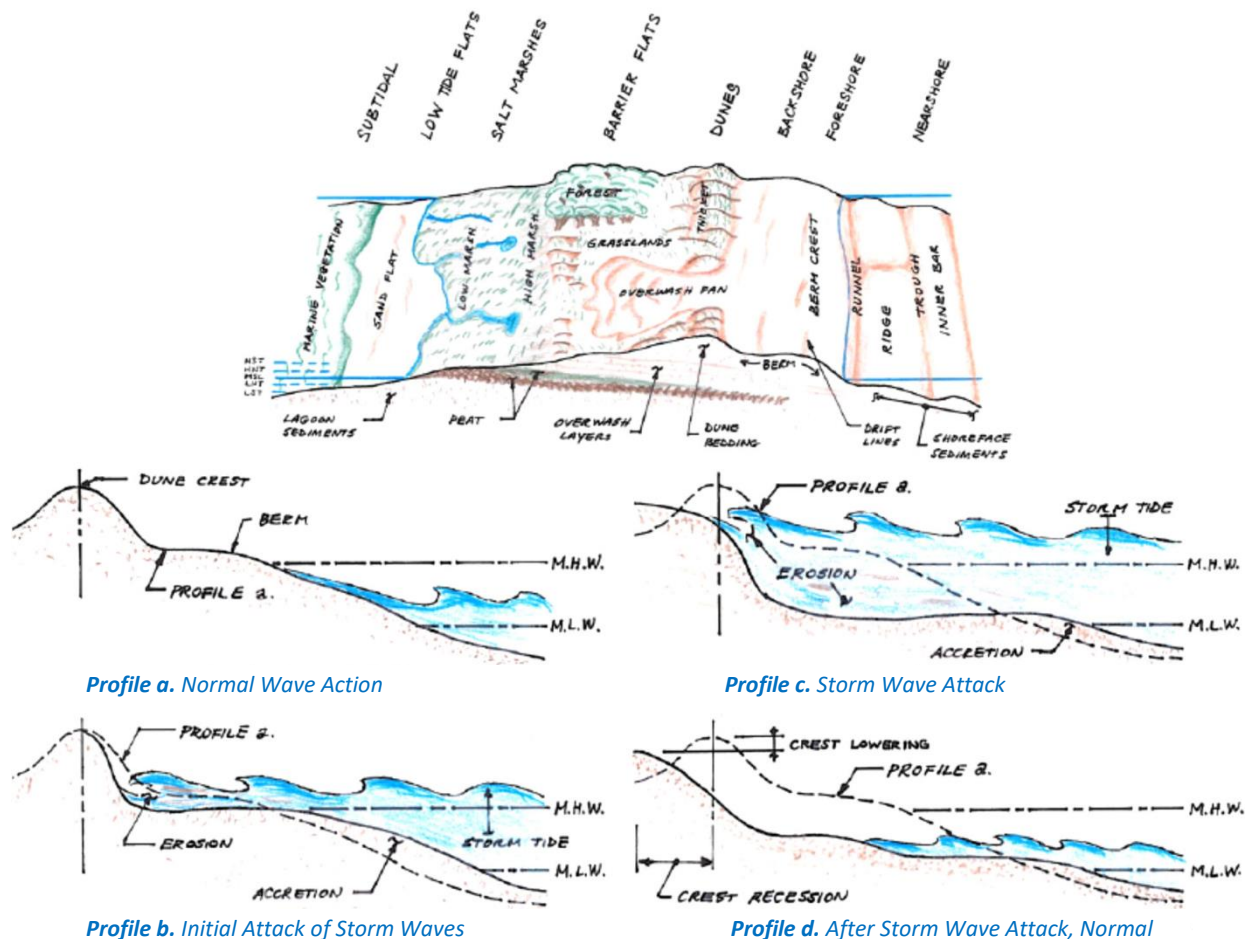
Figure 4. Barrier environments (top) and beach profile changes (bottom) in response to a coastal storm (Refs: A. Dyer from Leatherman, S.P., 1979; Godfrey, 1976; and U.S. Army Corps of Engineers, 1974).

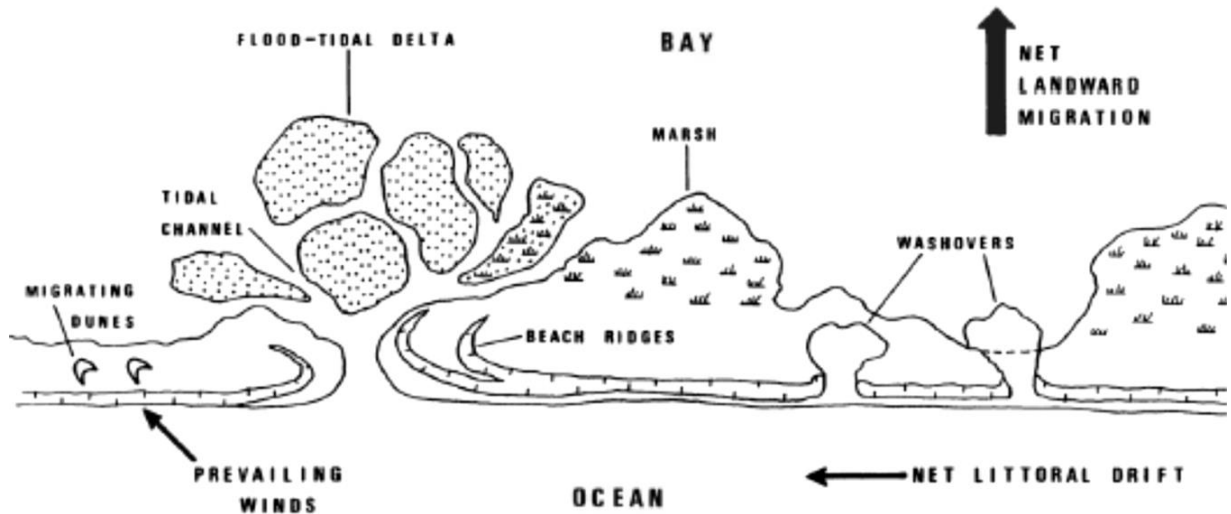
Figure 5. Geologic processes that build up a barrier island, allowing landward migration with sea level rise (Johnson, 1982).

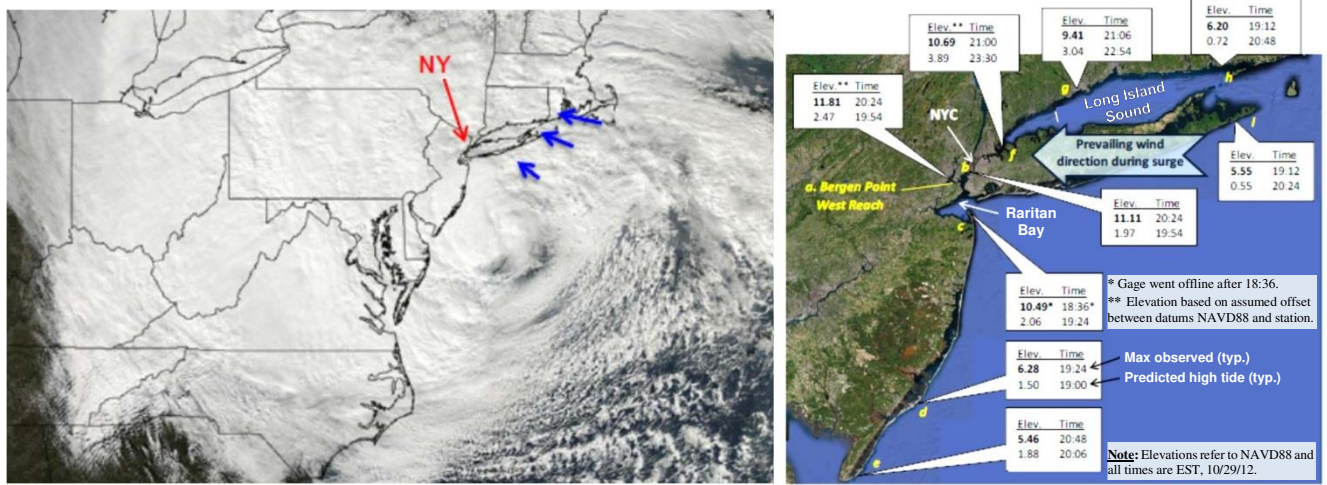
Figure 6 depicts the wind direction, fetch, coastline shape, and normal tidal cycle. The counterclockwise wind currents caused an eastern high velocity wind direction over LI and NYC. This pattern was verified by the GEER team's observation that many of the thousands of fallen trees in LI fell to the west. The following factors contributed to an increase of the surge:

- The westward direction of the winds created a long fetch distance from the east towards Raritan Bay and LI Sound.
- The “constricted” shape of both the Raritan Bay and LI Sound narrowing to the west caused the surge height to increase as it moved into those areas due to a “funneling” effect.
- The slow storm movement resulted in the maximum surge being superimposed above the astronomical high tide.

Figure 6. Hurricane Sandy's circulation on 10/29/12 at 2:20 pm EDT; blue arrows show wind direction close to landfall in southern NJ (left; [nasa.gov/hurricanes/h2012/Sandy](http://nasa.gov/hurricanes/h2012/Sandy)). Observed and predicted tide from NOAA stations (right).

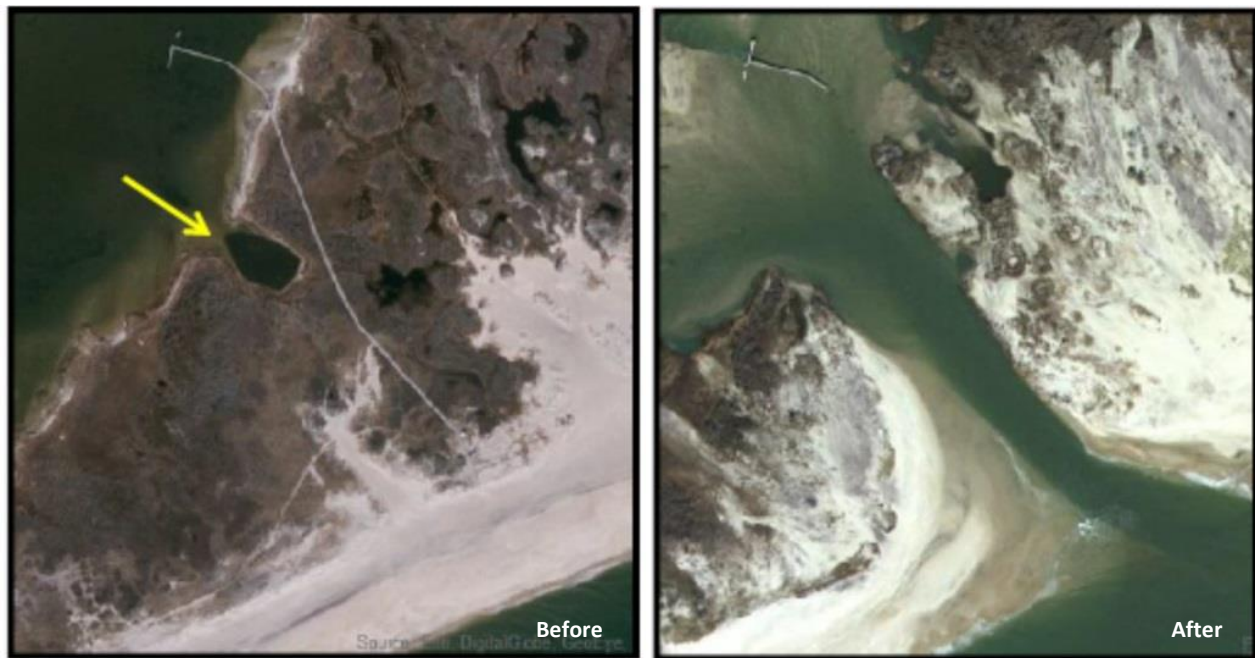
The storm surge significantly modified the coastal NY/NJ geomorphology, with the birth of new inlets and severe erosion and scour of soil on the shorelines (Fig. 7). While devastating in their path, these effects were largely consistent with predictions.

Figure 7. Fire Island, LI: New inlet with narrowing point by embayment in yellow arrow (Ref: [tmappsevents.esri.com/](http://tmappsevents.esri.com/)).

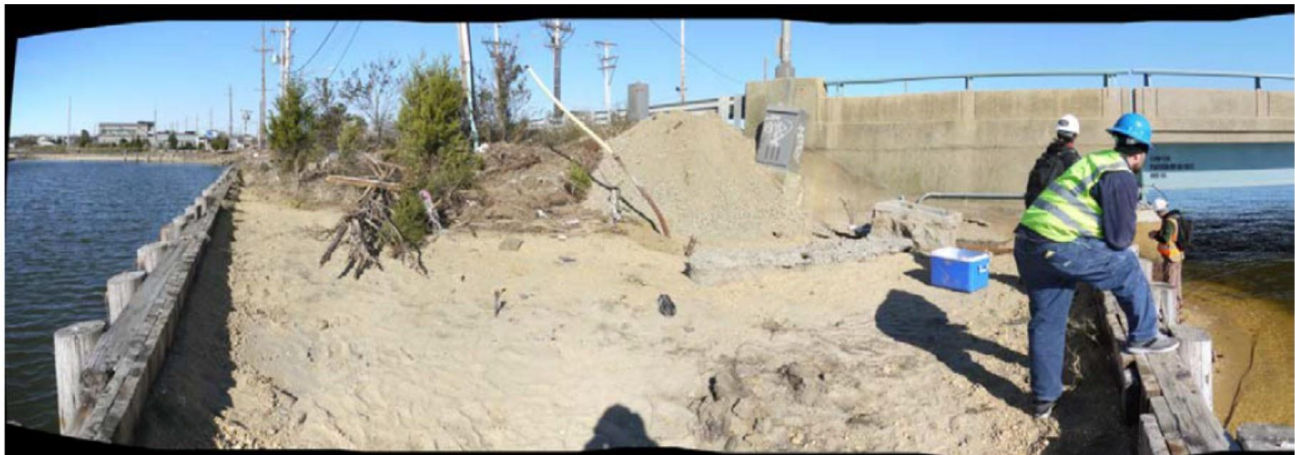
Figure 9. Erosion at Mathis Bridge southwest abutment (eastbound Rt37) ( $39.949350^{\circ}\text{N}$ ,  $74.113902^{\circ}\text{W}$ ; GEER 2014).

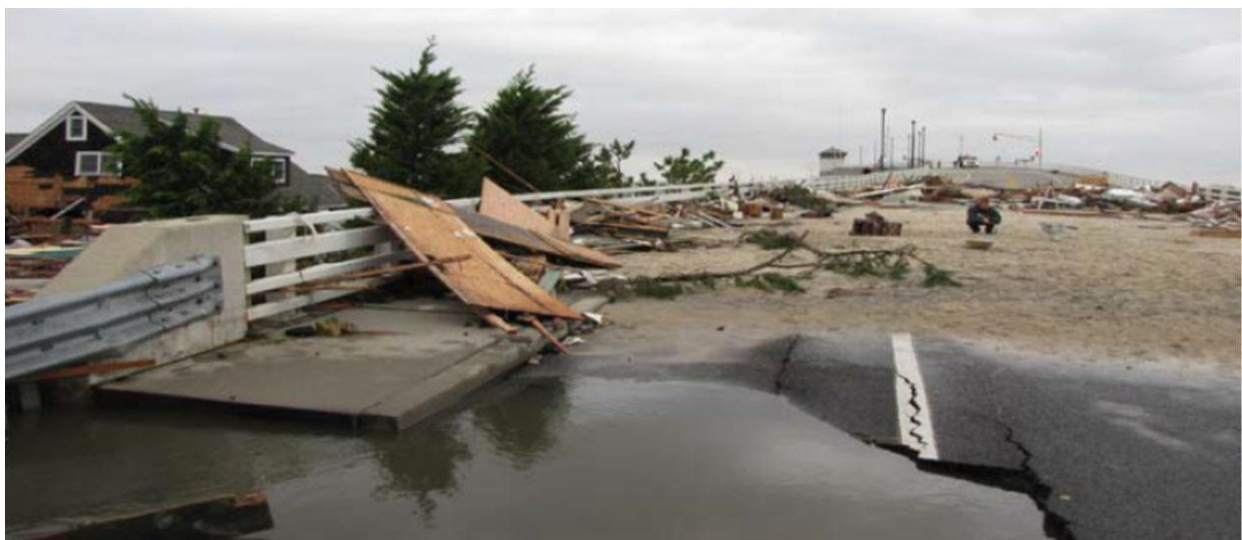
Figure 10. Foundation undermining at east abutment of Mantoloking Bridge ( $40.040058^{\circ}\text{N}$ ,  $74.051886^{\circ}\text{W}$ ; GEER, 2014).

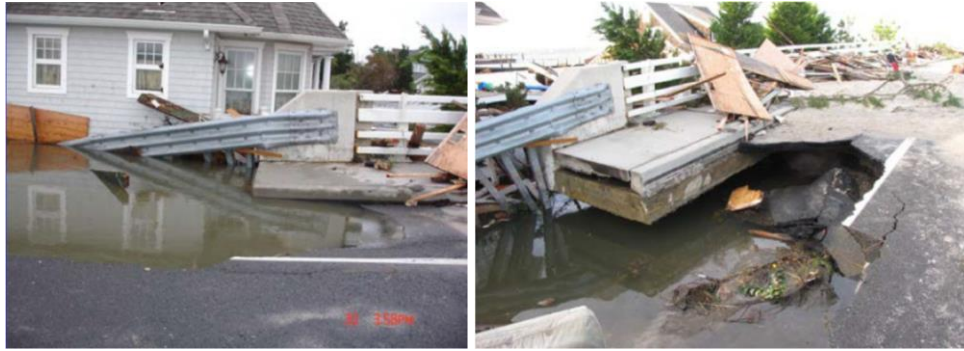
Figure 11. Mantoloking Bridge east abutment erosion (40.040058°N, 74.051886°W, Ocean Ct. Eng., 2012; GEER, 2014).

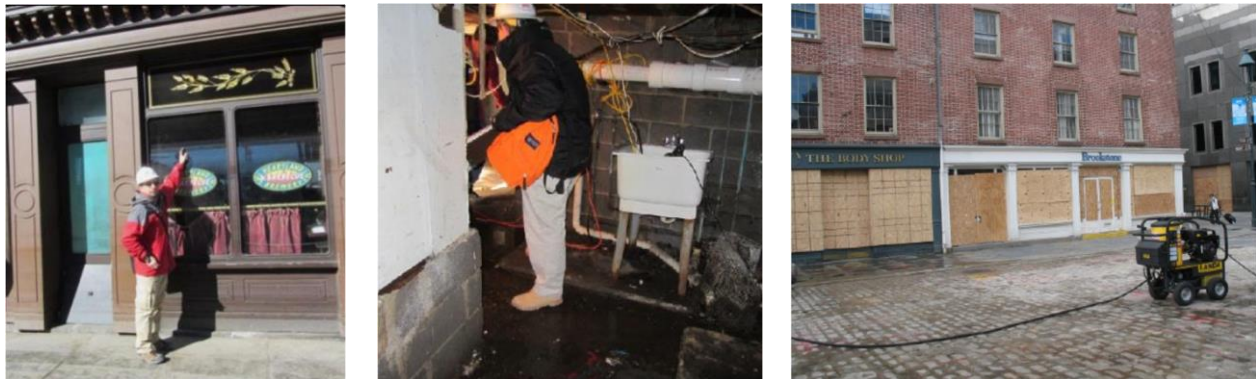
Damage in the dense urban NYC area of lower Manhattan was primarily related to flood inundation. High water marks and evidence of flood damage to approximately 1.2-2.1 m (4-7 ft) above street level were observed throughout low-lying neighborhoods (e.g., South Street Seaport) and water front areas (Fig. 12). Below-grade subway stations, tunnels, parking garages, and excavations experienced widespread flooding. While access to many of these locations was restricted to the GEER team due to ongoing recovery work, evidence of flood inundation was visible from the surface, e.g. at the Battery Park underpass and Bellevue Hospital. Based on reports in the days and months following the storm, the flooded tunnels included the Brooklyn Battery, Holland, and Queens-Midtown highway tunnels, the PATH rapid transit tunnels, NJ Transit / Amtrak / LI Railroad Hudson and East River rail, and seven subway tunnels. Several subway stations and open excavations were flooded, including South Ferry, which flooded to the ceiling, as well as an excavation at the World Trade Center site (Figs. 13-14).

Figure 12. South Street Seaport (40.706685°N, 74.003554°W), 11/4/12: High water line on window of a restaurant (left); typical flooded basement (middle); flood damage (right). (GEER Report, 2014).

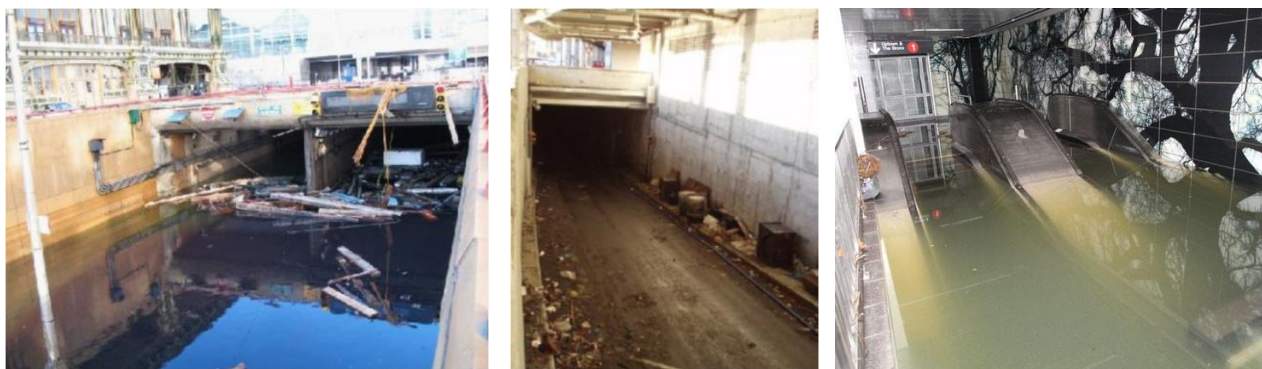
Figure 13. Flooded Battery Park underpass (40.701600°N, 74.011742°W) on 11/4/12 (left, by GEER 11/3/12); E30<sup>th</sup> St. (40.739830°N, 73.973263°W) Bellevue Hospital (middle, by GEER 11/3/12); South Ferry station (right, by MTA 10/30/12).

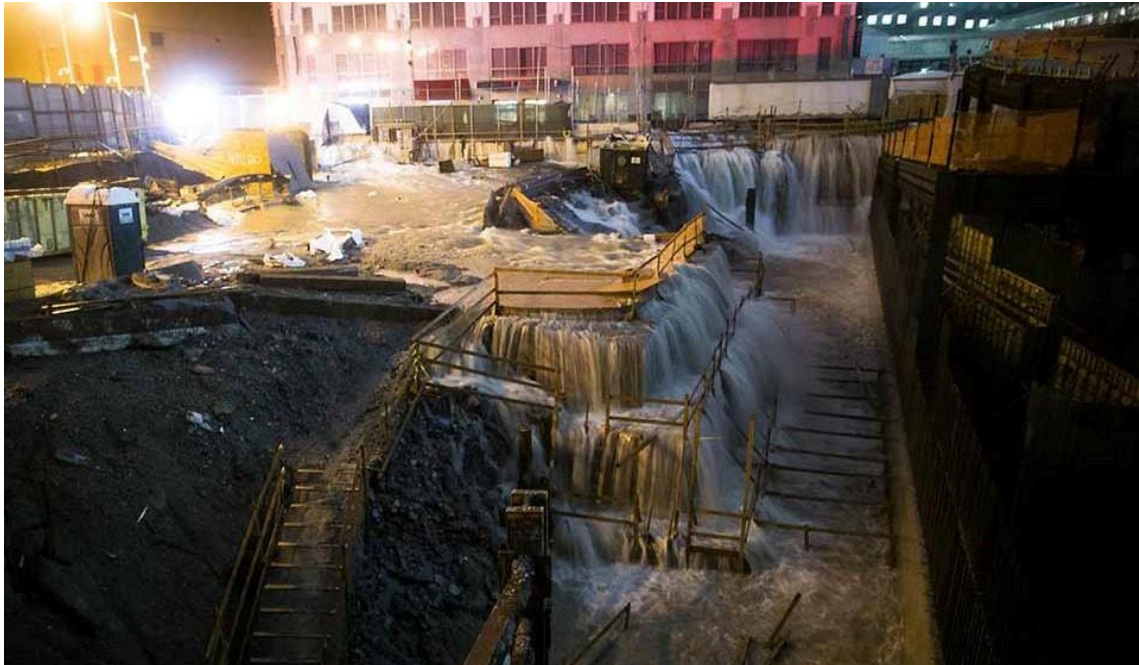
Figure 14. Open excavation flooding at the World Trade Center site (Photo: Associated Press).

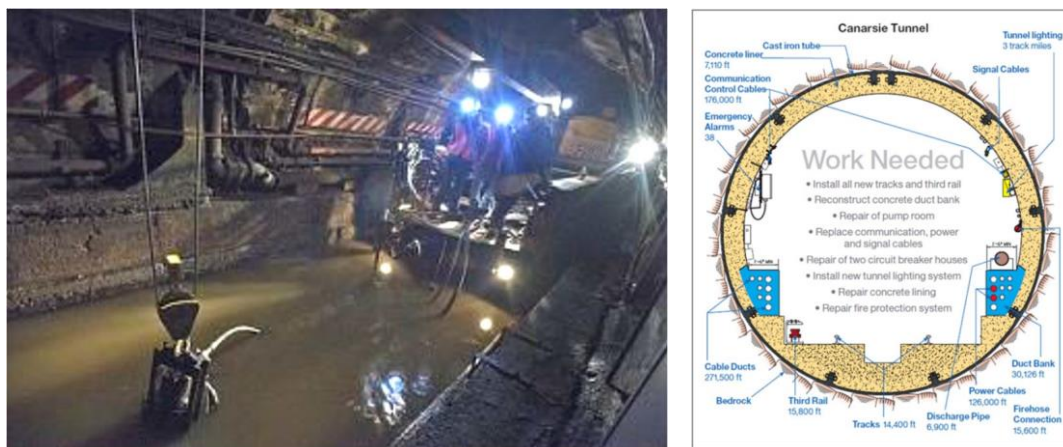
While most tunnels experienced minimal structural damage, utilities and ventilation systems were severely damaged and required lengthy repairs. Indicatively, the [R] Montague St. subway and the World Trade Center PATH tunnels were out of service for 2-3 months. The R line was taken out of service again in 2013 for lingering flood damage repairs. The Canarsie Tube of the [L] subway line was inundated with 265,000 m<sup>3</sup> (7M gallons) of saltwater that caused corrosion of cabling, circuit breakers, and disabling of power/track equipment. The duct bank alongside the track, which provides walkway for emergency egress, sustained heavy damage and exhibited a partial collapse. With an initial 15-month shutdown plan, a complete overhaul is still necessary today, in 2020 (Fig. 15), as the L line is critical with a large portion of its daily 400,000 riders travelling to 14<sup>th</sup> Street stations, some of which are not easily reached by other lines. The Queens [A] Rockaway subway line was out of service for nearly seven months due to two major washouts at the earth embankment crossing Jamaica Bay, which exposed the old Long Island Rail Road (LIRR) infrastructure (Fig. 16).

Figure 15. Canarsie tube of [L] line: damage from Sandy (left) and work needed to repair it (right) (MTA, 2017).

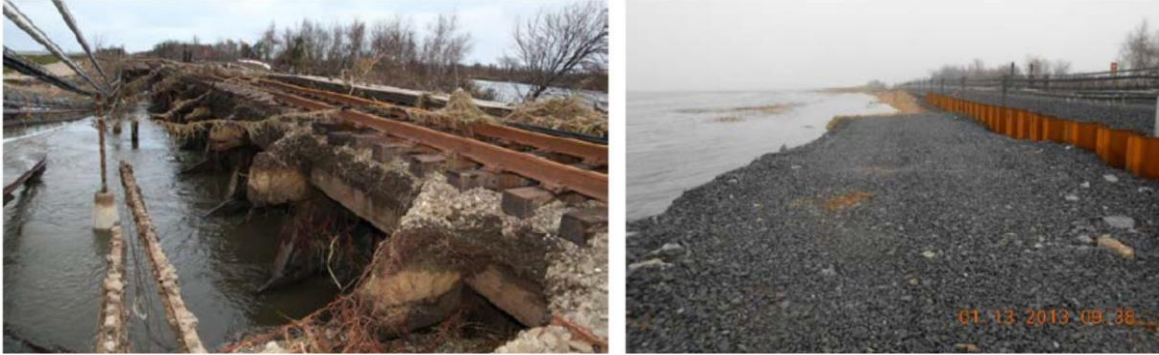
Figure 16. Earth embankment washouts in Queens, along Rockaway subway [A] line after Sandy with old LIRR infrastructure exposed (left) and post mitigation work (right). Photos by Khinda, ed. (2013).

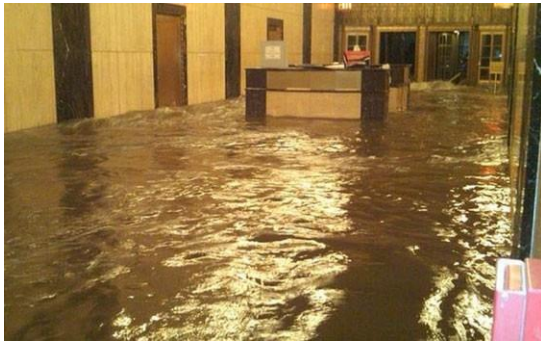
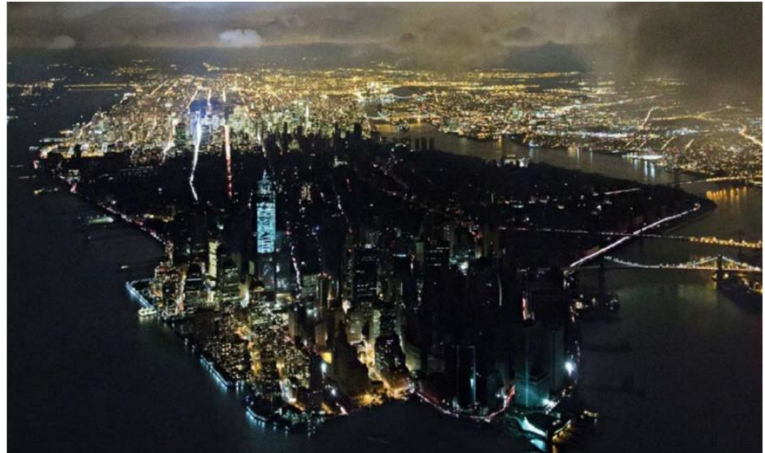
The storm surge exceeded predictions and caused unprecedented damage to the infrastructure of Consolidated Edison (Con Ed), which supplies electricity to nearly all of NYC's 3M customers (representing 8.3M people and 250,000 businesses) and provides 41% of the city's natural gas service. Precautionary measures were taken, including sand bags and "aqua dams" (polyethylene berms filled with water) at substations and vaults, pre-emptive de-energizing of equipment, isolation of 26 steam main segments, and the pre-emptive shutdown of the East River generating station and the Brooklyn Navy Yard co-generation steam plants. Still, the East River, E13<sup>th</sup> St., and Seaport substations were flooded, resulting in the loss of almost a third of NYC's

generating capacity south of 34<sup>th</sup> St. for four days, thus causing severe delays to the recovery effort and the restart of subways (Fig. 17).

Figure 17. Flooded lobby of the Verizon building (left, Photo by Governor A. Cuomo); Power outage south of 34<sup>th</sup> St., 10/29/12 in Lower Manhattan which lasted for four days (right, Photo by I. Baan, NY Magazine).

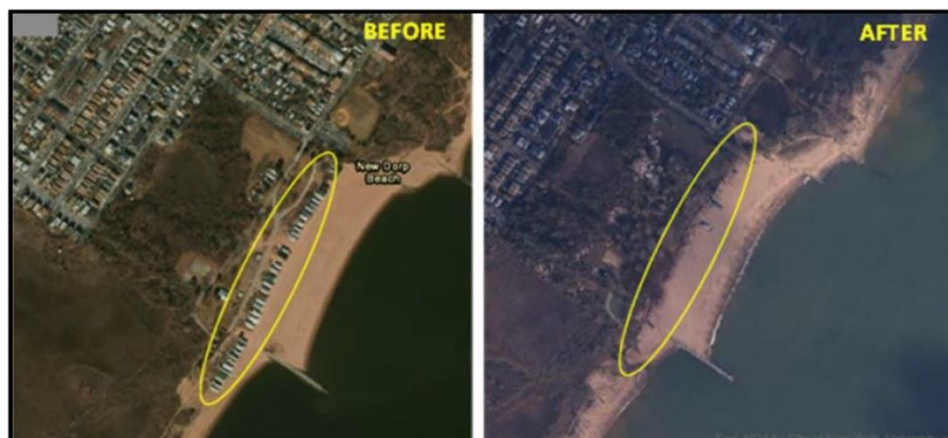
Storm surge, flooding, and erosion impacted residential housing and municipal infrastructure foundations in coastal areas investigated by the GEER team (Fig. 3). Destruction of wood-frame houses in Staten Island (SI) was common, as observed based on the "before" and "after" aerial photos of a row of houses (Fig. 18), which were completely removed by the storm. This area is underlain by glacial outwash sands, often overlain by man-made fill. Most of the structural/foundation failures occurred in dwellings built prior to 1938, typically developed as summer residences in areas with direct exposure to open ocean, constructed less robustly than modern, permanent-residence, homes (Eschenasy, 2013). Moving inland, dunes, and vegetated strips had a positive effect in reducing the damage.

Figure 18. Aerial photographs from New Dorp Beach, SI, before and after Sandy. Row of houses completely removed and debris moved inland. (Images from [tmappsevents.esri.com/website/swipe\\_sandy/](http://tmappsevents.esri.com/website/swipe_sandy/)).

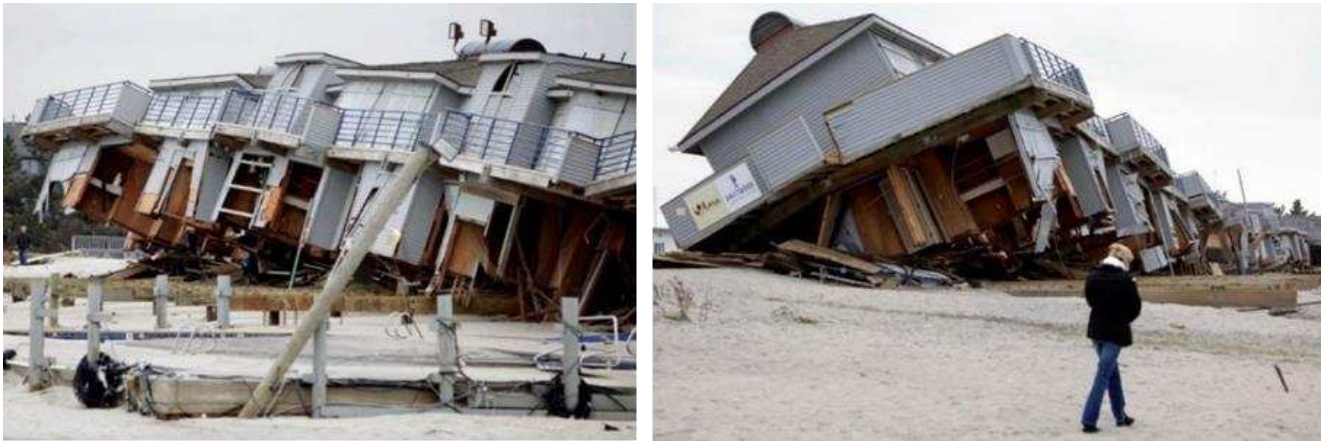
A common damage pattern among wood frame houses was the pulling off their foundation due to inadequate anchorage (e.g., Sea Bright, NJ, Fig. 19). These house were subject to flotation, which not only causes distress, but removes dead load from foundations, making them more susceptible to breakage. Particularly, Concrete Masonry Unit (CMU) wall foundations and piers performed poorly, and were found buckled, broken, or completely removed, causing tilt, dislocation, or collapse of the superstructure (Fig. 19). In Sea Gate, Brooklyn, a concrete beachfront retaining wall foundation was undermined by erosion and subsequently broke, while the soil behind the wall was washed out (Fig. 20). In Breezy Point and Roxbury, Queens, two-story wood-frame homes, on CMU block wall and pier foundations, sustained major structural damage, including being pulled off their partially or completely destroyed foundations (Fig. 20). On the other hand, foundations of high-rise residential buildings (typically piles) generally performed well.

Figure 19. Sea Bright, NJ, beach cabana (40.350086°N, 73.972954°W) pulled off its base (Photo by AP/Wenig; 11/19/12).

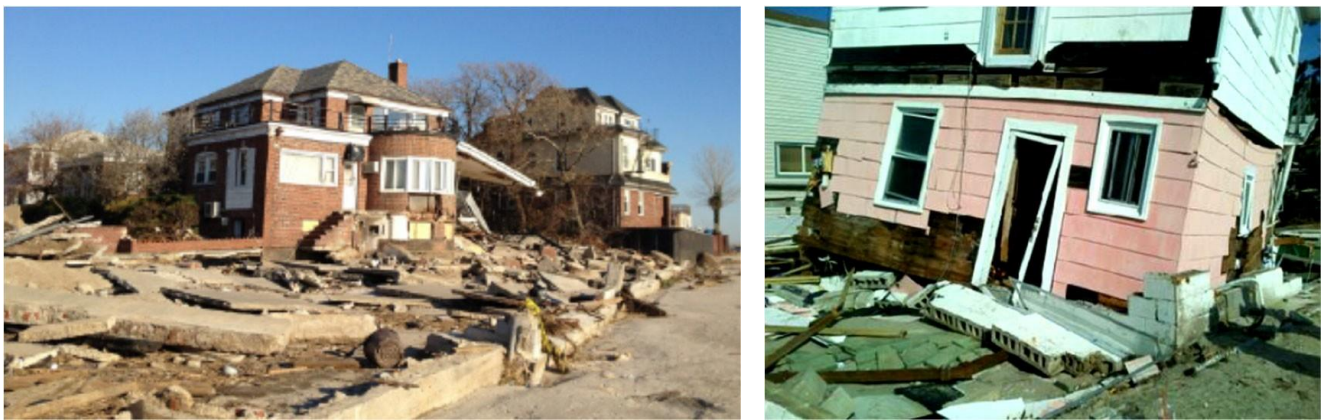
Figure 20. Undermining of beachfront retaining wall and loss of retained soil, Sea Gate, Brooklyn (left, 11/9/12); Destroyed CMU wall foundation, Breezy Point, Queens (right, 11/12/12). Photos by NYCDob (GEER, 2014).

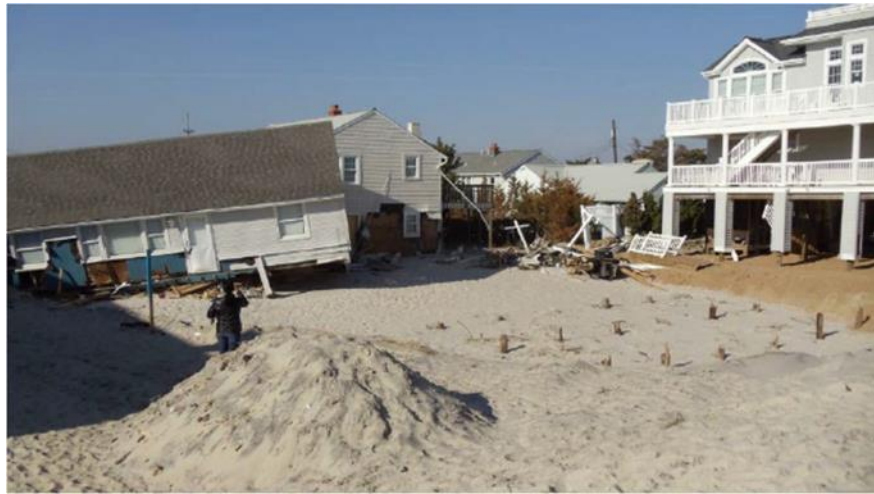
A spectacular failure was observed by the GEER team at a two-story home at Pehola Park, Long Beach Island, which was sheared off its piles due to storm surge forces as well as wave action. Only the upper story of the home was visible, found near its original location. The site's approximate ground elevation was 2.35 m (7.7 ft) and the high-water mark was about 0.7 m (2.3 ft) above ground. The surrounding homes were intact, with the only difference being that this home was at a lower elevation than the others (Fig. 21). This pattern of lower story disappearance and/or flattening was observed in other areas as well.

*Figure 21. Timber piles remain in place after a home was sheared off in Pehola Park (39.610016N, 74.206657W, GEER, 2014).*

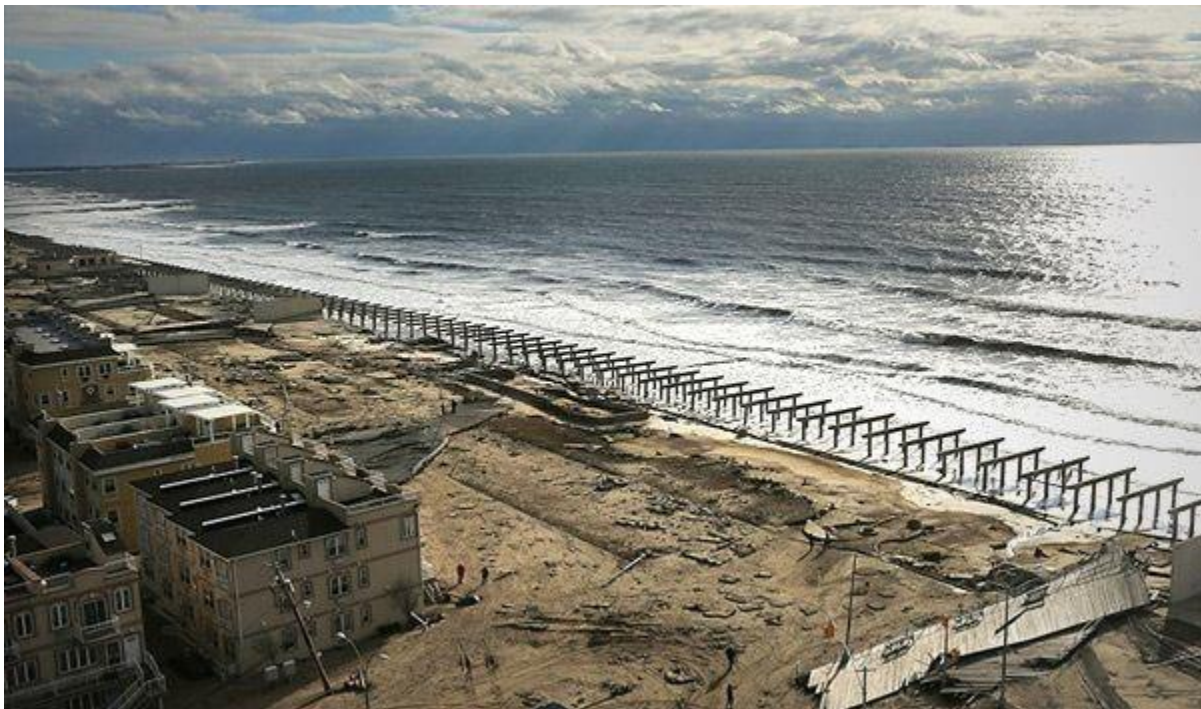
concrete pile-supported wooden boardwalks, and some homes are separated from the beach by concrete or sheet pile retaining walls. In Rockaways, Queens, the boardwalk had been lifted off its piers and damaged or destroyed over its entire length, with debris carried up to 60 m (~200 ft) inland (Fig. 22).

*Figure 22. Damage to Boardwalk at Rockaway Beach, Queens (40.583445°N, 73.81553°W). Photo by cnbc.*

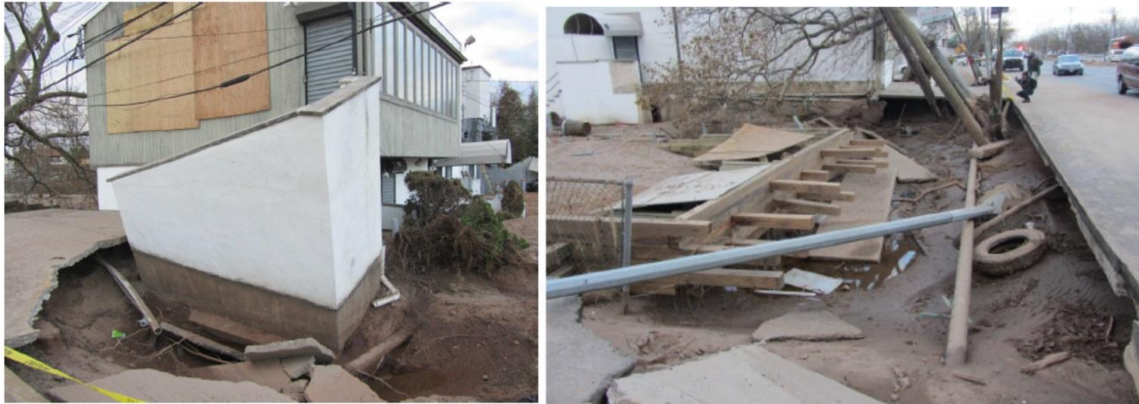
Severe soil erosion was observed along Father Capodanno Blvd in Midland Beach, Staten Island (SI), where sinkholes undermined the street, curb line, sidewalks, utility poles, and house foundations (Figs. 23, 24). Throughout the area, wood decks, trees, cars, and other debris had been deposited inland. Concrete wall foundations generally sustained little or no structural damage, though they sometimes experienced erosion and scour along their perimeter.

Figure 23. Scour undermining at Seaver Ave & Father Capodanno Blvd, SI (40.575944° N, 74.083015° W, 11/4/12). Damage to stair foundation and drain (left) and sidewalk, utilities, and light pole foundation (right). Photos by GEER (2014).

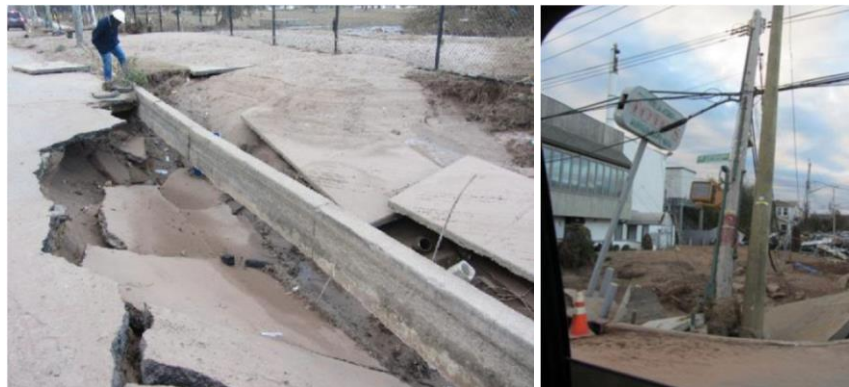
Figure 24. Scour undermining of street and utilities at Seaview Blvd, SI (40.579283°N, 74.077849°W, 11/4/12, GEER, 2014).

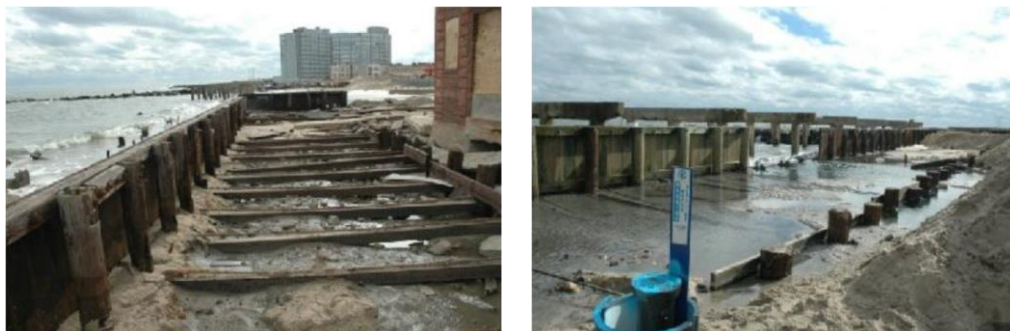
along a section of the shore in Atlantic City, NJ, were breached.. The breaches were attributed to the destruction and washing away of the timber facing . The surge and water washing through the breaches exposed the tierods and anchors (Fig. 25).

Figure 25. Bulkhead in Atlantic City, NJ: backfill soil washed away, exposing severely corroded tie rods (GEER, 2014).

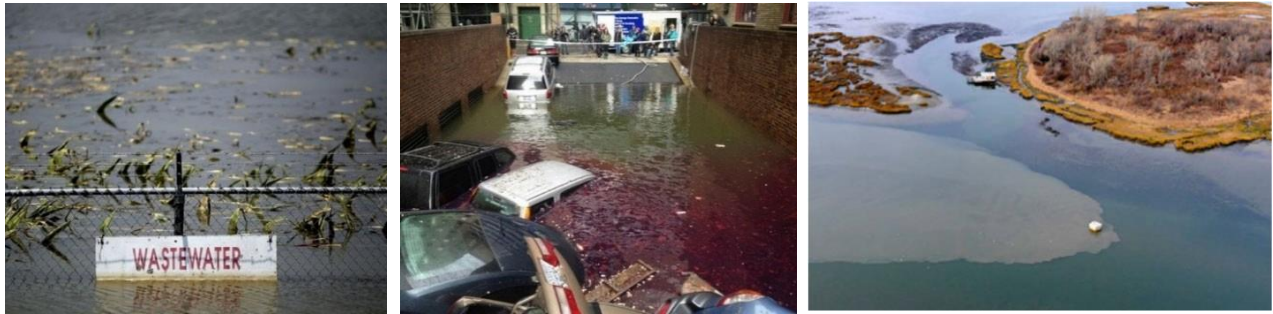
to shut down or divert sewage into waterways due to power outages and flooding (e.g., Fig. 26 shows untreated waste spilled in the LI South Shore Estuary from the Bay Park Sewage Plant in East Rockaway). GEER visited the WWTP that processes waste water from Yonkers. Founded on filled land along the east bank of the Hudson River, it experienced one of the largest overflows with 4.5M m<sup>3</sup> (1.2B gallons). The river frontage has a rip-rap revetment at the south and a steel seawall (Fig. 27) about 1.5 m (5 ft) higher than the north rip-rap. Normally, the plant handles daily 360 m<sup>3</sup> (95M gallons) of waste water; during in Hurricane Irene in 2011, it processed 1,150 m<sup>3</sup> (300M gallons). After Sandy, loss of gravity flow caused more than 2.8 m (9 ft) of tail water and therefore flooding of below-grade areas (Fig. 27), something that damaged equipment including boilers, the alarm system, pipes, and motors.

Figure 26. Untreated waste spilled in NY Harbor (left, photo Getty/Tama) and buried cars (middle, photo Bloomberg/Korby). Overflow from Bay Park Sewage Treatment Plant, East Rockaway (right, photo by D. Kuntz; Kenward et al., 2013).

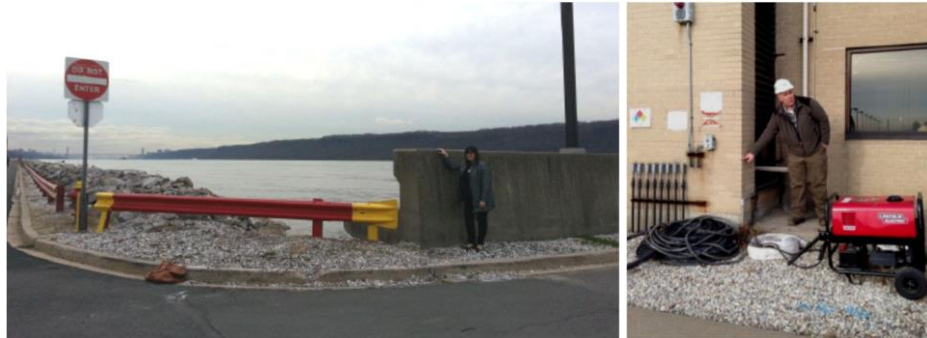
Figure 27. Yonkers Joint WWTP: junction of rip-rap revetment and seawall, looking south (left); vent grates in aeration blower building where water entered, with flood water elevation shown by plant superintendent (right); GEER (2014).

Preparedness allowed for on-site decisions that accelerated recovery to 3-4 days for primary treatment and 21 days for normal operations to resume. Planning before the storm prevented longer disruptions (e.g., sandbagging prevented flooding of the feeder, the control center, and the emergency generator), while on-site staff were properly trained to manually operate system components that failed.

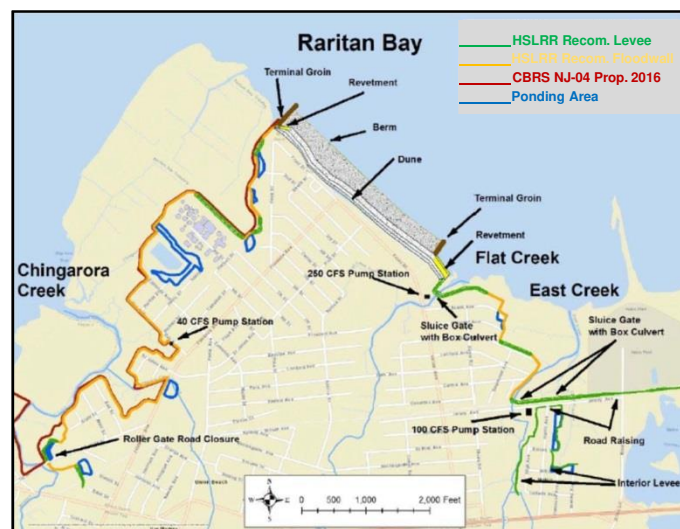
The NJ State issued a report five years after Sandy with: (i) a record of damage and response; (ii) an agency-by-agency response/recovery playbook applicable to other states exposed to hurricanes; and (iii) rebuild measures co-funded by FEMA, the Departments of Interior and Housing and Urban Development (HUD), and Federal Highway Administration (FHWA), such as: Sea Bright wall, Mantoloking and Brick sheet piling, Belmar Lake Como discharge, Brigantine pump stations, Little Ferry tide gate, and Wildwood/Stone Harbor storm water/flood control. The Union Beach project in Raritan Bay (Fig. 29) would rebuild beaches and dunes and restore 100,000 m<sup>2</sup> (25 acres) of degraded wetlands to better absorb flood waters, with levees, flood walls, tide gates, and pump stations.

Figure 29. Union Beach plan overview from U.S. Army Corps of Engineering Limited Reevaluation Report (USACE, 2017).

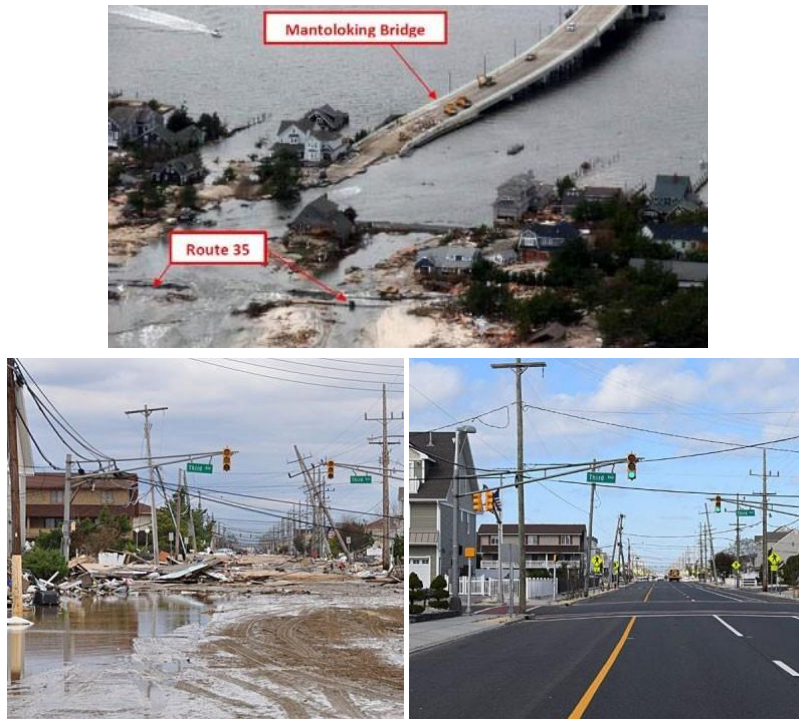
Figure 30. Rt 35 during Sandy (top); before/after photos at 3<sup>rd</sup> Ave, Ortley Beach (bottom, C. Raia, Toms River Township).

An example of a completed project is the \$340M Rt35 Reconstruction, which was a severely-damaged coastal emergency evacuation route that has since been rebuilt with state-of-the-art road construction and a thorough storm water drainage system (Fig. 30).

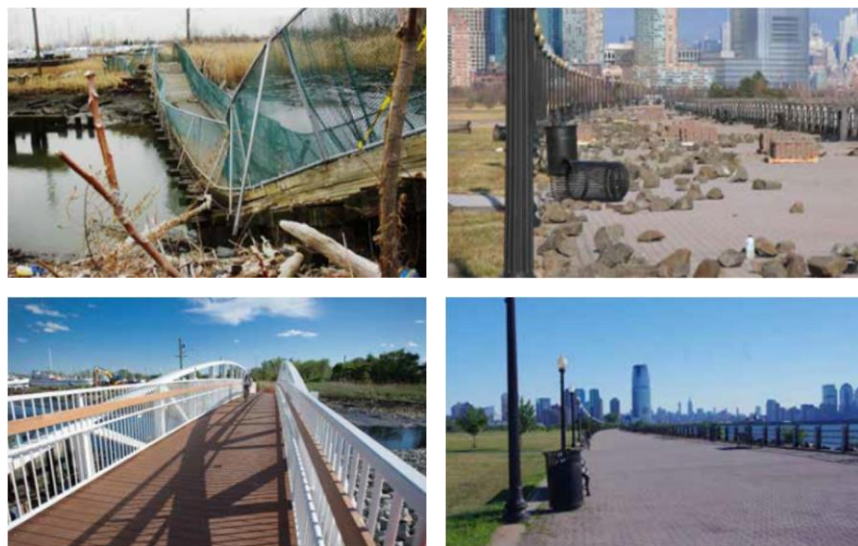
Figure 31. Liberty State Park (40.703100°N, 74.053700°W) before (top) and after rebuild (bottom).  
Photos by NJ State (2018).

Billions were invested to strengthen the electric and gas distribution networks toward a more resilient energy utilities grid. Advanced technologies were implemented to spot outages faster and deploy repair crews more efficiently. These projects increase the reliability of utility services, but also boost the NJ economy by creating new jobs. Investments in continuing the functionality of small businesses supported the tourism, which reached 98M in 2016 (breaking the 87M record of 2013). Intense efforts were made to reopen all parks within three months of Hurricane Sandy's passing, despite the enormous damage done across the entire state park system (Fig.31).

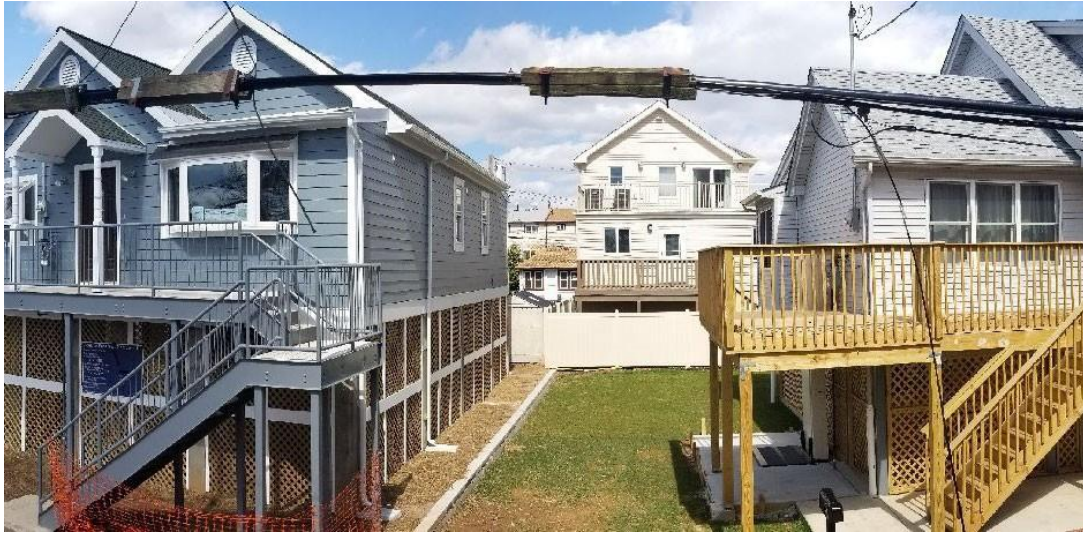
The Build It Back (BIB) program assisted 8,600 homeowners, landlords, and tenants of one- to four-unit homes affected in NYC boroughs by rebuilding homes damaged or destroyed by Sandy in the fall of 2018. The goal was to invest and create resilient neighborhoods through sustainable design, e.g. by requiring new homes to be elevated above projected sea level rise and flood heights. The program was funded by HUD's Community Development Block Grant (CDBG) to rebuild and elevate homes to current stringent flood regulations (Fig. 32) for 12,500 families. Additional support was provided to homeowners with moderate repair needs or without flood insurance, while a few low-income, households received rental assistance (HUD, 2018). Geotechnical considerations included foundations for the elevated homes designed to resist undermining by future flood events. The new foundation systems included jacked or drilled piles as well as the choice to leave open space below the structures to allow for flow.

Figure 32. Build It Back elevated homes in New Dorp Beach, Staten Island (NYC Housing Recovery, 2018).

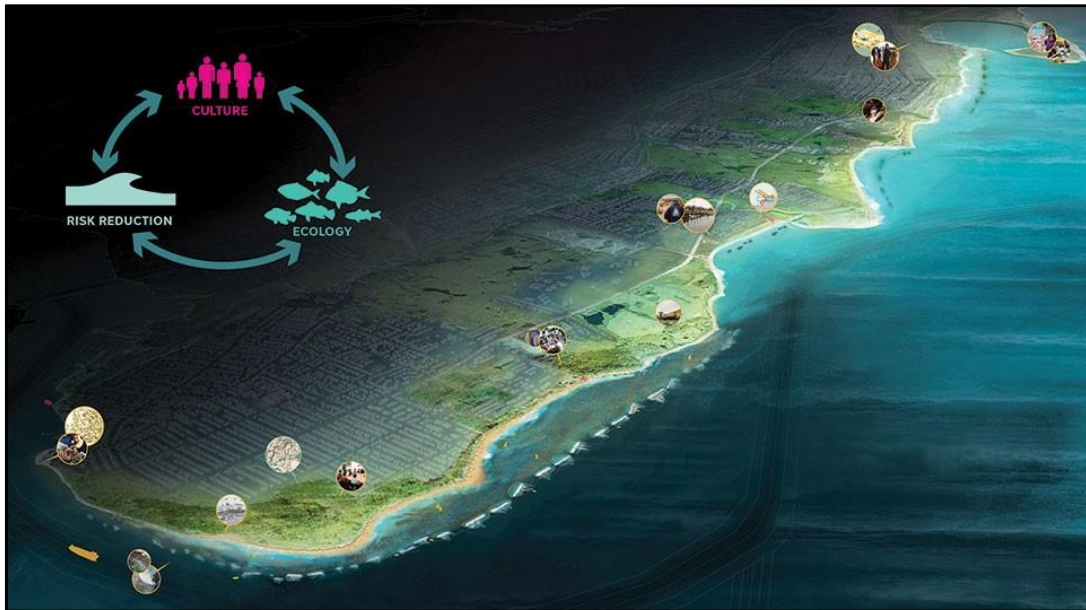
Figure 33. Living Breakwaters concept (SCAPE Landscape Architecture).
