## Geotechnical Effects and a 6-Year Outlook of the 2012 Hurricane Sandy in the Eastern United States

**ABSTRACT:** Hurricane Sandy was the deadliest and most destructive event of the 2012 Atlantic hurricane season. It originated as a storm off the coast of West Africa that turned into a tropical wave in the southwestern Caribbean Sea, and then into a hurricane that moved slowly north along the United States East Coast. Numerous regional coastal communities and urban centers in New Jersey (NJ) and the New York City (NYC) metropolitan area experienced widespread flooding, extreme winds, and heavy damage that disrupted daily life and business in Lower Manhattan, the world's financial capital. Consequences with great geotechnical engineering interest include: (i) modification of the regional coastal geomorphology due to storm surge, with the birth of new inlets, erosion, scour of soil at the shorelines; (ii) damage in coastal communities that revealed the vulnerability of residential building foundations not designed according to modern flood protection standards; and (iii) interruption of service of buried structures and below ground infrastructure due to flood damage to non-structu

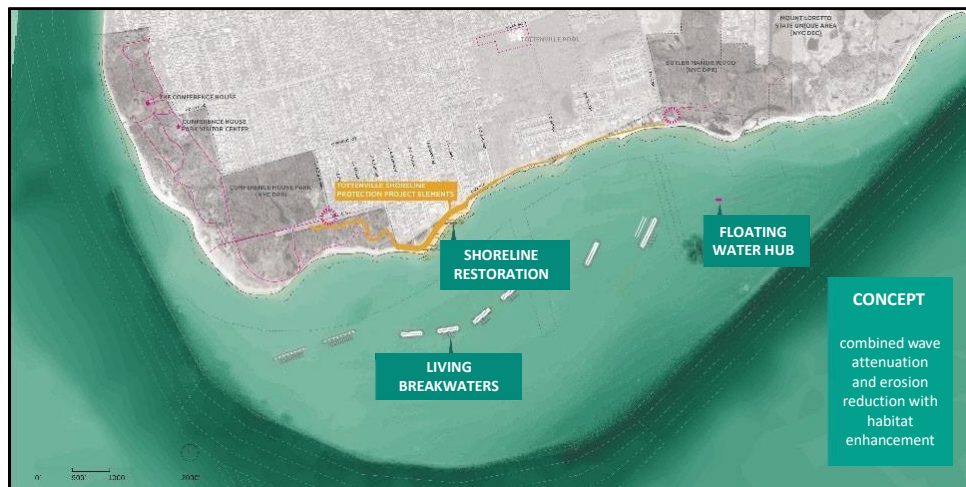
added to the shoreline will protect vulnerable beaches, while breakwaters work to accrete beach elsewhere (Fig. 34). Similarly, in NJ, Rebuild by Design includes several projects, such as: (i) CDBG (\$380M) projects to be completed by 2022; (ii) Hudson River (\$230M) communities and critical infrastructure flood-resistance structures (e.g., N. Hudson Sewerage Authority); and (iii) protection of Meadowlands (\$150M) Little Ferry, Moonachie, Carlstadt, Teterboro, and S. Hackensack.

Figure 34. Living Breakwaters system: combined wave attenuation and erosion reduction with habitat enhancement.

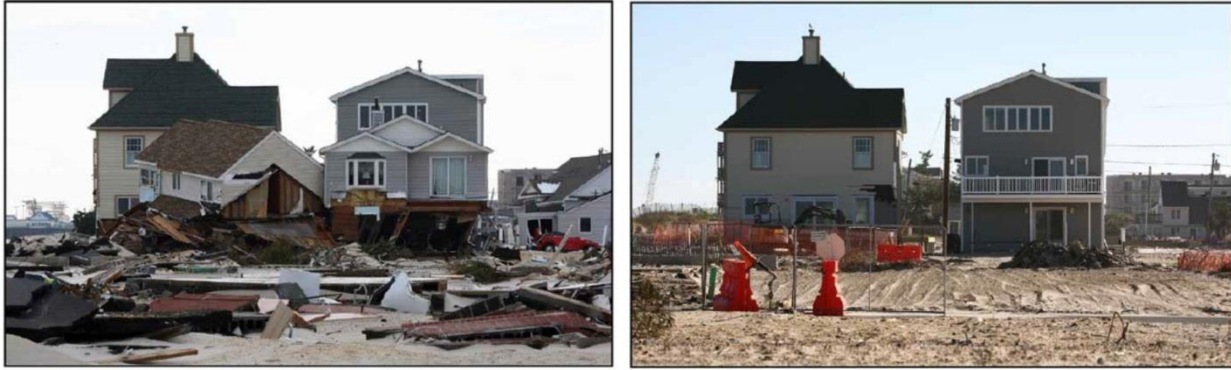
Figure 35. A home at Otely Beach, NJ, before (left) and after(right) rebuilding. Photos by NJ (2017).

In NJ, priority was given to needs for temporary housing assistance, health/social service benefits, and rental/rebuilding resources. The \$1.2B Reconstruction, Rehabilitation, Elevation, and Mitigation (RREM) program rebuilds damaged homes (Fig. 35) using post-Sandy design standards. By 2017, about 6,200 of 7,600 RREM grantees had returned to their homes while the remaining received assistance for mortgage costs or rent payment. Other homes that were flood-prone were sold by willing sellers at pre-Sandy values, allowing families to relocate through DEP's Blue Acres voluntary buyout program that is expanding to other flood-prone areas. These properties are converted to open spaces to serve as a natural buffer for future storms.

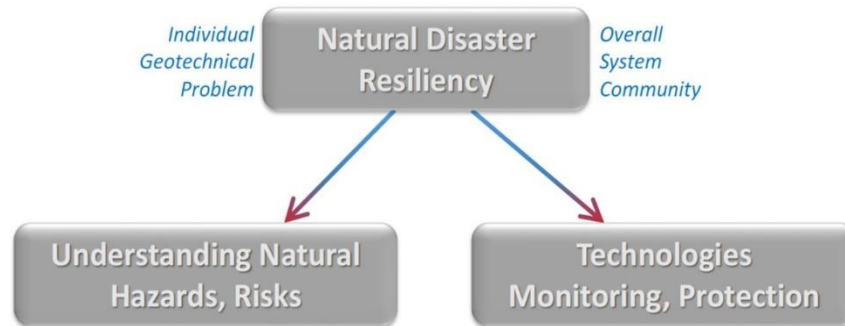
and risk-based engineering framework which considers life cycle costs is needed to address both new infrastructure components and the (often aged) legacy components. A design framework as shown conceptually in Fig. 36 can address both the individual component as well as the overall system needs, while planning for cascading hazards (Nikolaou et al., 2017). The GEER-organized efforts and presentation of data highlighted key flaws, demonstrating to stakeholders and the public that geotechnical engineers should be involved early in the decision-making process after major events such as Hurricane Sandy.

Figure 36. Framework for resilient-based design (Nikolaou et al., 2017).
