Geotechnical Effects and a 6-Year Outlook of the 2012 Hurricane Sandy in the Eastern United States

ABSTRACT: Hurricane Sandy was the deadliest and most destructive event of the 2012 Atlantic hurricane season. It originated as a storm off the coast of West Africa that turned into a tropical wave in the southwestern Caribbean Sea, and then into a hurricane that moved slowly north along the United States East Coast. Numerous regional coastal communities and urban centers in New Jersey (NJ) and the New York City (NYC) metropolitan area experienced widespread flooding, extreme winds, and heavy damage that disrupted daily life and business in Lower Manhattan, the world's financial capital. Consequences with great geotechnical engineering interest include: (i) modification of the regional coastal geomorphology due to storm surge, with the birth of new inlets, erosion, scour of soil at the shorelines; (ii) damage in coastal communities that revealed the vulnerability of residential building foundations not designed according to modern flood protection standards; and (iii) interruption of service of buried structures and below ground infrastructure due to flood damage to non-structural com

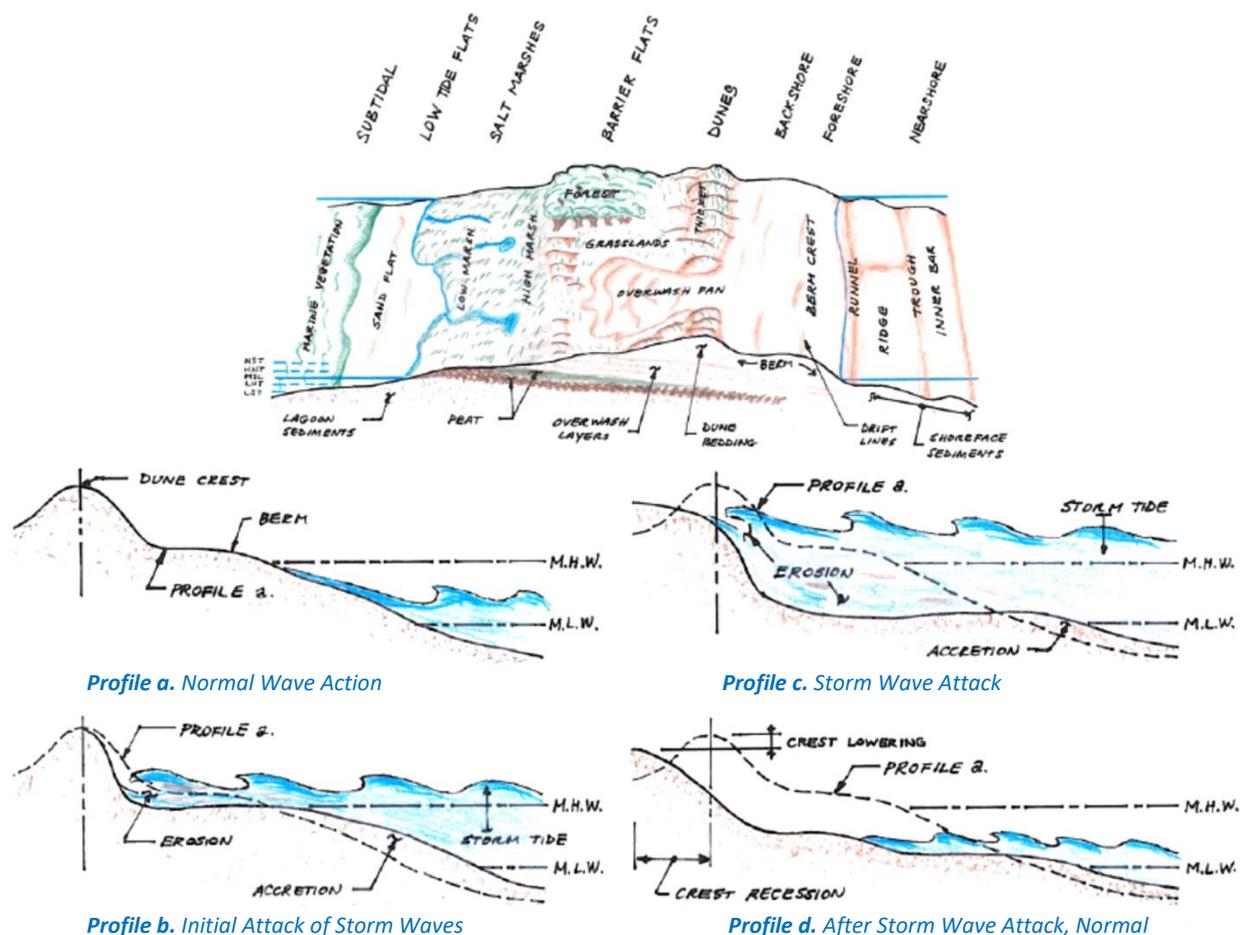
Figure 4. Barrier environments (top) and beach profile changes (bottom) in response to a coastal storm (Refs: A. Dyer from Leatherman, S.P., 1979; Godfrey, 1976; and U.S. Army Corps of Engineers, 1974).

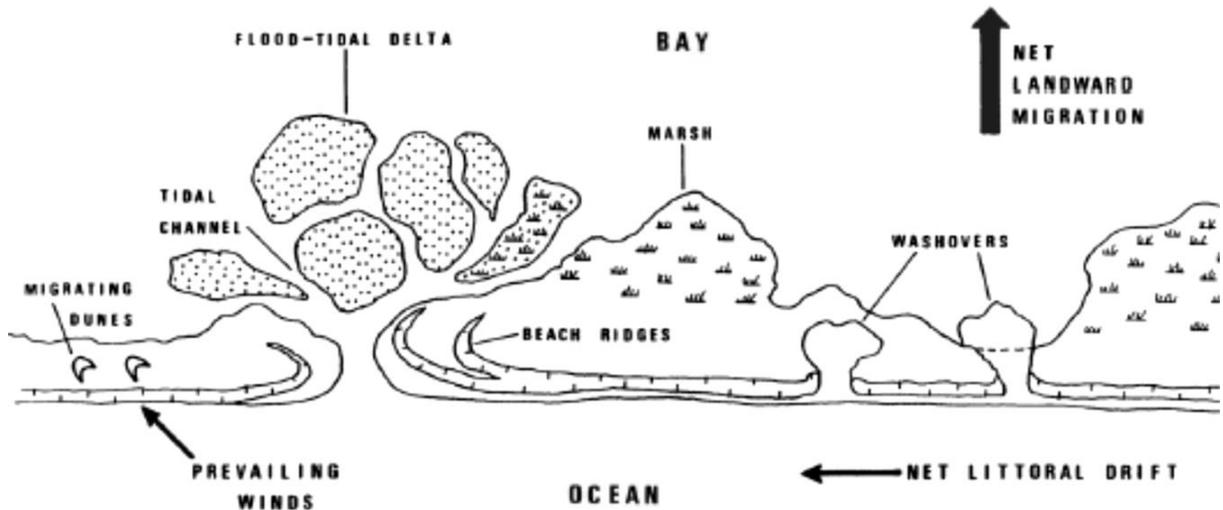
Figure 5. Geologic processes that build up a barrier island, allowing landward migration with sea level rise (Johnson, 1982).

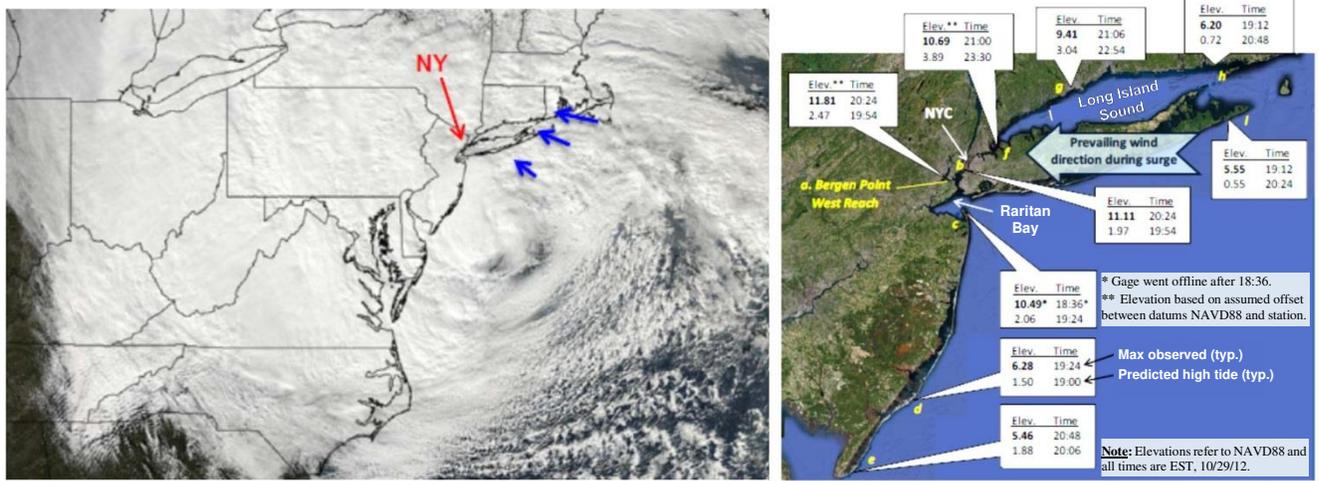
Figure 6. Hurricane Sandy's circulation on 10/29/12 at 2:20 pm EDT; blue arrows show wind direction close to landfall in southern NJ (left; nasa.gov/hurricanes/h2012/Sandy). Observed and predicted tide from NOAA stations (right).

Figure 6 depicts the wind direction, fetch, coastline shape, and normal tidal cycle. The counterclockwise wind currents caused an eastern high velocity wind direction over LI and NYC. This pattern was verified by the GEER team's observation that many of the thousands of fallen trees in LI fell to the west. The following factors contributed to an increase of the surge:

- The westward direction of the winds created a long fetch distance from the east towards Raritan Bay and LI Sound.
- The “constricted” shape of both the Raritan Bay and LI Sound narrowing to the west caused the surge height to increase as it moved into those areas due to a “funneling” effect.
- The slow storm movement resulted in the maximum surge being superimposed above the astronomical high tide.

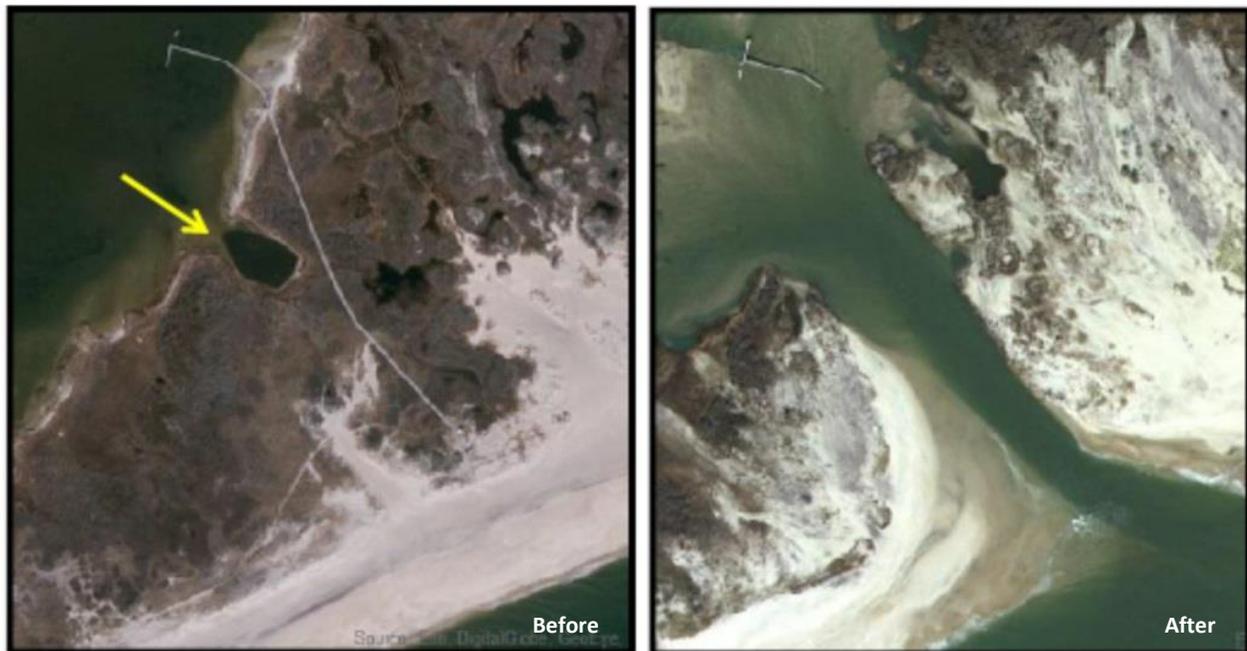
Figure 7. Fire Island, LI: New inlet with narrowing point by embayment in yellow arrow (Ref: tmappsevents.esri.com/).

The storm surge significantly modified the coastal NY/NJ geomorphology, with the birth of new inlets and severe erosion and scour of soil on the shorelines (Fig. 7). While devastating in their path, these effects were largely consistent with predictions.

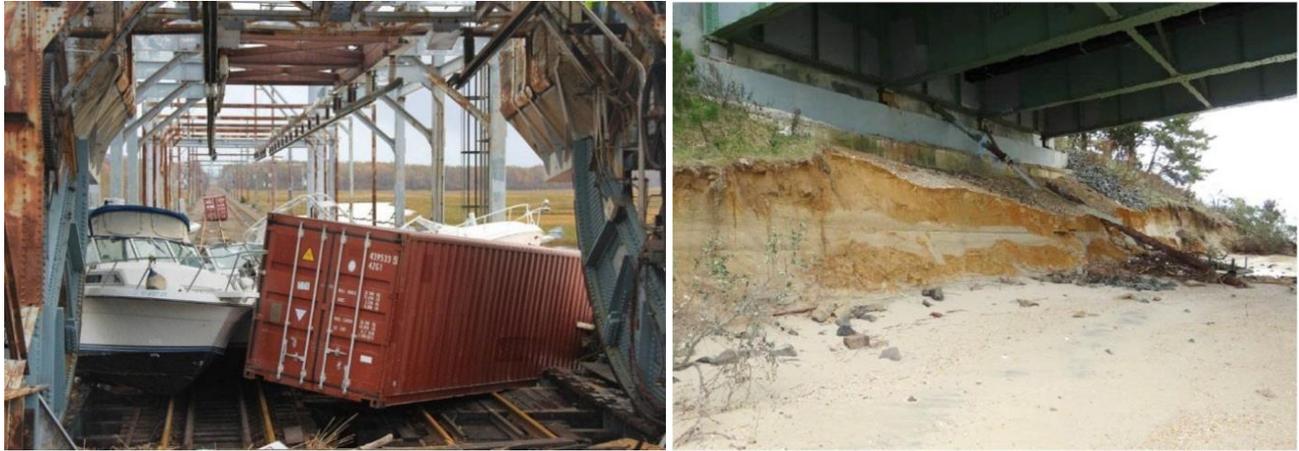
Figure 8. Morgan Drawbridge (left; NJ Transit) and Rt. 72 abutment erosion, looking south-east (right; NJDoT).

GEER observations of seven NJ bridges (NJ 35 - Cheesequake/Manasquan River Drawbridges; Railroad Drawbridge - Manasquan River; NJ 70 - Metedeconk River; NJ 37 - Mathis/Stanley Tunney; NJ 528 - Mantoloking; NJ 72 - Henderson Memorial) and data by the NJ Department of Transportation, Transit Authority, and Ocean County Engineering suggest that bridges remained mostly serviceable immediately or soon after the storm. Two primary themes of damage were identified: (i) flooding effects to drawbridges (e.g., Morgan Drawbridge, Fig. 8) and their electrical systems, and (ii) soil erosion at approaches and abutments (often supported on structures formed by fill within a perimeter soldier pile wall) in several bridges, averaging at 1.5 m (5 ft) of soil removal (e.g., Fig. 8: Rt. 72 Bridge, Fig. 9: Mathis Bridge). The exception was the Mantoloking Bridge that was unserviceable for a long period due to undermining of its abutments and approaches. Figs. 10 and 11 show large floating debris, including houses, that destroyed the T-wall, forcing the coping and sidewalk to cantilever out by about 3 m (10 ft).

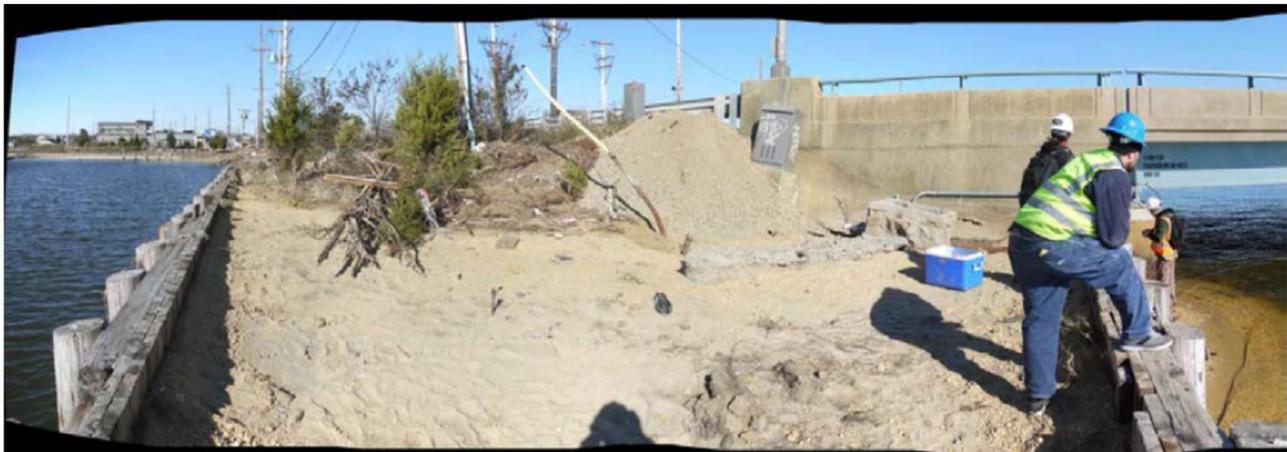
Figure 9. Erosion at Mathis Bridge southwest abutment (eastbound Rt37) ($39.949350^{\circ}\text{N}$, $74.113902^{\circ}\text{W}$; GEER 2014).

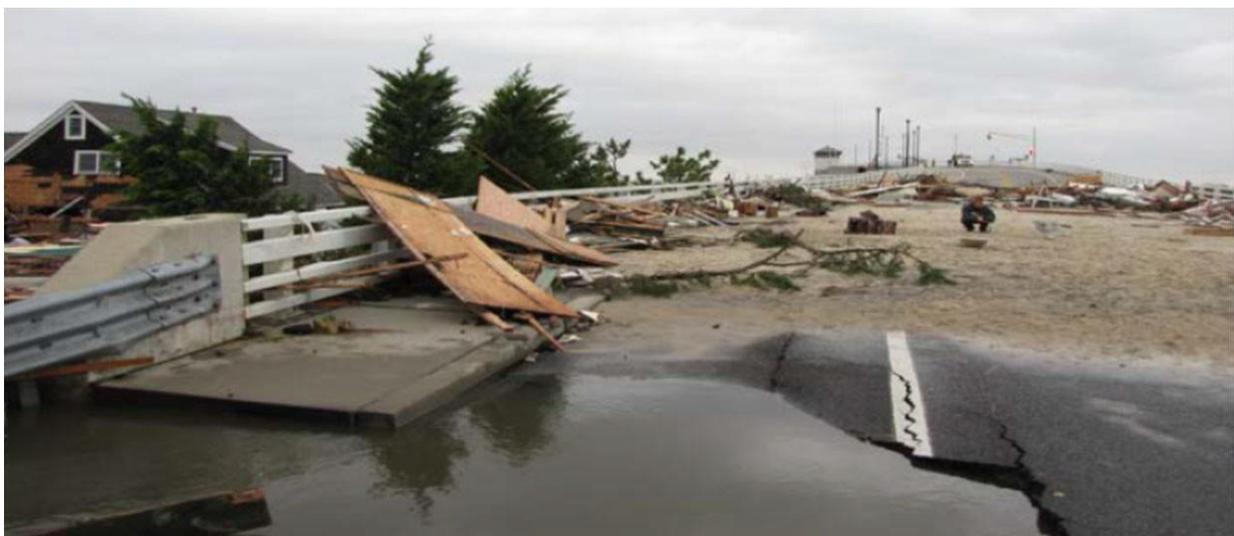
Figure 10. Foundation undermining at east abutment of Mantoloking Bridge ($40.040058^{\circ}\text{N}$, $74.051886^{\circ}\text{W}$; GEER, 2014).

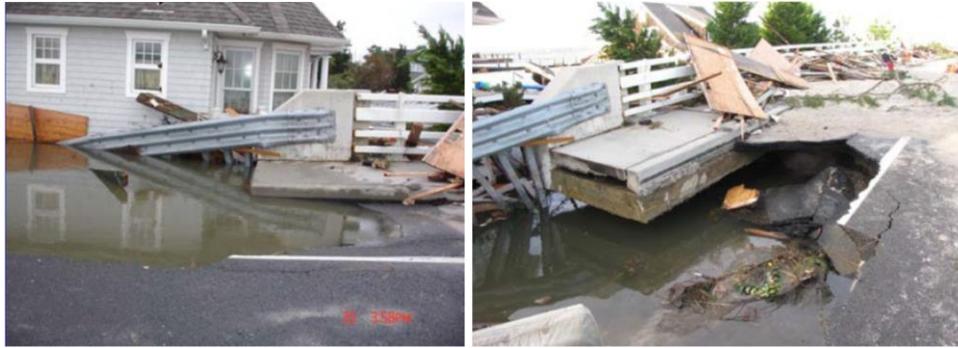
Figure 11. Mantoloking Bridge east abutment erosion (40.040058°N, 74.051886°W, Ocean Ct. Eng., 2012; GEER, 2014).

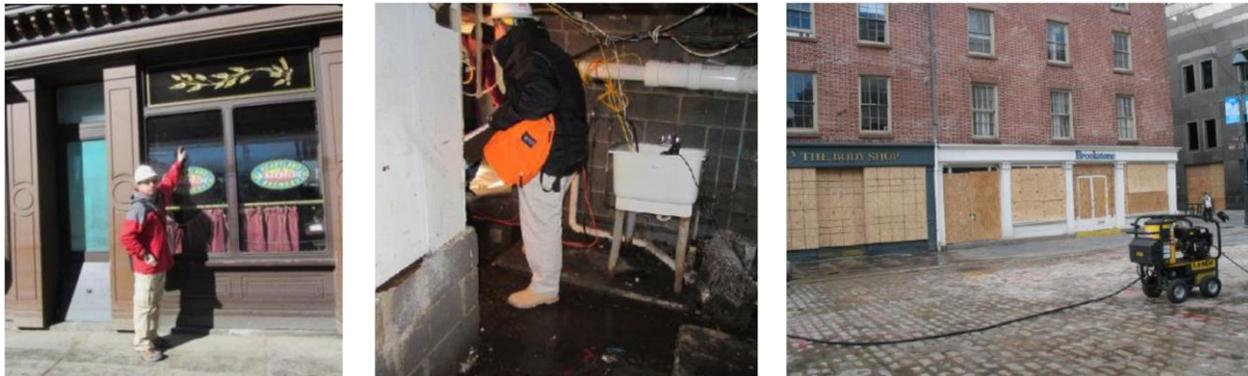
Figure 12. South Street Seaport (40.706685°N, 74.003554°W), 11/4/12: High water line on window of a restaurant (left); typical flooded basement (middle); flood damage (right). (GEER Report, 2014).

Damage in the dense urban NYC area of lower Manhattan was primarily related to flood inundation. High water marks and evidence of flood damage to approximately 1.2-2.1 m (4-7 ft) above street level were observed throughout low-lying neighborhoods (e.g., South Street Seaport) and water front areas (Fig. 12). Below-grade subway stations, tunnels, parking garages, and excavations experienced widespread flooding. While access to many of these locations was restricted to the GEER team due to ongoing recovery work, evidence of flood inundation was visible from the surface, e.g. at the Battery Park underpass and Bellevue Hospital. Based on reports in the days and months following the storm, the flooded tunnels included the Brooklyn Battery, Holland, and Queens-Midtown highway tunnels, the PATH rapid transit tunnels, NJ Transit / Amtrak / LI Railroad Hudson and East River rail, and seven subway tunnels. Several subway stations and open excavations were flooded, including South Ferry, which flooded to the ceiling, as well as an excavation at the World Trade Center site (Figs. 13-14).

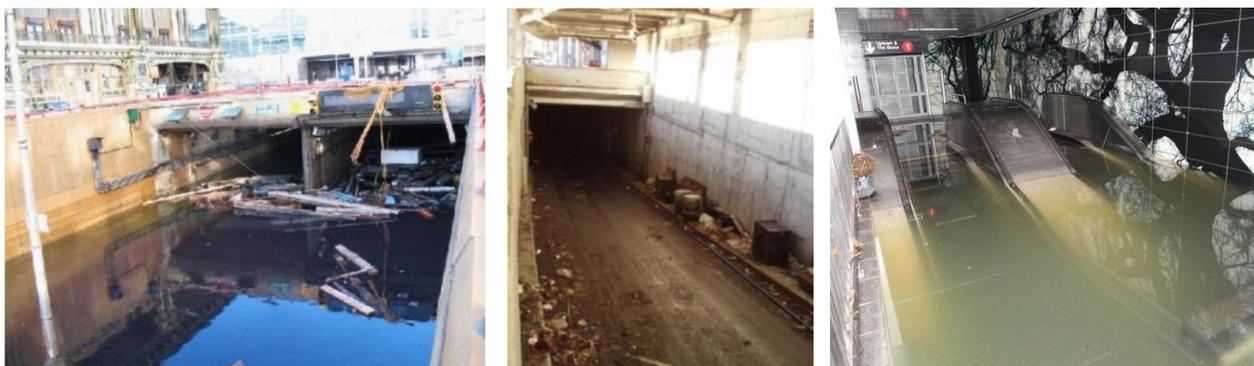
Figure 13. Flooded Battery Park underpass (40.701600°N, 74.011742°W) on 11/4/12 (left, by GEER 11/3/12); E30th St. (40.739830°N, 73.973263°W) Bellevue Hospital (middle, by GEER 11/3/12); South Ferry station (right, by MTA 10/30/12).

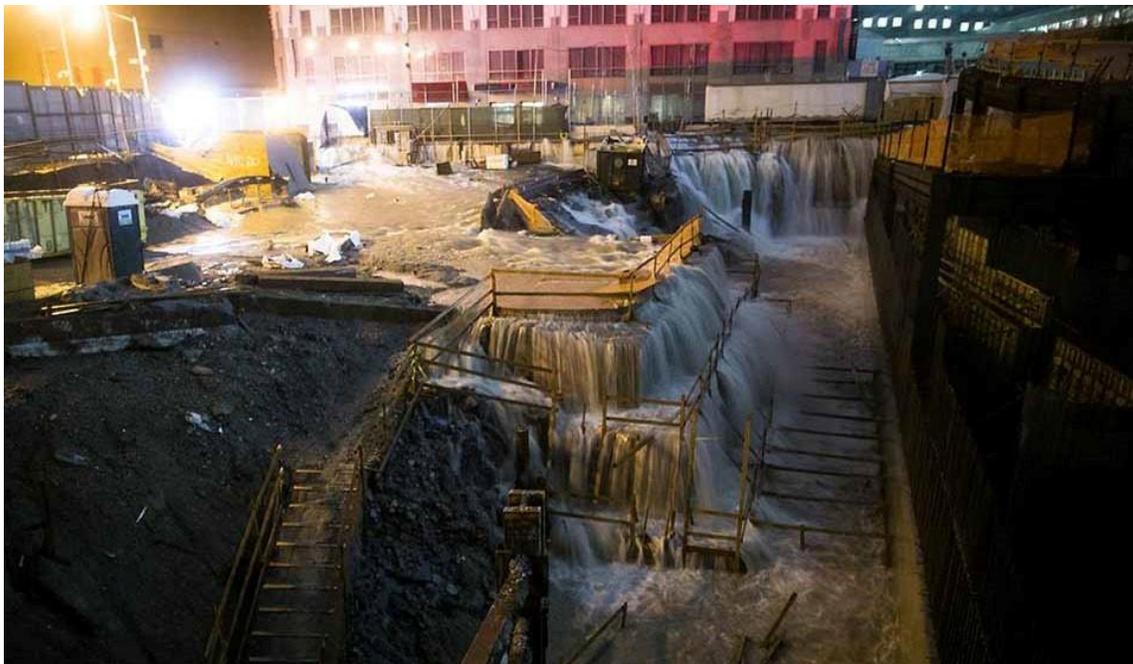
Figure 14. Open excavation flooding at the World Trade Center site (Photo: Associated Press).

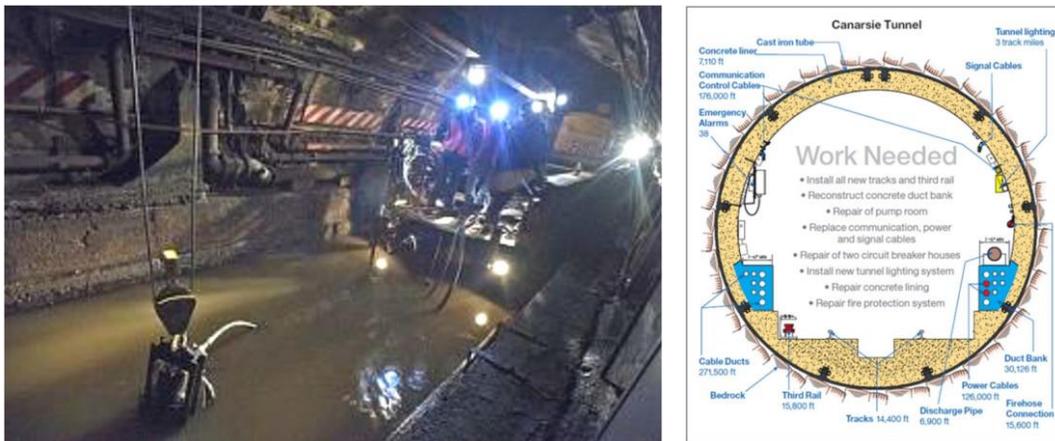
Figure 15. Canarsie tube of [L] line: damage from Sandy (left) and work needed to repair it (right) (MTA, 2017).

While most tunnels experienced minimal structural damage, utilities and ventilation systems were severely damaged and required lengthy repairs. Indicatively, the [R] Montague St. subway and the World Trade Center PATH tunnels were out of service for 2-3 months. The R line was taken out of service again in 2013 for lingering flood damage repairs. The Canarsie Tube of the [L] subway line was inundated with 265,000 m³ (7M gallons) of saltwater that caused corrosion of cabling, circuit breakers, and disabling of power/track equipment. The duct bank alongside the track, which provides walkway for emergency egress, sustained heavy damage and exhibited a partial collapse. With an initial 15-month shutdown plan, a complete overhaul is still necessary today, in 2020 (Fig. 15), as the L line is critical with a large portion of its daily 400,000 riders travelling to 14th Street stations, some of which are not easily reached by other lines. The Queens [A] Rockaway subway line was out of service for nearly seven months due to two major washouts at the earth embankment crossing Jamaica Bay, which exposed the old Long Island Rail Road (LIRR) infrastructure (Fig. 16).

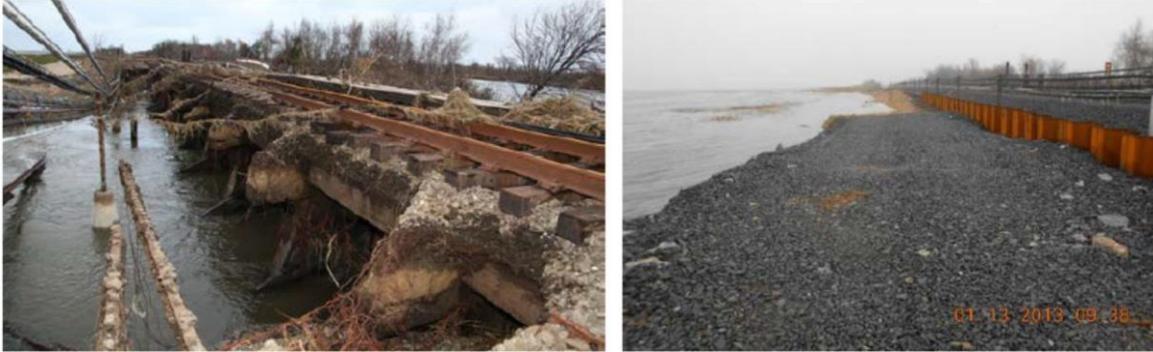
Figure 16. Earth embankment washouts in Queens, along Rockaway subway [A] line after Sandy with old LIRR infrastructure exposed (left) and post mitigation work (right). Photos by Khinda, ed. (2013).

NYC flooded tunnels and re-opening dates are presented in Table 1 (from Kaufman et al., 2012; Khinda, 2013; North American Tunneling Journal, 2012; and other news media reports). Underground grid utilities were also affected, including power, telephone, and telecommunications (internet and cable TV). The map of lower Manhattan on Table 1 shows flooded tunnels along with the historic shoreline (Viele, 1865) and the limit of the Sandy flood inundation line (O'Rourke, 2012).

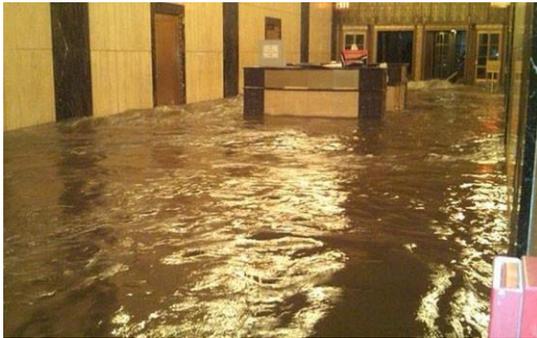
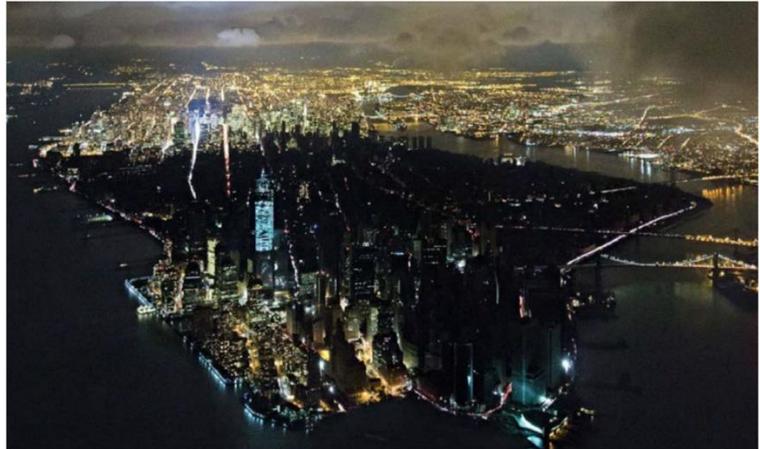
Figure 17. Flooded lobby of the Verizon building (left, Photo by Governor A. Cuomo); Power outage south of 34th St., 10/29/12 in Lower Manhattan which lasted for four days (right, Photo by I. Baan, NY Magazine).

generating capacity south of 34th St. for four days, thus causing severe delays to the recovery effort and the restart of subways (Fig. 17).

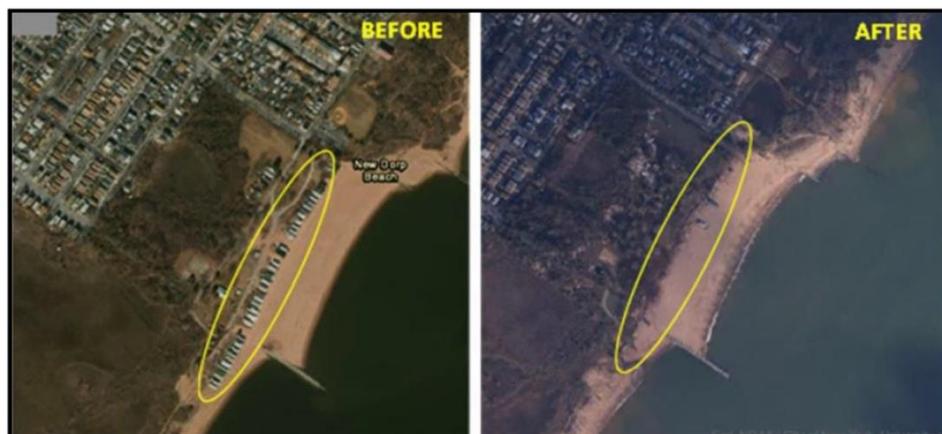
Figure 18. Aerial photographs from New Dorp Beach, SI, before and after Sandy. Row of houses completely removed and debris moved inland. (Images from tmappsevents.esri.com/website/swipe_sandy/).

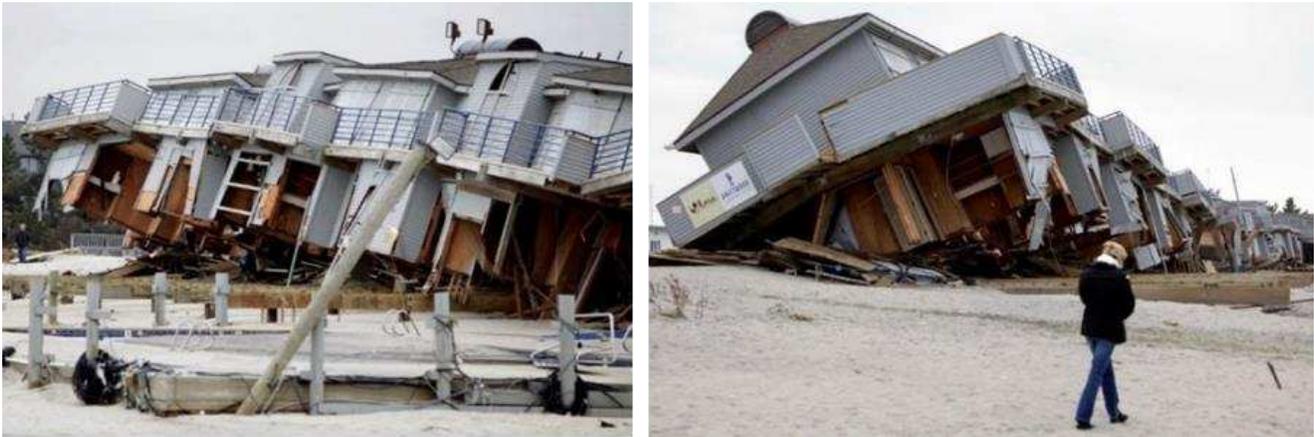
Figure 19. Sea Bright, NJ, beach cabana (40.350086°N, 73.972954°W) pulled off its base (Photo by AP/Wenig; 11/19/12).

A common damage pattern among wood frame houses was the pulling off their foundation due to inadequate anchorage (e.g., Sea Bright, NJ, Fig. 19). These house were subject to flotation, which not only causes distress, but removes dead load from foundations, making them more susceptible to breakage. Particularly, Concrete Masonry Unit (CMU) wall foundations and piers performed poorly, and were found buckled, broken, or completely removed, causing tilt, dislocation, or collapse of the superstructure (Fig. 19). In Sea Gate, Brooklyn, a concrete beachfront retaining wall foundation was undermined by erosion and subsequently broke, while the soil behind the wall was washed out (Fig. 20). In Breezy Point and Roxbury, Queens, two-story wood-frame homes, on CMU block wall and pier foundations, sustained major structural damage, including being pulled off their partially or completely destroyed foundations (Fig. 20). On the other hand, foundations of high-rise residential buildings (typically piles) generally performed well.

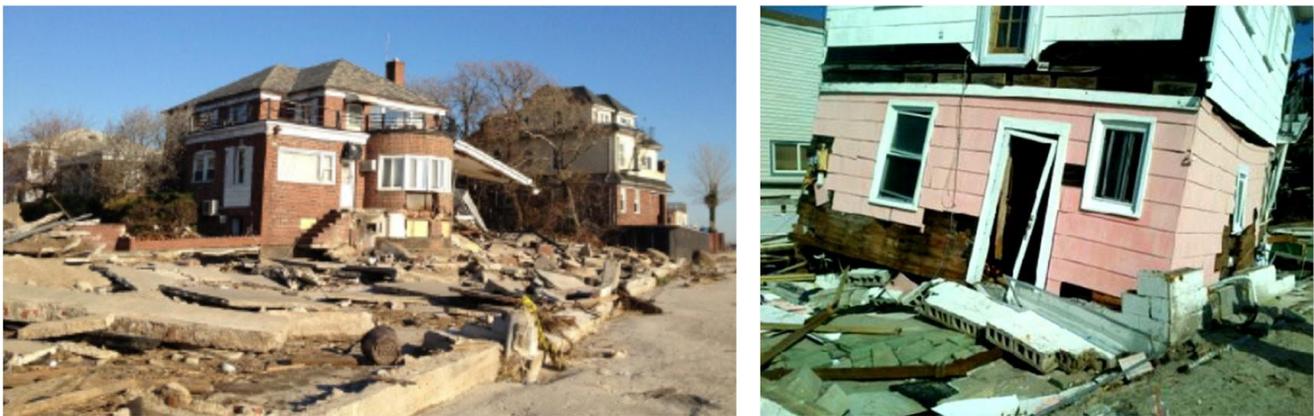
Figure 20. Undermining of beachfront retaining wall and loss of retained soil, Sea Gate, Brooklyn (left, 11/9/12); Destroyed CMU wall foundation, Breezy Point, Queens (right, 11/12/12). Photos by NYCDob (GEER, 2014).

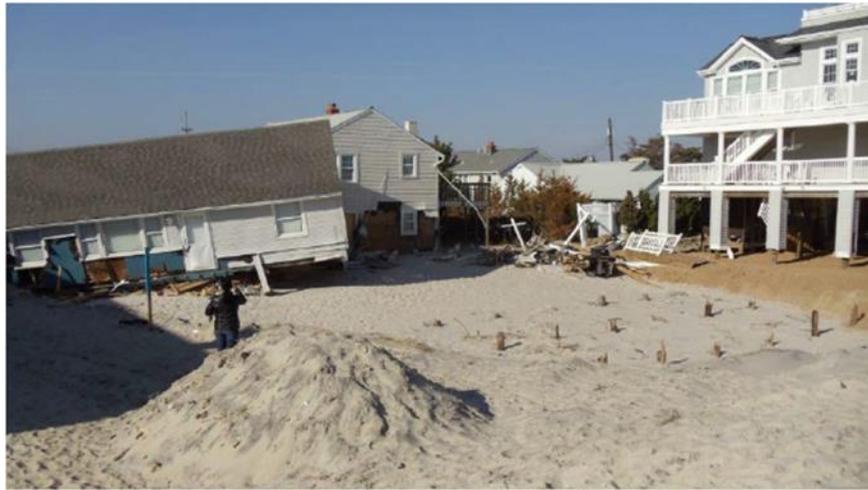
Figure 21. Timber piles remain in place after a home was sheared off in Pehola Park (39.610016N, 74.206657W, GEER, 2014).

A spectacular failure was observed by the GEER team at a two-story home at Pehola Park, Long Beach Island, which was sheared off its piles due to storm surge forces as well as wave action. Only the upper story of the home was visible, found near its original location. The site's approximate ground elevation was 2.35 m (7.7 ft) and the high-water mark was about 0.7 m (2.3 ft) above ground. The surrounding homes were intact, with the only difference being that this home was at a lower elevation than the others (Fig. 21). This pattern of lower story disappearance and/or flattening was observed in other areas as well.

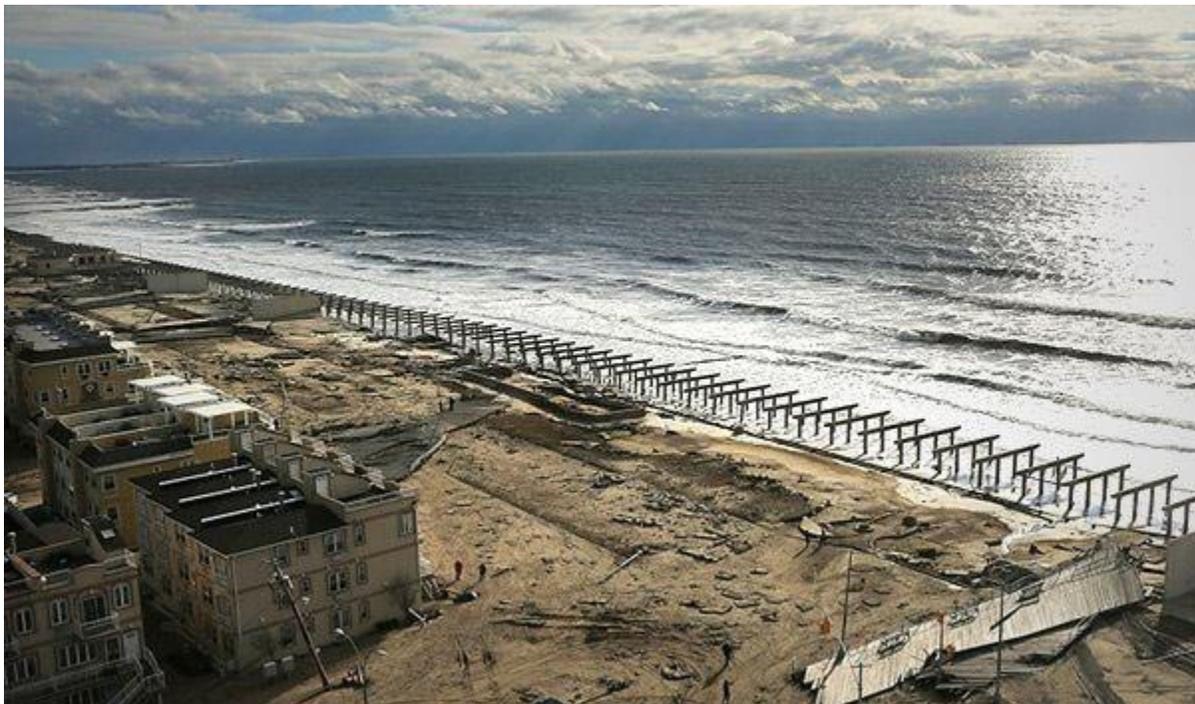
Figure 22. Damage to Boardwalk at Rockaway Beach, Queens (40.583445°N, 73.81553°W). Photo by cnbc.

concrete pile-supported wooden boardwalks, and some homes are separated from the beach by concrete or sheet pile retaining walls. In Rockaways, Queens, the boardwalk had been lifted off its piers and damaged or destroyed over its entire length, with debris carried up to 60 m (~200 ft) inland (Fig. 22).

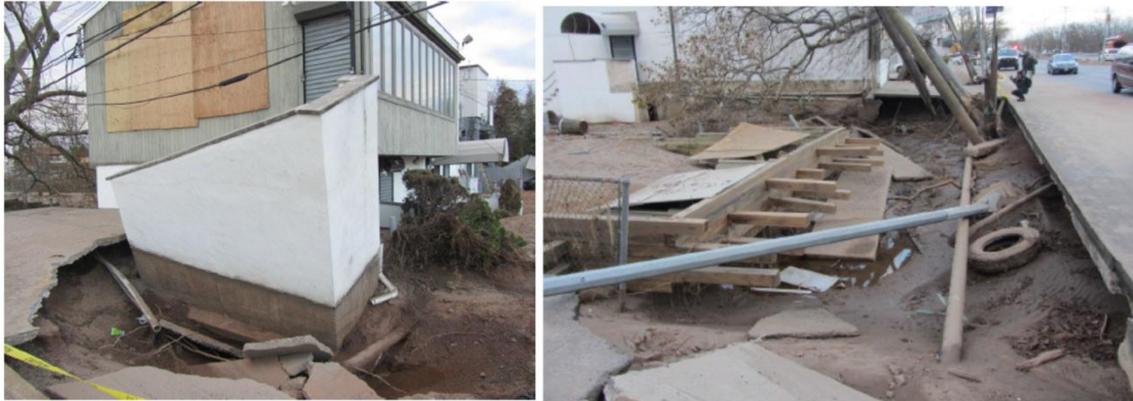
Figure 23. Scour undermining at Seaver Ave & Father Capodanno Blvd, SI (40.575944° N, 74.083015° W, 11/4/12). Damage to stair foundation and drain (left) and sidewalk, utilities, and light pole foundation (right). Photos by GEER (2014).

Severe soil erosion was observed along Father Capodanno Blvd in Midland Beach, Staten Island (SI), where sinkholes undermined the street, curb line, sidewalks, utility poles, and house foundations (Figs. 23, 24). Throughout the area, wood decks, trees, cars, and other debris had been deposited inland. Concrete wall foundations generally sustained little or no structural damage, though they sometimes experienced erosion and scour along their perimeter.

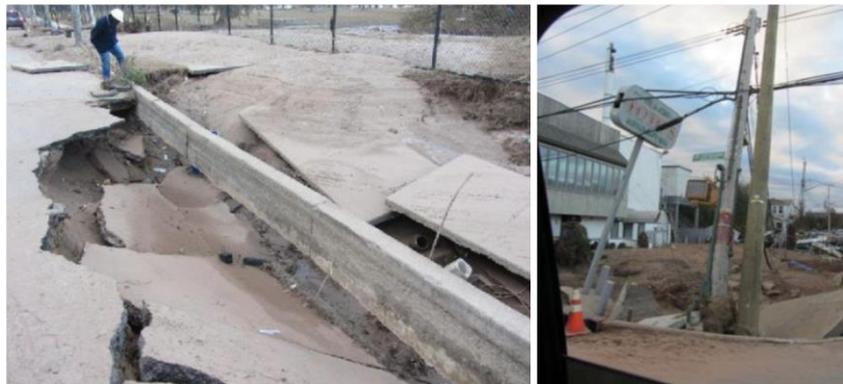
Figure 24. Scour undermining of street and utilities at Seaview Blvd, SI (40.579283°N, 74.077849°W, 11/4/12, GEER, 2014).

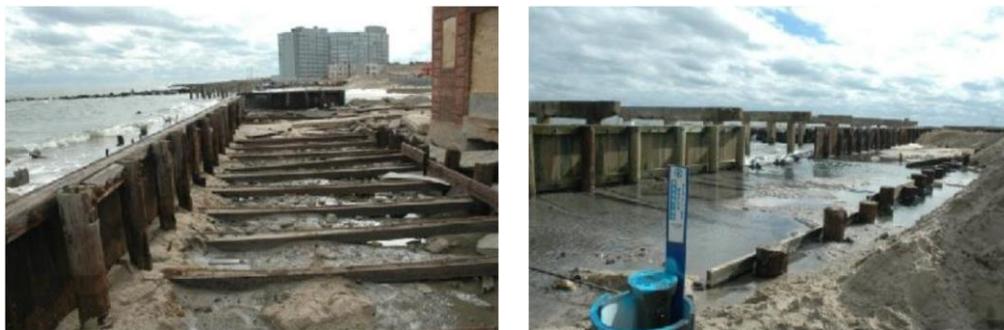
Figure 25. Bulkhead in Atlantic City, NJ: backfill soil washed away, exposing severely corroded tie rods (GEER, 2014).

along a section of the shore in Atlantic City, NJ, were breached.. The breaches were attributed to the destruction and washing away of the timber facing . The surge and water washing through the breaches exposed the tierods and anchors (Fig. 25).

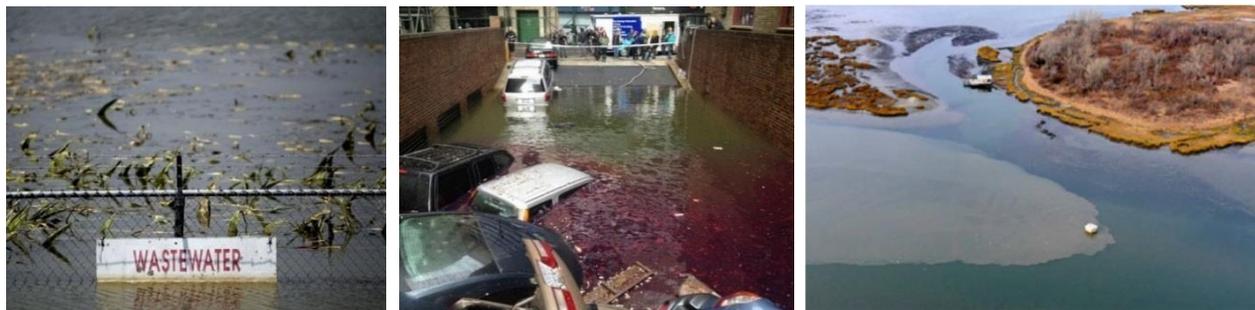
Figure 26. Untreated waste spilled in NY Harbor (left, photo Getty/Tama) and buried cars (middle, photo Bloomberg/Korby). Overflow from Bay Park Sewage Treatment Plant, East Rockaway (right, photo by D. Kuntz; Kenward et al., 2013).

to shut down or divert sewage into waterways due to power outages and flooding (e.g., Fig. 26 shows untreated waste spilled in the LI South Shore Estuary from the Bay Park Sewage Plant in East Rockaway). GEER visited the WWTP that processes waste water from Yonkers. Founded on filled land along the east bank of the Hudson River, it experienced one of the largest overflows with 4.5M m³ (1.2B gallons). The river frontage has a rip-rap revetment at the south and a steel seawall (Fig. 27) about 1.5 m (5 ft) higher than the north rip-rap. Normally, the plant handles daily 360 m³ (95M gallons) of waste water; during in Hurricane Irene in 2011, it processed 1,150 m³ (300M gallons). After Sandy, loss of gravity flow caused more than 2.8 m (9 ft) of tail water and therefore flooding of below-grade areas (Fig. 27), something that damaged equipment including boilers, the alarm system, pipes, and motors.

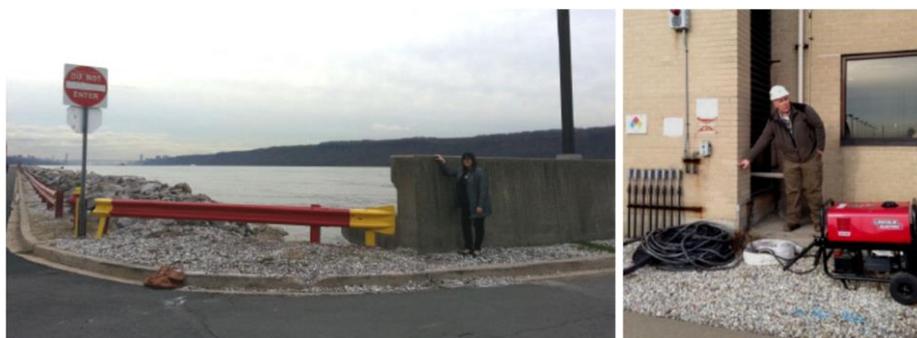
Figure 27. Yonkers Joint WWTP: junction of rip-rap revetment and seawall, looking south (left); vent grates in aeration blower building where water entered, with flood water elevation shown by plant superintendent (right); GEER (2014).

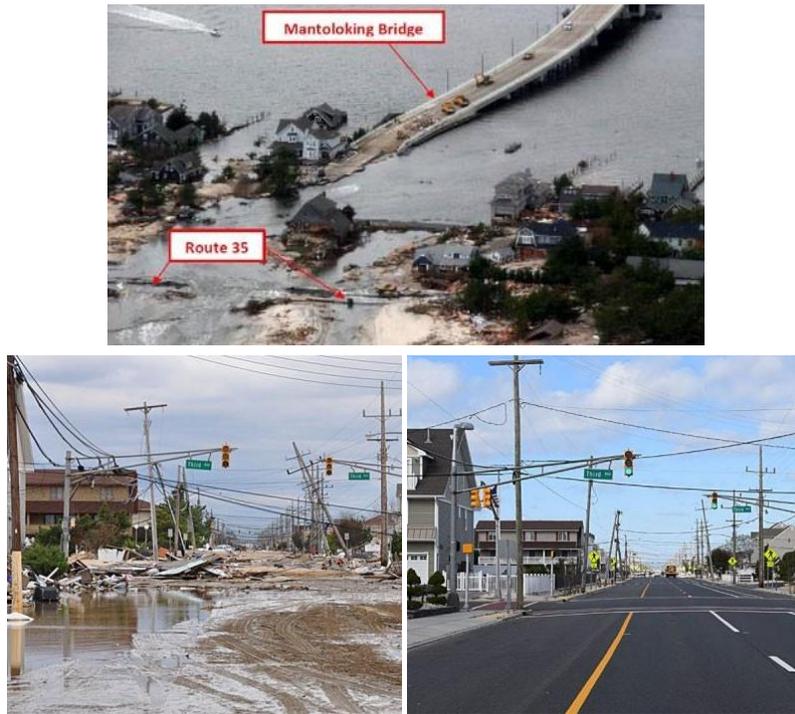
Figure 30. Rt 35 during Sandy (top); before/after photos at 3rd Ave, Ortleigh Beach (bottom, C. Raia, Toms River Township).

An example of a completed project is the \$340M Rt35 Reconstruction, which was a severely-damaged coastal emergency evacuation route that has since been rebuilt with state-of-the-art road construction and a thorough storm water drainage system (Fig. 30).

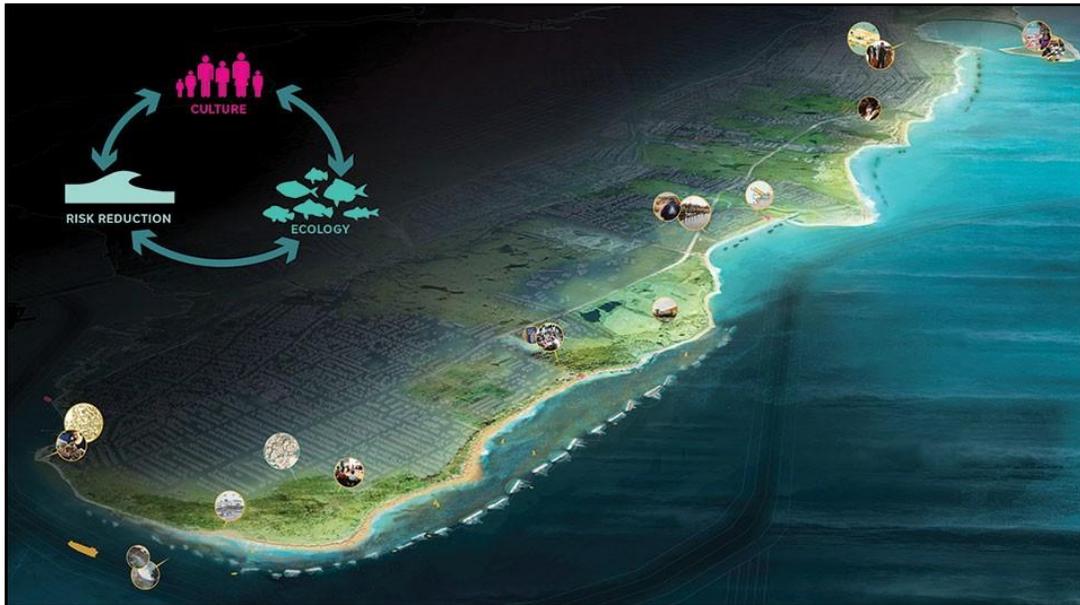
Figure 33. Living Breakwaters concept (SCAPE Landscape Architecture).

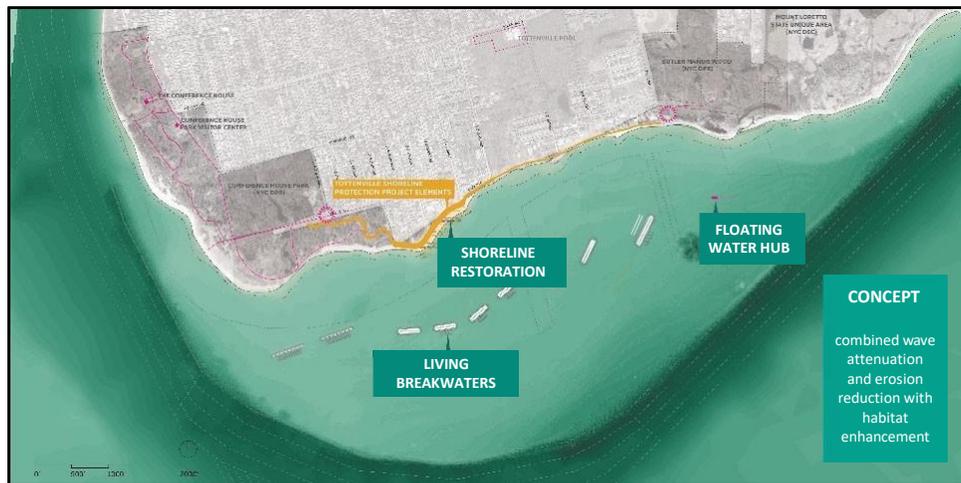
Figure 34. Living Breakwaters system: combined wave attenuation and erosion reduction with habitat enhancement.

added to the shoreline will protect vulnerable beaches, while breakwaters work to accrete beach elsewhere (Fig. 34). Similarly, in NJ, Rebuild by Design includes several projects, such as: (i) CDBG (\$380M) projects to be completed by 2022; (ii) Hudson River (\$230M) communities and critical infrastructure flood-resistance structures (e.g., N. Hudson Sewerage Authority); and (iii) protection of Meadowlands (\$150M) Little Ferry, Moonachie, Carlstadt, Teterboro, and S. Hackensack.

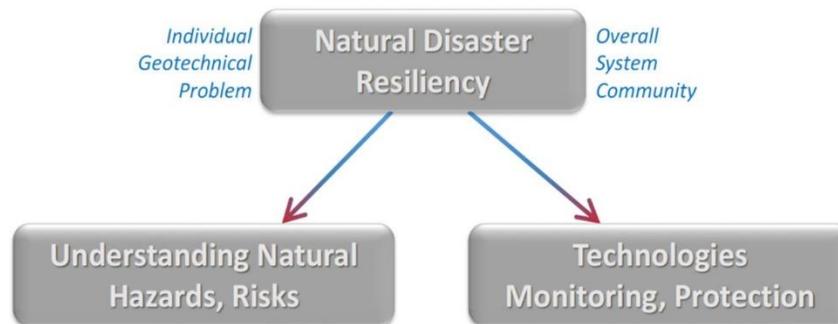
Figure 36. Framework for resilient-based design (Nikolaou et al., 2017).

and risk-based engineering framework which considers life cycle costs is needed to address both new infrastructure components and the (often aged) legacy components. A design framework as shown conceptually in Fig. 36 can address both the individual component as well as the overall system needs, while planning for cascading hazards (Nikolaou et al., 2017). The GEER-organized efforts and presentation of data highlighted key flaws, demonstrating to stakeholders and the public that geotechnical engineers should be involved early in the decision-making process after major events such as Hurricane Sandy.
