Geotechnical Effects and a 6-Year Outlook of the 2012 Hurricane Sandy in the Eastern United States

ABSTRACT: Hurricane Sandy was the deadliest and most destructive event of the 2012 Atlantic hurricane season. It originated as a storm off the coast of West Africa that turned into a tropical wave in the southwestern Caribbean Sea, and then into a hurricane that moved slowly north along the United States East Coast. Numerous regional coastal communities and urban centers in New Jersey (NJ) and the New York City (NYC) metropolitan area experienced widespread flooding, extreme winds, and heavy damage that disrupted daily life and business in Lower Manhattan, the world's financial capital. Consequences with great geotechnical engineering interest include: (i) modification of the regional coastal geomorphology due to storm surge, with the birth of new inlets, erosion, scour of soil at the shorelines; (ii) damage in coastal communities that revealed the vulnerability of residential building foundations not designed according to modern flood protection standards; and (iii) interruption of service of buried structures and below ground infrastructure due to flood damage to non-structural com

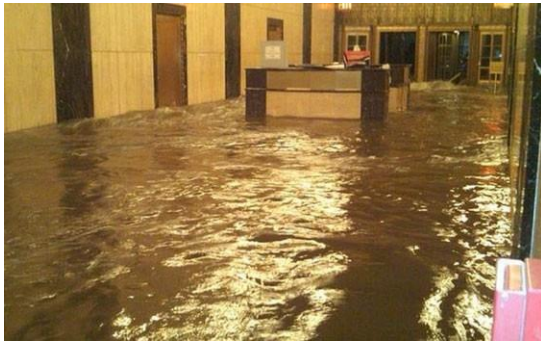
The storm surge exceeded predictions and caused unprecedented damage to the infrastructure of Consolidated Edison (Con Ed), which supplies electricity to nearly all of NYC's 3M customers (representing 8.3M people and 250,000 businesses) and provides 41% of the city's natural gas service. Precautionary measures were taken, including sand bags and "aqua dams" (polyethylene berms filled with water) at substations and vaults, pre-emptive de-energizing of equipment, isolation of 26 steam main segments, and the pre-emptive shutdown of the East River generating station and the Brooklyn Navy Yard co-generation steam plants. Still, the East River, E13th St., and Seaport substations were flooded, resulting in the loss of almost a third of NYC's

generating capacity south of 34th St. for four days, thus causing severe delays to the recovery effort and the restart of subways (Fig. 17).

Figure 17. Flooded lobby of the Verizon building (left, Photo by Governor A. Cuomo); Power outage south of 34th St., 10/29/12 in Lower Manhattan which lasted for four days (right, Photo by I. Baan, NY Magazine).
