# Scour at the Seawall in Surfside, Texas, During Hurricane Harvey (2017)

**ABSTRACT:** Hurricane Harvey was a Category 4 hurricane on the Saffir-Simpson hurricane wind scale. National Oceanic and Atmospheric Administration (NOAA) water level gages documented 1.1 m of water level elevation over predicted tide in Freeport, Texas, on 25 – 26 August 2017. The NOAA wave buoy 42019 offshore off Freeport documented wave heights > 7 m. A reconnaissance team of the Geotechnical Extreme Events Reconnaissance (GEER) Association visited Surfside, Texas, on 3 September 2017. While no significant damage to infrastructure was observed, the GEER team identified a significant scour runnel parallel to the Surfside seawall. The purpose of this article is to present the detailed observations of the scour runnel parallel to the Surfside seawall during Hurricane Harvey (2017). The sloped seawall is separating a shore-parallel street from the beach and is composed of angular boulders of approximately 30-50 cm in diameter. The observed runnel represented a depression of up to ~ 0.3 m in depth and ~ 4 m in width. It maintained mostly a distance of 0-5 m from the visible toe of the seawall. Boulders seeme

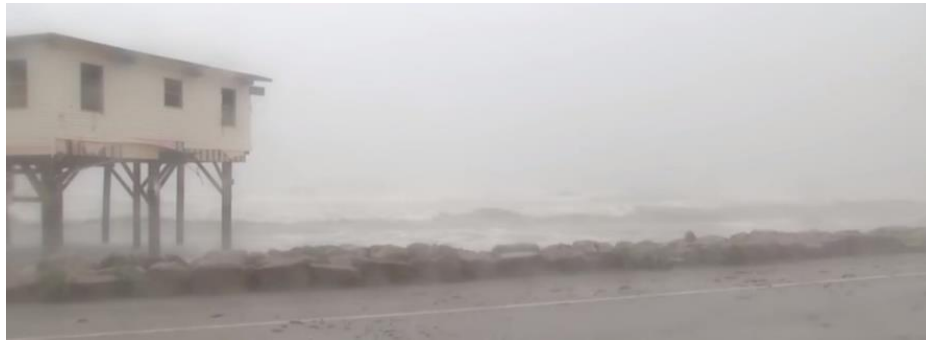
Figure 13. Screenshot from video footage from Surfside Beach on yearday 237 extracted and modified after Henry (2017).

Sumer and Fredsoe (2002) depicted different flow processes leading to two-dimensional scour at seawalls: wave breaking near the wall, wave breaking on the wall, wave reflection, and overtopping of the seawall. News outlets presented video footage from Surfside Beach from yearday 237 with no visible overtopping of the seawall, but rather waves breaking offshore of the beach house structures (Fig. 13). While the video footage provided limited images of the beach, it suggested that wave breaking on the wall and overtopping of the seawall were unlikely. Even wave breaking near the seawall seems unlikely based on the video footage, the shallow water conditions, and an overall flat nearshore slope. Therefore, wave reflection after initial wave breaking may be a likely mechanism. Sumer and Fredsoe (2002) depicted that in the case of a rubble-mound breakwater and dominant bedload transport, sediment deposition (formation of a ridge) occurs at the nodes of a standing wave resulting from wave reflection. Nodes and antinodes (i.e., runnel and ridge) have a distance of a quarter of a wave length, and in the case of a sloped rubble-mound wall the first antinode in contact with the wall is practically located on the sloped surface of the seawall. This means the seawall slope impacts the location of the runnels and ridges. Furthermore, sediment suspension changes the organization pattern. However, dominant near-bed transport may be an acceptable assumption, considering the shallow water depth. Another impact on the ridge-runnel profile is wave irregularity, which also likely contributed to the longshore variability in addition to some minor local variations in seawall slope.
