A Constructability Problem in a Deep Shoring System

ABSTRACT: *The construction of deep excavations and retaining structures for the deep basements and infrastructures has frequently been implemented in İstanbul. Primary design concerns for underground construction are the protection of adjacent buildings, properties of the project site, and planned structures; thus, the appropriate selection and design of the retaining wall system are critical for the project's success. This case history presents the design and construction details of the watertight retaining wall for the seven levels of basement which required an excavation depth of up to 30.0m. Considering the presence of high groundwater level in the project area, the temporary retaining system initially consisted of secant bored piles with a diameter of 1.0m and 0.2m overlapping, supported by multilevel prestressed anchors along the entire site perimeter. During the construction of the secant piles, it was seen that the mechanical properties of the encountered rock units of Trakya Formation were better than the expected in design phase, and therefore piles could be constructed with a length of approximately 25.0m which was 10

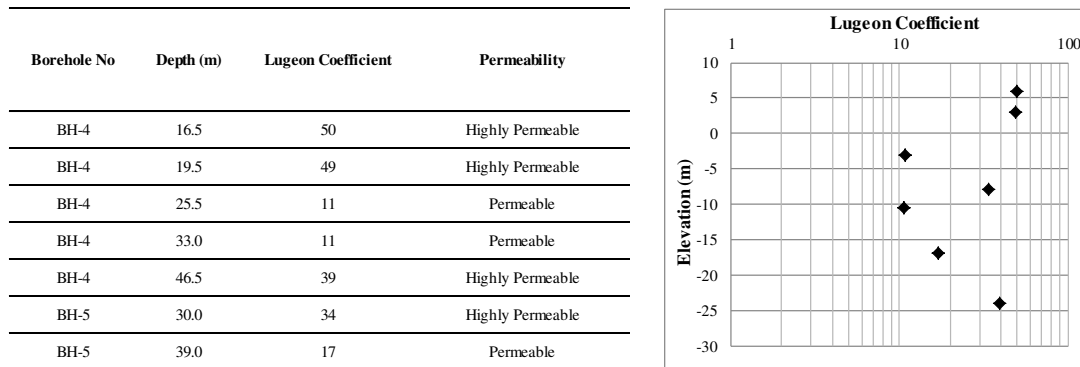
Figure 4. Packer Permeability Test Results.

To determine the permeability characteristics of the Trakya formation rock units, the packer permeability tests were conducted within the suitable rock conditions in BH-4 and BH-5 boreholes. The summary of obtained results and the variation of the Lugeon coefficient versus elevation are given in Figure 4. The Lugeon values are $L_v=10$ to 50, indicating permeable to highly permeable formation.

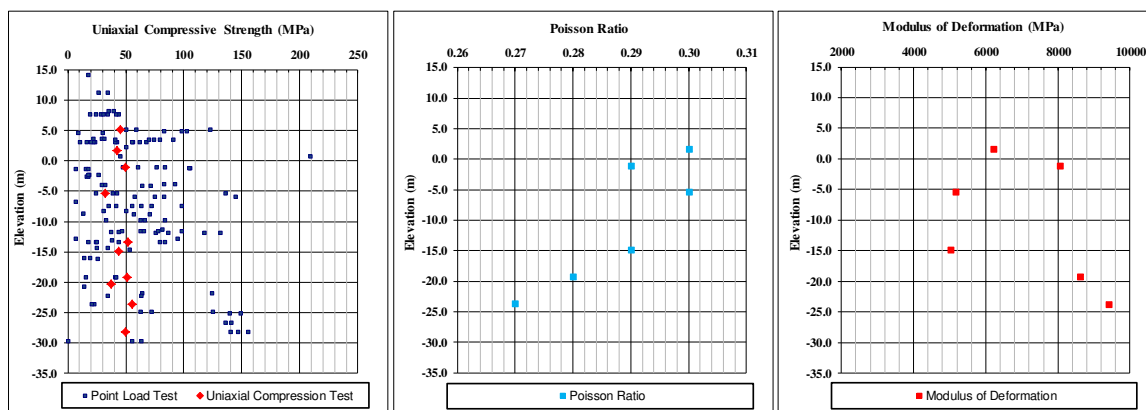
Figure 5. Rock Mechanics Laboratory Test Results.

The following soil laboratory tests were performed: sieve analysis, hydrometer tests, specific gravity, Atterberg limits, natural water content, consolidation, and undrained unconsolidated triaxial tests. Point load and uniaxial compression tests (with deformation modulus) were performed on obtained rock core samples. The results are summarized in Table 2 and Figure 5.
