## A Constructability Problem in a Deep Shoring System

Reference: Köpüklü H., Ekli O., Akçakal Ö., Durgunoğlu H. T. (2021). A Constructability Problem in a Deep Shoring System. International Journal of Geoengineering Case Histories, Volume 6, Issue 1, pp. 53-66, doi: 10.4417/IJGCH-06-01-03

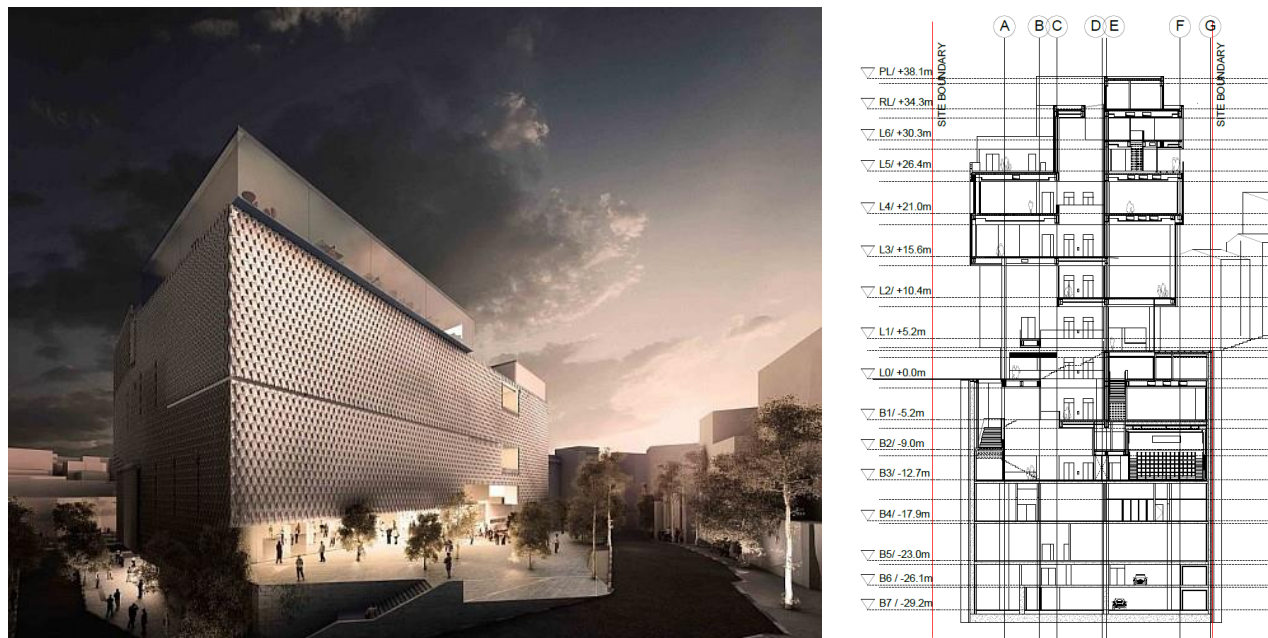
Figure 1. Architectural View and Section of Building.

The subject site is at the Dolapdere District of İstanbul, covering an area of approximately 3397.0m<sup>2</sup> with additional green areas. The project area is located at Dereboyu Street, and is surrounded by Can Eriği, Yeni Bostan, and Keresteci Ali Streets. After the demolition of the old existing building, plans are made for a contemporary gallery with 7 stories and 7 basements to be constructed. The gallery covers approximately 1214.0m<sup>2</sup> area, with 18621.0m<sup>2</sup> total construction area. According to the conveyed information the architectural ±0.00m elevation will be as +22.00m. The foundation depth is 31.2m and base elevation will be -9.15m. The architectural view and cross section of the building is given in Figure 1.

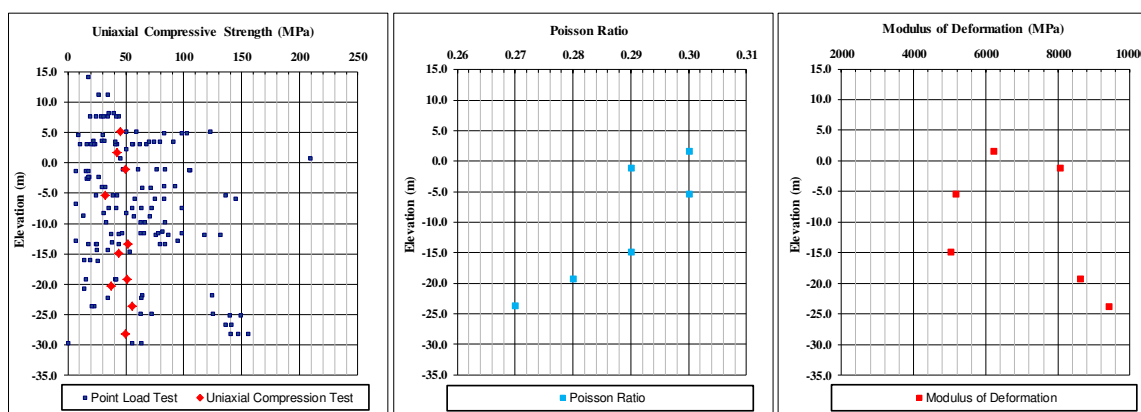
Figure 5. Rock Mechanics Laboratory Test Results.

The following soil laboratory tests were performed: sieve analysis, hydrometer tests, specific gravity, Atterberg limits, natural water content, consolidation, and undrained unconsolidated triaxial tests. Point load and uniaxial compression tests (with deformation modulus) were performed on obtained rock core samples. The results are summarized in Table 2 and Figure 5.
