A Constructability Problem in a Deep Shoring System

ABSTRACT: *The construction of deep excavations and retaining structures for the deep basements and infrastructures has frequently been implemented in İstanbul. Primary design concerns for underground construction are the protection of adjacent buildings, properties of the project site, and planned structures; thus, the appropriate selection and design of the retaining wall system are critical for the project's success. This case history presents the design and construction details of the watertight retaining wall for the seven levels of basement which required an excavation depth of up to 30.0m. Considering the presence of high groundwater level in the project area, the temporary retaining system initially consisted of secant bored piles with a diameter of 1.0m and 0.2m overlapping, supported by multilevel prestressed anchors along the entire site perimeter. During the construction of the secant piles, it was seen that the mechanical properties of the encountered rock units of Trakya Formation were better than the expected in design phase, and therefore piles could be constructed with a length of approximately 25.0m which was 10

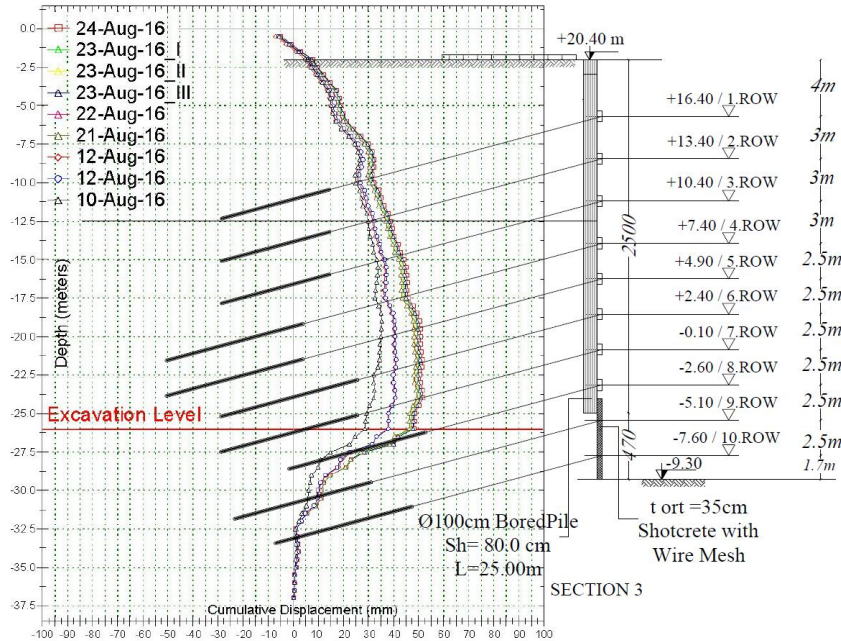
Figure 10. Encountered Excessive Displacements on Section 3.

In the excavation phase of Section 3, the lateral displacement exceeded the critical limit (45mm) in the middle of August 2016. Following immediate discussion by the client, contractor, and project engineers, mitigation measures were determined.

In the second half of August 2016, toe filling was carried out up to the middle of 6th and 7th row prestressed anchor levels (19.25m depth, +1.15m elevation), and six additional prestressed anchors (each 32.0m in length) were installed.
