A Constructability Problem in a Deep Shoring System

KEYWORDS: Deep Excavation, Retaining Wall, Secant Bored Pile, Prestressed Anchors, Shotcrete, Inclinometer Measurements

Reference: Köpüklü H., Ekli O., Akçakal Ö., Durgunoğlu H. T. (2021). A Constructability Problem in a Deep Shoring System. International Journal of Geoengineering Case Histories, Volume 6, Issue 1, pp. 53-66, doi: 10.4417/IJGCH-06-01-03

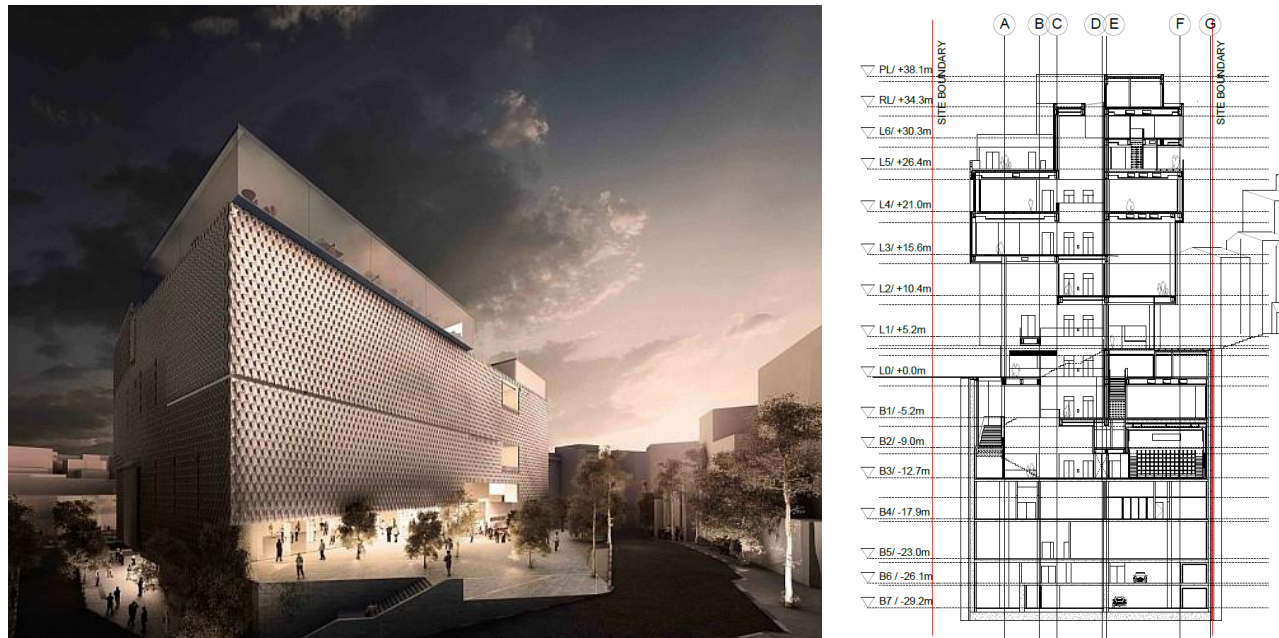
Figure 1. Architectural View and Section of Building.

The subject site is at the Dolapdere District of İstanbul, covering an area of approximately 3397.0m² with additional green areas. The project area is located at Dereboyu Street, and is surrounded by Can Eriği, Yeni Bostan, and Keresteci Ali Streets. After the demolition of the old existing building, plans are made for a contemporary gallery with 7 stories and 7 basements to be constructed. The gallery covers approximately 1214.0m² area, with 18621.0m² total construction area. According to the conveyed information the architectural ±0.00m elevation will be as +22.00m. The foundation depth is 31.2m and base elevation will be -9.15m. The architectural view and cross section of the building is given in Figure 1.

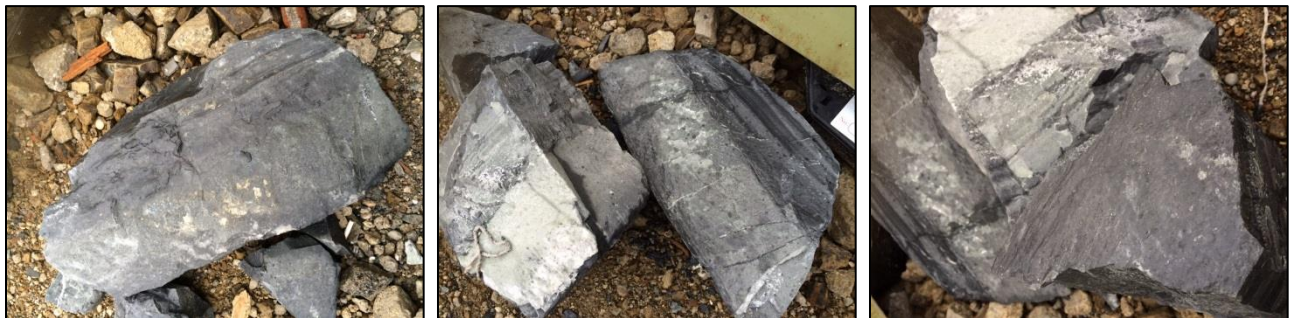
Figure 8. Encountered Diabase Units.

During the pile installation, it was observed that the strength of the Trakya Formation rock units fared better than expected, especially below the 25.0m depth (-4.6m elevation). The progress rate of the drilling unit was controlled regularly for each pile; it is shown that the progress rate was less than 1.0m/hour after 25.0m depth. Additionally, magmatic origin diabase blocks were encountered after a certain depth.

Diabase, also called Dolerite, is a fine- to medium-grained, dark gray to black intrusive igneous rock. It is extremely hard and tough and compositionally equivalent to gabbro and basalt but is texturally between them. It occurs mostly in shallow intrusions (dikes and sills) of basaltic composition. It grades to basalt when it solidifies rapidly and to gabbro when more time is provided for the crystals to grow.

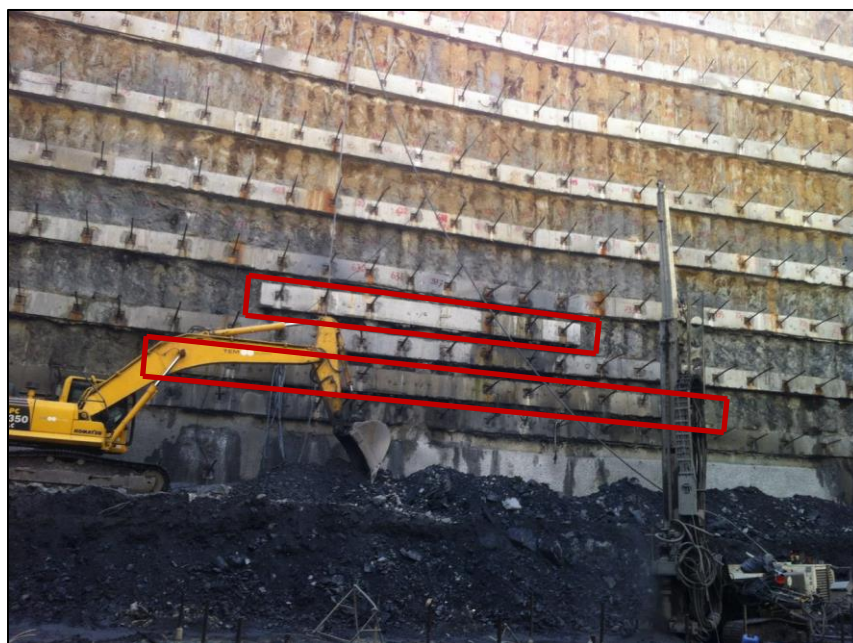
Figure 11. Additional Anchors on Section 3.

At the beginning of September 2016, excessive lateral displacements were observed again in the inclinometer readings. An additional ten prestressed anchors, each 32.0m in length, were also implemented between the 7th and 8th row anchor levels. A frontal view of Section 3 is shown in Figure 11.
