The Multi-Purpose Bottom Plug for the Galataport Project

ABSTRACT: The paper describes an innovative geotechnical engineering solution that was provided by TREVI for the renovation project at Galataport in Istanbul, Turkey. Among other interesting geotechnical works included in the project, this paper also presents the design considerations and construction of the multi-purpose bottom plug (MPBP). This original geotechnical engineering solution was employed for a three-basement excavation in Karaköy and consists of a combination of seepage control, ground improvement, and load bearing elements, which were executed with double-fluid jet grouting, pseudo-elliptical jet grouting, and permanent micropiles, respectively. The paper describes each step of the design, execution, and the preliminary and final testing phases. Moreover, it highlights the importance of employing cutting-edge technologies used in deep foundation geo-construction and state-of-the-art electronic control devices, along with expertise, to obtain the desired results for this high-profile project.

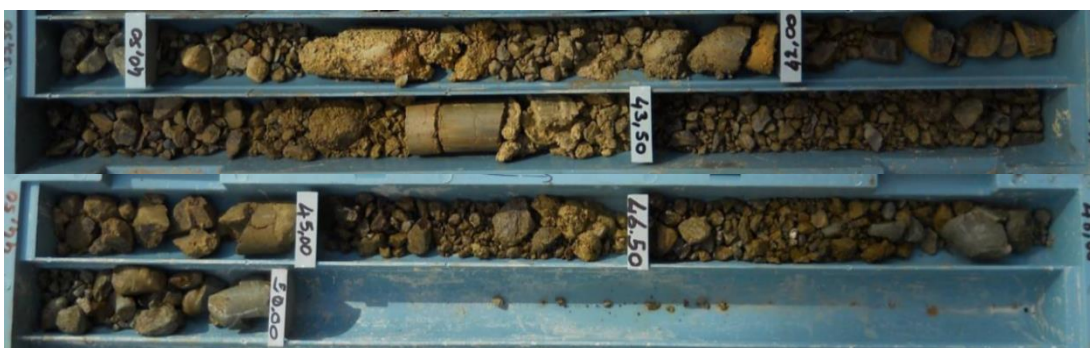
Figure 7. Very weathered GREYWACKE.

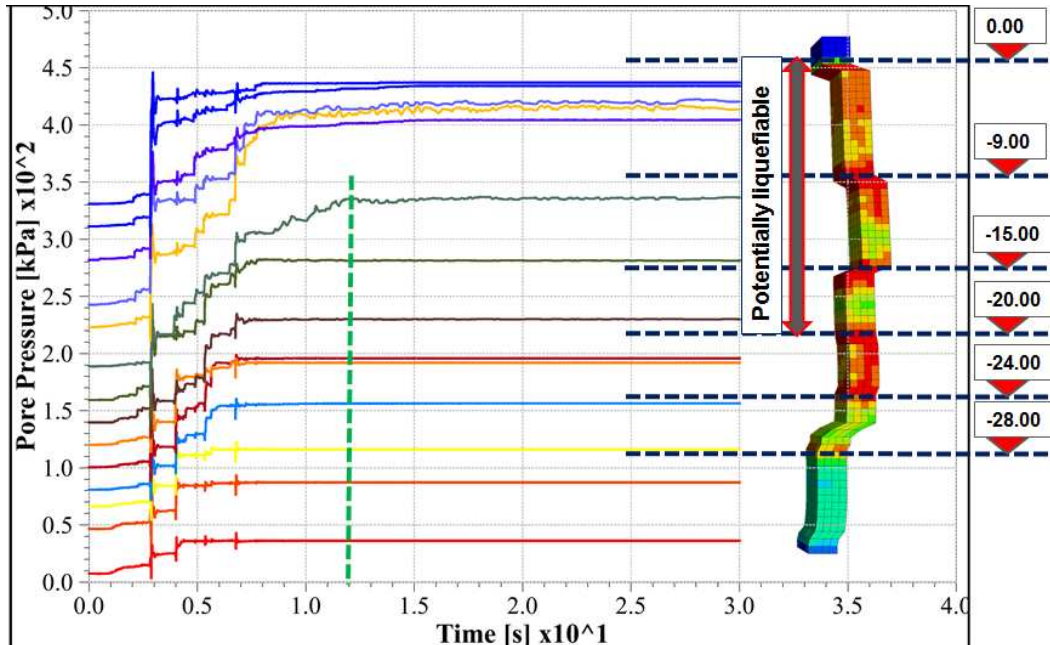
The results of the main analysis are shown in Figures 16 and 17: the red points are those where the ratio R_u between the excess pore pressure and the effective vertical stress reach the value of 1. It is possible to notice that, in natural soil, liquefaction occurs down to a depth of 24 m below the groundwater table. Instead, in the presence of the soil improvement, the value of R_u approaches 1 in just a thin band beneath the soil treatment. The 7 m x 7 m grid was selected; the 10 m x 10 m option provided satisfactory results but presented some local liquefaction phenomena at the surface of the excavation.

Figure 16. Pore pressure history and Max R_u in natural soil.

The different coloured lines in Figures 16 and 17 represent the pore pressure history at various depths. The two green rectangular blocks in Figure 17 represent the cross section of the jet grouting cell.

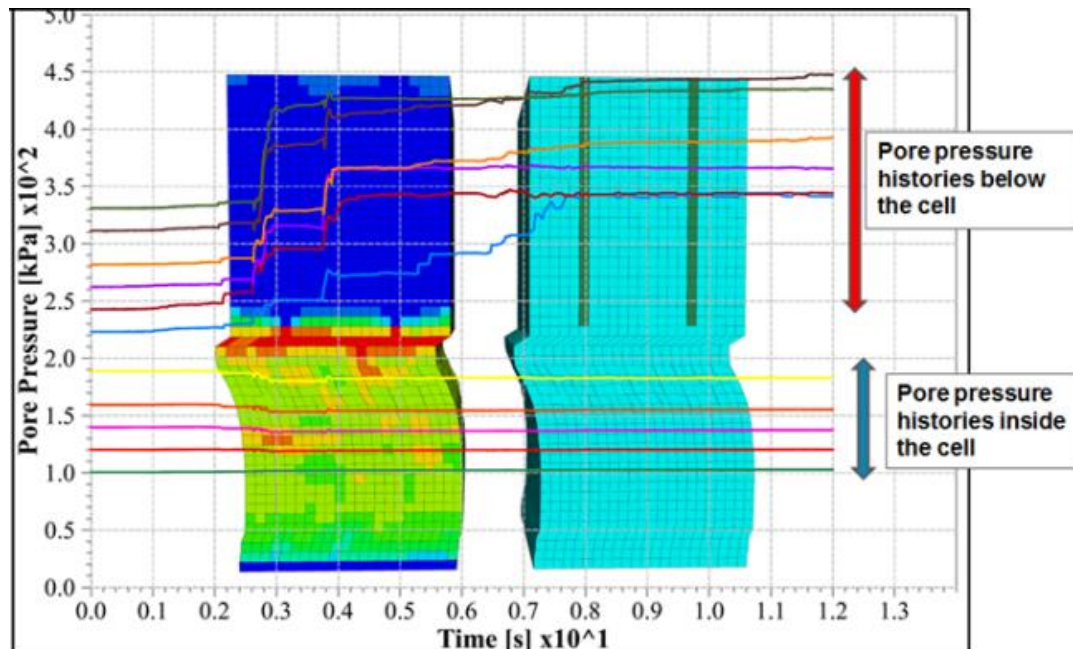
Figure 17. Pore pressure history and Max R_u in improved soil.

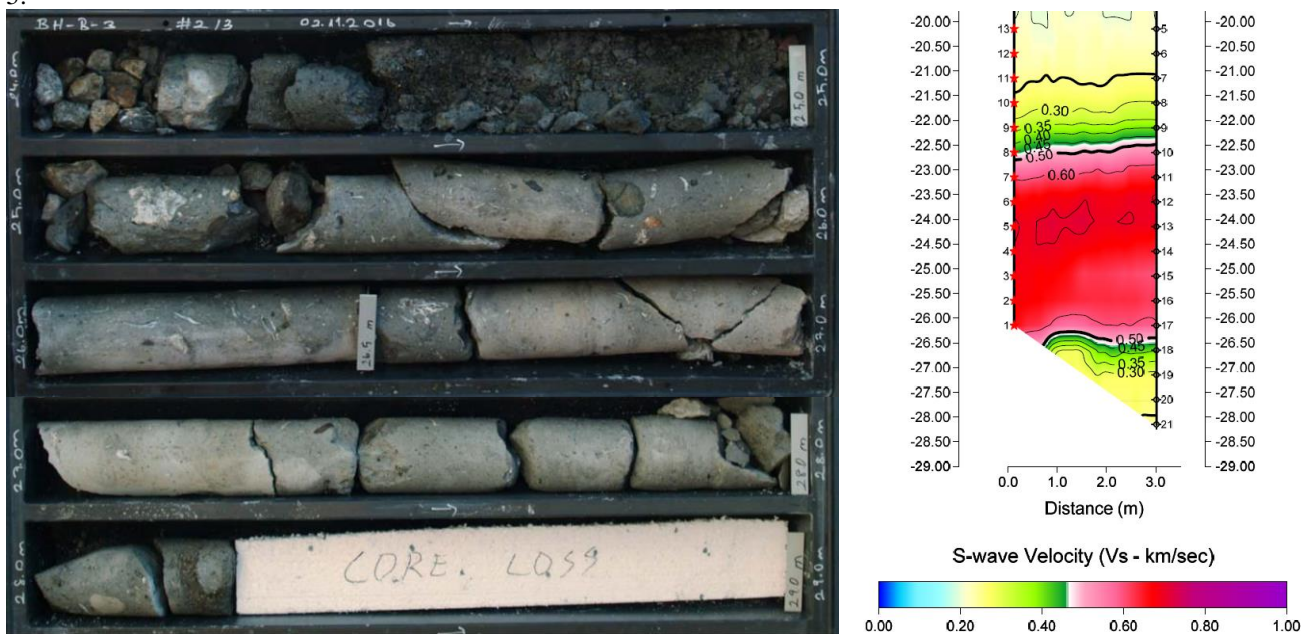
Figure 25. Core box photos of coring BH-B-3 between 24 and 29 m depth. Measured V_s across overlapping columns.

Several cracks were visible on the extracted core, which could be due to the coring effects but could be also related to the overlapping of two different jet grouting columns.

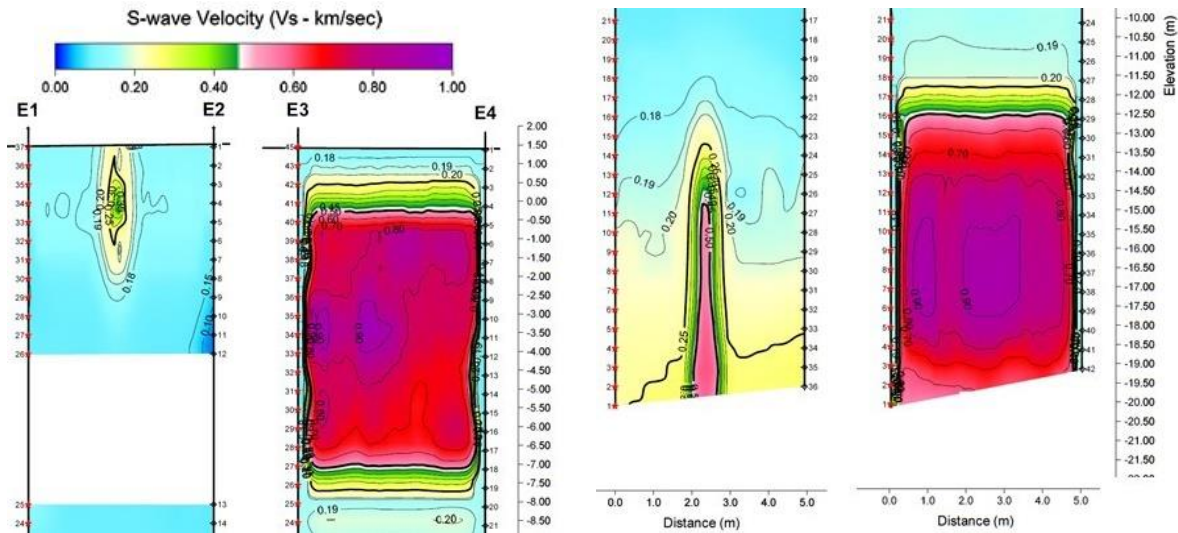
Figure 26. Measured Vs for E-JG-1 and E-JG-2.

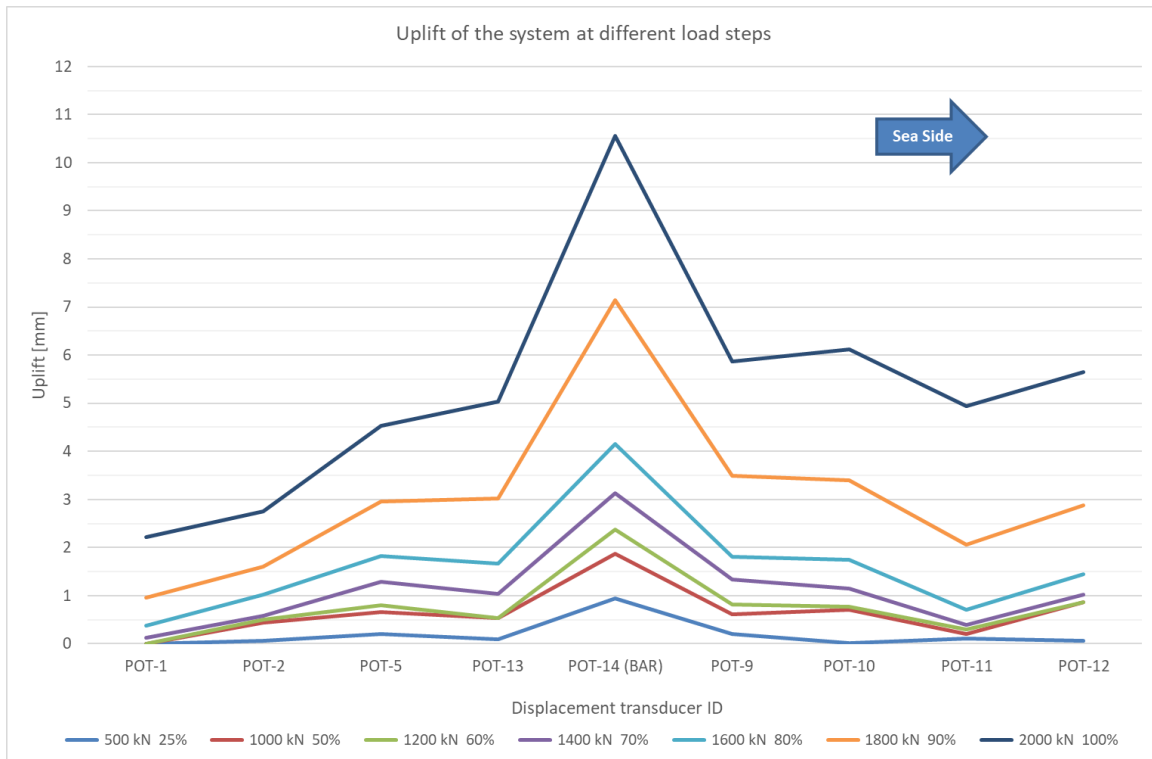
Figure 32. Uplift of elliptical jet grouting column and DCP bar at different load steps.

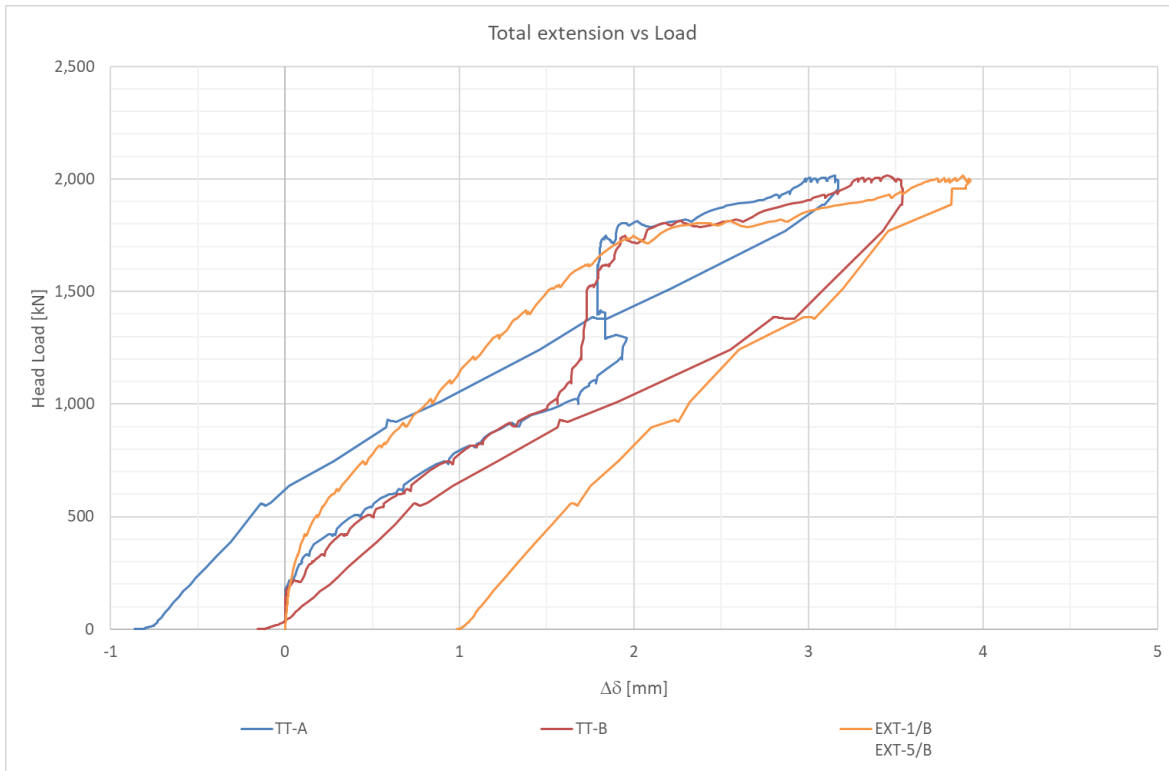
Figure 34. Total extension versus load.

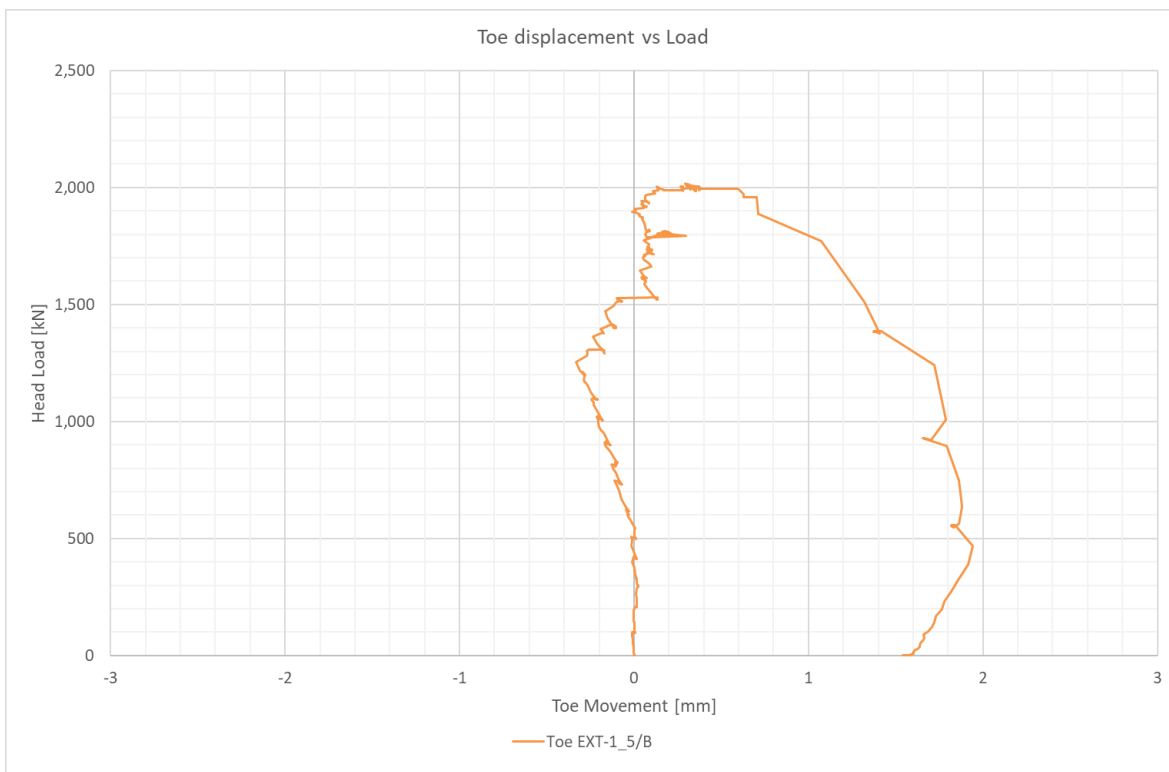
Figure 35. Toe movement versus load.

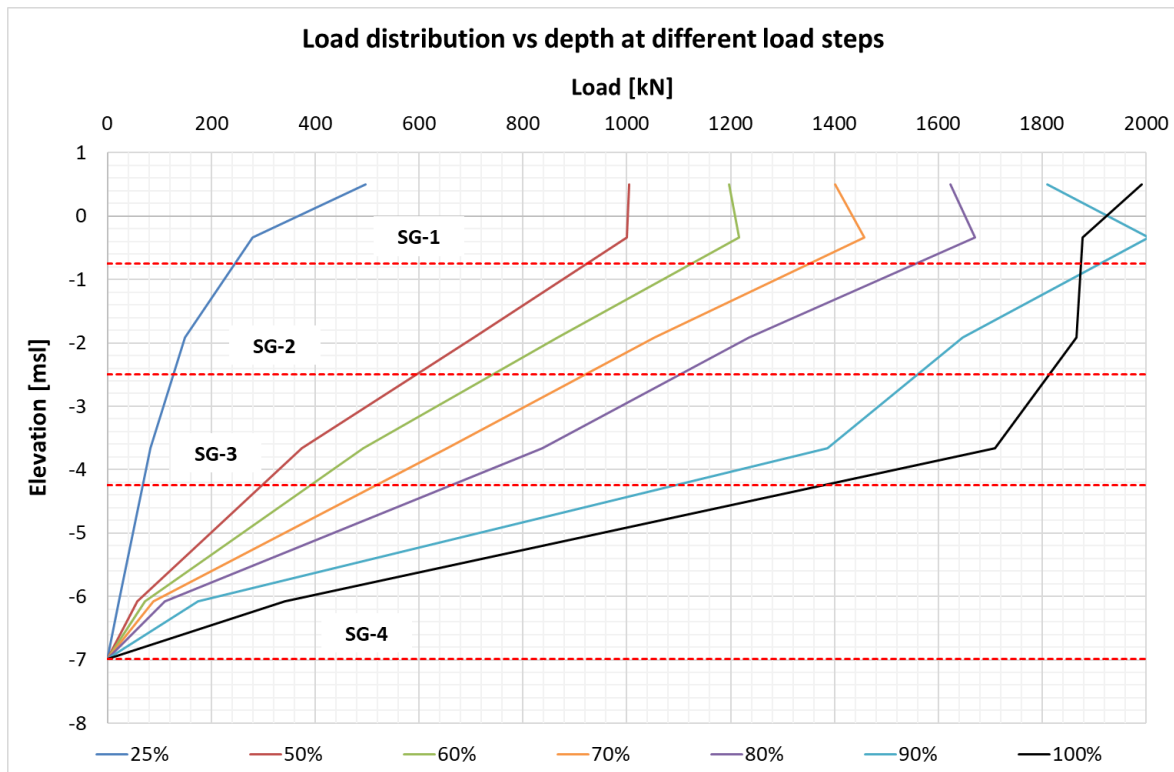
The load distribution (Figure 37) and relevant t-z curves along the micropile shaft (Figures 38 and 39) were calculated according to Fellenius et al (2000). It was possible to see that in the top portion of micropile near ground surface, the limit shaft friction is about 25 to 30 kPa and 300 to 350 kPa at the micropile-to-jet grouting interface and at the jet grouting-to-soil interface, respectively. At greater depths, the shaft friction values of 57 kPa and 720 kPa were achieved at micropile shaft and jet grouting shaft, respectively.

Figure 37. Load distribution at different load steps.

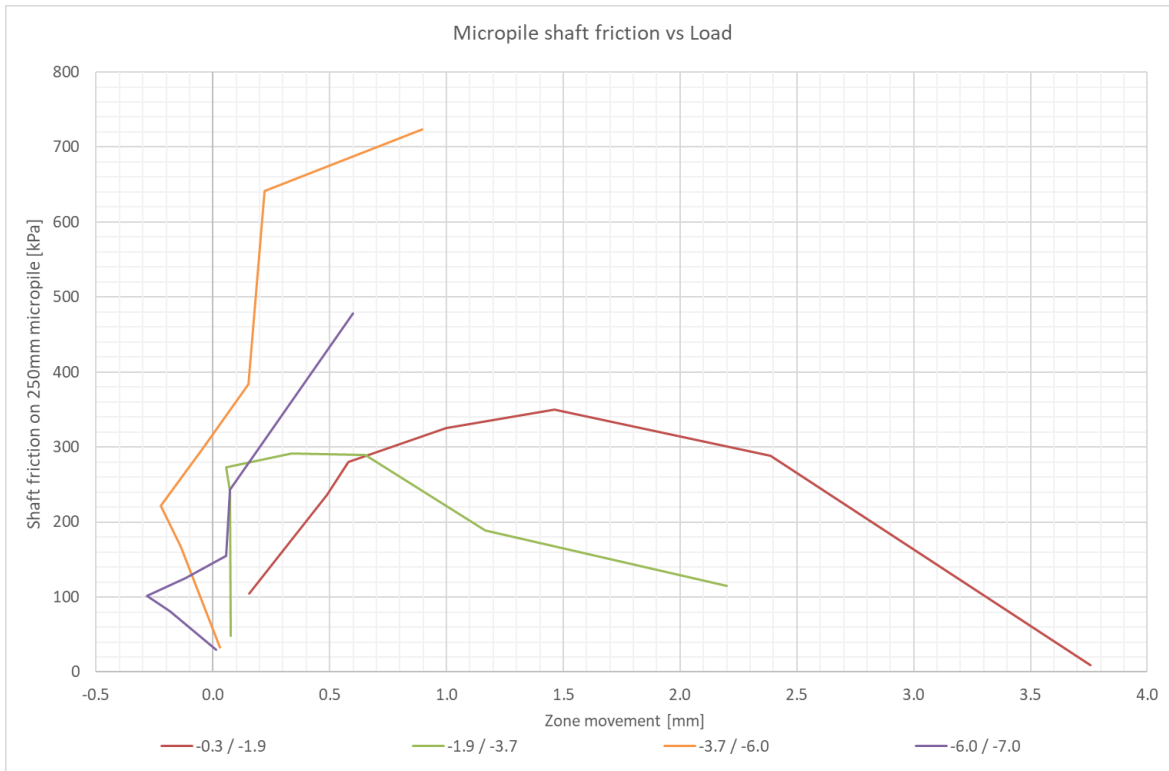
Figure 38. Micropile-to-jet grouting shaft friction vs zone movement.

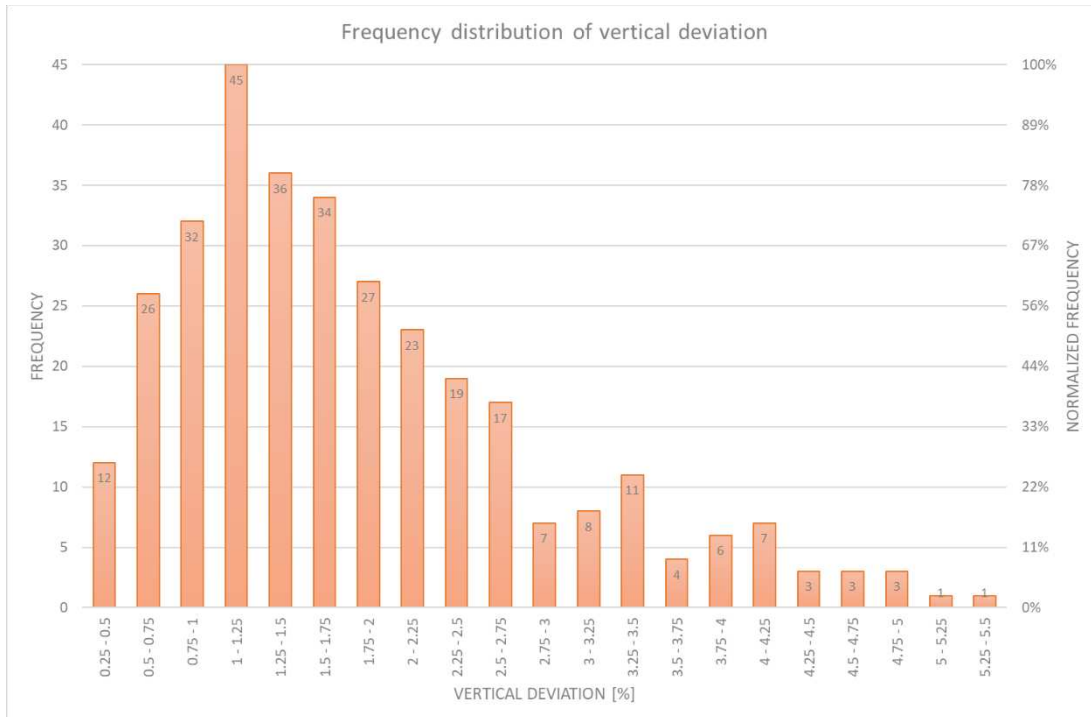
The technologies involved and the electronic control devices employed for the execution of the MPBP are latest-generation. For the execution of the double fluid jet grout bottom plug, the drill rigs were equipped with the “Jet-Vision System” and with the “Drilling Position System” (DPS) electronic devices. The former controls and monitors the automatic rising of the drilling tool/rods during the jetting phase; the latter controls the 3D position of the drilling tool during the drilling phase, which is needed to ensure the overlapping between the jet grouting columns and the consequent successful execution of the bottom plug. The DPS consists of an inclinometer attached to the bottom of a drilling rod string, which takes readings at pre-determined depths (usually every 0.5 m to 1.0 m) during the drilling process. Recorded deviation data are downloaded at the end of each executed jet grouting column. As an example, the measured frequency distribution of vertical deviation is shown in Figure 40 and has a median of 1.41 % and a standard deviation of 1.33 %.

Figure 40. Frequency distribution of vertical deviation during drilling, measured with DPS.

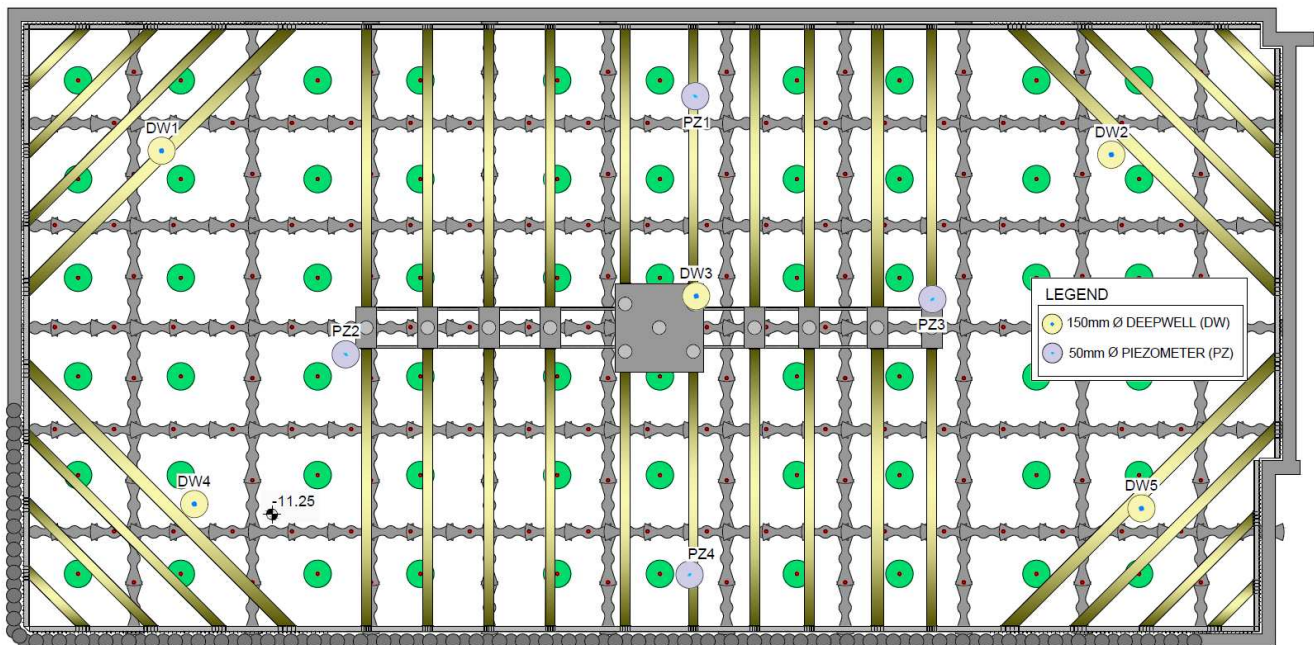
Five deepwells and four piezometers were installed in the Bina 4 excavation area (Figure 42). In reality, the ingress of water can happen through the whole system consisting of the jet grout bottom plug, secant piles, and diaphragm wall; however, it is assumed that the surrounding shoring is almost watertight and that the water inflow affects mainly the bottom plug.

Figure 42. Pumping test layout.

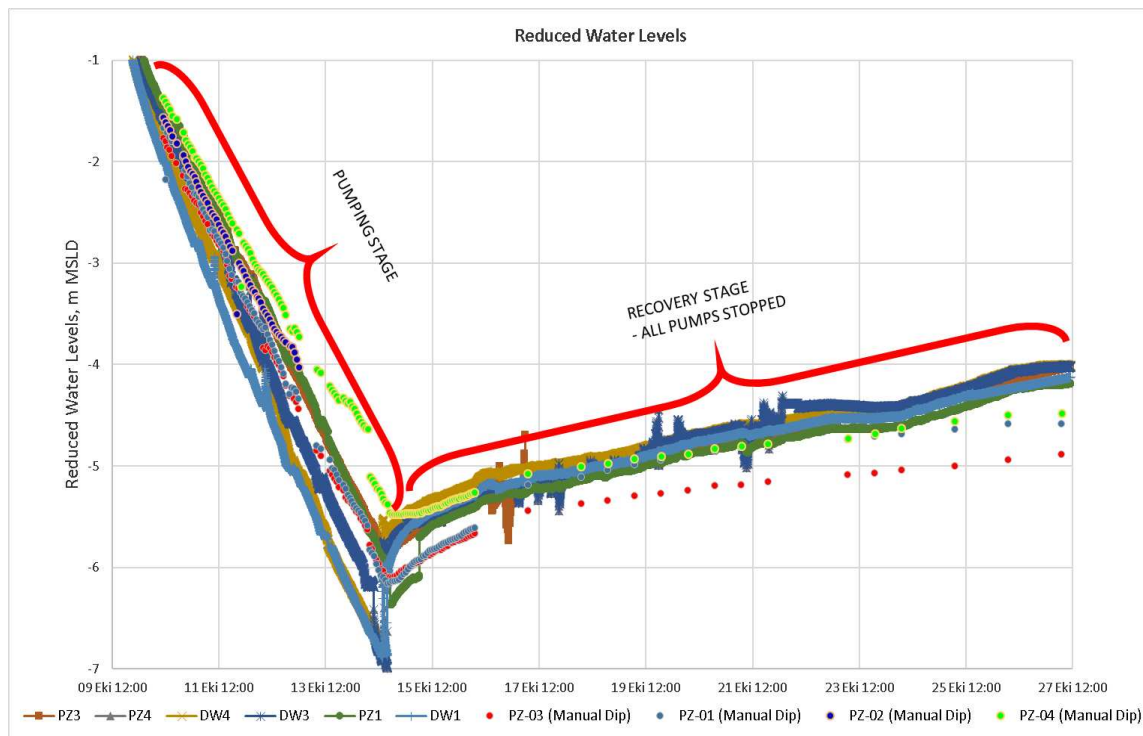
The drawdown phase was run from 9 to 14 October 2017, and the groundwater table was lowered from the original El. 0.00 msl to around El. -5.0 msl. The recharge phase followed. In addition to the manual readings, the water level in three deepwells (DW-1-3-4) and three piezometers (PZ-1-3-4) was automatically measured by means of level loggers. The two phases can be separated and the trendlines generated. The manual and automatic readings taken during the drawdown phase are shown in Figures 44 and 45 and relevant trendlines have an average slope of -1 m/day, showing that for every one day period, there is a 1 m drop in water level. During the recharge phase, a slope between 0.05 and 0.07 m/day was measured with manual readings (Figure 46), while 0.10 to 0.12 m/day was measured by the automatic level logger (Figure 47).

Figure 43. Water levels during pumping test.

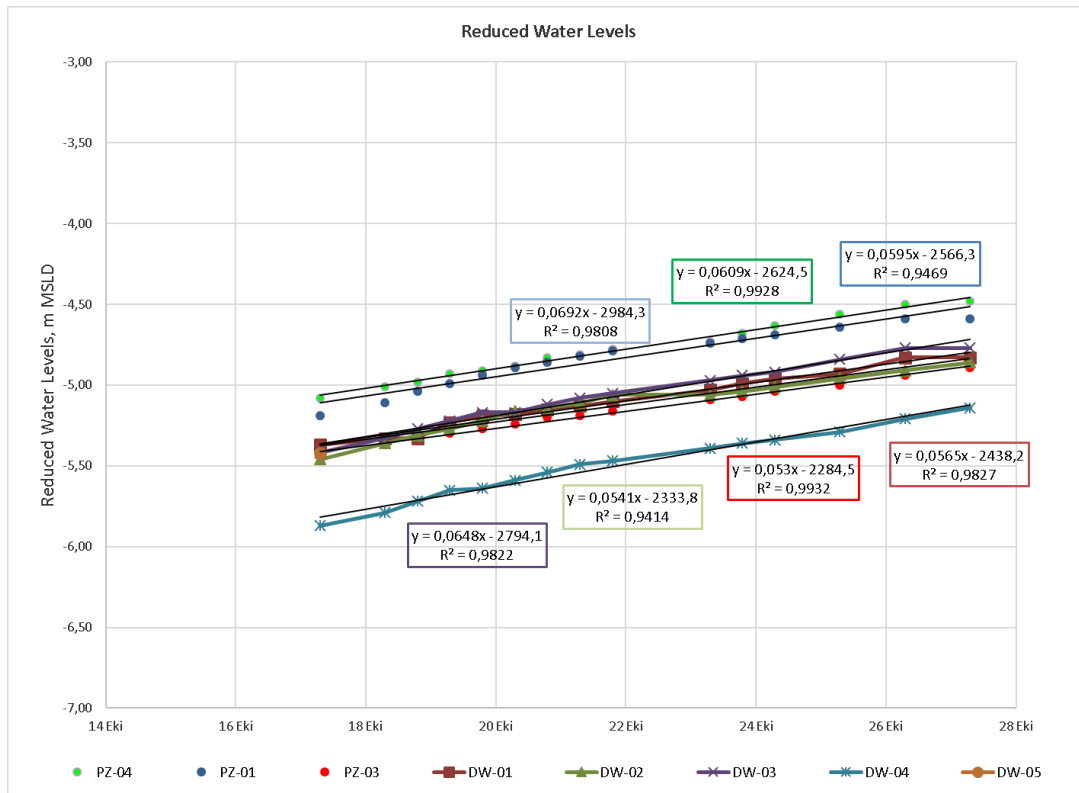
Figure 46. Graph of Manual Dipmeter Readings in Recovery Stage.

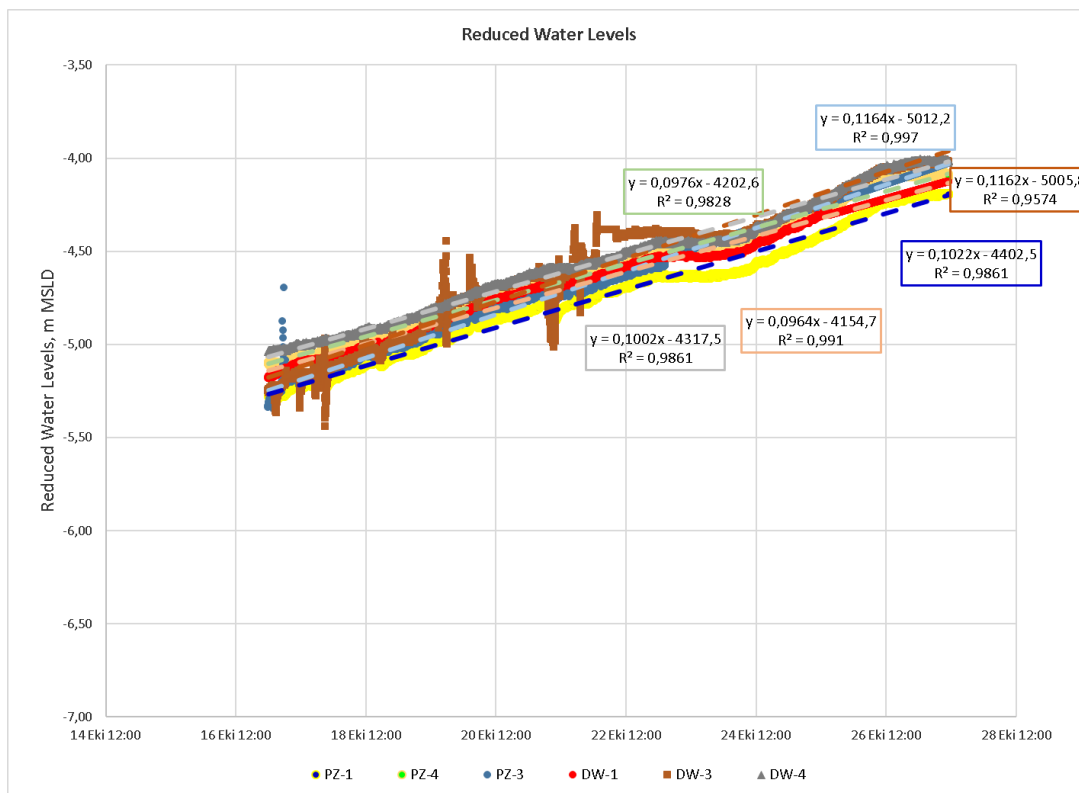
Figure 47. Graph of Automatic Levellogger Readings in Recovery Stage.

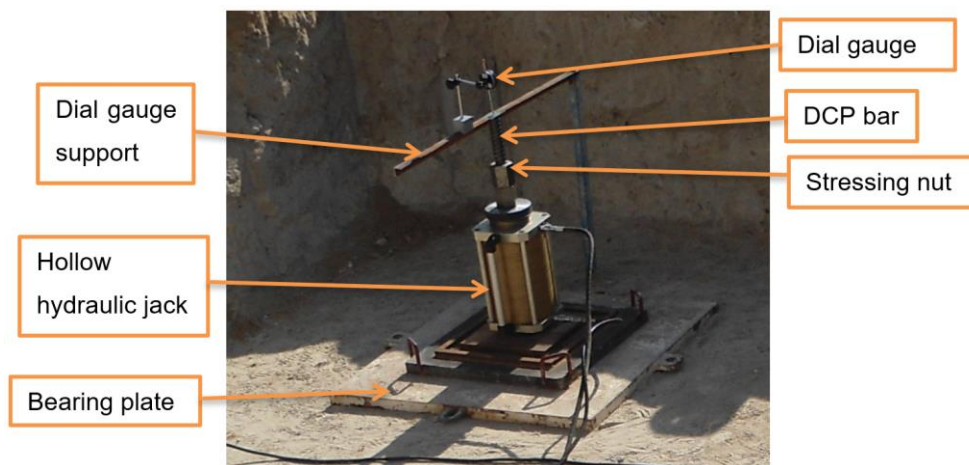
Once the final excavation level was reached, all permanent micropiles were subjected to acceptance testing up to 125% of the design working load (test load of 1,731 kN and design working load of 1,385 kN) to evaluate the micropile response. The typical acceptance test arrangement is shown in Figure 51.

Figure 51. Typical arrangement of acceptance test.
