The Multi-Purpose Bottom Plug for the Galataport Project

Salvatore Miranda, Technical Manager, TREVI Turkey, Istanbul (Turkey); email: smiranda@trevispa.com

ABSTRACT: The paper describes an innovative geotechnical engineering solution that was provided by TREVI for the renovation project at Galataport in Istanbul, Turkey. Among other interesting geotechnical works included in the project, this paper also presents the design considerations and construction of the multi-purpose bottom plug (MPBP). This original geotechnical engineering solution was employed for a three-basement excavation in Karaköy and consists of a combination of seepage control, ground improvement, and load bearing elements, which were executed with double-fluid jet grouting, pseudo-elliptical jet grouting, and permanent micropiles, respectively. The paper describes each step of the design, execution, and the preliminary and final testing phases. Moreover, it highlights the importance of employing cutting-edge technologies used in deep foundation geo-construction and state-of-the-art electronic control devices, along with expertise, to obtain the desired results for this high-profile project.

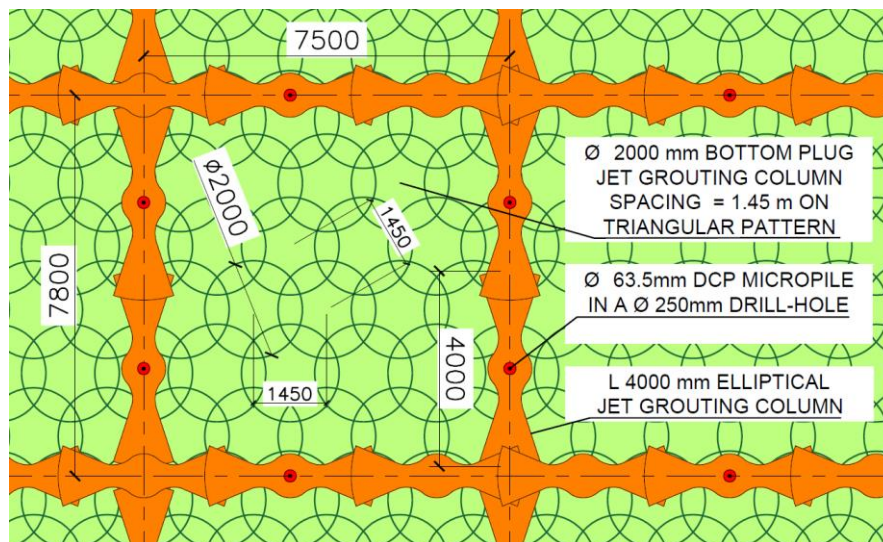
Figure 10. Details of single MPBP element – Plan view.

The multi-purpose bottom plug (MPBP) is an innovative geotechnical solution, which is formed by a combination of seepage control, ground improvement, and load bearing elements (Figures 10 and 12).

The main body of the bottom plug is composed of overlapping jet grouted circular columns executed with the double-fluid method and designed to have a diameter of 2,000 mm. The columns are executed on a triangular pattern with an average center-to-center spacing of 1,450 mm. The thickness of the bottom plug is the one constraint necessary to ensure the hydraulic stability of the excavation.

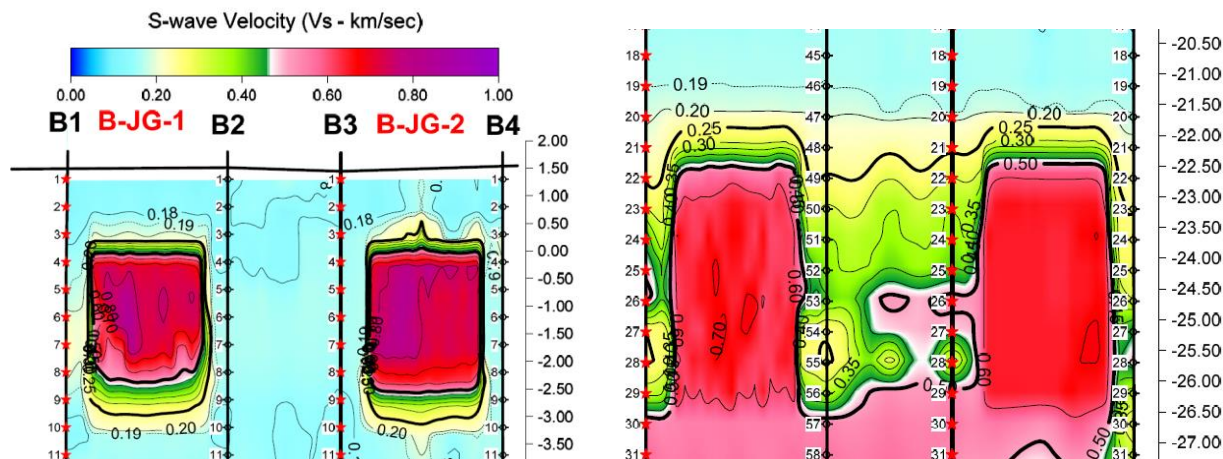
Figure 24. Measured V_s for columns B-JG-1 and B-JG-2 at two different depths.

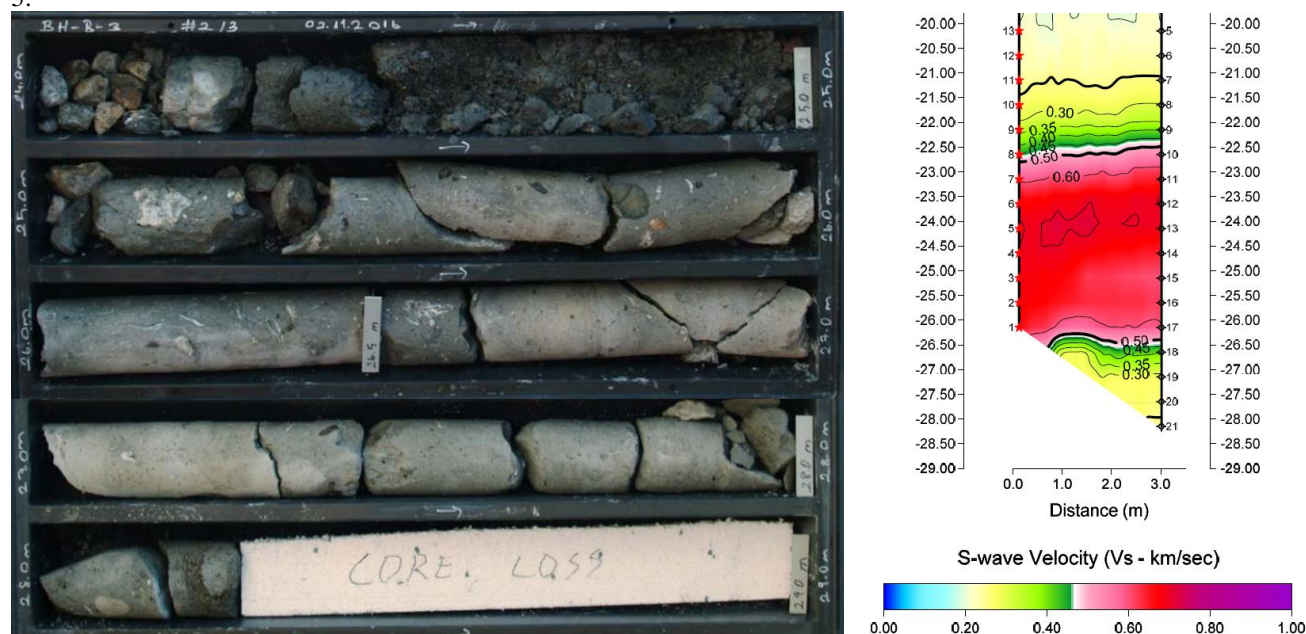
Figure 25. Core box photos of coring BH-B-3 between 24 and 29 m depth. Measured V_s across overlapping columns.

Several cracks were visible on the extracted core, which could be due to the coring effects but could be also related to the overlapping of two different jet grouting columns.

group of six overlapping columns (B-JG-3 to 8) at the design depth of bottom plug. Two continuous corings were executed in the overlapping zones and one seismic crosshole tomography line was also conducted across the columns to verify the presence and quality of the overlapping. Pictures of one coring (BH-B-3) and measured values of shear wave velocity (V_s) can be found in Figure 25. The results of the seismic crosshole tomography executed on the overlapping columns show a full overlapping and continuity in the block of treated soil without relevant defects. The median measured value of V_s was 640 m/s.

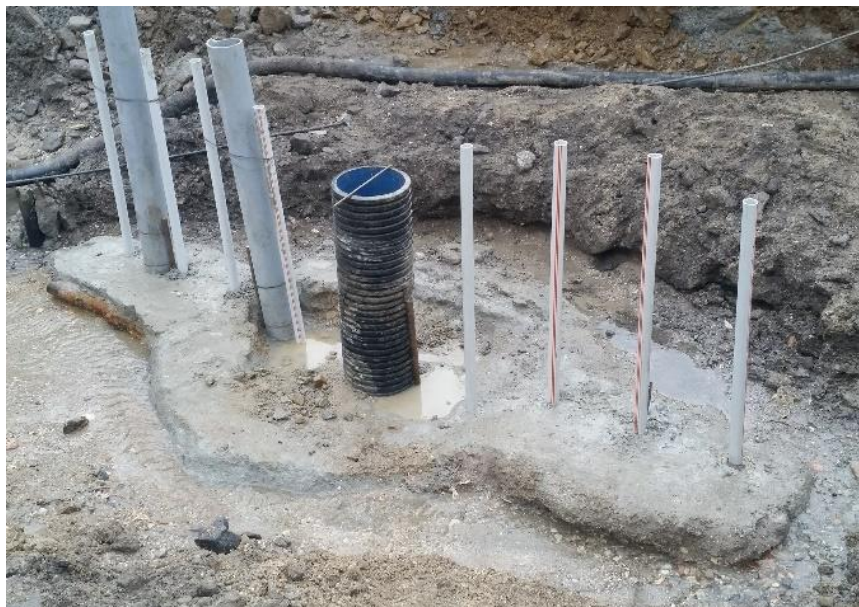
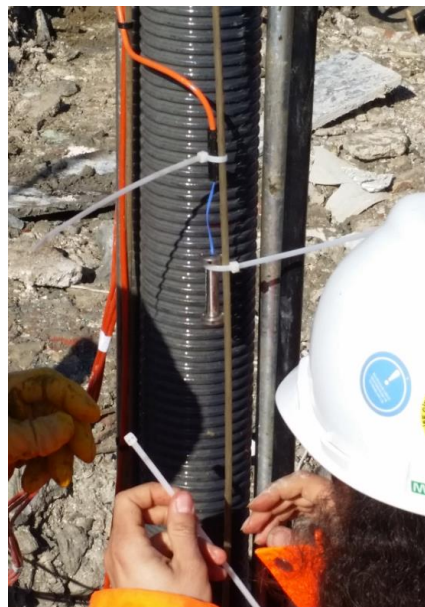
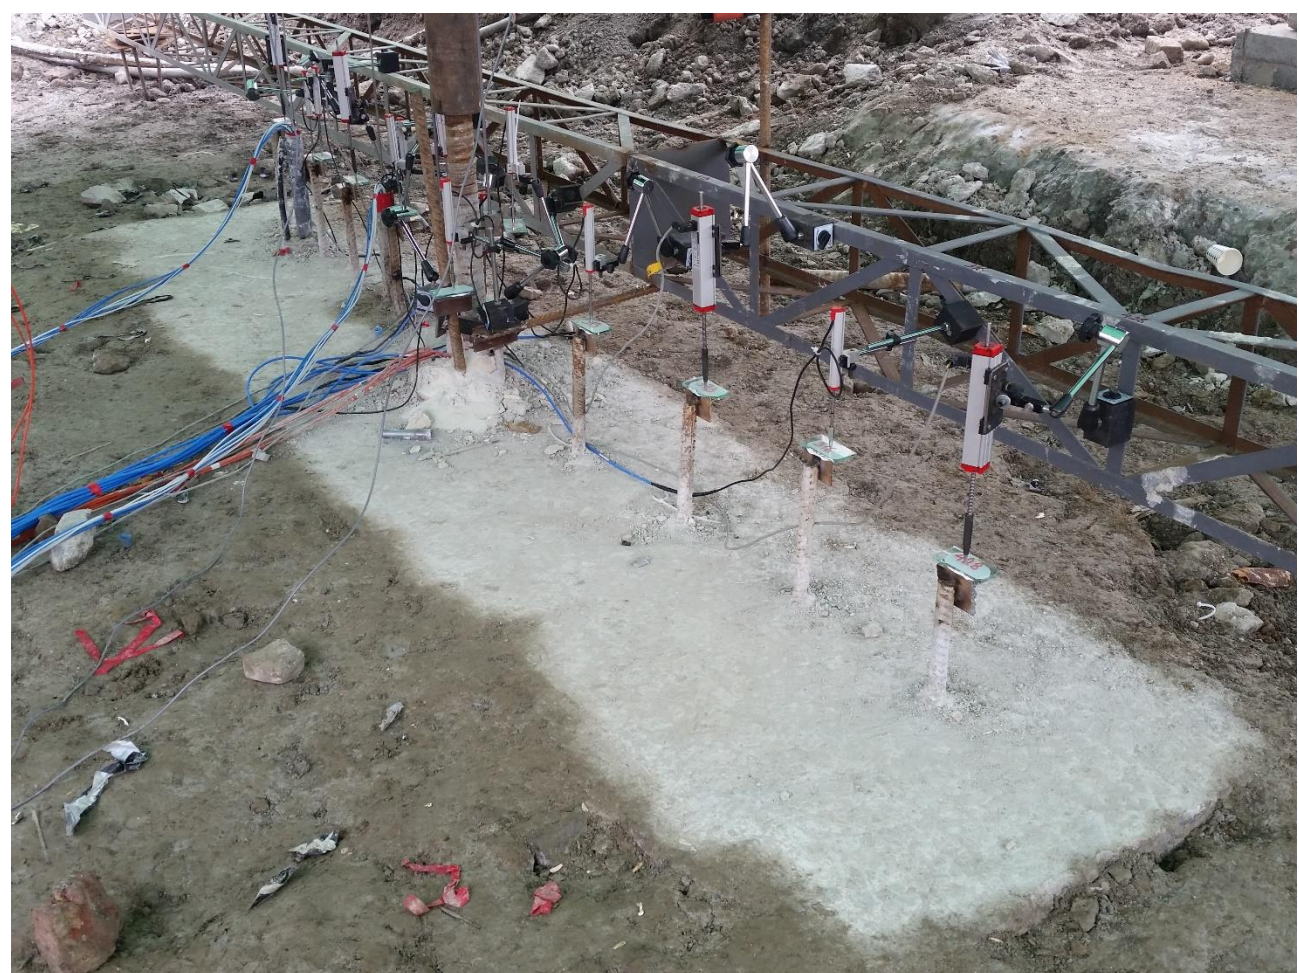
Figure 30. (a) Exposed jet grouting column and preparation for drilling; (b) Installation of instrumented DPC bar, with visible vibrating wire miniature embedment strain gauges; and (c) General view of test set-up.

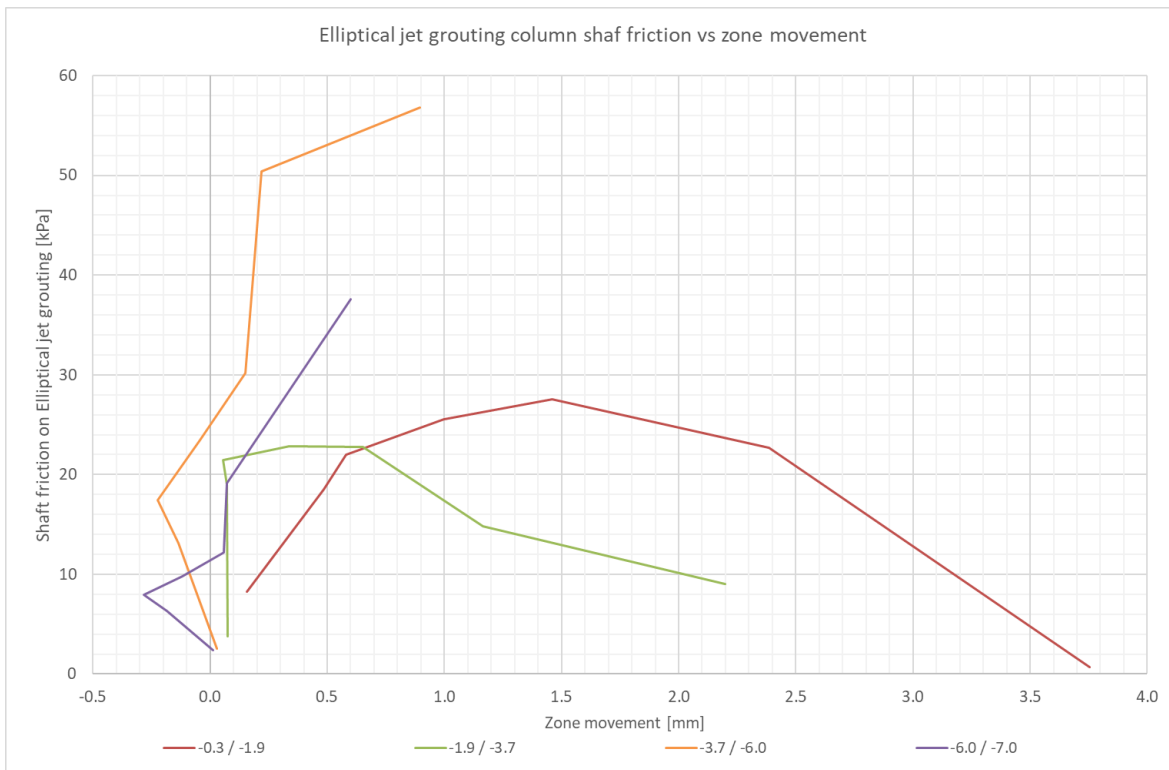
Figure 39. Jet grouting-to-soil shaft friction vs zone movement.

The load distribution (Figure 37) and relevant t-z curves along the micropile shaft (Figures 38 and 39) were calculated according to Fellenius et al (2000). It was possible to see that in the top portion of micropile near ground surface, the limit shaft friction is about 25 to 30 kPa and 300 to 350 kPa at the micropile-to-jet grouting interface and at the jet grouting-to-soil interface, respectively. At greater depths, the shaft friction values of 57 kPa and 720 kPa were achieved at micropile shaft and jet grouting shaft, respectively.
